9 April 2020

Reference No. 1896230-046-L-Rev0

Broken Hill Operations Pty Ltd
Eyre Street
Broken Hill
NSW

LIQUEFACTION ASSESSMENT OF TAILINGS – RASP MINE TAILINGS STORAGE FACILITY 1

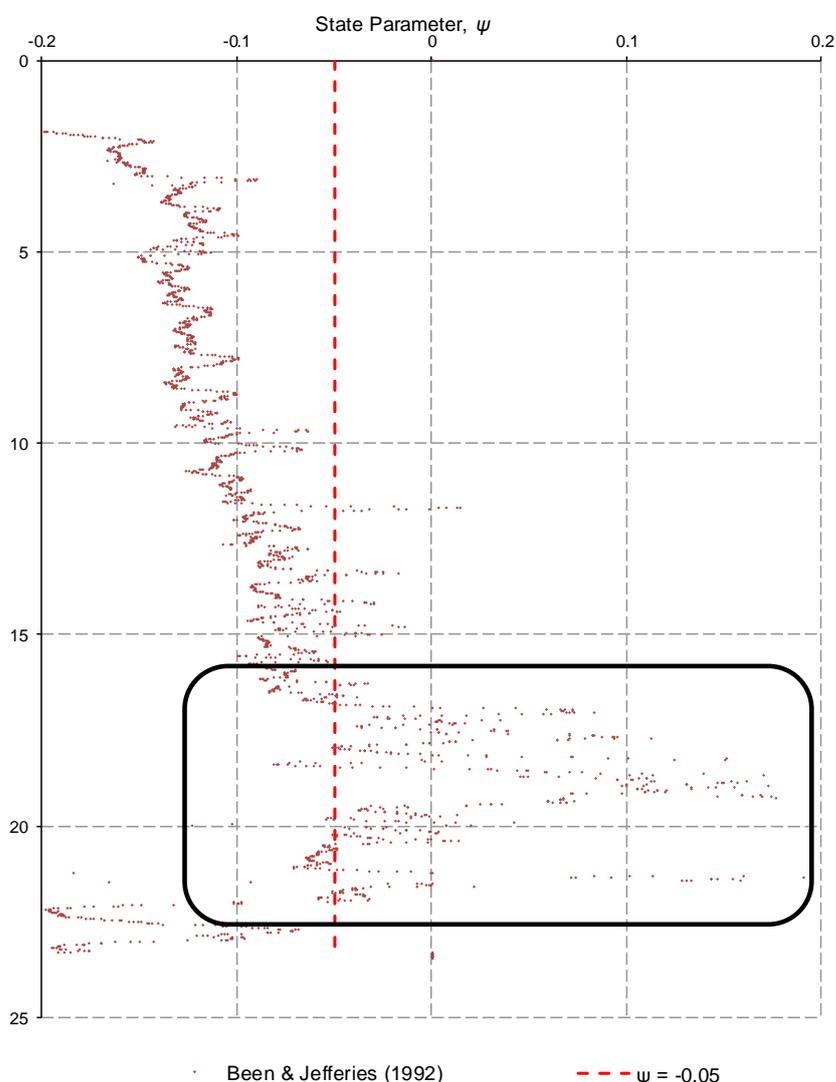
Generally, the upper layers of tailings in the TSF are inferred to be in a dilative state with a characteristic state parameter less than -0.05, and thus not susceptible to static liquefaction. In some probes, there are discrete layers of contractive tailings within the upper portion, however the 85% percentile of test results indicates dilative tailings. Lower layers of tailings are typically contractive having a characteristic state parameter greater than -0.05. An example of the state parameter graph is shown in Figure 1.

Figure 1: State parameter with depth bgl for CPTu 03 (lower layer of contractive tailings highlighted within the boxed zone).

Note at all of the locations the tailings is assessed to be contractive below the elevation of near saturation, except at CPTu 06A. At CPTu 06A the top 4 m of contractive tailings are marginally contractive with a state parameter between 0 and -0.05, with contractive behaviour coinciding with the saturation elevation.

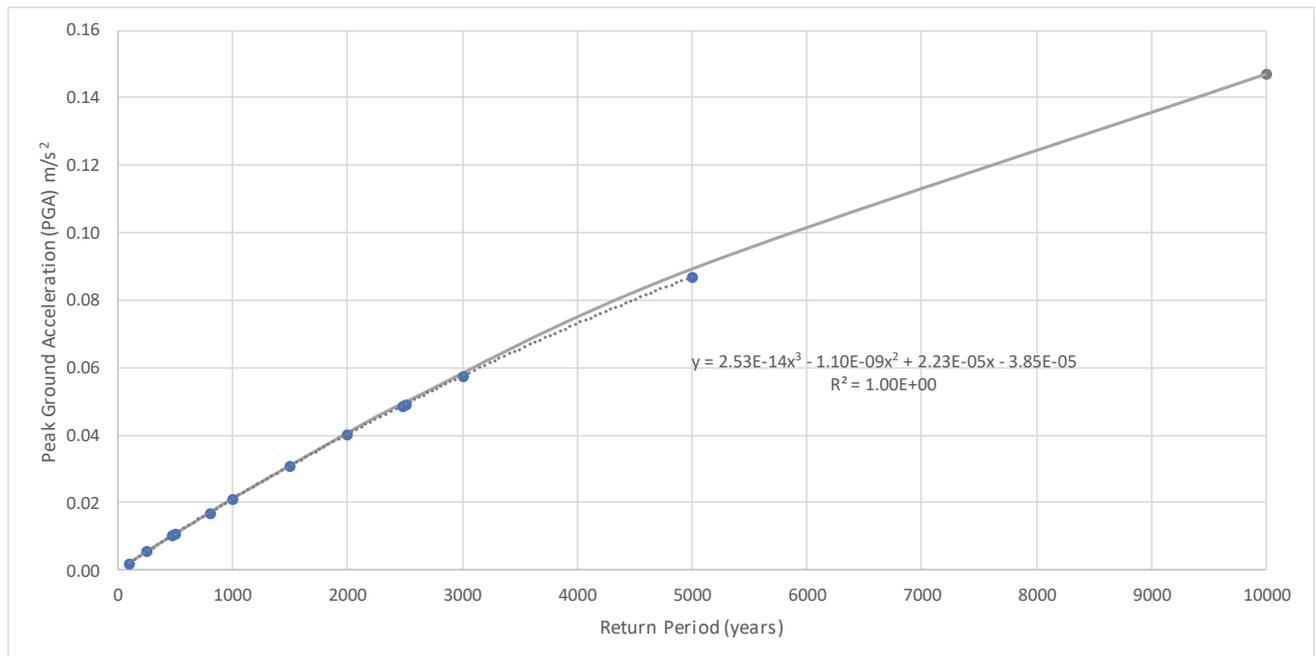
The TSF has been assessed against a maximum credible earthquake (MCE) with a return period of 1 in 10 000 to meet closure requirements outlined in ANCOLD (2019). Geoscience Australia (Allen et al 2018) publishes seismic hazard maps and peak ground accelerations (PGA) for Australia for various return periods up to 5 000 years. In the absence of site specific hazard information we have extrapolated from this data to estimate the PGA for a return period of 10 000 years. This extrapolation is presented in Figure 2. The PGA for this return period is estimated at 0.147m/s².

Figure 2: Return periods and peak ground acceleration relationship

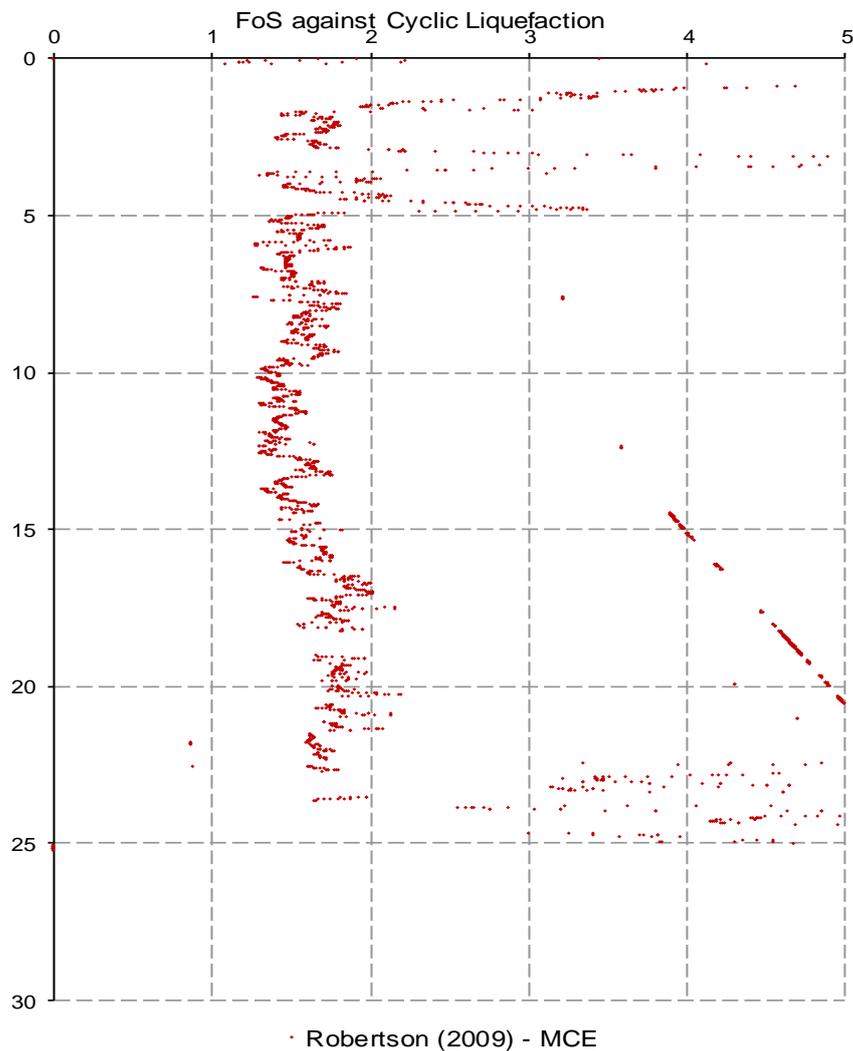
The factor of safety (FoS) against liquefaction is estimated as the ratio of CRR/CSR for a magnitude 7.5 earthquake. Data for all the CPTu's analysed indicate a FoS above 1 for a PGA from a return period of 10 000 years or less (Appendix C). This indicates that the tailings are not expected to liquefy under these conditions. As an example the FoS plot for the results for CPTu 5 are shown in Figure 3.

Figure 3: Factor of safety against MCE cyclic liquefaction for CPTu 05.

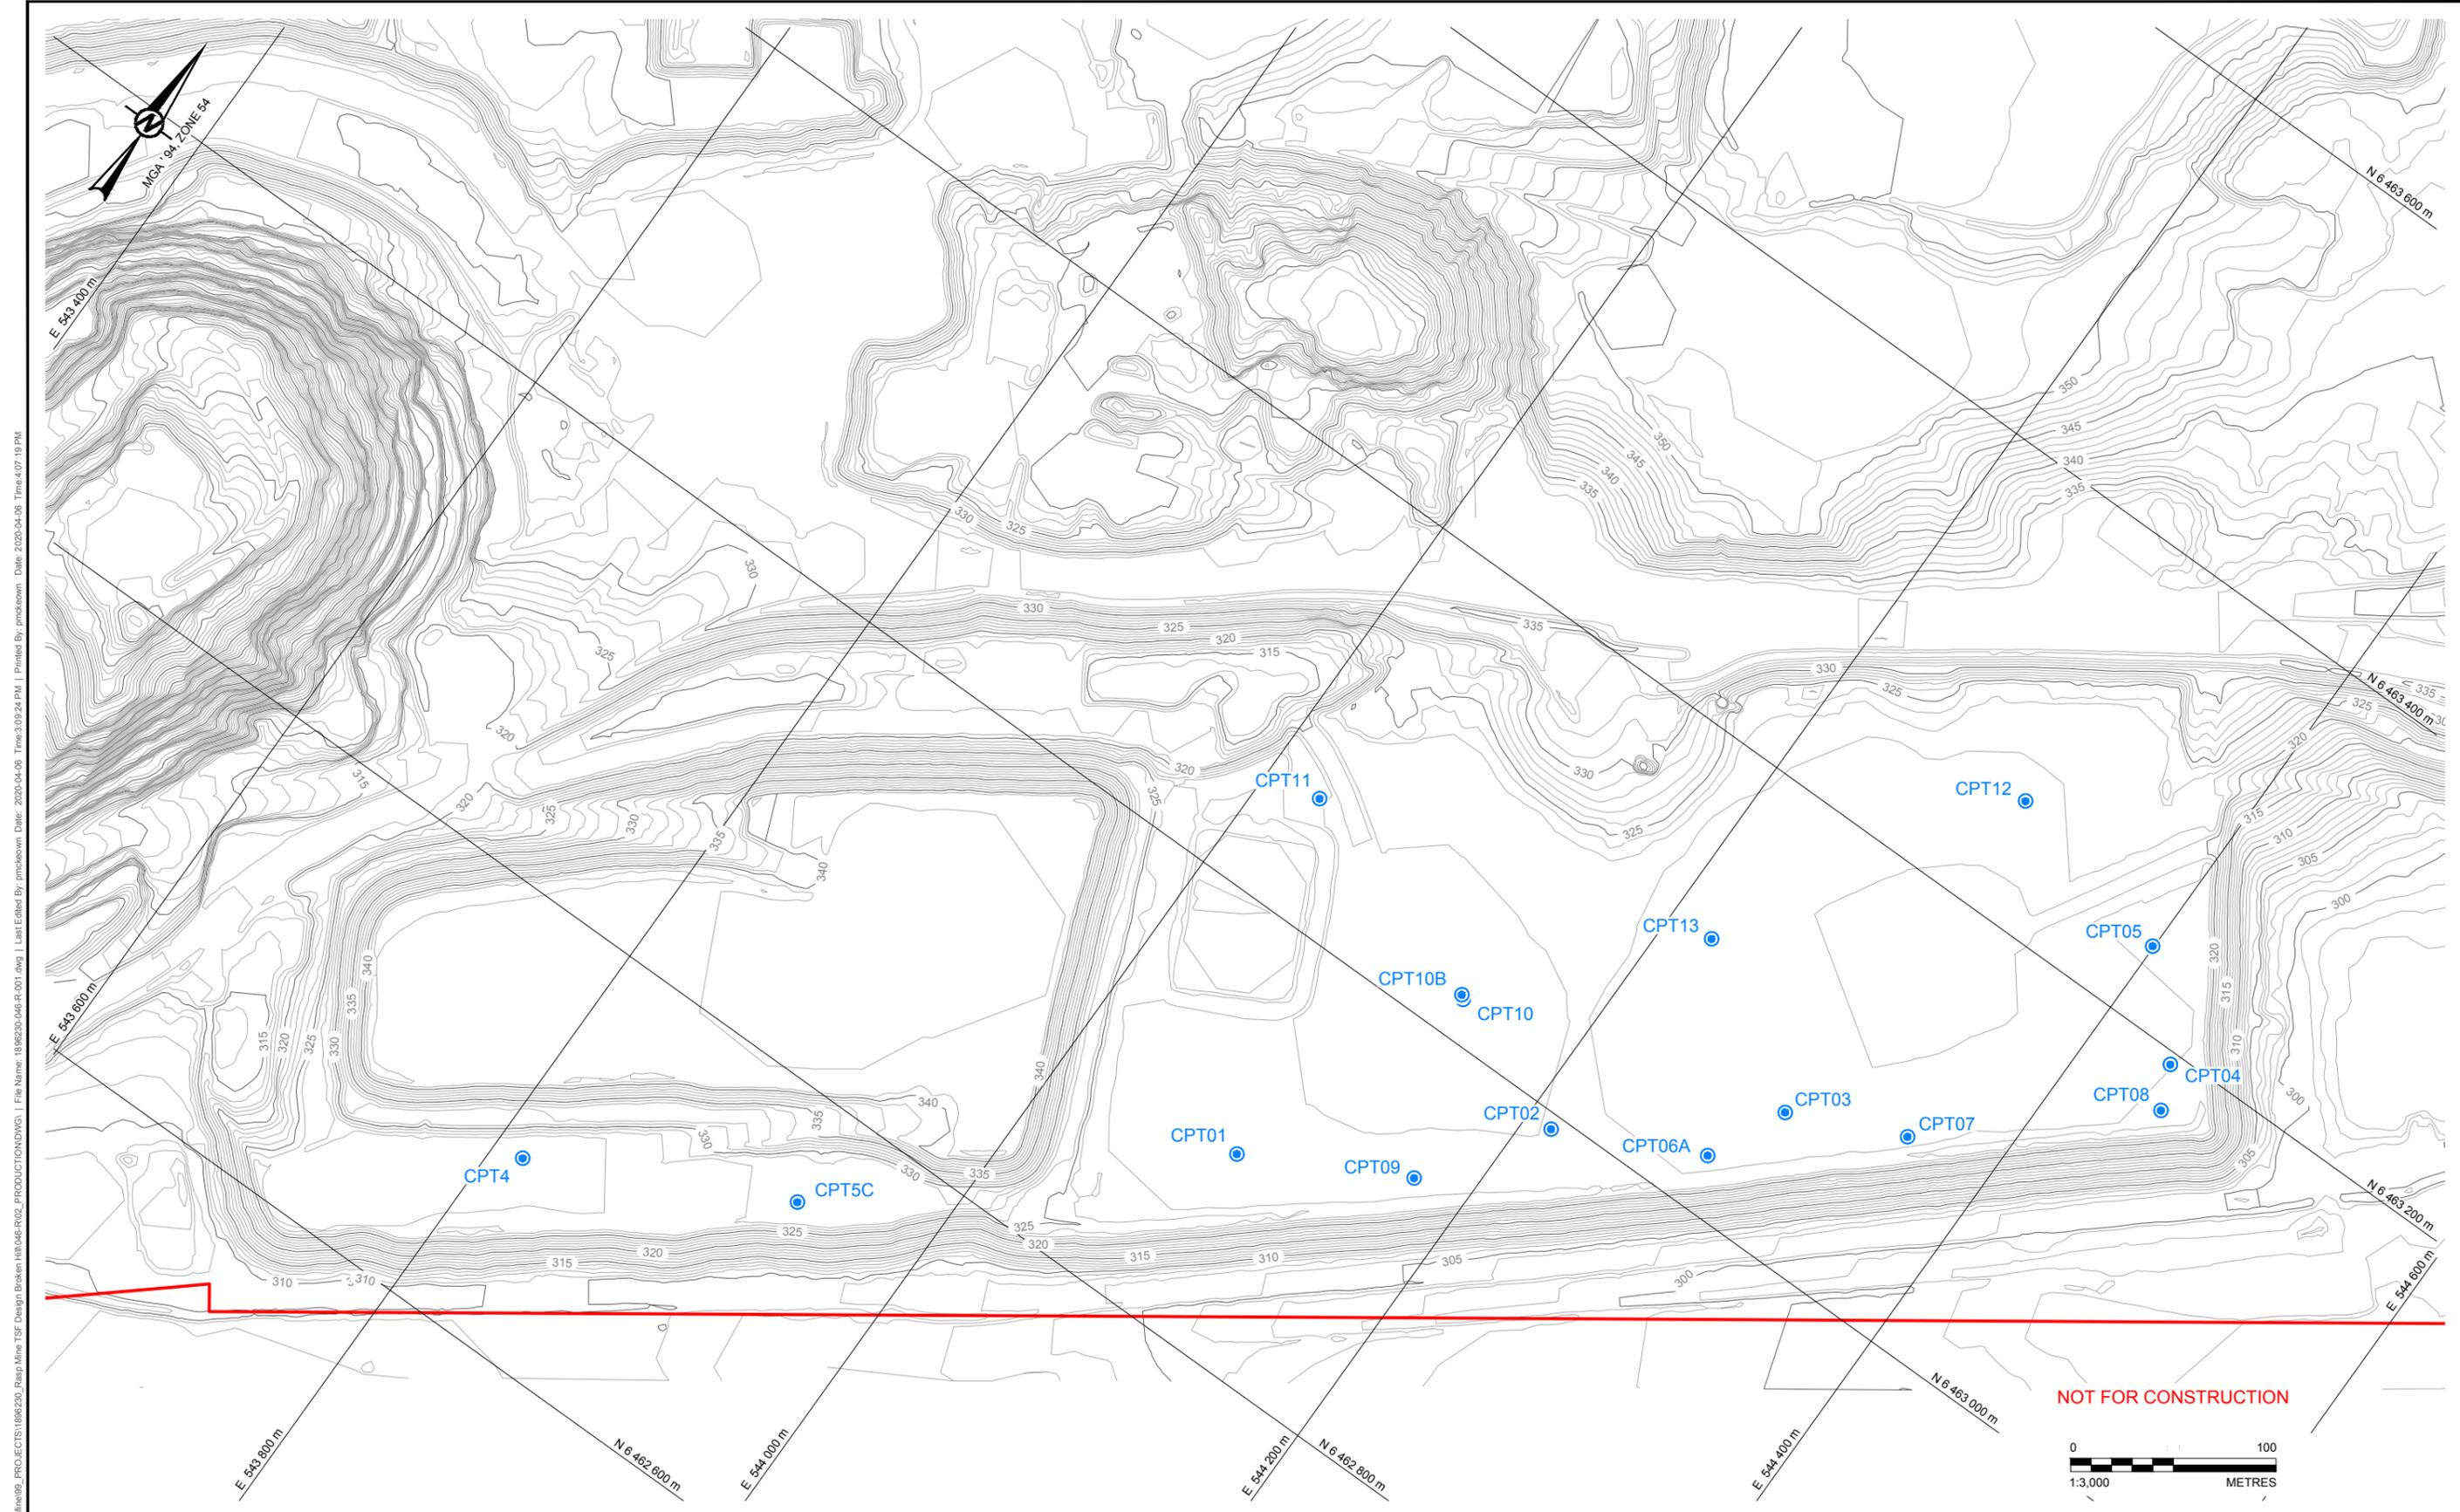
The layout of the locations of the CPT probes is presented in the attached Figure 1, in Appendix A. The measurement summaries of the CPT probes are presented in Appendix B, and the results of the analyses of the measurements are presented in Appendix C.

PROJECT		RASP MINE, BROKEN HILL	
TITLE		TAILINGS SURFACE (MARCH 2018) - APPROXIMATE CPT LOCATIONS	
PROJECT NO.	CONTROL	REV.	FIGURE
1896230	046-R	0	1
