## **TECHNICAL REPORT**

**Identification of Potential Inrush and Inundations Pathways from present and future TSF Facilities into Rasp Mine Underground Workings (with a focus on Kintore Pit proposed TSF3).**

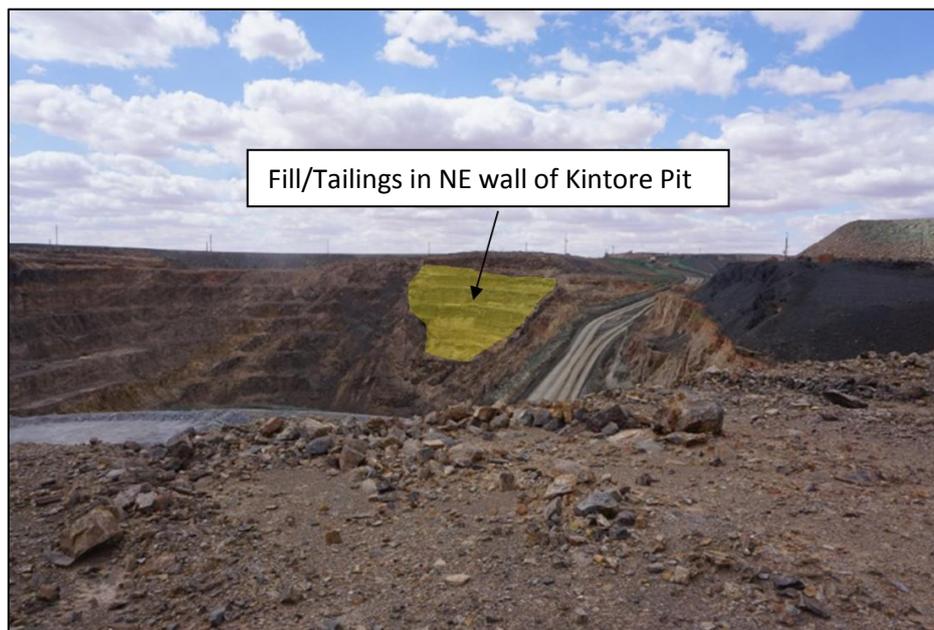
**Figure 13- Fill/tailings slope in North Eastern wall of the Kintore Pit**

Percussion holes drilled by MMM (including holes K46, K31, K43, K45 and K44, see Figure 12) indicate poor ground conditions and the presence of fill material in this zone. In addition, percussion intercepts match the depth of the fill in the north eastern wall of the Kintore Pit, see Figure 13. It is important to note that no seepage has been observed at the base of the existing tailings within the Kintore Pit.

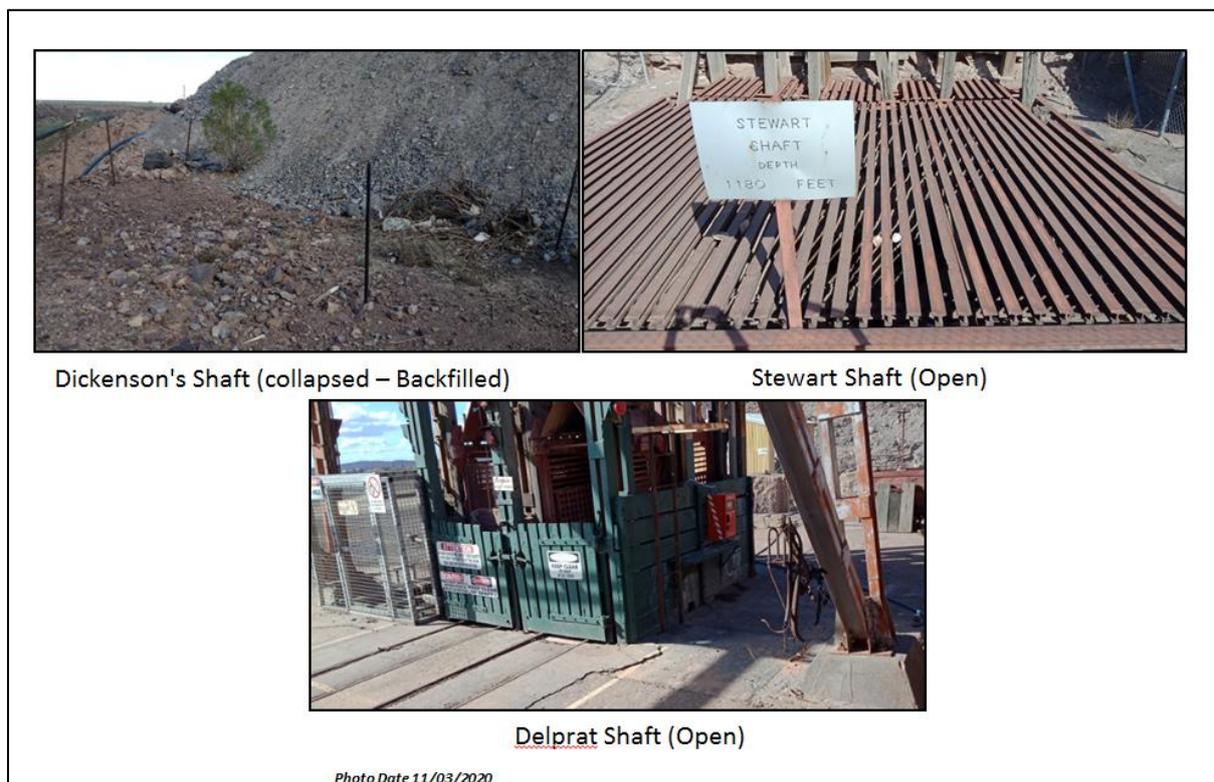
**Figure 17- Surface Collar Photos of Dickenson Shaft, Stewart Shaft and Delprat Shaft.**

In the unlikely event that significant water accumulated (via the historical workings on the 200 ft, 300 ft 500 ft levels) within the shafts and open drives, the resulting head of water may have high enough head pressures that could result in an inundation impact to the Western Mineralisation at the intersecting 1000 ft level.

It is important to note that Delprat Shaft is linked to the current 1000 ft level and that this shaft is not making water as at January 2021.

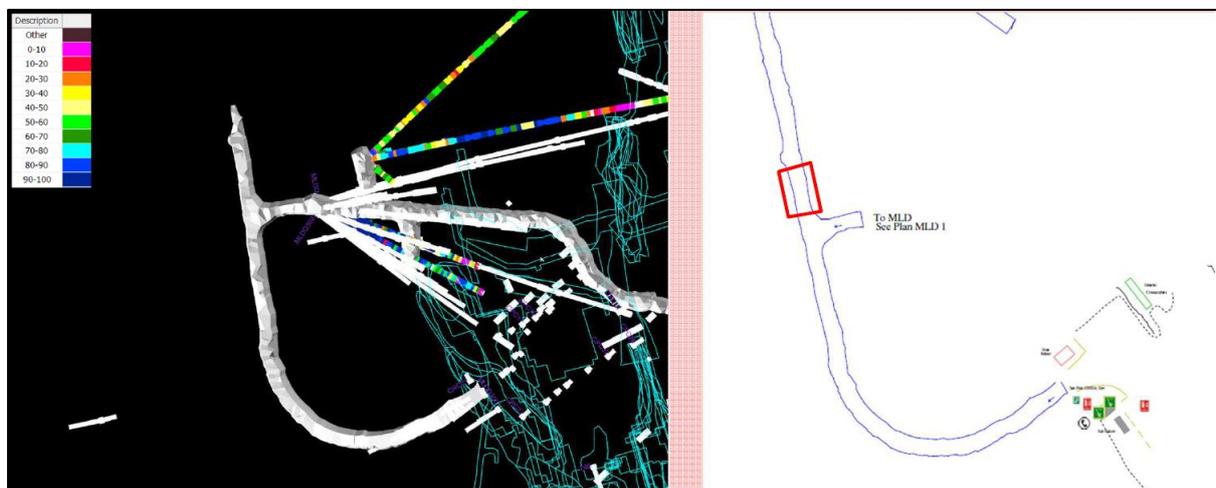
Figure 28- MLD Barrier Location and Drill hole RQD

Geotechnical characteristics: Fair to good bedded rockmass (RQD 50-60), 3 joint sets (Jn 9), Planar Rough (Jr 1.5), Surface Stain Only (Ja 1), Dry (Jw 1), Near surface (SRF 2). Fair Rockmass (Q 5). Moderately corroded resin and mesh in backs, moderately corroded split sets and mesh in sidewalls to grade, minor scats. Intersection with MLD shotcreted. Dry rockmass, damp area in photos due to decline sprays.

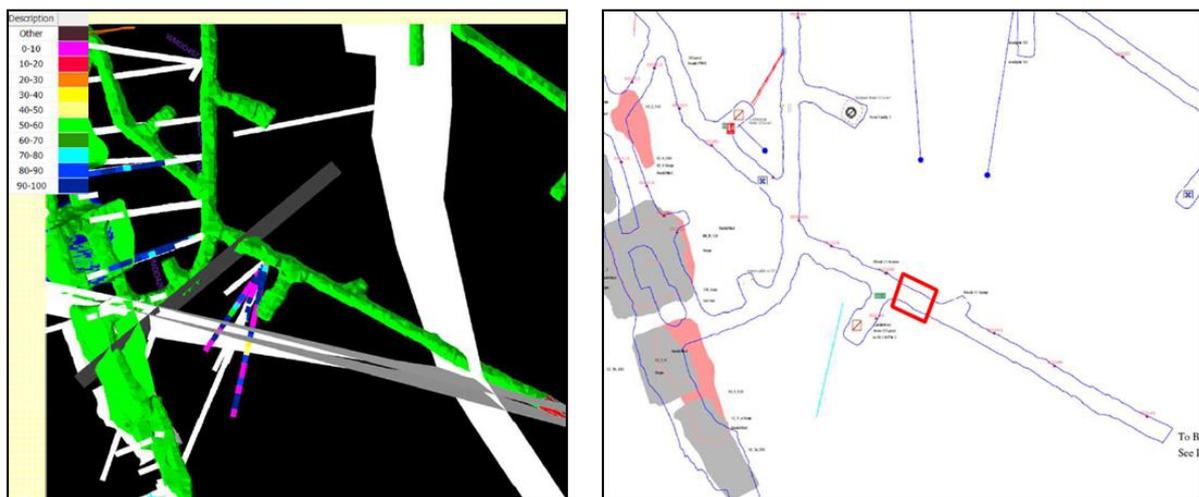
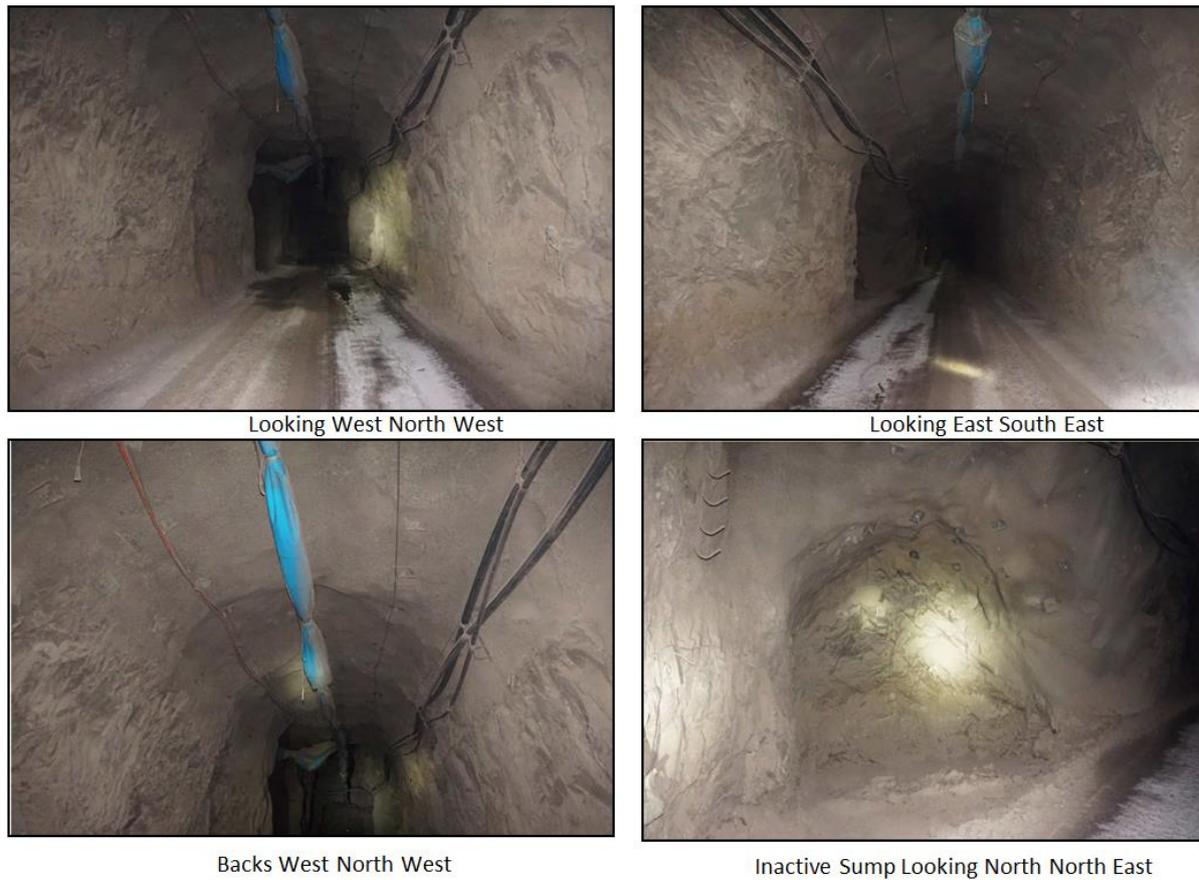
Figure 30- Block 11 Barrier Location

This Barrier location is illustrated in Figure 30 and Figure 31 and referenced by the following coordinates 9451mN, 1698mE, 9944mRL.

Geotechnical Characteristics: Fair to good bedded rockmass (RQD 50-60), 3 joint sets (Jn 9), Planar Smooth (Jr 1), Surface Stain Only (Ja 1), Dry (Jw 1), Medium confining stress (SRF 0.5). Good Rockmass (Q 13). Lightly corroded resin through shotcrete in backs, moderately corroded split sets in sidewalls. Dry rockmass. Sump inactive, filled in.

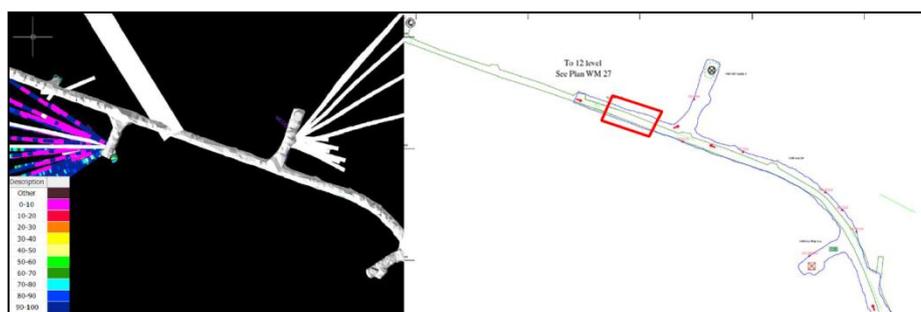
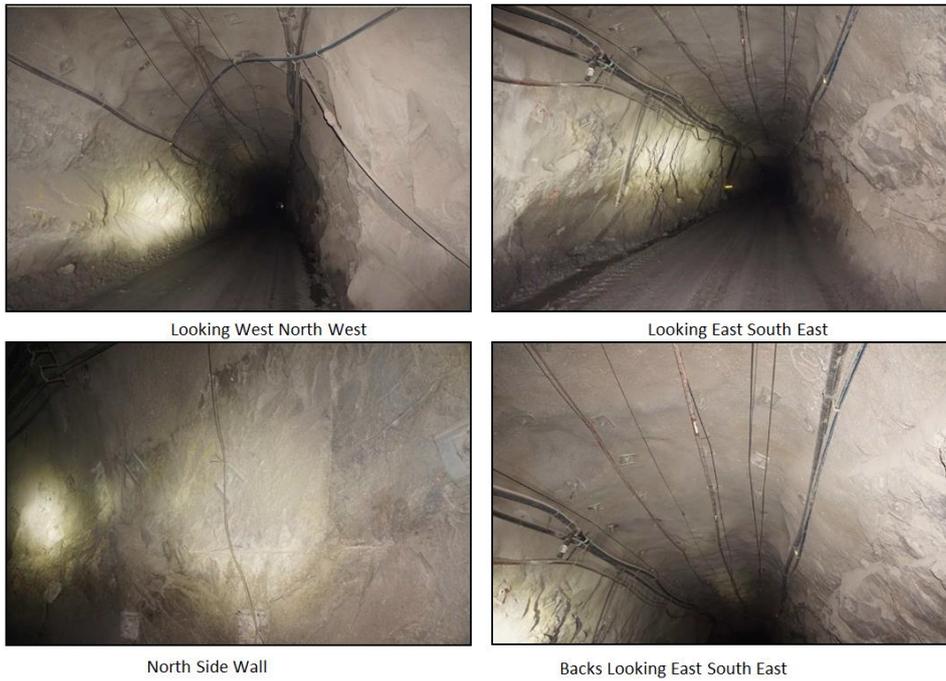
**Figure 32- 1480 ft Barrier Location**

This Barrier location is illustrated in Figure 32 and Figure 33 and referenced by the following coordinates 9600mN, 1514mE, 9900mRL.

Geotechnical Characteristics: Good bedded rockmass (RQD 70-80), 3 joint sets (Jn 9), Planar Rough (Jr 1.5), Surface Stain Only (Ja 1), Dry (Jw 1), Medium confining stress (SRF 0.5). Good Rockmass (Q 27). Lightly corroded resin through shotcrete in backs, moderately corroded split sets in sidewalls. Dry rockmass.

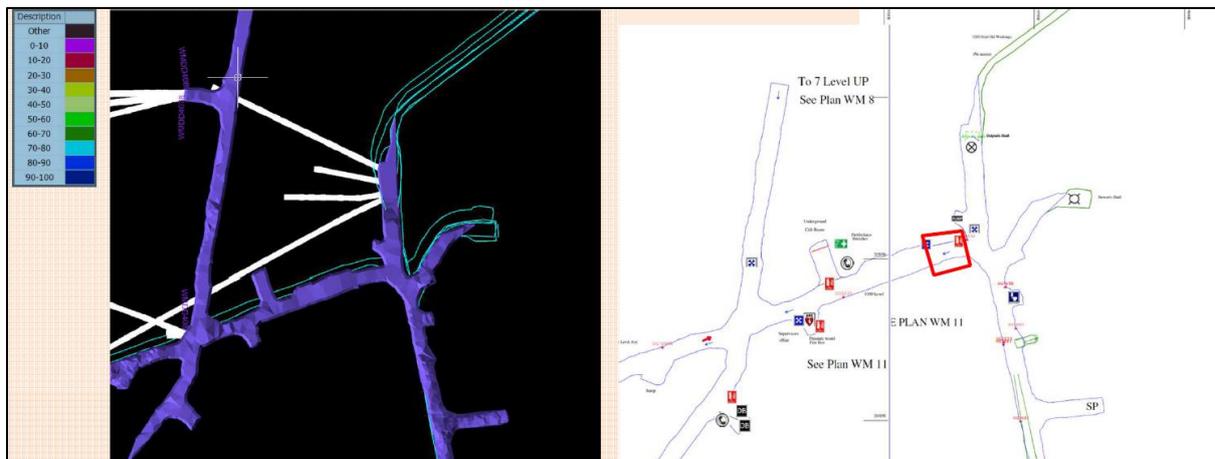
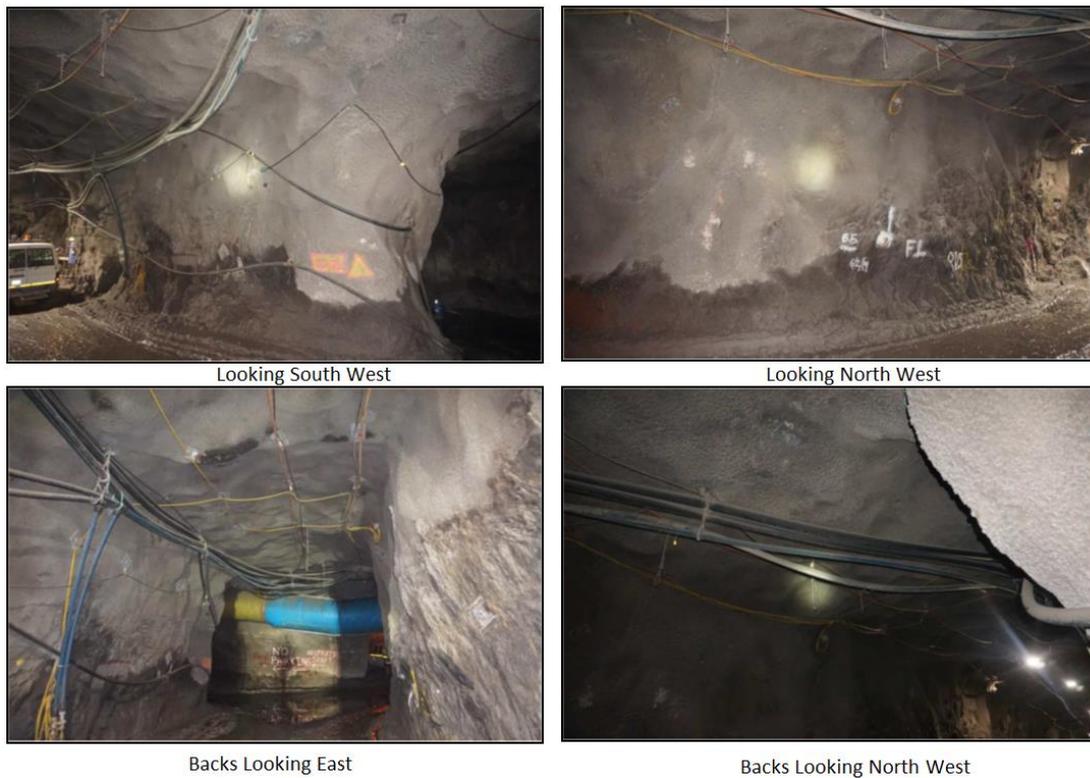
**Figure 34- 1000 ft Barrier Location**

This Barrier location is illustrated in Figure 34 and Figure 35 and referenced by the following coordinates 9612mN, 2052mE, 1046mRL.

Geotechnical characteristics: Good bedded rockmass (RQD 60-70), 3 joint sets (Jn 9), Planar Smooth (Jr 1), Surface Stain Only (Ja 1), Dry (Jw 1), Medium confining stress (SRF 0.5). Good Rockmass (Q 16). Moderately corroded resin through shotcrete in backs, split sets through shotcrete in sidewalls. No major cracks. Dry rockmass, damp area due to sump.

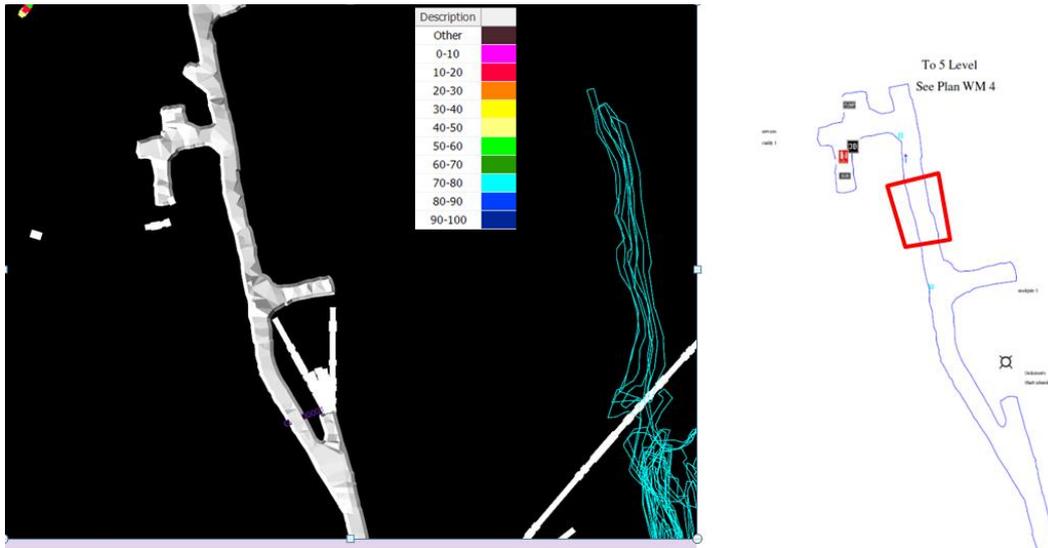
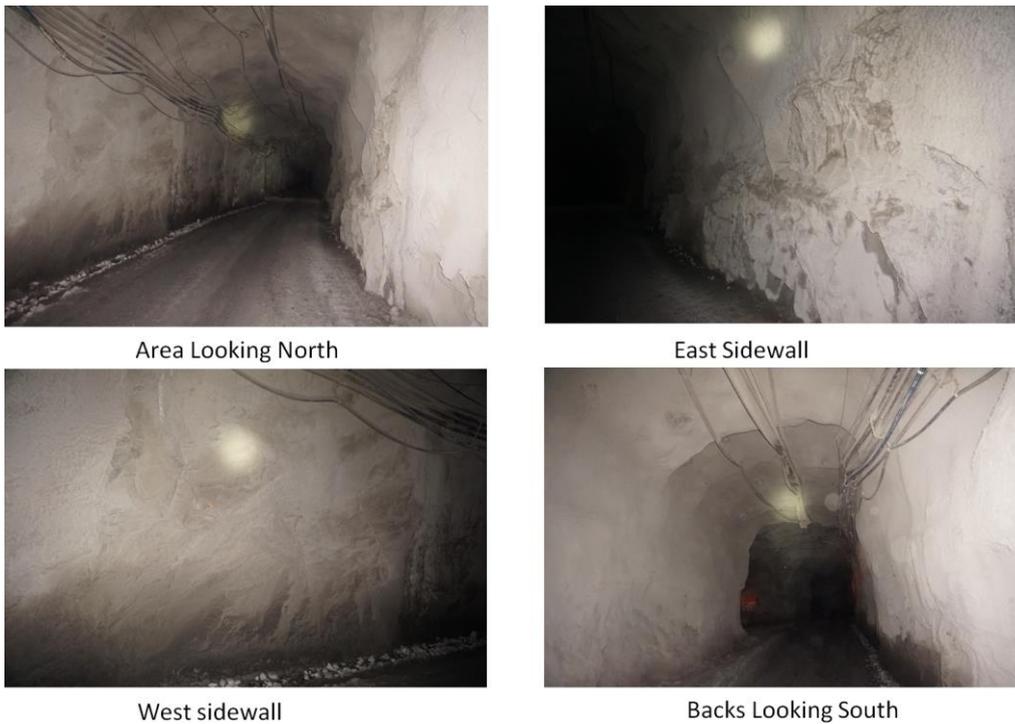
Figure 36- Dickenson's Shaft Western Min Decline below SP3 barrier Location

This Barrier location is illustrated in Figure 36 and Figure 37 and referenced by the following coordinates 9903mN, 1149mE, 9906mRL.

Geotechnical Characteristics: Fair to good bedded rockmass (RQD 50-60), 3 joint sets (Jn 9), Planar Rough (Jr 1.5), Surface Stain Only (Ja 1), Dry (Jw 1), Near Surface (SRF 2). Fair Rockmass (Q 4). Lightly corroded resin through shotcrete in backs, lightly corroded split sets through shotcrete in sidewalls. Dry rockmass.
