2006 50' Jefferson Rivanna 50 SE

Report of Marine Survey

Inspection performed on: 07/19/23 with Report submitted on: 07/21/23.

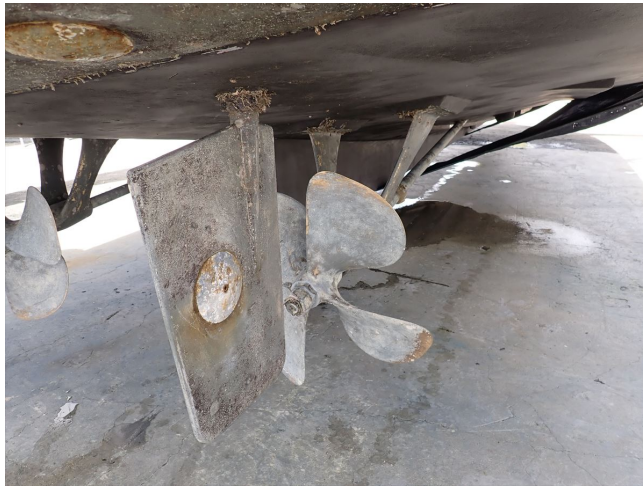
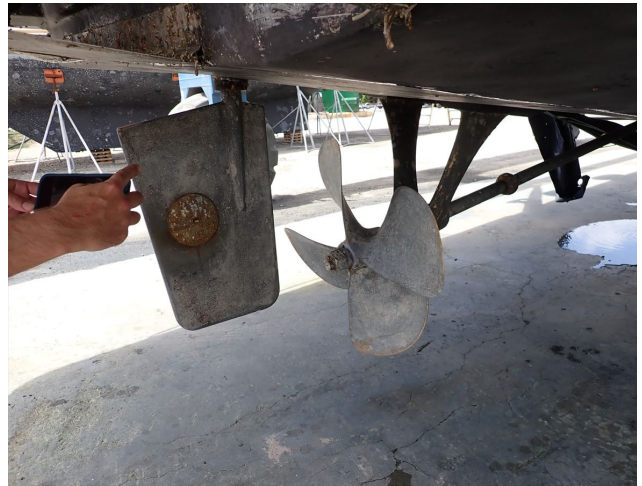
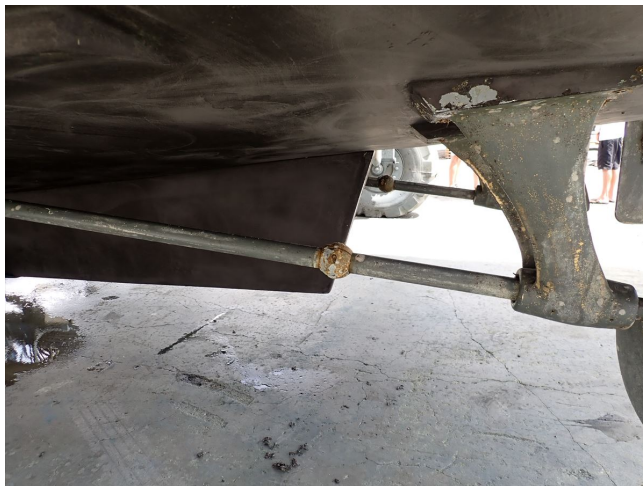
Exact propeller diameter and pitch could not be determined during underwater inspection due to epoxy application to assist with corrosion prevention. The propellers were visually examined with no indications of damage to the blades or hub. Both propellers spun with little force as intended while the vessel was out of the water.

The propeller shaft, struts, cutlass bearings, and rudders were also visually inspected and found in good and serviceable condition. All anodes found during inspection showed no evidence of deterioration. Continue to monitor the condition and replace when necessary.

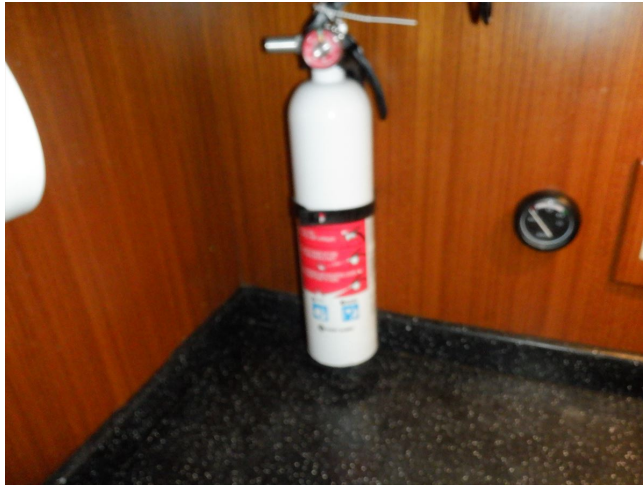
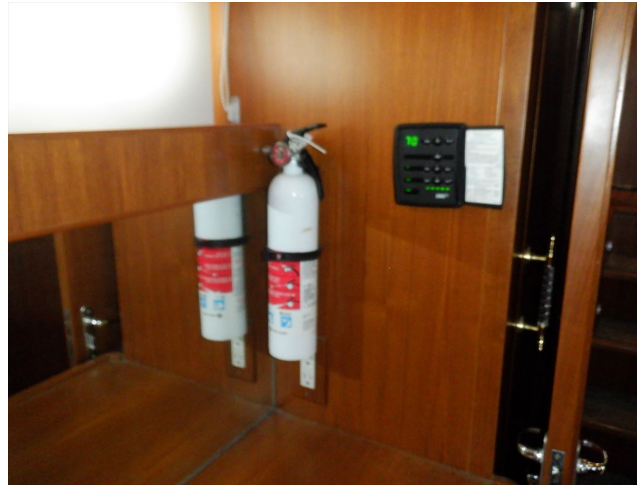
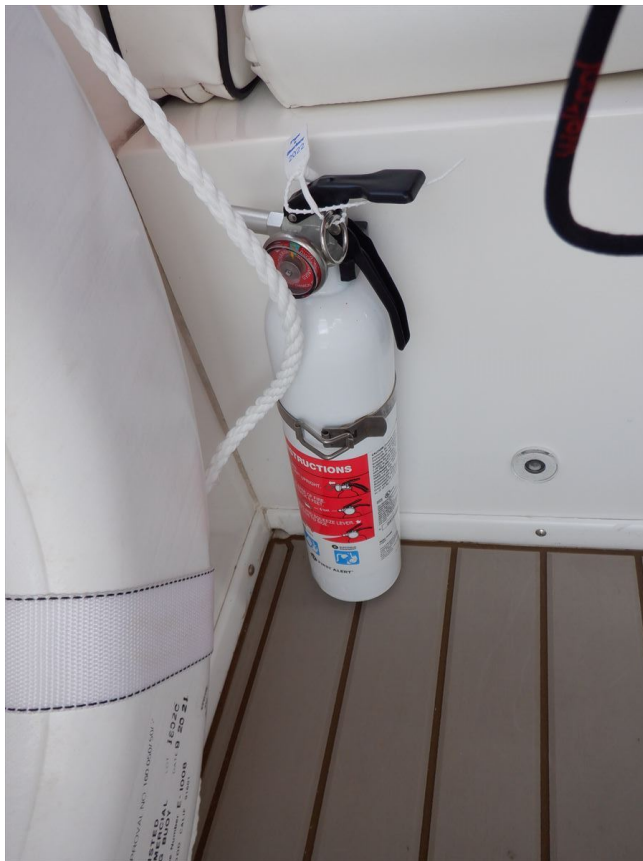
Three (3) Type BC-10 lb. dry chemical fire extinguishers were sighted. The gauges for all three fire extinguishers showed fully charged and the exterior of the extinguishers were in good condition with no rust or other damage evident. One (1) fire extinguisher was mounted in the galley, one (1) fire extinguisher was mounted in the master stateroom (port-side), and the last fire extinguisher was mounted in vicinity of the flybridge helm (port-side). No current annual inspection tags were observed (EXP: May 2023) and all three (3) fire extinguishers were stamped 2010 making them thirteen (13) years old (all fire extinguishers must be replaced after twelve (12) years. Replace fire extinguishers with a minimum of two (2) 5-B, or two (2) 10-B, or one (1) 20-B fire extinguisher and continue to have fire extinguishers inspected and serviced annually by qualified service personnel.

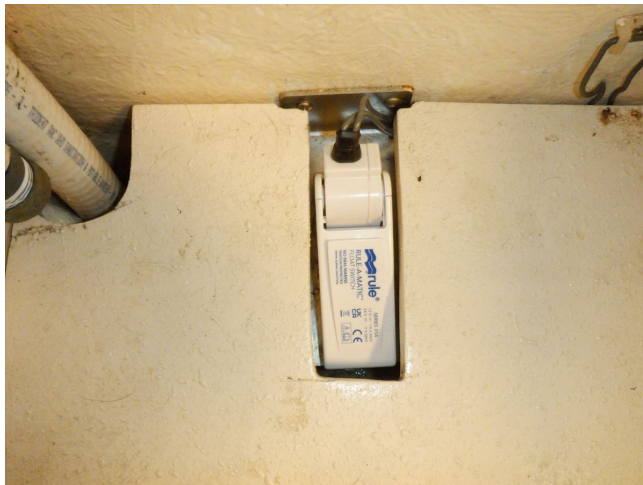
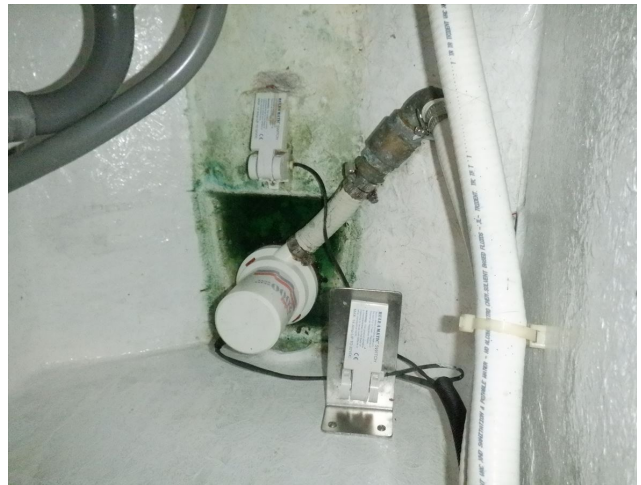
FINDING A-5

One (1) Bilge High Water Alarm with alarm speaker located at the helm and four (4) float switches located in several locations throughout the vessel. One (1) float switch is located in the engine room, one (1) float switch is located in the bow stateroom head, one (1) float switch is located in the master stateroom head, and the last float switch is located under the master bed. All float switches were test and no audible alarm was heard throughout the vessel. Recommend a qualified marine technician diagnose and repair high water alarm system.

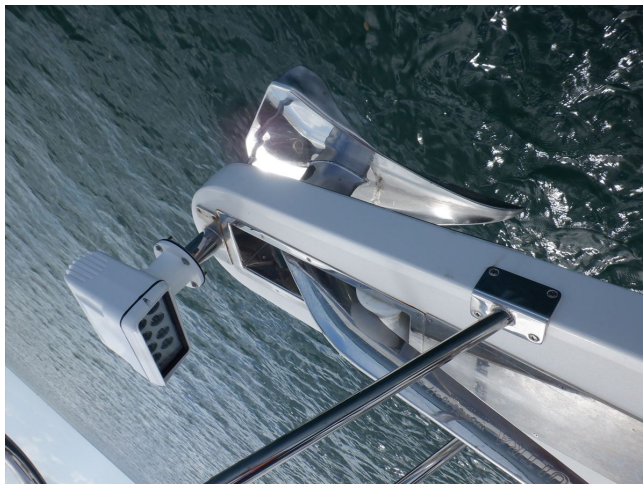
One (1) 12-volt DC light observed on the bow pulpit. The exterior light was tested and found to be in serviceable condition. Additionally, four (4) LED underwater lights were observed during the haul-out. One (1) light each on the port and starboard quarter and two (2) lights secured to the transom. The LED underwater lights were not tested for functionality due to the port-side LED light having excessive amounts of water.
