HVAC Assessment Sample

| Reason for Inspection | Possible mold/mildew issues in home |

AIR RESCUE Heating and Cooling

Overview

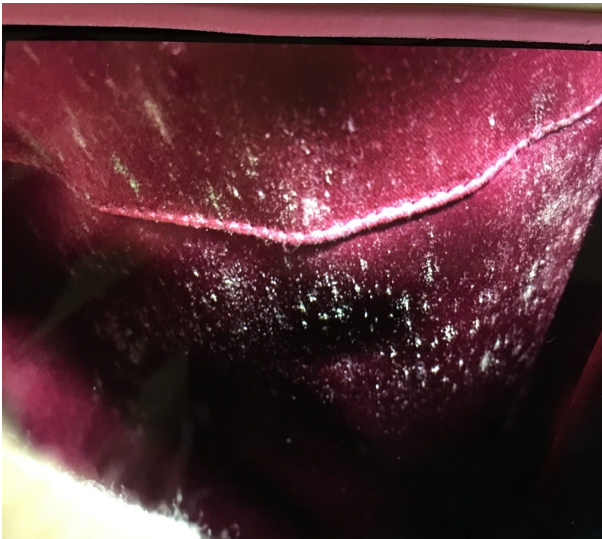
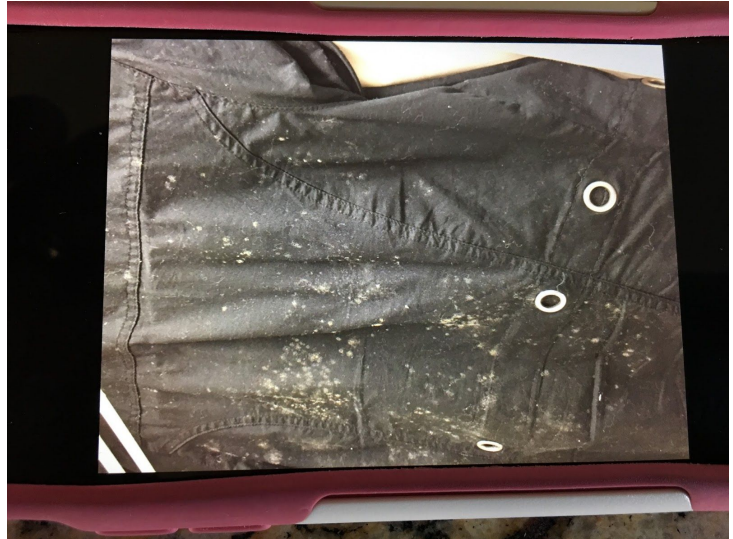
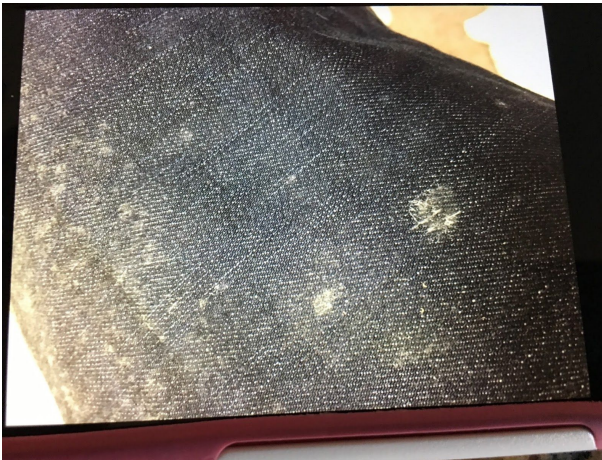
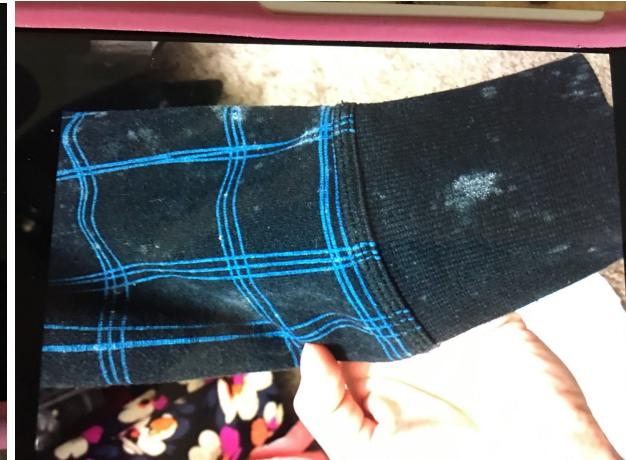
I was requested to assess this single story home with a four-ton heat pump installed. The home was new in April 2016 and the homeowner stated issues began shortly after moving in. The homeowner did not voice any concerns about system operation. When questioned, the customer felt that the unit performance was okay. The homeowner's biggest concern was the recurring presence of mold/mildew on some clothing items in the master closets and child closet. In addition, there have been a couple of occurrences of mold/mildew on some pieces of furniture (see photos below of mold/mildew). I did not notice any musty smells in the home while I was there. The pictures below were given to me by the homeowner. I did not witness any of the conditions myself.

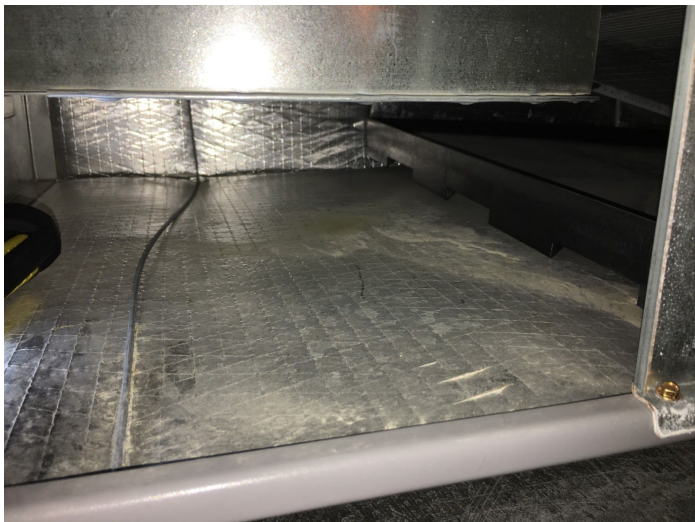
Fig. 1

The air handler installation appeared to meet reasonable standards. It was level right-to-left and front-to-back. It is recommended that the air handler be installed with about $\frac{1}{8}$ inch tilt towards front right to assist with condensation draining. The air handler did show signs of being wet inside (Fig. 1-2) but had no signs of mold. The air handler's internal insulation was in good condition.

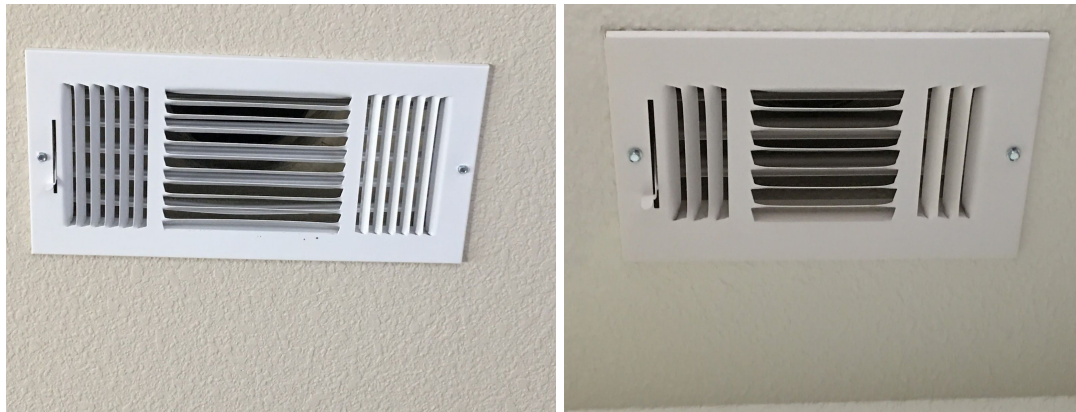
The supply plenum was made of duct board and did not have starting collars sealed internally. There was no gross evidence of mold/mildew in the plenum. The ducts were partially sealed with mastic on the outside. I did not see any evidence of mold/mildew on any of the registers.

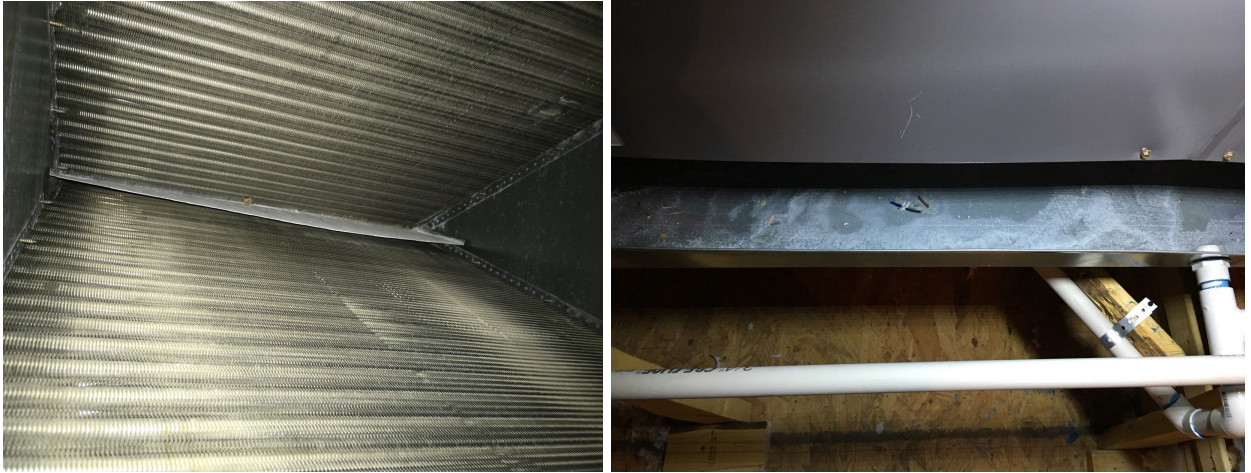
The evaporator coil was clean and had both a primary and secondary drain attached. The drain pan did show residual evidence that it had possibly been holding water over a long period of evaporation. There may have been some issues with drainage at some point. The emergency pan also showed evidence of water across the front at some point.

It is possible that the internal drain pan had been holding water at some point; and that during normal operation, the unit may have not been dehumidifying as it should. It is also possible that during

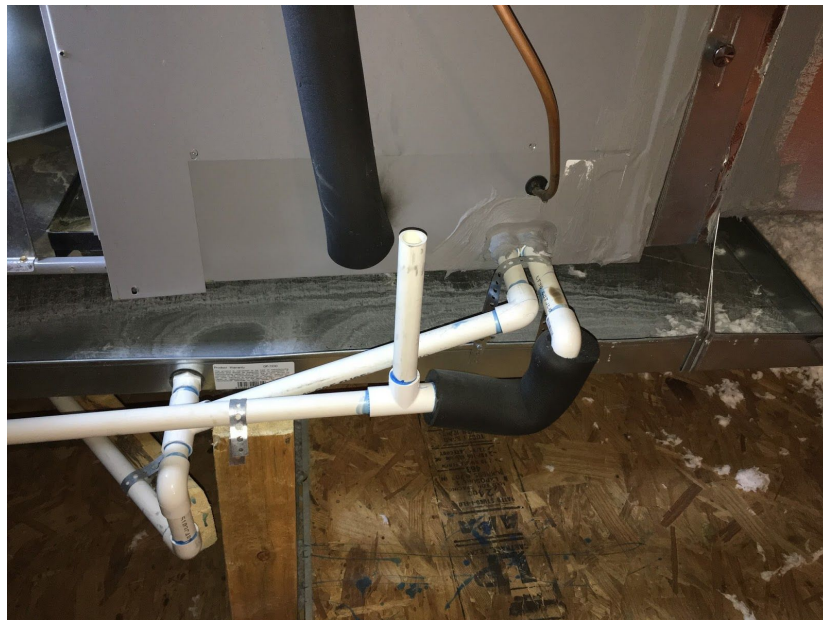
There was both a primary and secondary drain attached with adequate slope. The primary had a P-trap but no cleanout and the secondary had no P-trap in place. As a precaution, I blew the primary out with nitrogen. I believe the primary drain is terminated to the washing machine drain and not a bathroom sink.
