Technical Report

| Client | Evil GT | Your File Ref | HY52DLJ |

| Make & Model | BMW M3 |

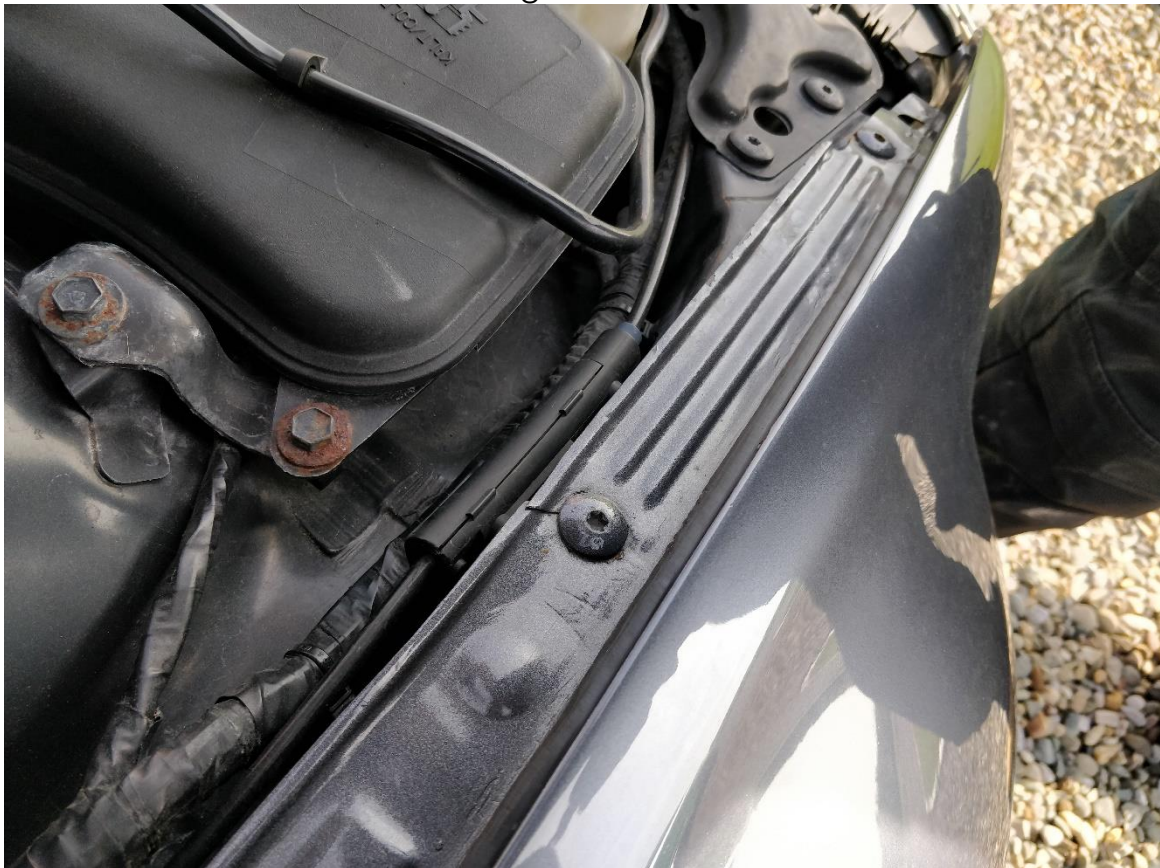
Wing Condition

The wing displayed excessive use of body filler with readings of 1300 microns. In one area, no reading was evident, indicating a lack of metal content. The wing positioning was also incorrect with uneven panel gaps. There was also peeling paint to the upper side of the wing.

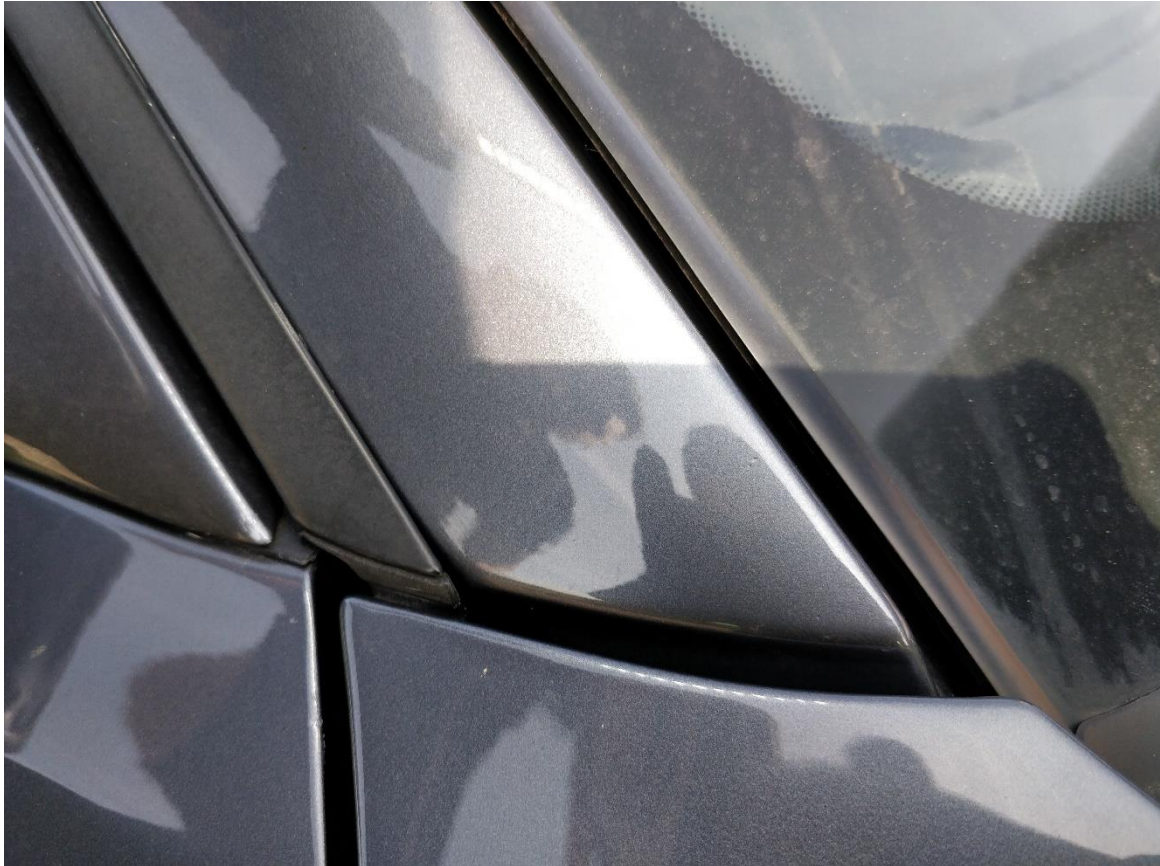
'A' Pillar Condition

Structurally, aside from some refinishing of the 'A' pillar, no evident major damage or repair was visible during our inspection.

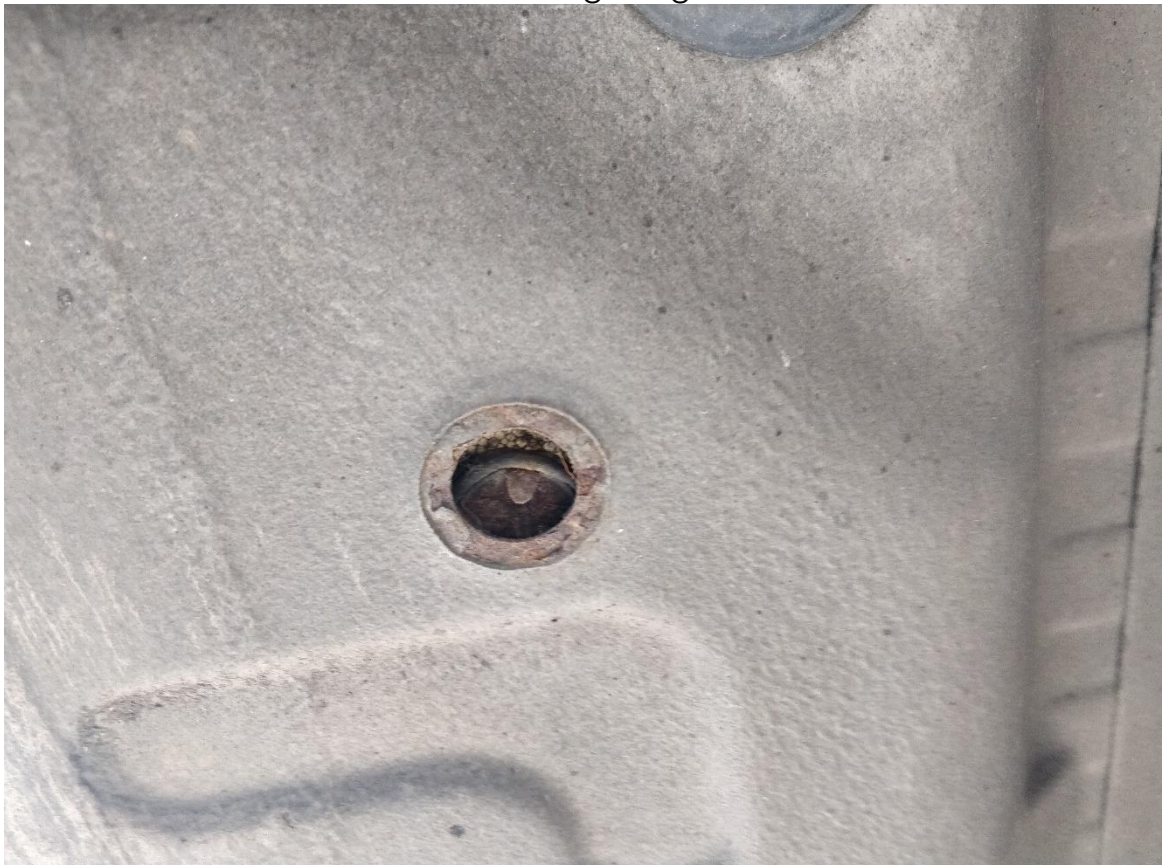
Blanking Bung

An underside examination did, however, reveal that the rear floor area was heavily corroded around a rubber blanking plug. On manual manipulation of the floor pan surrounding the corrosion, there was excessive movement indicating further corrosion, however, further investigation will be required to fully confirm the extent of the corrosion.

In our opinion, the rear floor pan does require some welding, however, the extent of this is unknown at present.
