PROPERTY INSPECTION REPORT

Inspection Prepared For: Preferred Customer

Date of Inspection: 1/18/2021

Year Built: 1972 Size: 1744

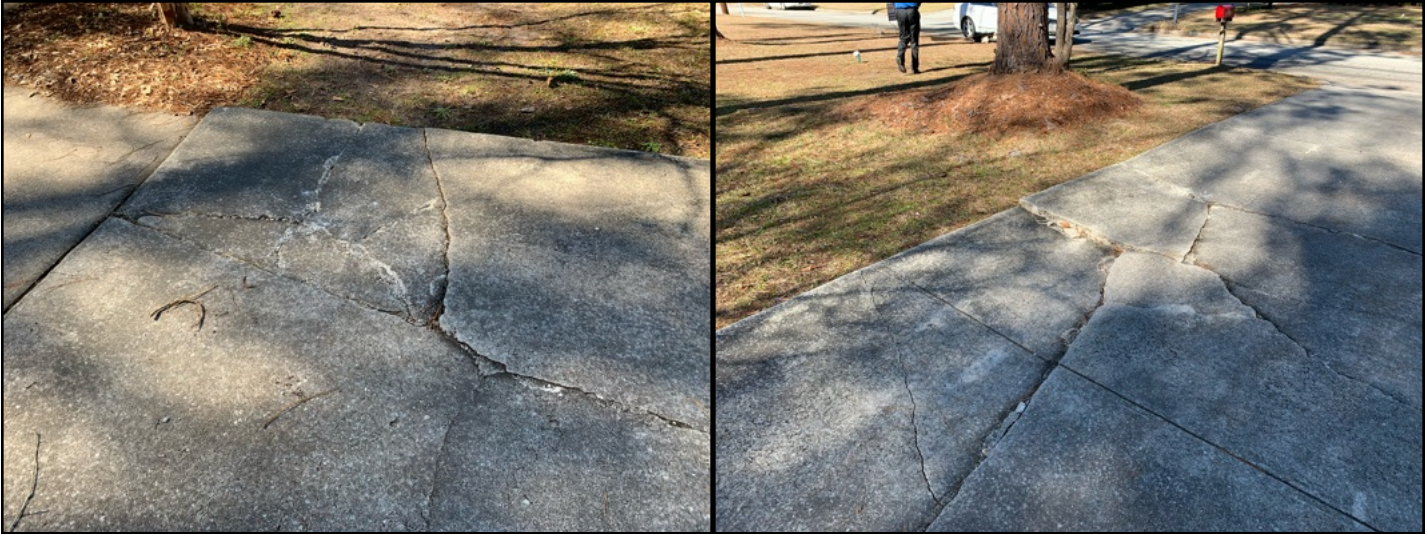
Grounds		
Page 13 Item: 1	Driveway and Walkway Condition	<ul style="list-style-type: none">• REPAIR: excessive cracks in sidewalk. Repair and/or monitor for expansion and development of trip hazards.

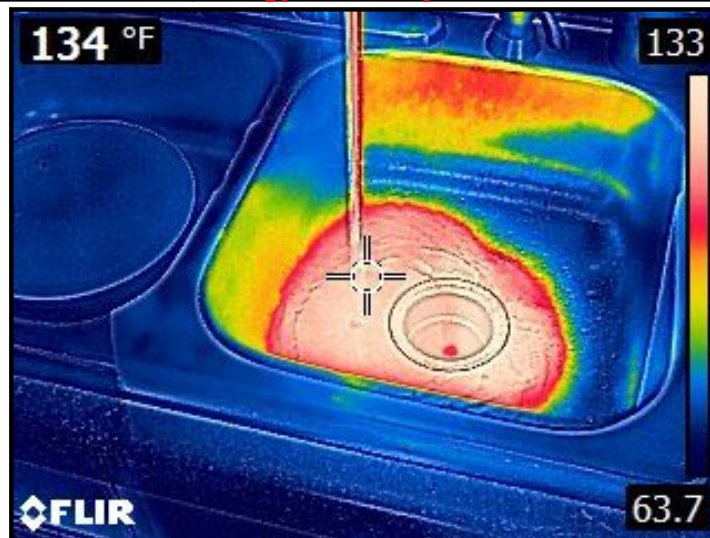
SAFETY ISSUE: Temperature - Water temperature observed to be: 134 degree F. This is unsatisfactory and too hot. Recommended temp should be set at 118-122 degrees F. to prevent scalding, extend water heater life, and improve energy efficiency and conservation.

Water temperature

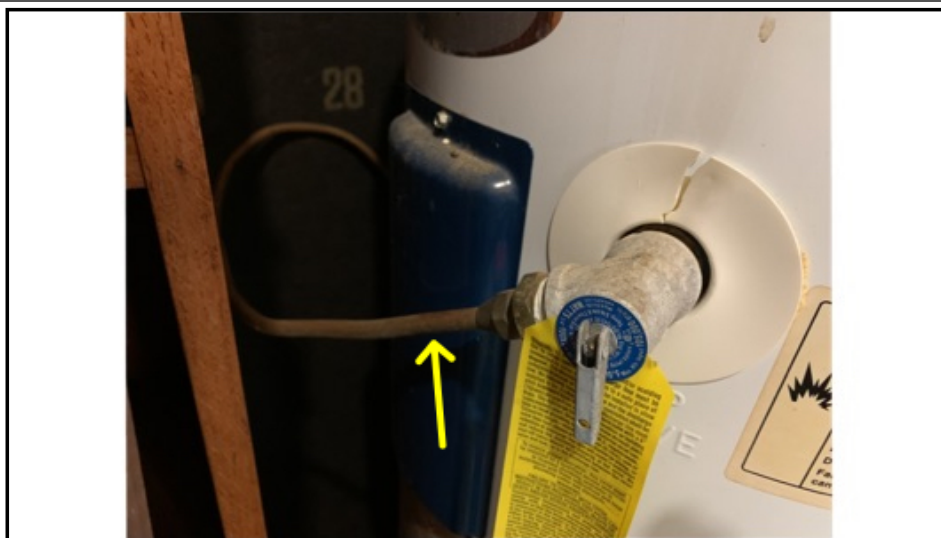
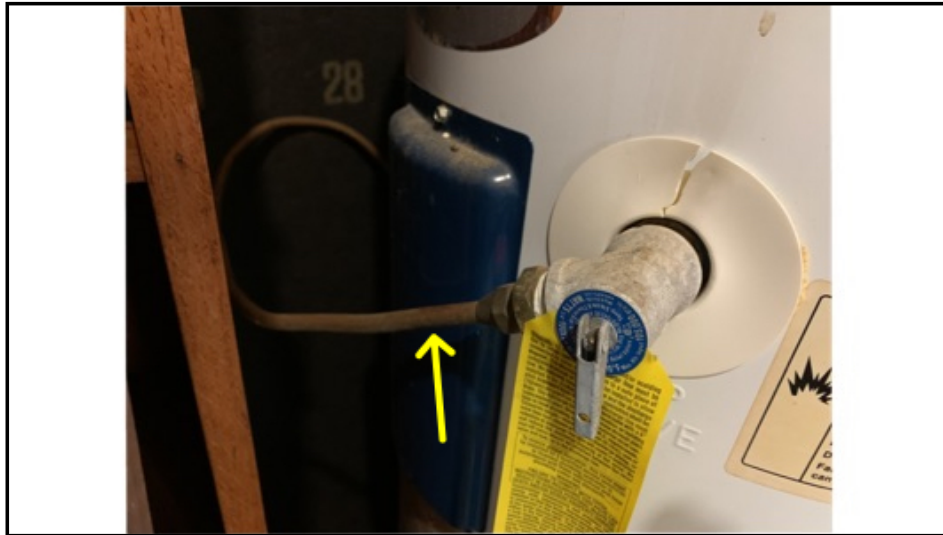
- **REPAIR:** TPRV Material - The Temperature and Pressure Relief Valve (TPRV) drain line is made of PVC or other inappropriate material. This material may melt in the event the relief valve opens. The line should be full size 3/4 inches and made of copper, CPVC, or galvanized steel

TPRV - reduced line

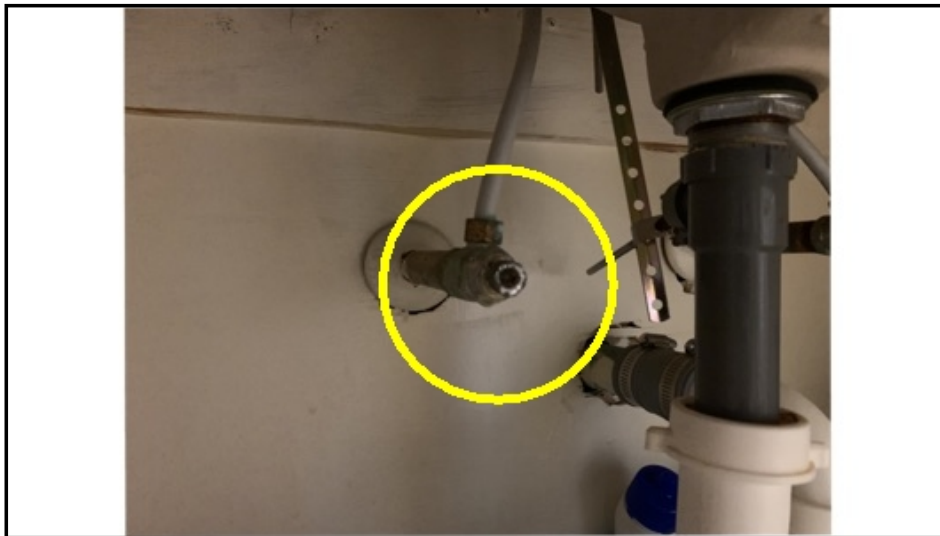
Page 46 Item: 2	Sinks	• REPAIR: Both bathrooms have low water pressure when using hot water. Recommend further evaluation by qualified plumber.
Page 47 Item: 6	Plumbing	• REPAIR: hallway bathroom hot water shut off valve handle broken. Recommend replacing shut off handle.

Hallway- shut broken handle

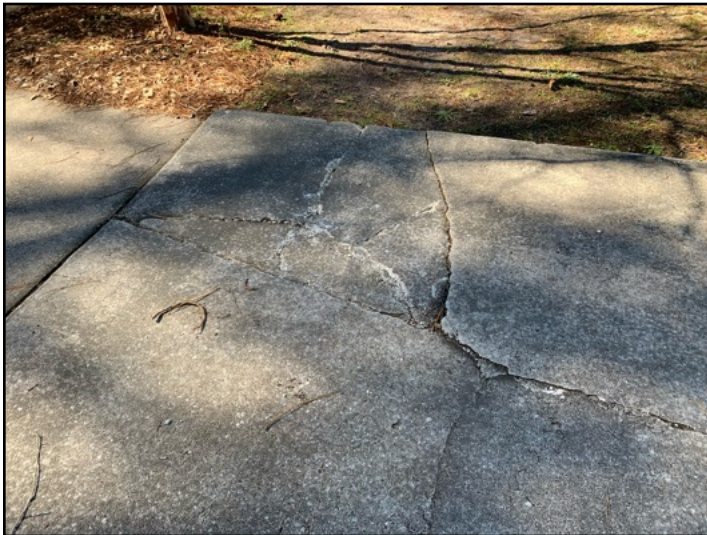
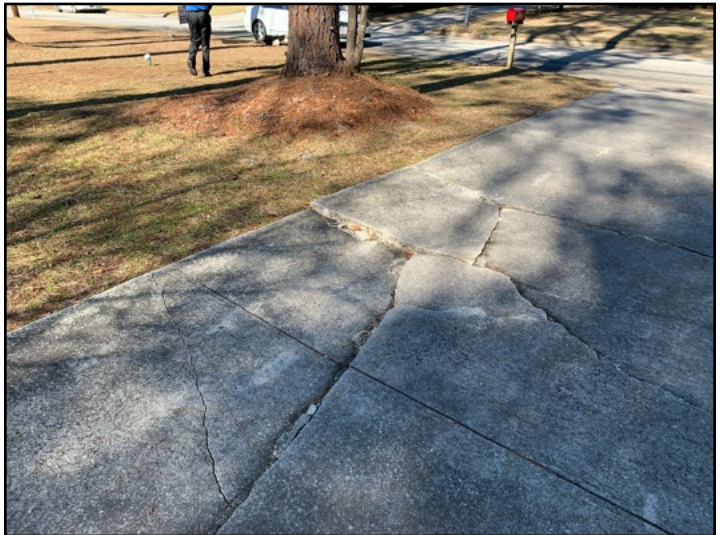
1. Driveway and Walkway Condition

- Driveway materials noted: Concrete
- **REPAIR: excessive cracks in sidewalk. Repair and/or monitor for expansion and development of trip hazards.**

Driveway cracks

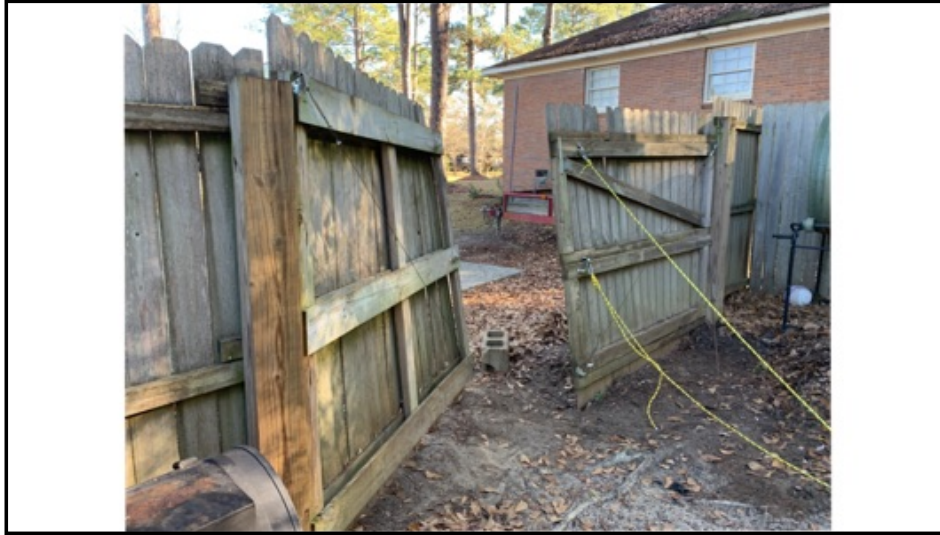
- Fence or wall material: wood
- Inspecting fences and/or gates are not within the scope of this inspection (except when in conjunction with a swing pool). Any observations/recommendations are courtesy. Recommend confirming that all fences and gates are in serviceable condition before the close of escrow.
- **OBSERVATION:** Wood fence and gates are older and in need of some repairs, but functional.

Gate in disrepair

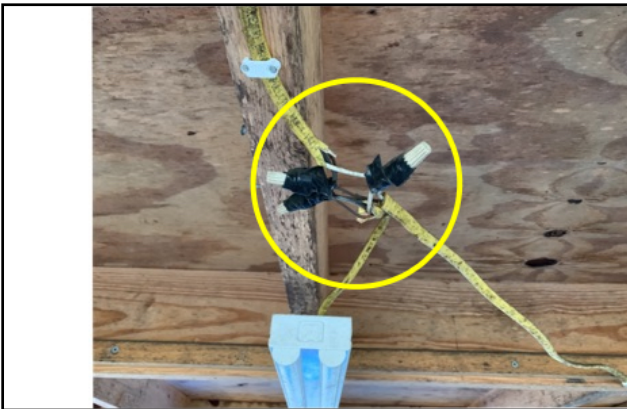
- **REPLACE:** Front porch outlet cover weather seal worn.
- **REPAIR:** Outbuilding overhang light and interior switch has wire splices made outside of junction boxes. Back flood light not properly installed. Recommend licensed electrician to properly install with junction box.
- **REPAIR:** No Ground Fault Circuit Interrupter (**GFCI**) protection outdoors, or anywhere throughout the home at the time of inspection. Although GFCI protection may not have been required at the time the home was built, for safety reasons, consider upgrading the electrical system to include GFCI protection at all wet area locations (kitchen, bathrooms, carport, outside, etc).

Improper wiring

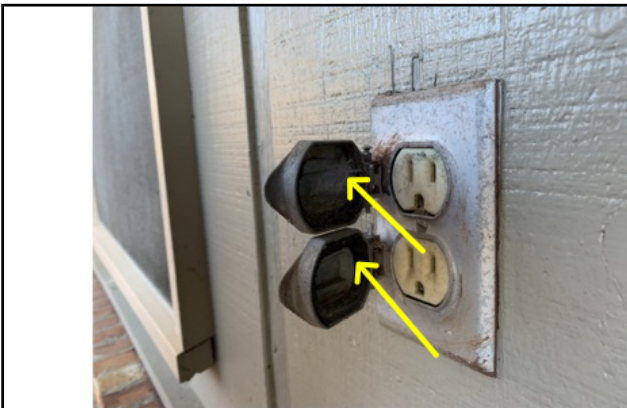
Missing/worn seal

No GFCI protection

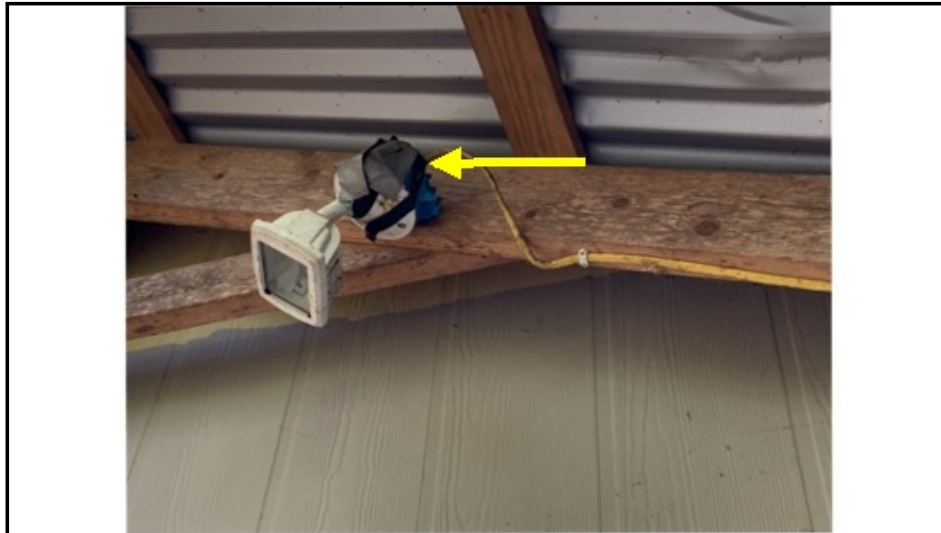
Improperly installed fixture

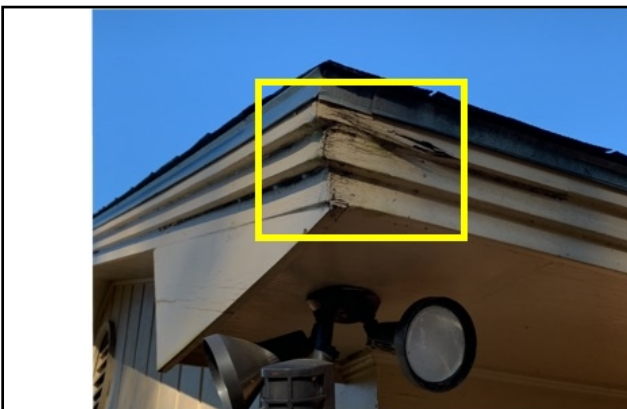
- Soffits are non-ventilated and made of wood or wood-like material
- Fascia is made of wood or wood-like material
- **REPAIR:** Moisture damage noted to facia and soffit areas in numerous places around home. Recommend repair and replacement as necessary.

Moisture damage

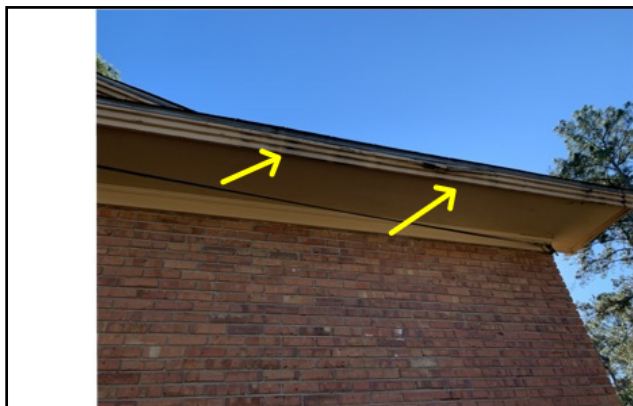
Moisture damage

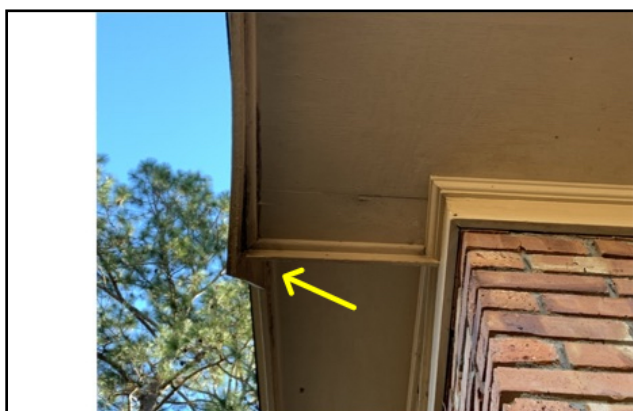
Moisture damage

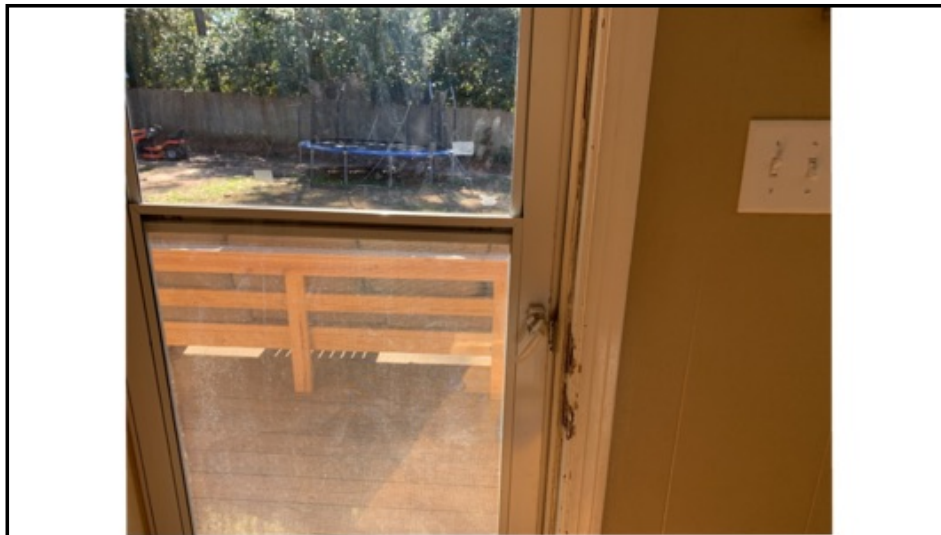
- REPAIR: Storm door handle broken.

Handle doesn't work

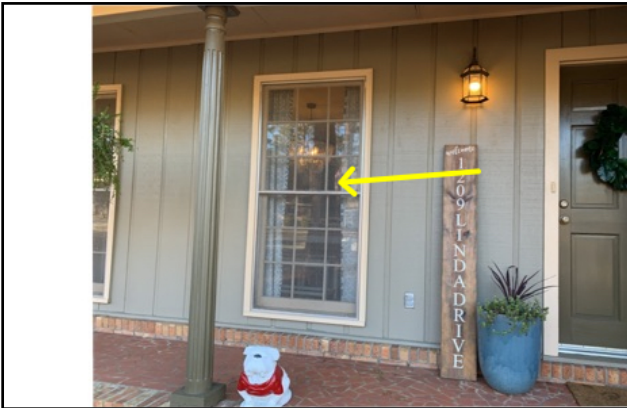
- ROUTINE MAINTENANCE: Paint - Windows are weathered; paint is chipping and peeling away. Any exterior wood must be protected from the elements as best as possible. Suggest scraping and painting as necessary.
- ROUTINE MAINTENANCE: Suggest sealing/caulking and as necessary for part of routine maintenance to prevent further deterioration.
- REPLACE: Some window screens missing/torn/damaged. Repair/replace as necessary.
- REPLACE: Multiple windows at front of house broken. Replace as necessary.

Broken window

Broken windows

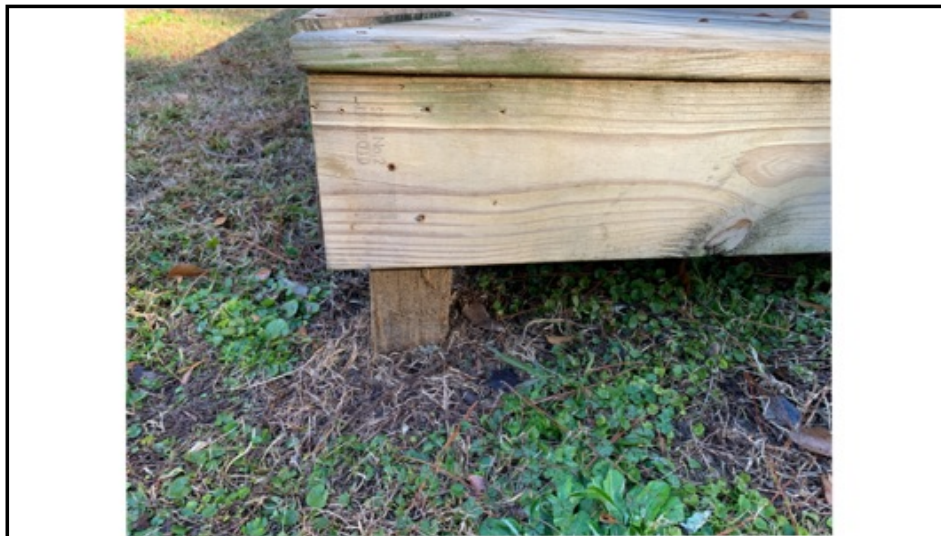
- Walking surface is Wood.
- IMPROVE: Wood to soil contact at deck supports. Deterioration may occur and it provides easier access for insects to gain access.

Wood to ground contact

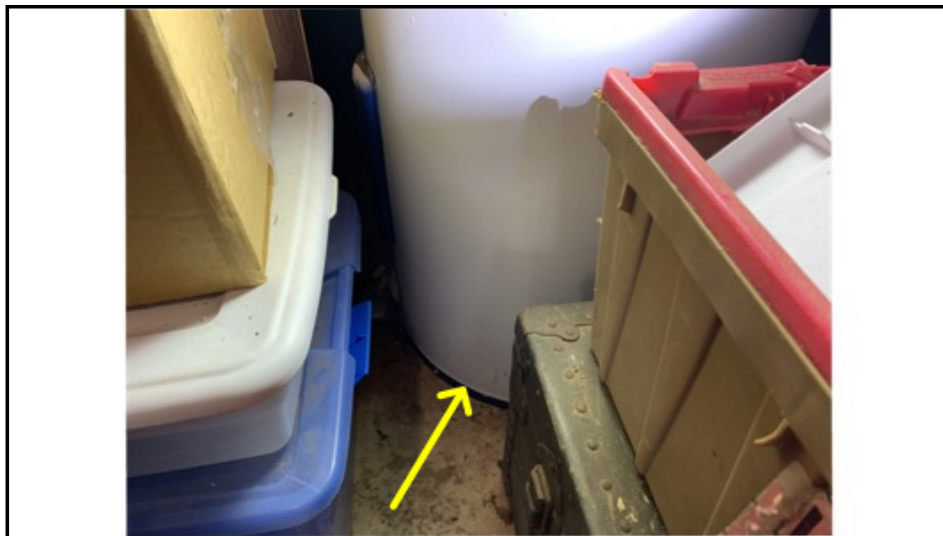
- **IMPROVE:** No catch pan found under the hot water heater. If a water leak occurs, there's no containment for that leak and it's likely to damage surrounding finished surfaces. Recommend adding a catch pan and drain pipe to route any potential water leak out and away from finished surfaces.

No catch pan

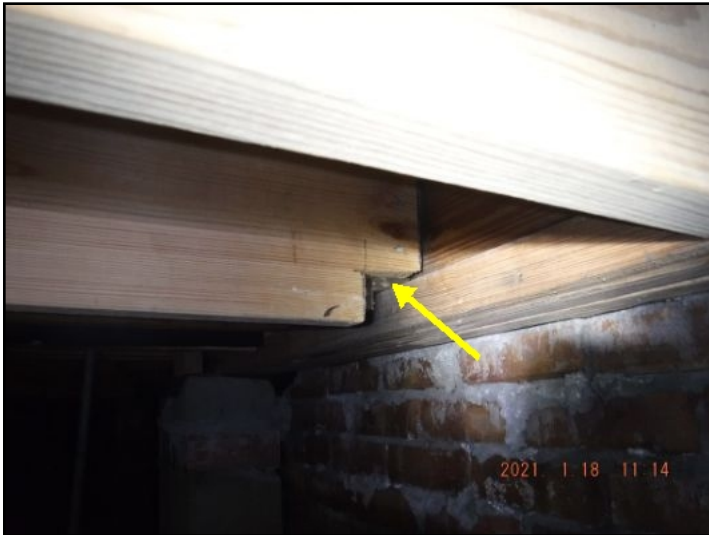
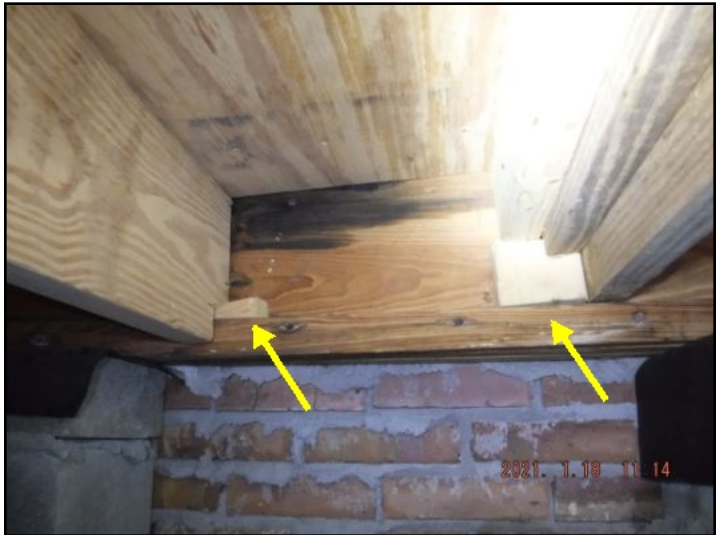
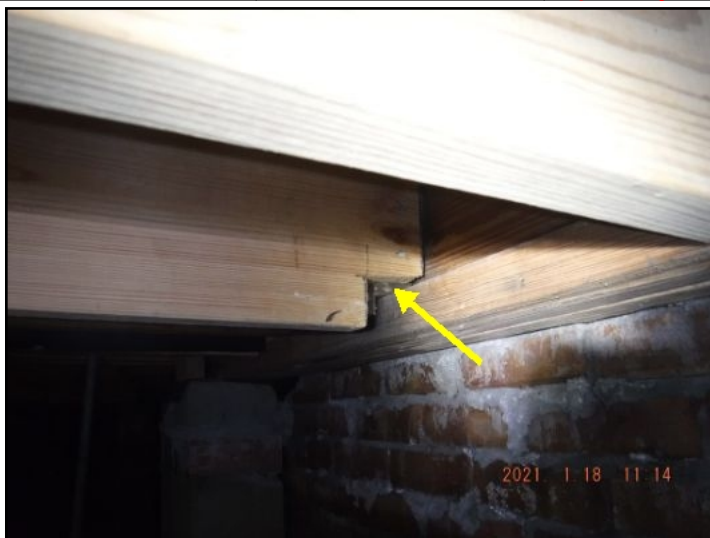
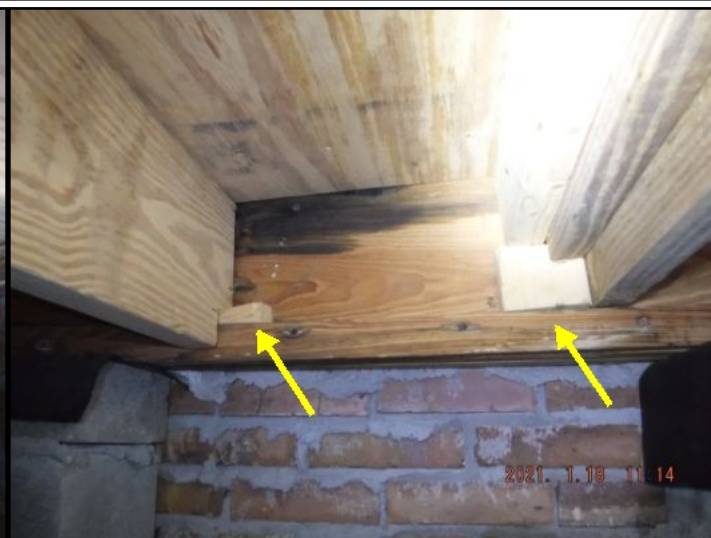
- Framing material: Dimensional lumber wood joists
- **FURTHER EVALUATION: One or more joist hangers are improperly installed or lacks fasteners. Further review and repair by a qualified contractor recommended.**

Improper repairs

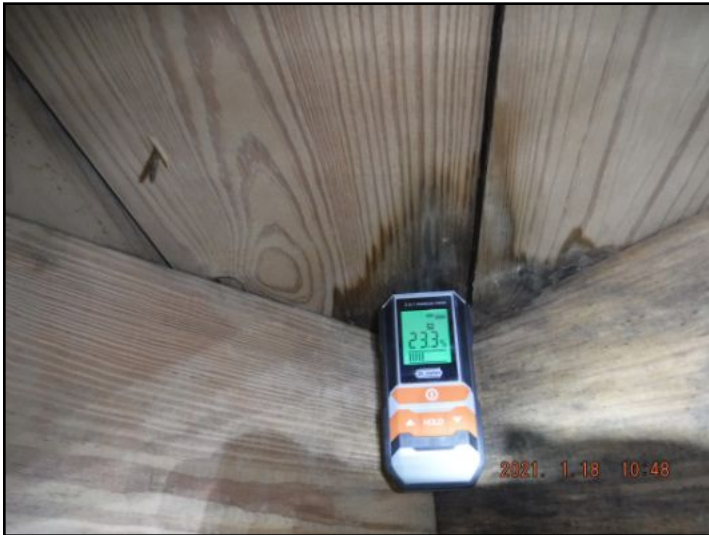
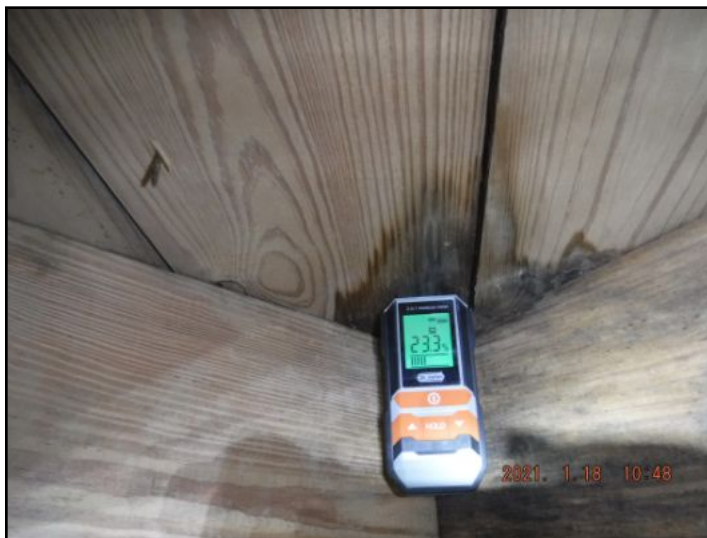
- Sub-floor decking material: Diagonal plank sub-floor
- Additional sub-floor decking material: Plywood sheathing sub-floor
- **OBSERVATION:** Evidence of past repairs to sub-floor noted.
- **FURTHER EVALUATION:** Elevated moisture noted at both bathroom areas and kitchen, along with some moisture damage and staining under air handler unit. No active leak observed at time of inspection, but due to elevation in moisture readings, further evaluation and repairs by qualified plumber is recommended.

Excess moisture around bathrooms

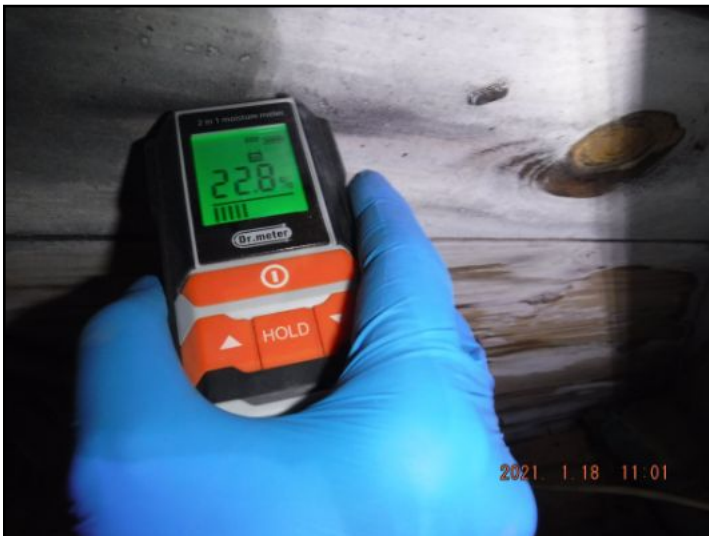
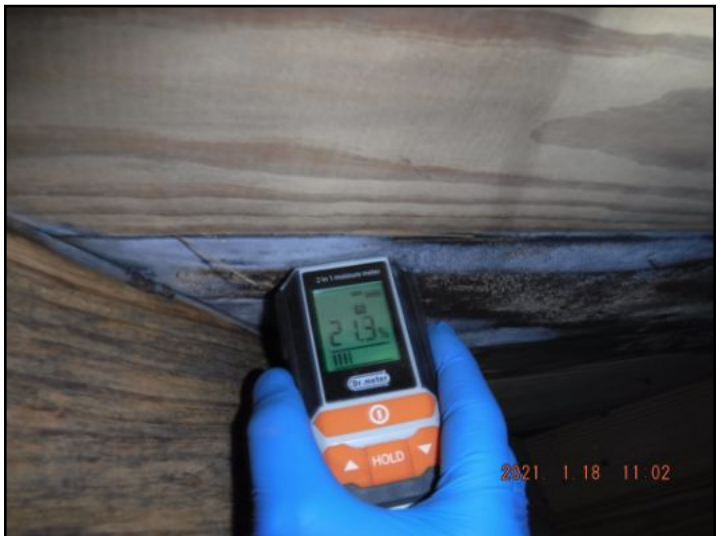
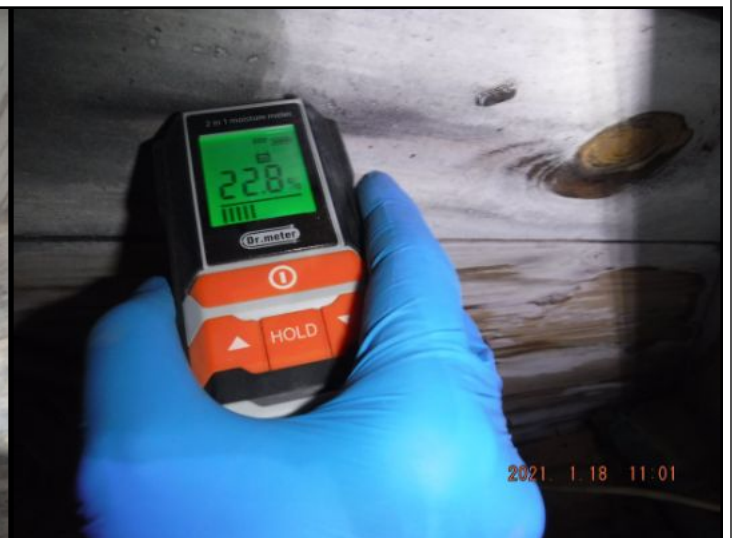
Elevated moisture - below kitchen

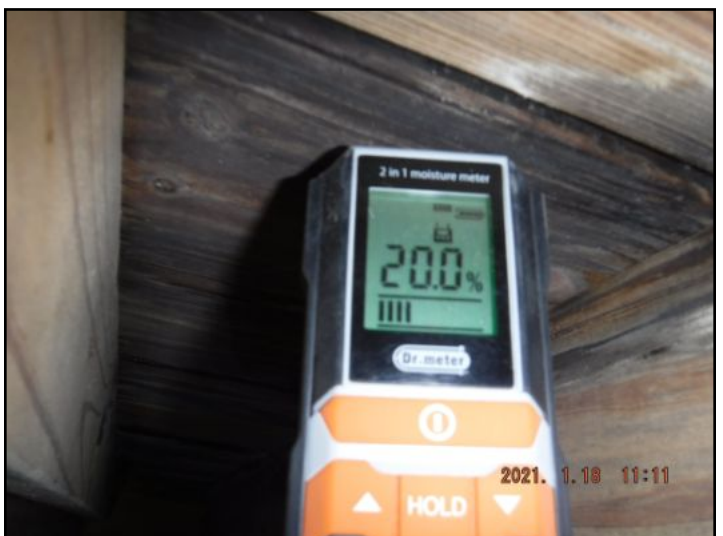
Moisture damage/elevated moisture - bathroom area

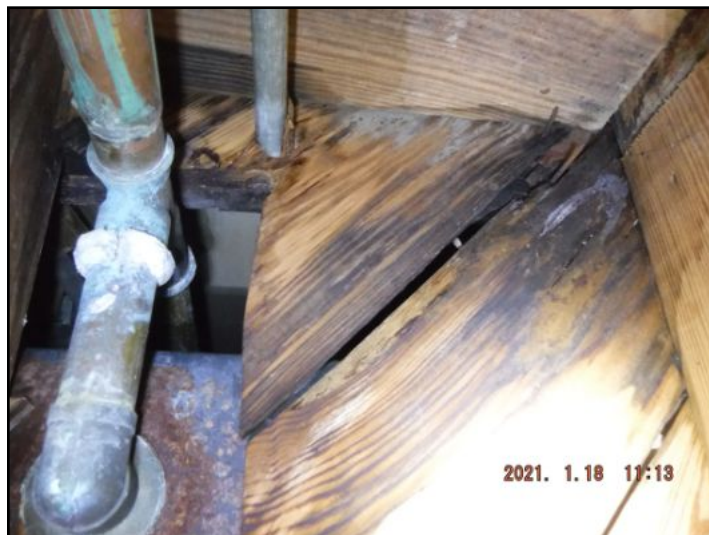
Moisture damaged/elevated moisture - bathroom area

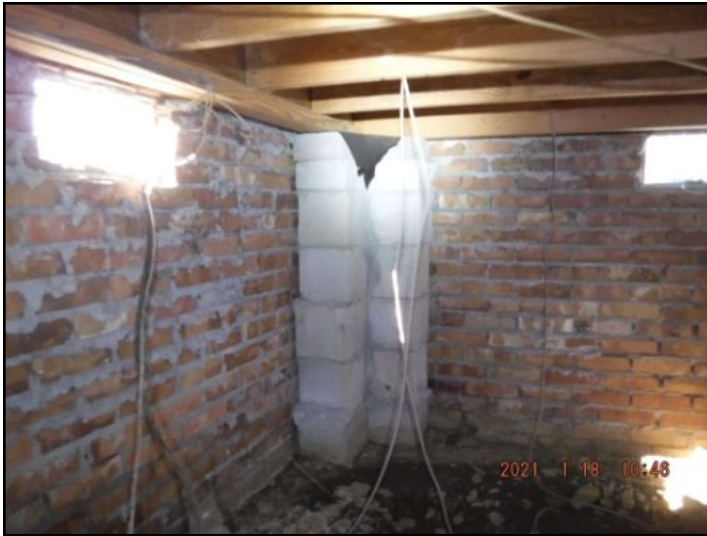
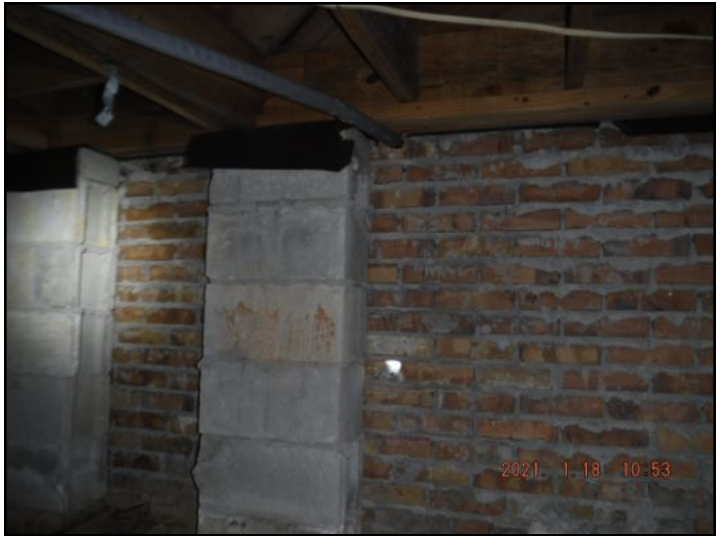
- Cracks/Holes (1/4" or less) present in foundation/exterior wall and appear to be minor shrinkage cracks. Generally speaking, cracks that are less than 1/4" are not commonly regarded as being structurally significant. This is a relatively common condition that occurs during the curing process and is normally no reason for concern. Recommend sealing them to prevent water infiltration and monitor. Consult with a qualified contractor should condition worsen or if water intrusion occurs.
- IMPROVE: The crawl space has openings that can allow water and critters to possibly enter. Recommend filling in the cells of the CMU blocks with concrete to help seal the area better.

Foundation wall

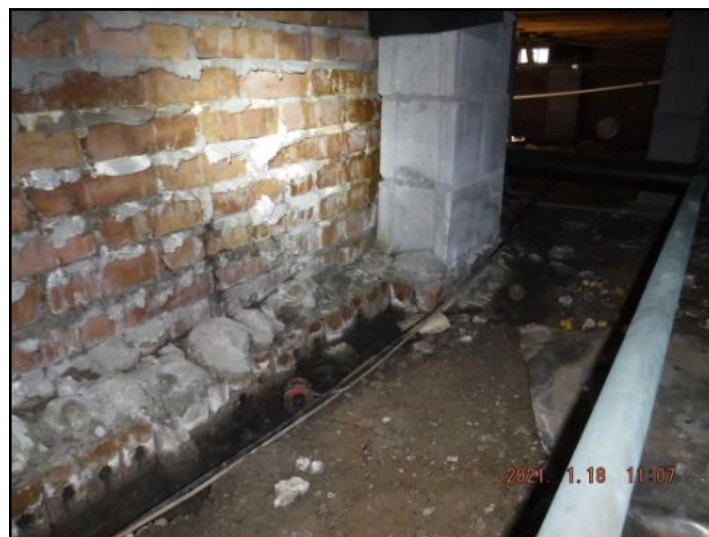
- OBSERVATION: Excess moisture noted along foundation walls. A gutter system on the roof and downspouts to route the excess water away from home can help this, along with a proper moisture barrier throughout the entirety of the crawlspace.

Moisture along exterior wall

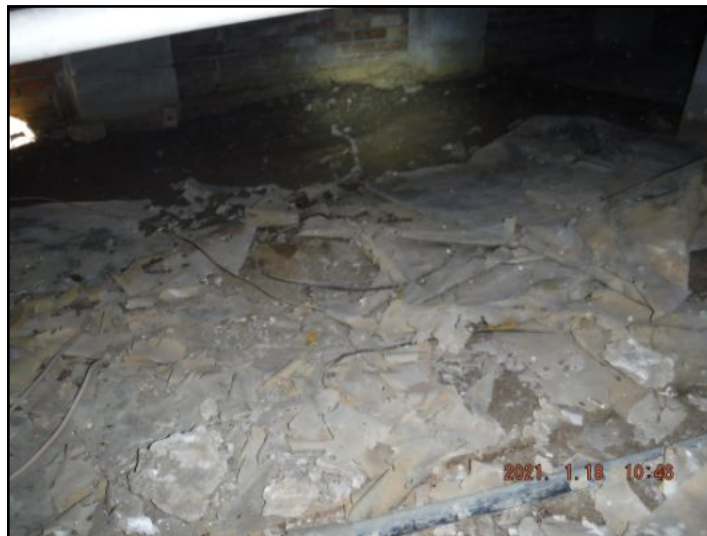
- **REPAIR:** Portions of the crawlspace vapor barrier is in disrepair. The vapor barrier blocks excessive moisture from entering up through the soil. Excess moisture can and lead to mold and mildew growth and be a serious health concern along with cause structural decay/deterioration. Recommend replacing vapor barrier to help control excess moisture levels in this space.

Vapor barrier in disrepair

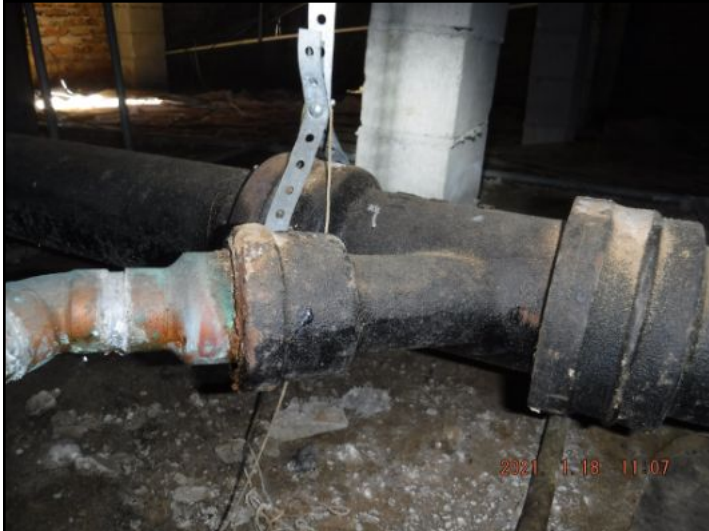
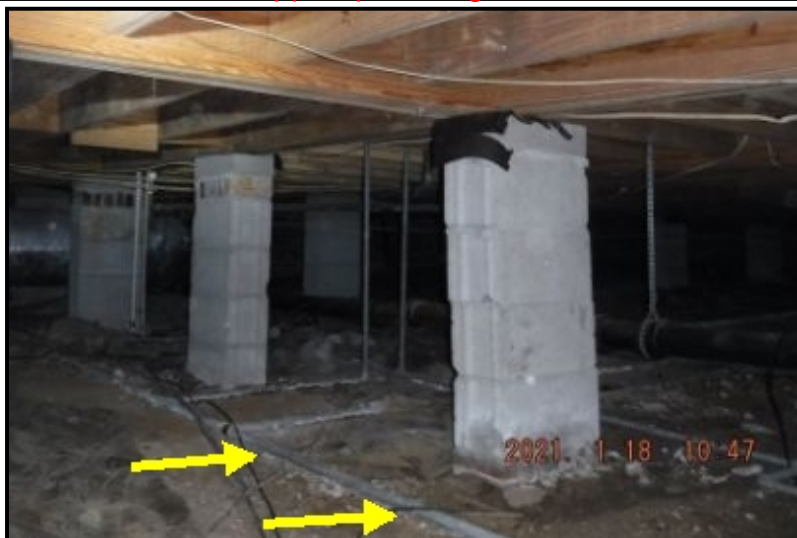
Plumbing unsupported

- **REPAIR:** Crawl space had plumbing that was unsupported and laying in dirt/on ground. Recommend repair to properly support plumbing.

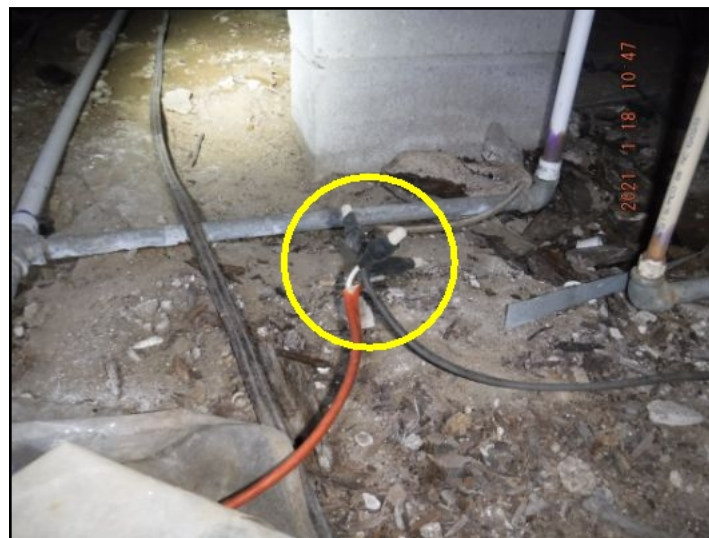
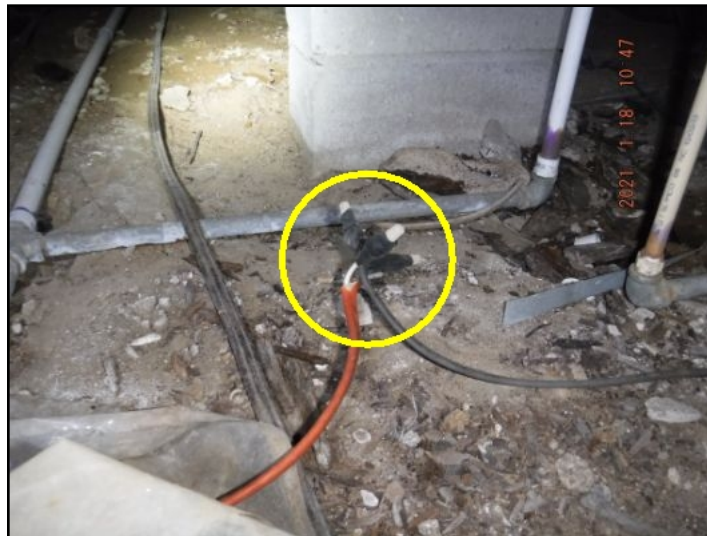
- **REPAIR:** Improper wiring with junctions outside of junction box observed, which is a safety concern. Recommend licensed electrician to install junction box as needed.

Improper electrical connection

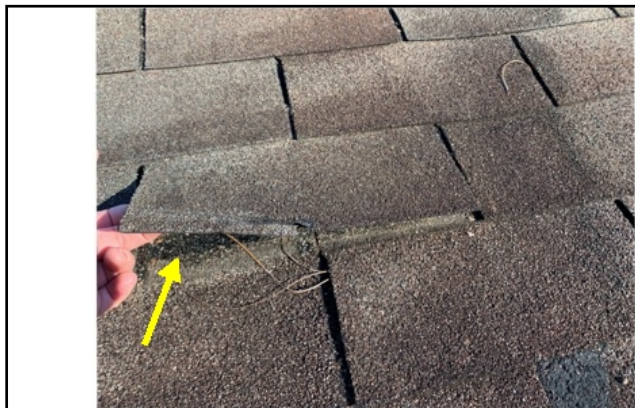
- **REPAIR:** Shingles are starting to curl and they are brittle and some shingles loose when tested. Could not access majority of the attic space due to personal items and duct work blocking access which prevented underside decking inspection. Unable to determine age due to no permit on file. Some roofing wet from condensation. Dry parts did not have many granules. Recommend further evaluation/repair from qualified roofer as necessary.

Loose

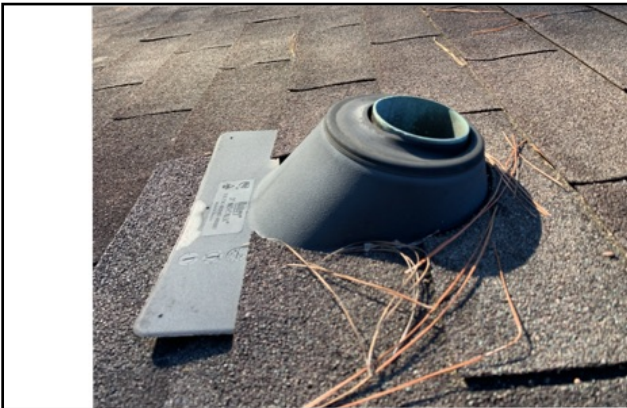
- Metal flashing present.
- Rubber/Plastic flashing present.
- **REPLACE:** Rubber plumbing vent boots are at the end of there life and should be replaced to prevent moisture damage to interior areas.
- **REPAIR:** Vent pipe too low, which should be a minimum of 6" high where it comes through the roof.

Vent stack too low

Rubber flashing/boot worn

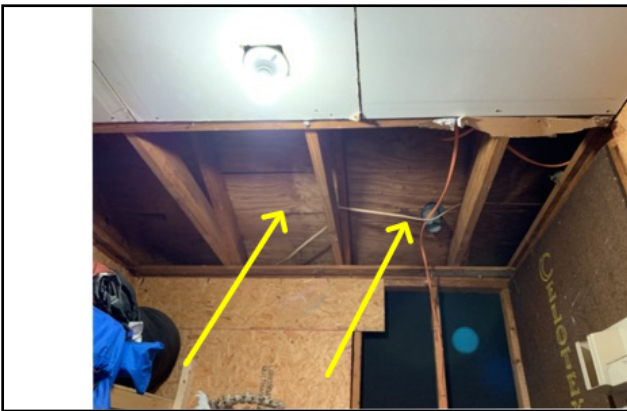
- There are drywall ceilings noted.
- **OBSERVATION:** Carport mechanical/storage room has drywall missing from ceiling.
- **OBSERVATION:** Crack noted in car port entry area ceiling. Unable to inspect attic above that area due to personally stored items blocking access. Typical crack noted along wall/ceiling in living room.
- **OBSERVATION:** Small stains noted on the ceiling. They tested dry at the time of the inspection. Paint peeling on ceiling around register.

Missing drywall

Crack

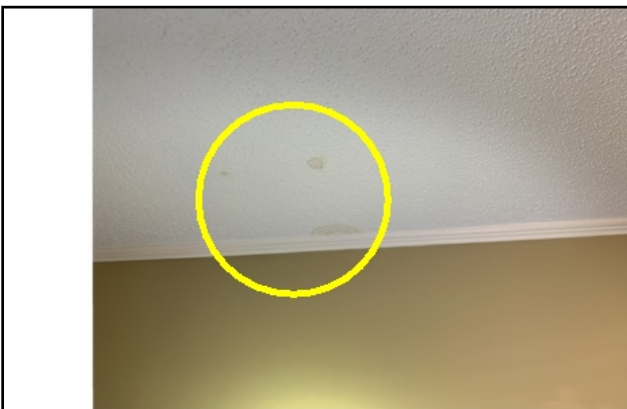
Small ceiling stains

Typical cracking

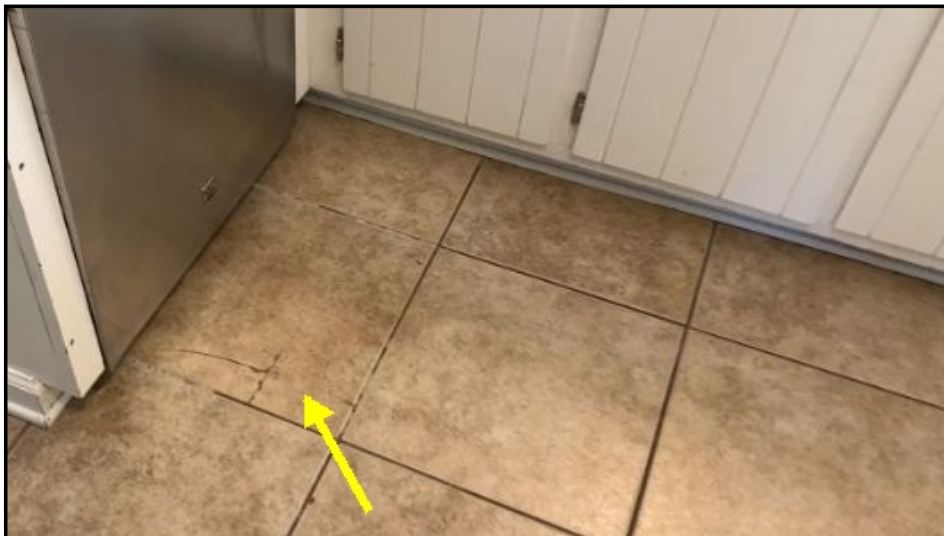
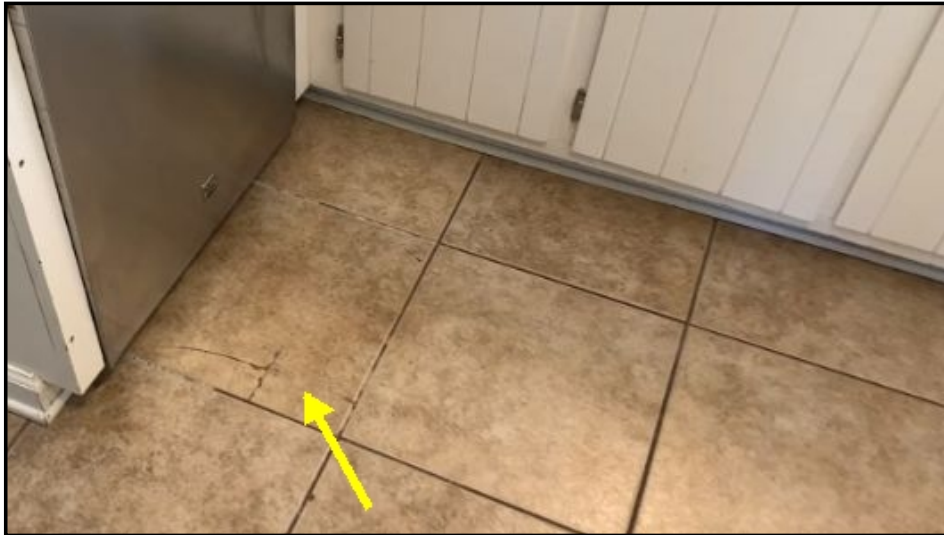
- Overall flooring is in good condition
- **REPAIR:** Cracked tile noted in kitchen near dishwasher.

Cracked tile

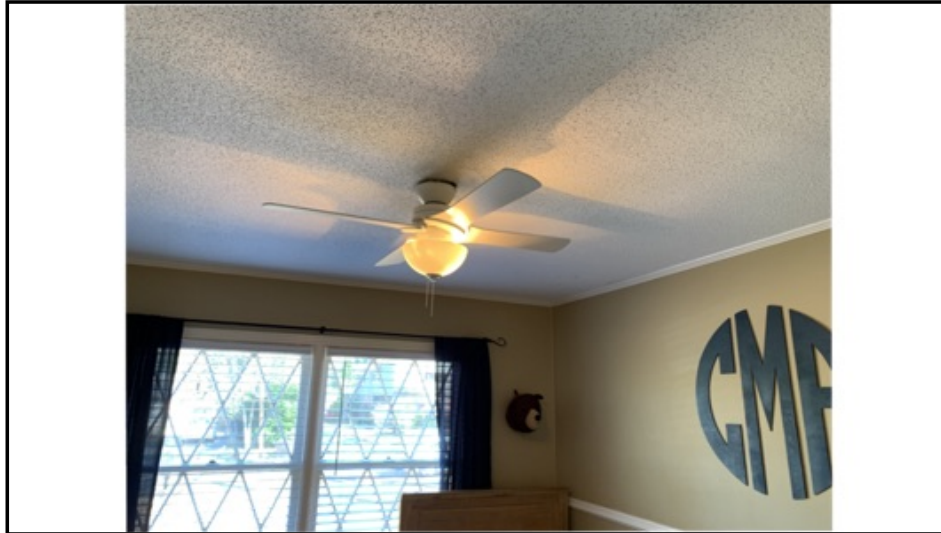
- REPAIR: Ceiling fan in bedroom did not work, but light did.

Fan didn't work

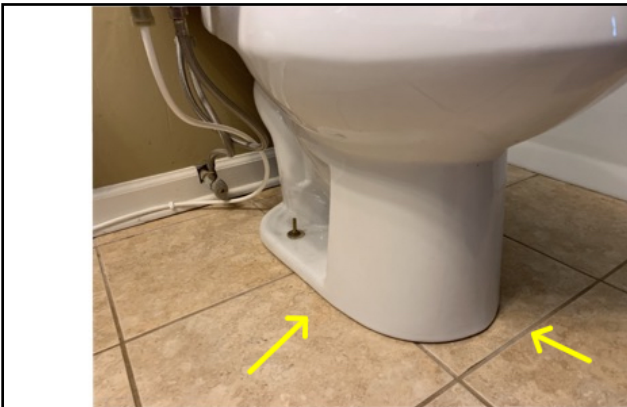
- The toilet bowl is loose at floor anchor bolts in both bathrooms. The wax ring inside the unit must have a snug, secure fit in order to keep from leaking. Properly resealing and re-securing this unit is suggested to prevent water leakage and damage to the sub-floor area. This type of damage is not always visible or accessible to the inspector at time of inspection.

Master bath toilet loose

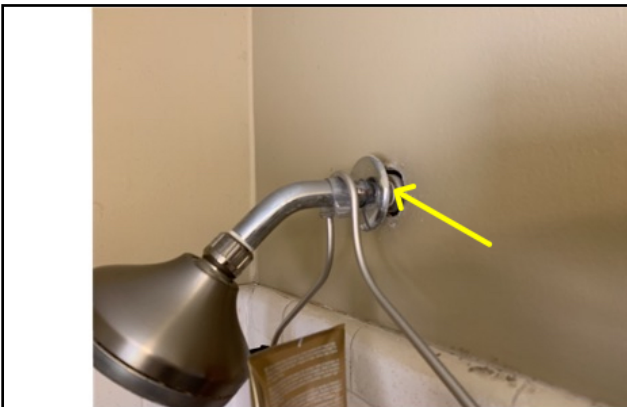
- REPAIR: Loose escutcheon plates noted. These should be refastened and caulked to keep water from infiltrating the walls.
- REPAIR: Shower head leaks in hallway bathroom. Replace/repair as necessary.
- REPAIR: Master bath faucet center handle for shower leaks when operated. Recommend repair/replacement as necessary.

Loose - master bath

Leaking - master bath

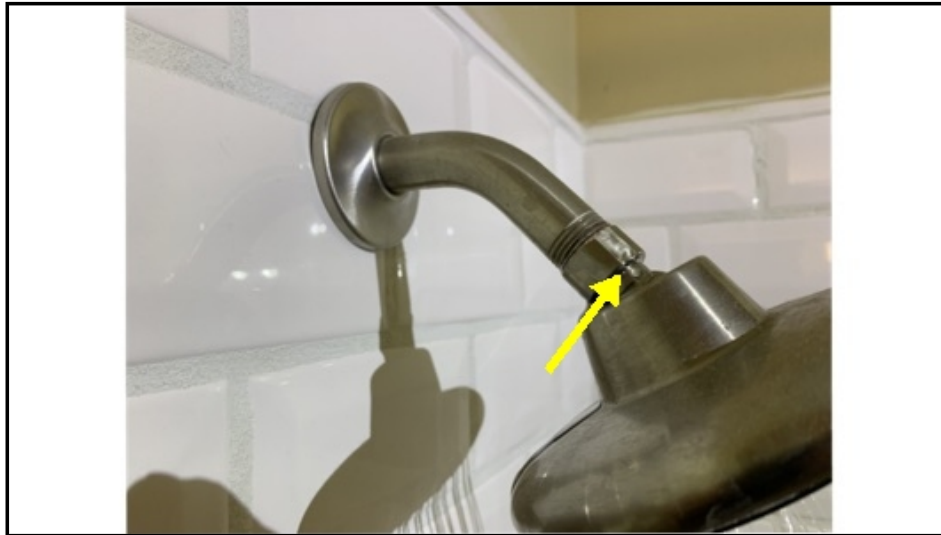
Leaking - hallway

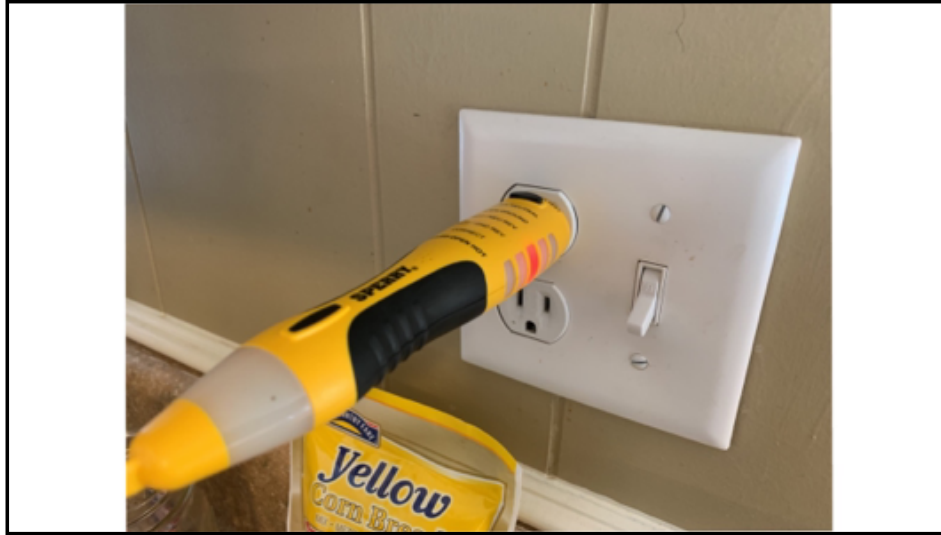
- REPAIR: Wiring - Hot-neutral reversed outlet present. This means that the black and white wires in the circuit have been reversed, and may be a concern with items such as computers and electronic devices.
- REPAIR: No Ground Fault Circuit Interrupter (GFCI) protection. Consider upgrading the electrical system to include GFCI protection for safety in kitchen.

Reverse neutral/hot

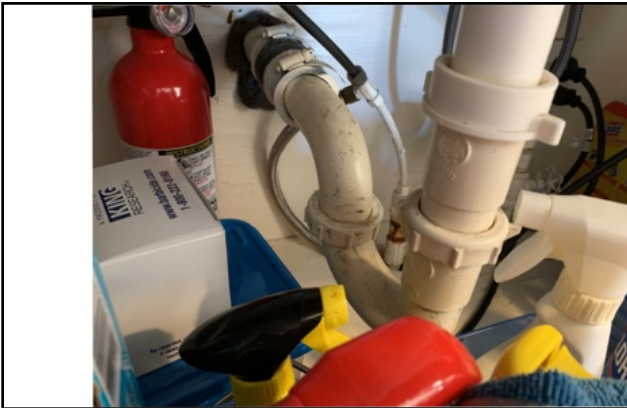
- REPAIR: Dishwasher hose connected to drain line missing hose clamp. Recommend installing hose clamp to prevent leakage.

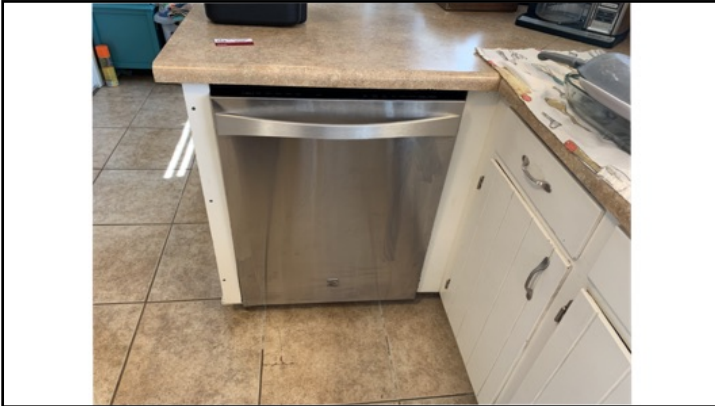
- REPAIR: **Air Gap** - Lack of a proper air gap noted at dishwasher drain line. In the event of a sewer backup this device prevents sewer matter from entering into dishwasher. Recommend having a qualified plumber install a air gap to prevent possible contamination.
- Dishwasher was operational at the time of inspection. Dishwashers most commonly fail internally at the pump, motor or seals. We do not disassemble these units to inspect these components. We recommend you operate this unit prior to closing.
