PROPERTY INSPECTION REPORT

Next Step Inspections

Date of Inspection: 1/1/2021

Year Built: 2021 Size: 1561

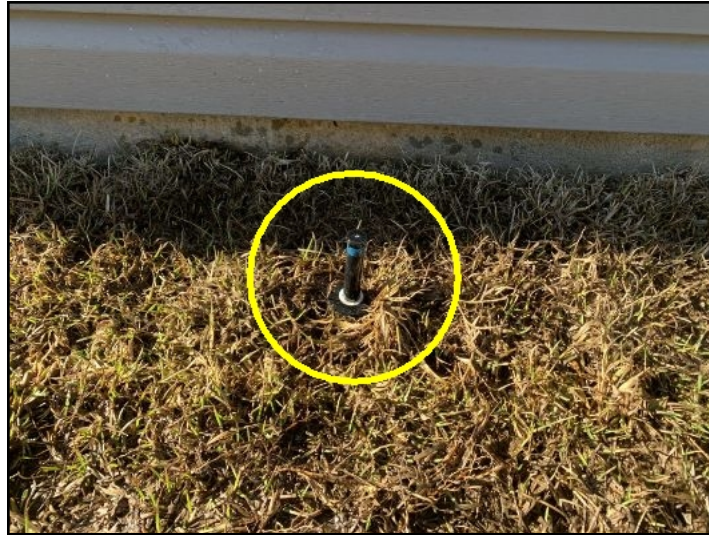
- REPAIR: Sprinkler head not operational at the east side of home.

Not spraying

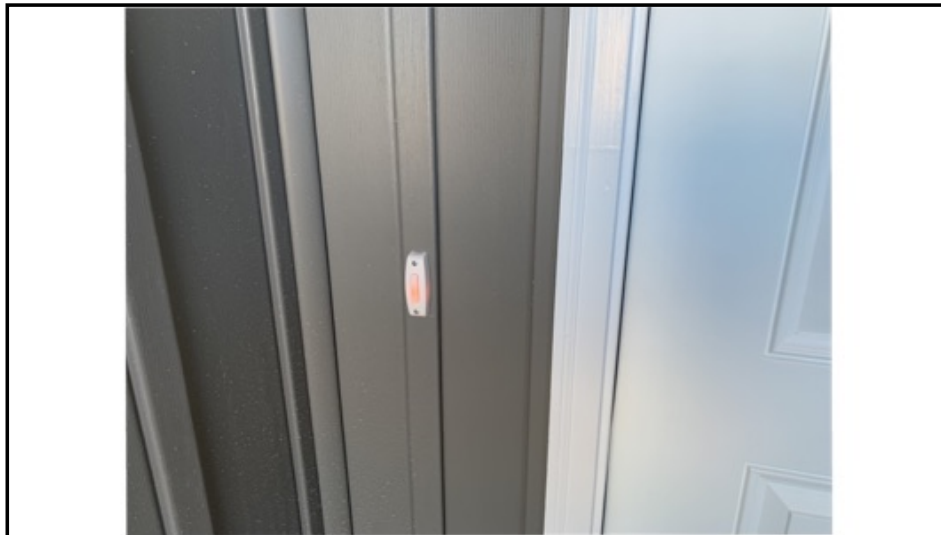
- REPAIR: Doorbell does not work when tested.

Doorbell doesn't work

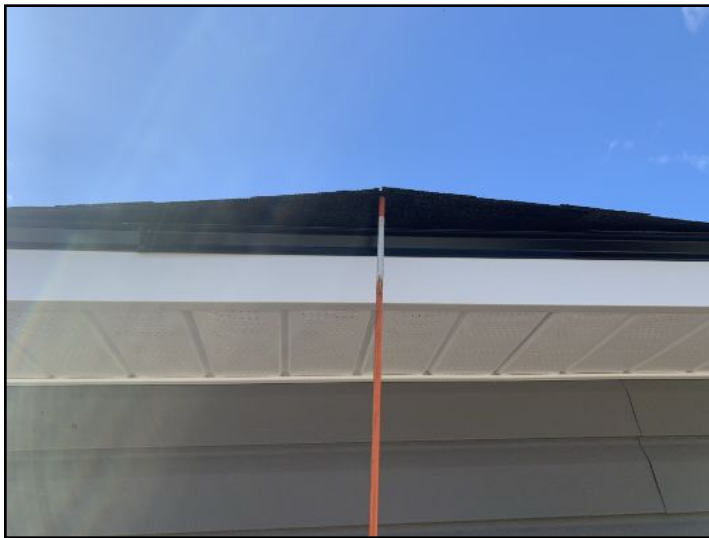
- REPAIR: Starter course (1st layer of shingles applied to roof) around eaves of roof not sealed. If the first course is not adhered, it is susceptible to blow-off in strong winds.

Starter course loose

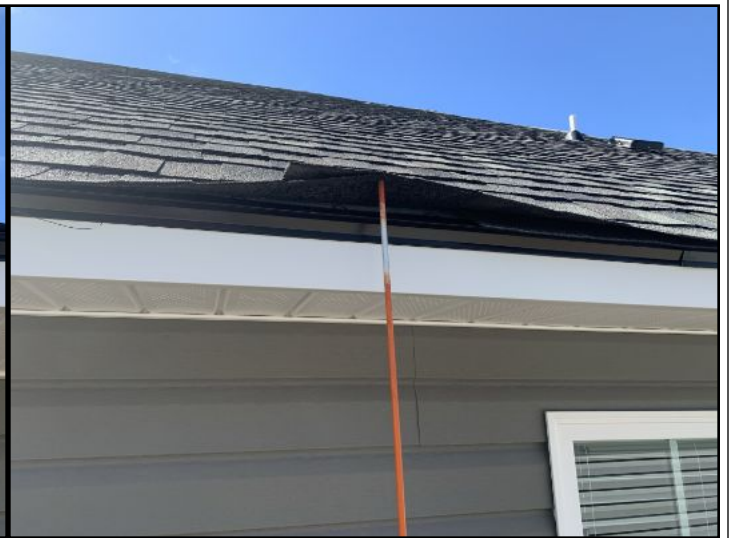
Starter course loose

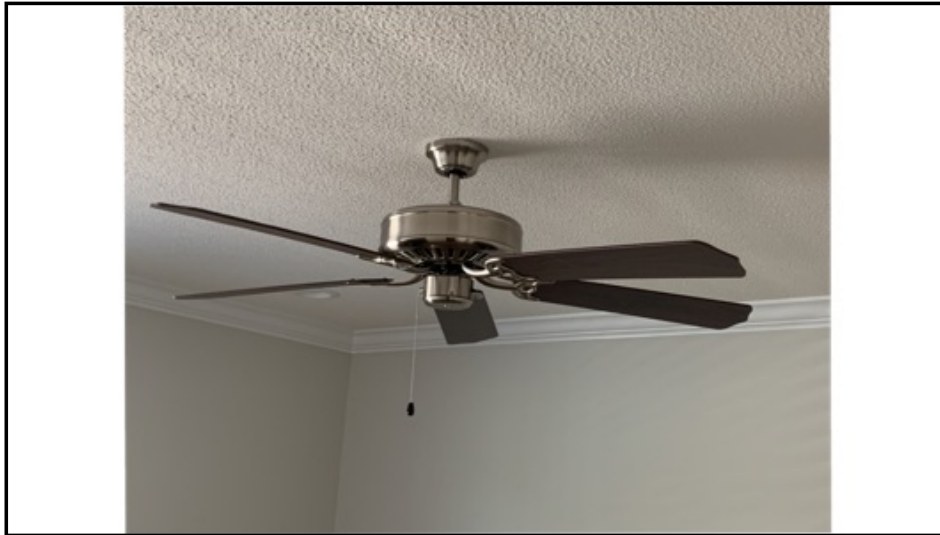
- **REPLACE:** Ceiling fan in east side bedroom unbalanced. Motor makes loud noise when operated. Recommend replacing fan.

Unbalanced & loud

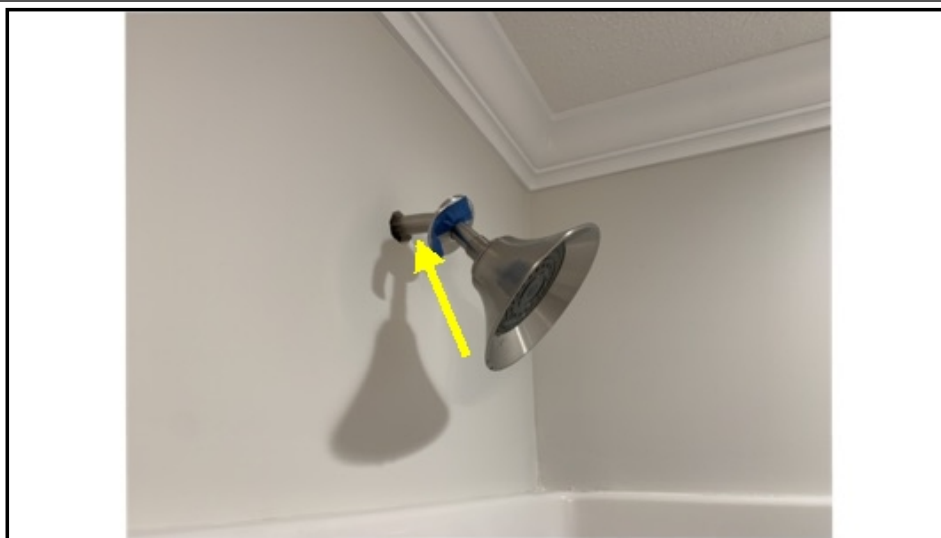
- **REPAIR:** Loose escutcheon plates noted. These should be refastened and caulked to keep water from infiltrating the walls.

Loose - Hallway bathroom

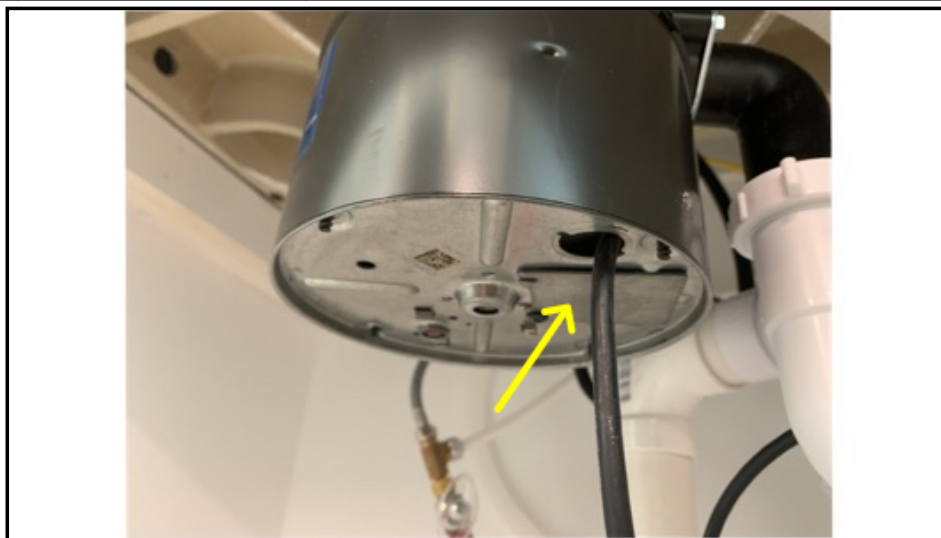
Page 32 Item: 4	Disposal Condition	• REPAIR: Wire strain relief clamp loose or missing. Recommend installing and securing wire per manufacturer's instructions.
-----------------	--------------------	---

Wire clamp not installed

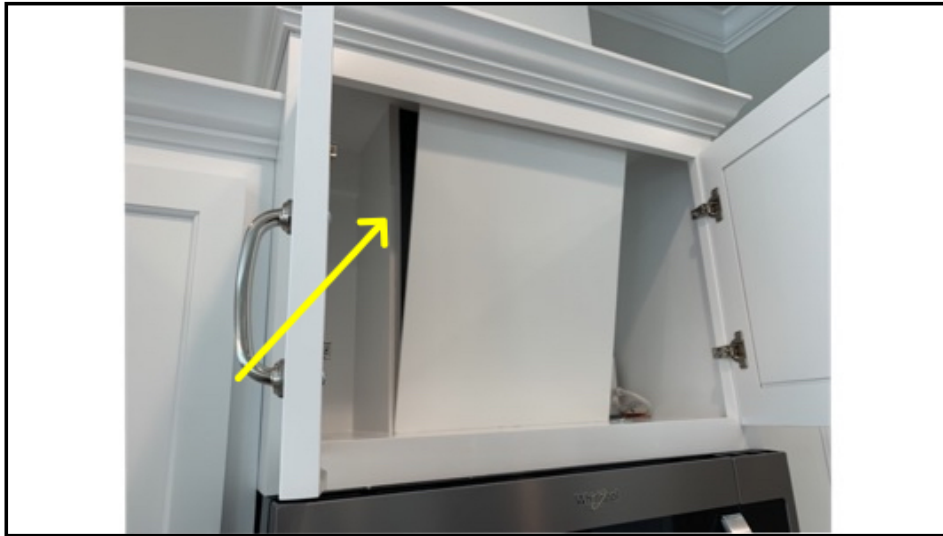
Page 32 Item: 5	Vent Condition	• REPAIR: Vent shroud not secured.
-----------------	----------------	---

Shroud unsecured

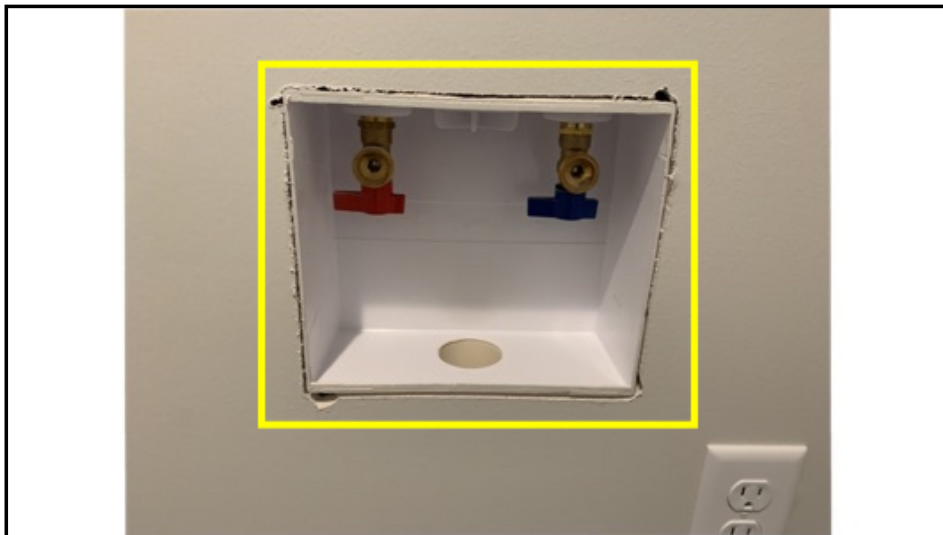
- MISSING: Laundry recessed plumbing missing face plate trim.

Laundry plumbing - Missing trim

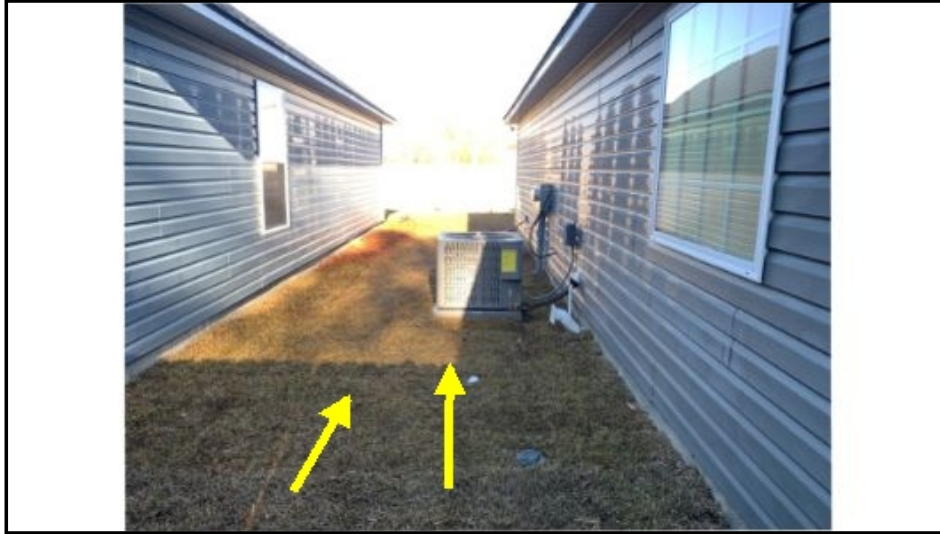
- **OBSERVATION:** Saturated ground. Recommend monitoring once rain has stopped to see how long it takes water to dissipate.
- Recommend monitor lot drainage, particularly during heavy rains. Over time, soils settle around structures and grading improvements may be needed. Slope should fall away from the foundation at a minimum of 1/2 inch per foot and extend at least 10 feet away from the foundation.

Ground saturated

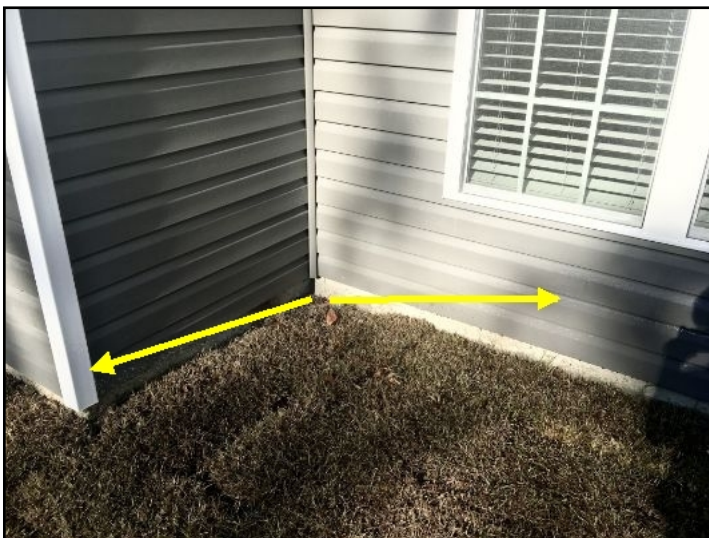
Spraying house

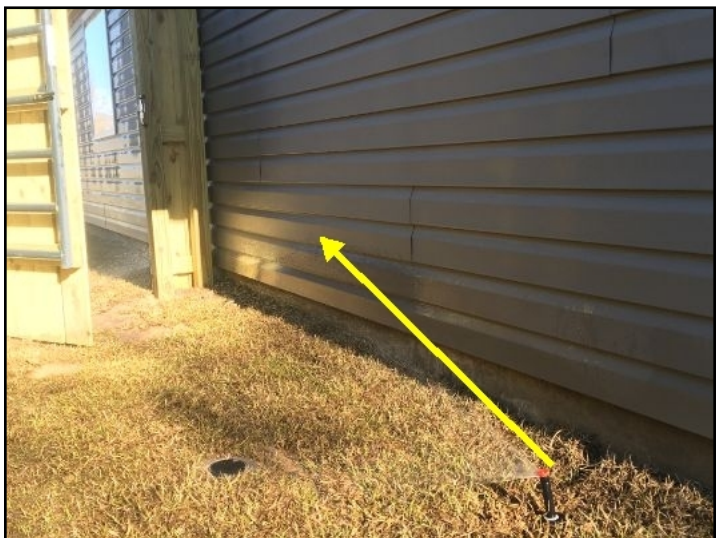
Spraying house

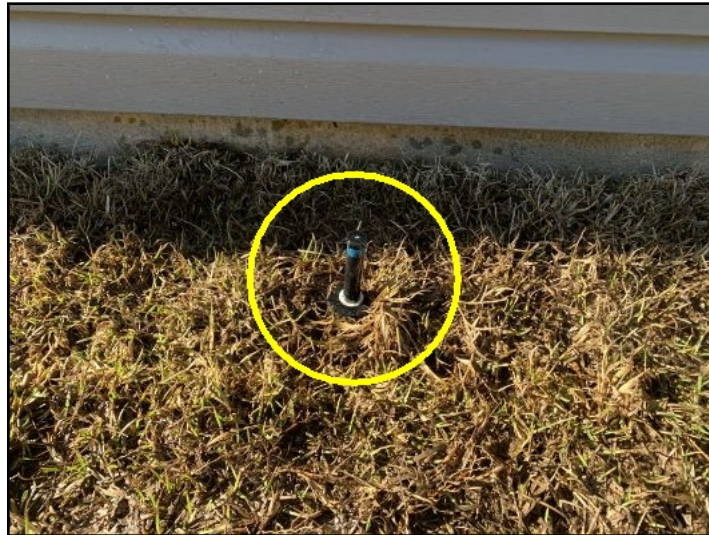
- Home is equipped with an underground sprinkler system.
- The irrigation system was tested.
- The sprinkler system operates with a control panel in the garage.
- Water source is Public
- Number of zones 2
- A vacuum break or backflow preventer was not observed.
- Inspecting irrigation is not within the scope of this inspection. Any observations or recommendations are courtesy. Recommend confirming that irrigation system is in serviceable condition before the close of escrow.
- ADJUST: Some irrigation heads are spraying against the house on the south and west side which can cause siding to wear out prematurely. Even worse, it can cause water to seep/leak into the home's structure causing significant damage if left unchecked and adjusted.
- **REPAIR: Sprinkler head not operational at the east side of home.**

Not spraying

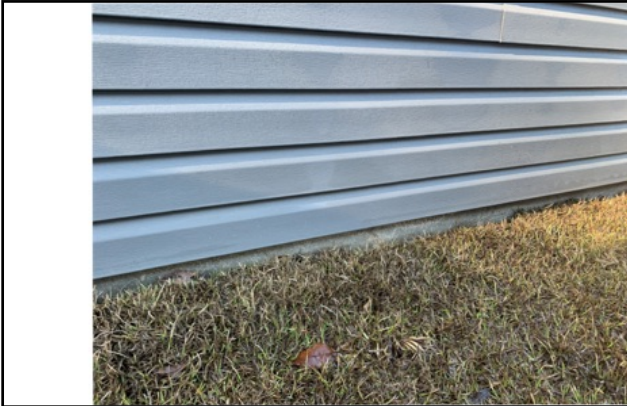
- **OBSERVATION:** Siding-Soil contact or proximity. This may provide entrance of moisture or insects to siding. Recommend grading soil so there is at least 6" of space (where practical) between the siding and the soil below and checking for any damaged trim and siding materials.

Siding/soil close proximity

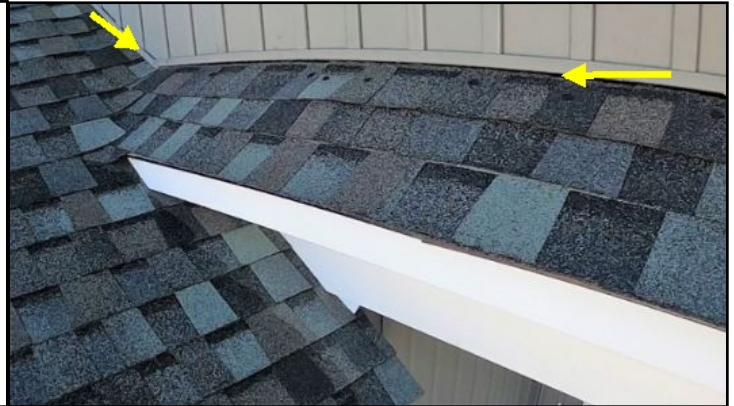
- **OBSERVATION:** Roof to sidewall missing gap. Typically there should be a 1.5" gap between the roofing material and siding. Without a gap, the exterior wall-covering can wick up moisture from the roof. This can lead to decay, delamination, peeling paint, and other problems.

Lacking gap

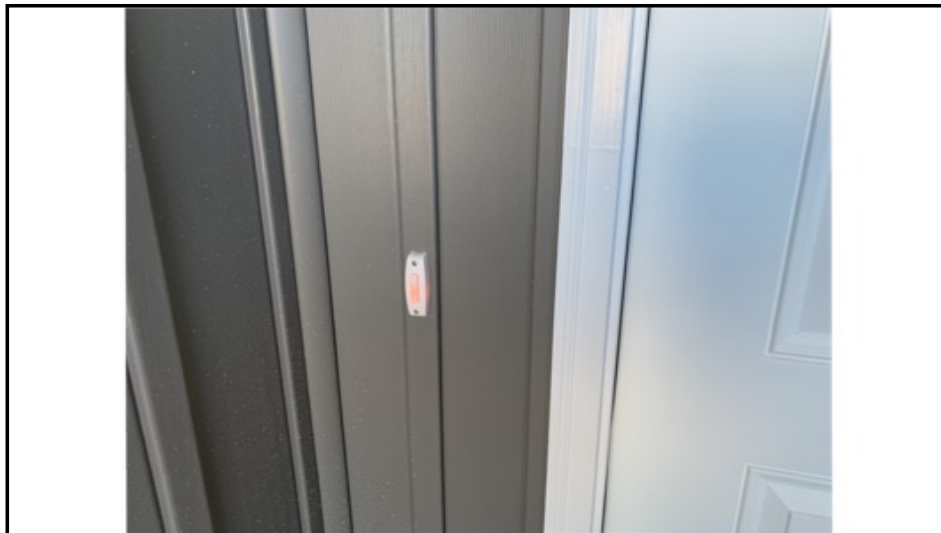
- Walking surface is Concrete, Bare.
- The patio roofing materials noted: Same as the main structure
- **REPAIR: Doorbell does not work when tested.**

Doorbell doesn't work

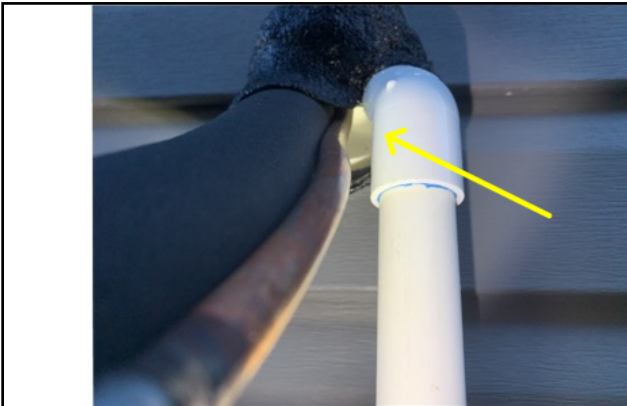
- The Condenser is located outside on the East of the house/unit
-
- REPAIR: Opening - The AC refrigerant lines that penetrate the wall needs sealing. Water and/or pest are able to enter structure. Recommend sealing/caulking as needed.

Opening - recommend sealing

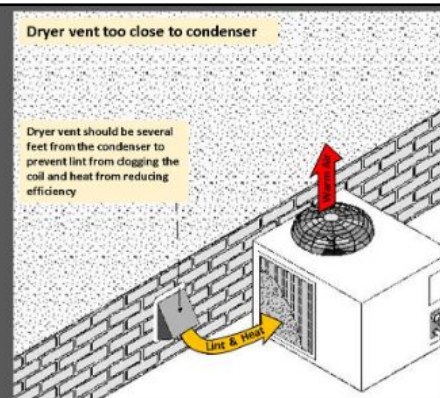
- ROUTINE MAINTENANCE: Recommend having the system serviced at least annually by a qualified HVAC company.
-
- MONITOR: Dryer vent located within 3-feet of exterior condenser. This allows for lint and hot air to be sucked into the fins of the condenser. This can both clog the fins of the condenser and decrease its efficiency. Recommend relocating the dryer vent or divert the dryer vent exhaust away from the condenser.

Dryer vent / Condenser proximity

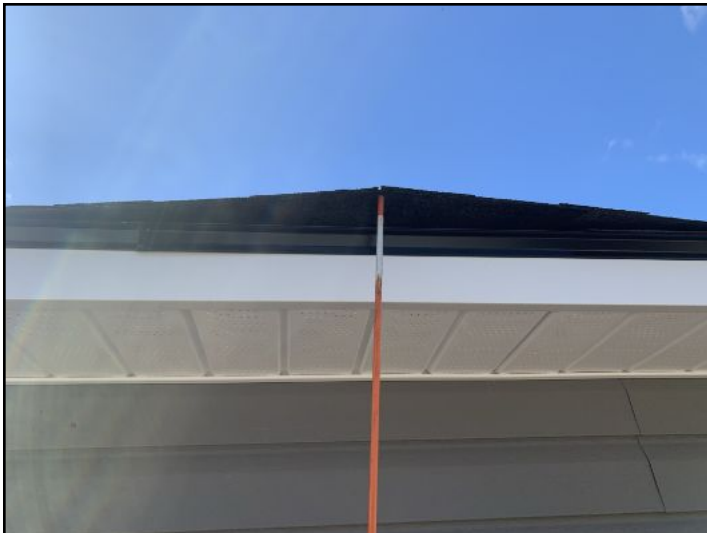
- **REPAIR:** Starter course (1st layer of shingles applied to roof) around eaves of roof not sealed. If the first course is not adhered, it is susceptible to blow-off in strong winds.

Starter course loose

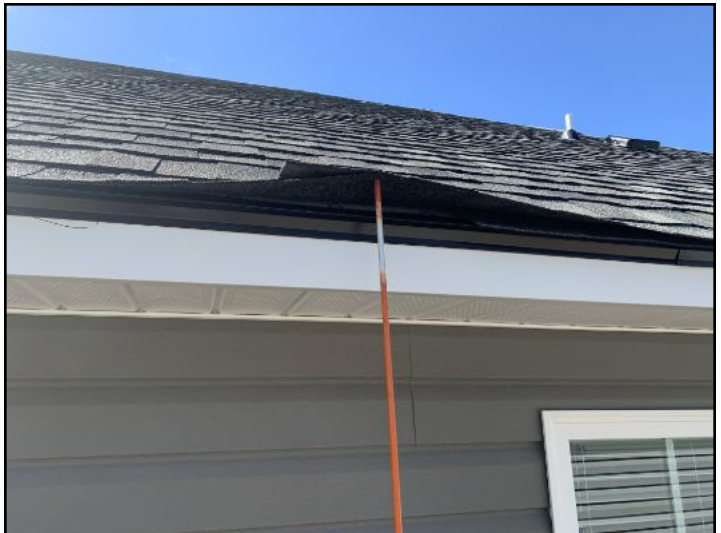
Starter course loose

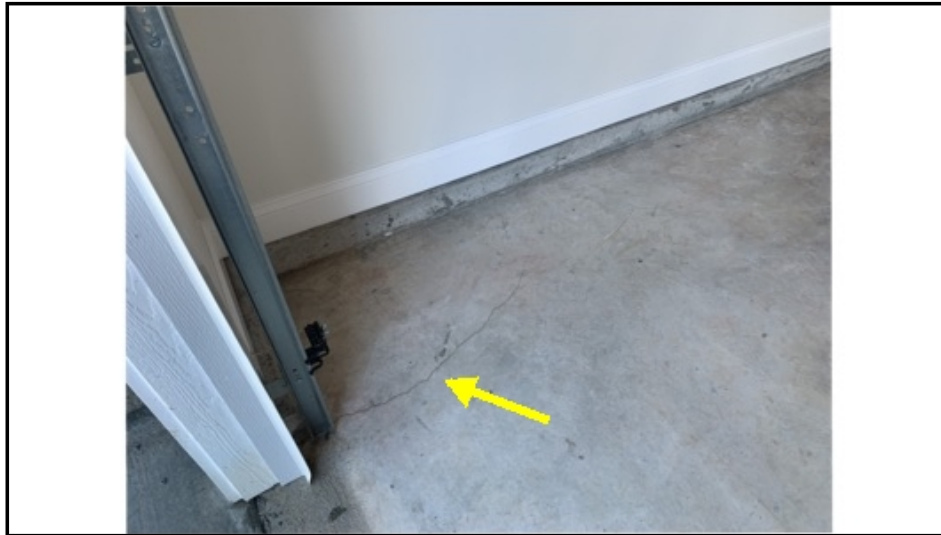
- Floors are free of cracks and appear to be in good condition. No major system safety or function concerns noted at time of inspection.
- OBSERVATION: Cracks - Typical cracks noted.

Typical settlement crack

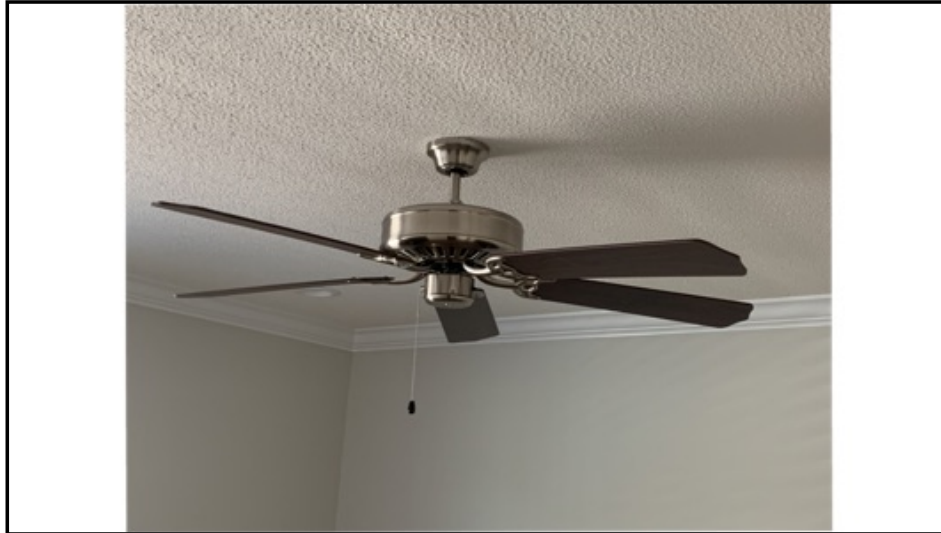
- **REPLACE:** Ceiling fan in east side bedroom unbalanced. Motor makes loud noise when operated. Recommend replacing fan.

Unbalanced & loud

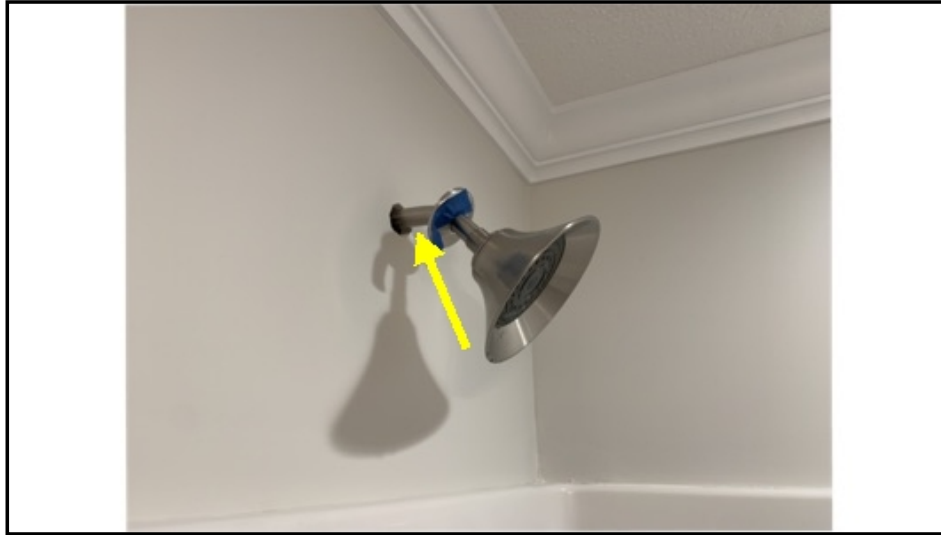
- **REPAIR:** Loose escutcheon plates noted. These should be refastened and caulked to keep water from infiltrating the walls.

Loose - Hallway bathroom

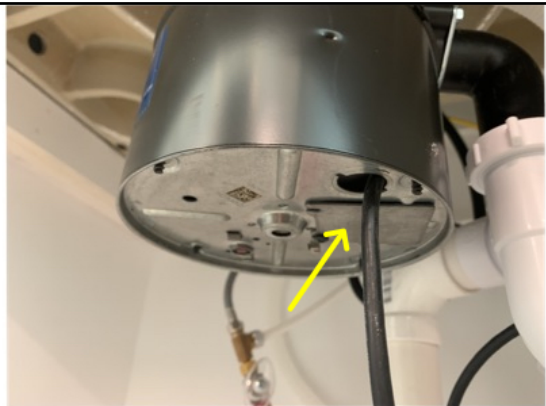
- **REPAIR:** Wire strain relief clamp loose or missing. Recommend installing and securing wire per manufacturer's instructions.

Wire clamp not installed

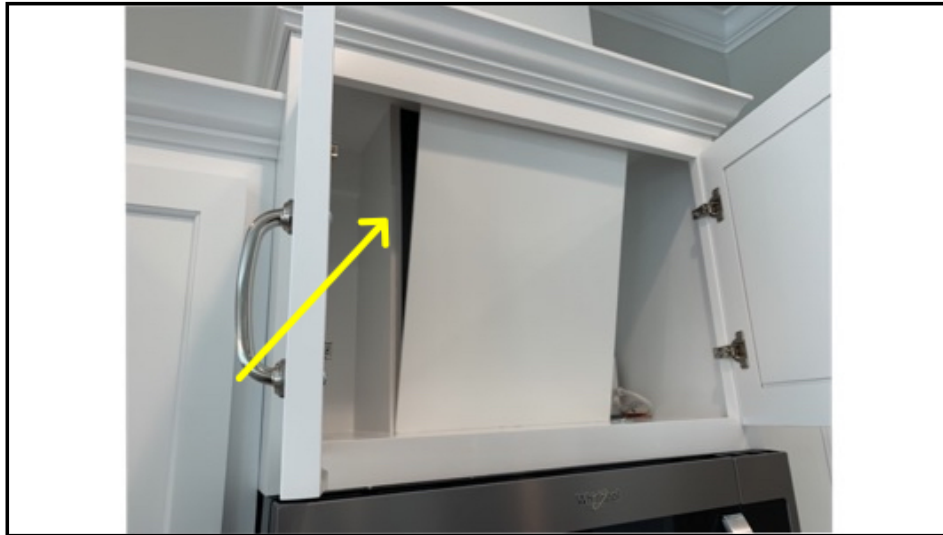
- **REPAIR:** Vent shroud not secured.

Shroud unsecured

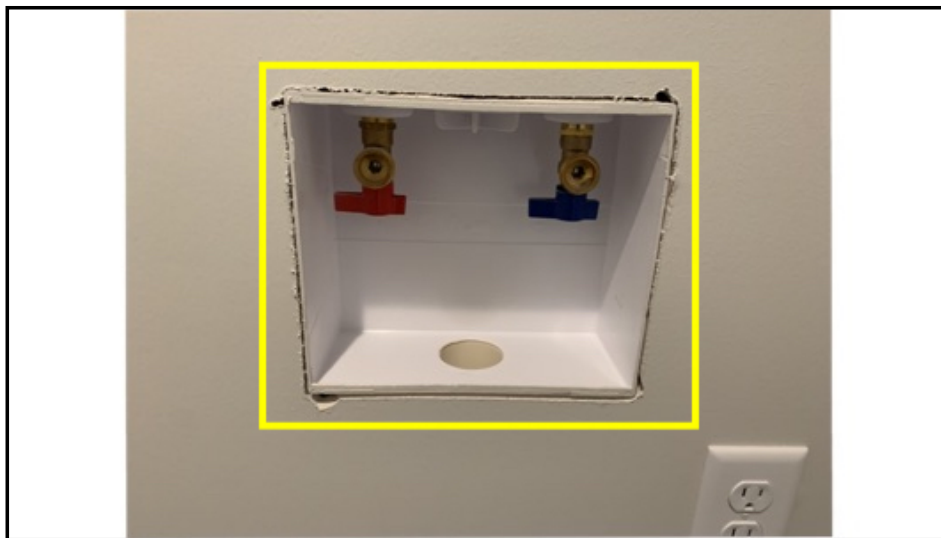
- **MISSING:** Laundry recessed plumbing missing face plate trim.

Laundry plumbing - Missing trim

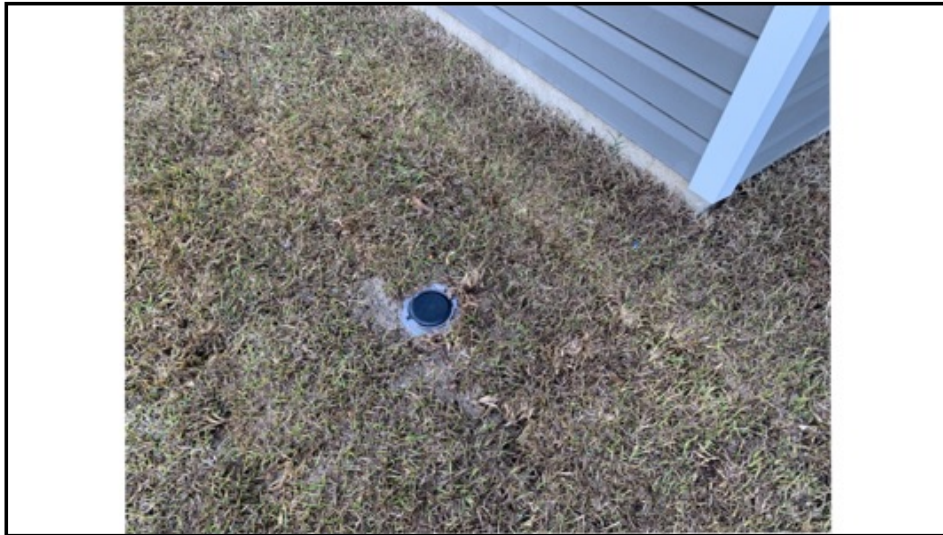
- If not already done, we recommend a licensed pest control operator be called in to make an inspection for wood destroying organisms, and to make a further evaluation of the status of such activity to determine if treatment is needed.
- **OBSERVATION:** Outside bait stations observed around home.

Outside bait station
