**Present during inspection:** Client  
**Client present for discussion at end of inspection:** Yes  
**Weather conditions during inspection:** Dry  
**Temperature during inspection:** Warm  
**Ground condition:** Damp  
**Type of building:** Single family  
**Buildings inspected:** One house  
**Age of main building:** 53 yrs. built 1960  
**Source for main building age:** Municipal records or property listing  
**Front of building faces:** South  
**Occupied:** No

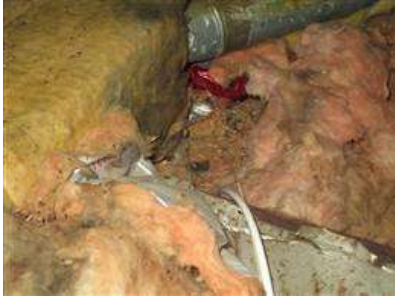
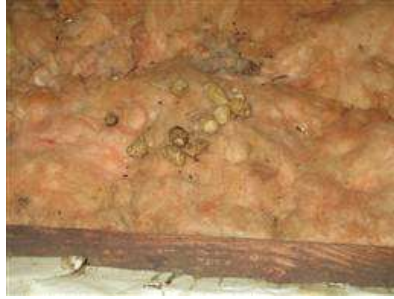
Evidence of rodent infestation was found in the form of feces, damaged insulation in the attic. Consult with the property owner about this. A qualified person should make repairs to seal openings in the structure, set traps, and clean rodent waste as necessary. Recommend following guidelines in these Center for Disease Control articles:  
[http://www.cdc.gov/rodents/prevent\\_infestations/seal\\_up.html](http://www.cdc.gov/rodents/prevent_infestations/seal_up.html)  
[http://www.cdc.gov/rodents/prevent\\_infestations/trap\\_up.html](http://www.cdc.gov/rodents/prevent_infestations/trap_up.html)  
[http://www.cdc.gov/rodents/prevent\\_infestations/clean\\_up.html](http://www.cdc.gov/rodents/prevent_infestations/clean_up.html)

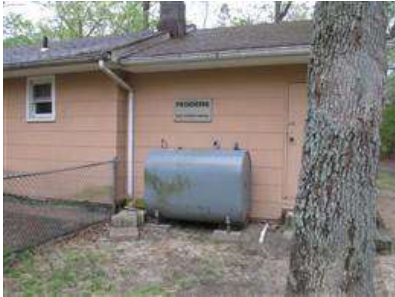
**Photo 21**

Fuel oil was not available during the inspection (tank empty, shut-off valve turned off, etc.). The inspector operates only "normal" controls such as thermostats and on/off switches, and does not operate oil shut-off valves or attempt to re-light furnaces. As a result, items such as but not limited to the fuel oil supply system and oil fired furnaces or boilers weren't fully evaluated. Recommend that a qualified person make a full evaluation of the fuel oil supply system and oil-fired appliances after the fuel oil supply is restored. Any problems that are found after this evaluation should be repaired by a qualified contractor.

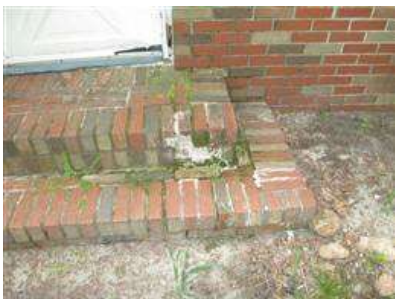
**Photo 2**

Masonry steps have settled or deterioration were found. Recommend that a qualified contractor repair or replace steps as necessary.

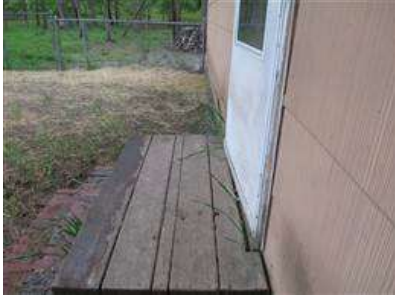
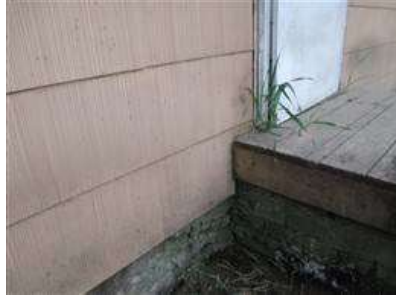
Soil was in contact with or close to wooden stairs at the rear porch. This is a conducive condition for wood-destroying organisms. Soil should be graded and/or removed so no wood-soil contact is present, if possible. Otherwise, installing products such as borate-based Impel rods may help to prevent infestation and damage. For more information, visit:

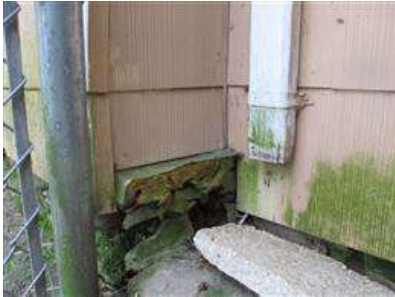
Photo 23

Significant erosion was found in one or more areas. Recommend having a qualified person evaluate and make repairs as necessary to repair erosion, and to prevent erosion in the future.

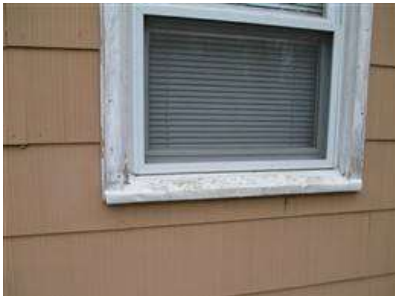
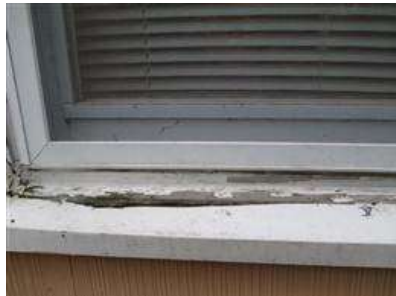
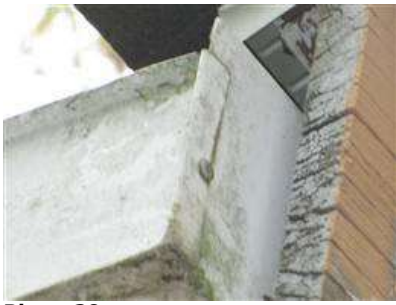
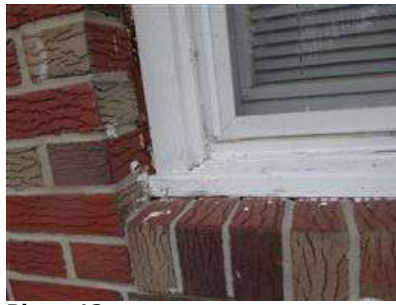
Rot was found at one or more window frames, fascia. Recommend that a qualified person repair as necessary. All rotten wood should be replaced.

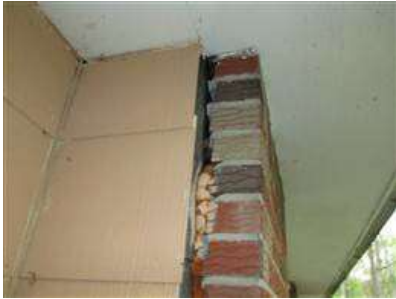
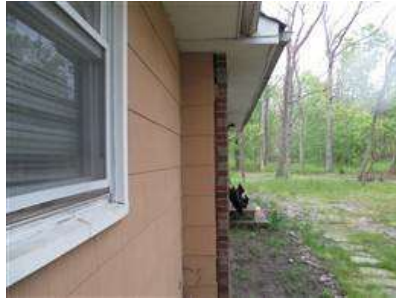
The masonry (brick or stone) veneer was deteriorated or damaged in some areas. Where cracks or openings are exposed, water can enter the wall structure causing mold, fungal growth and structural damage. This is a conducive condition for wood-destroying organisms. Recommend that a qualified contractor repair as necessary. For example, by repointing mortar or replacing broken or missing masonry.

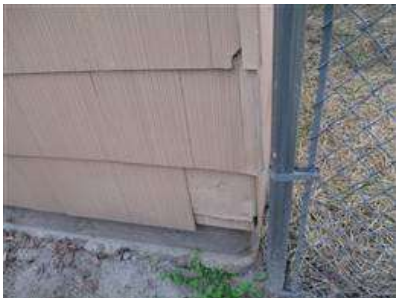
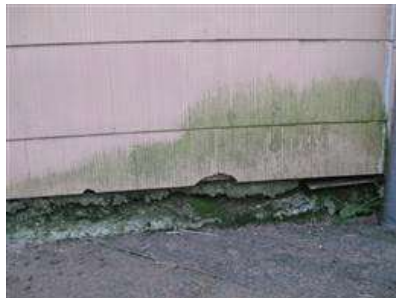
Some sections of siding and/or trim were missing, damaged. Recommend that a qualified person repair, replace or install siding or trim as necessary.

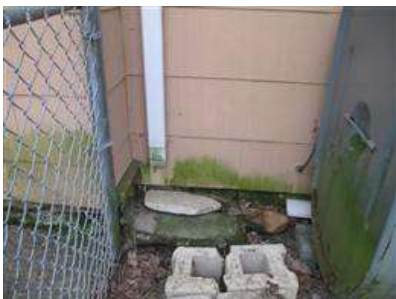
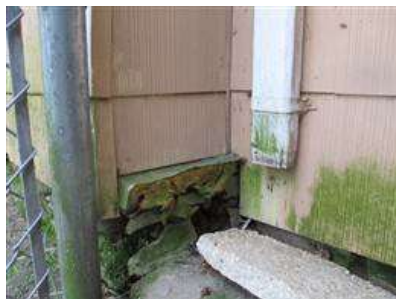
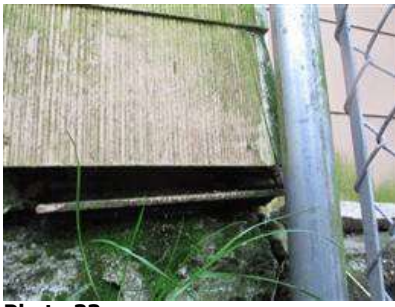
Moderate deterioration was found in the foundation. This may be a structural concern or an indication that settlement is ongoing. The client should consider hiring qualified contractors and/or engineers as necessary for further evaluation. Such contractors may include:

- Foundation repair contractors who may prescribe repairs, and will give cost estimates for such repairs
- Masonry contractors who repair and/or replace brick veneer
- Geotechnical engineers who attempt to determine if settlement is ongoing, and the cause of the settlement
- Structural engineers who determine if repairs are necessary, and prescribe those repairs

At a minimum, recommend sealing cracks to prevent water infiltration. Numerous products exist to seal such cracks including hydraulic cement, resilient caulks and epoxy sealants.

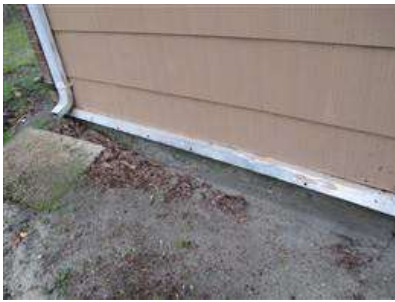
**Photo 17**

Clearances between the cement fiber siding and horizontal flashing were too small. Moisture can penetrate and damage the siding as a result, and the manufacturer's warranty can be voided. Normally, minimum clearances below the bottom of cement fiber siding and trim include:

- 6 inches to the finished grade below
- 2 inches to paths, steps, driveways or deck surfaces below
- 2 inches to roof surfaces below
- 1/4 inch to horizontal flashing below, with no caulk applied

Recommend that a qualified contractor repair per the siding/trim manufacturer's specifications.

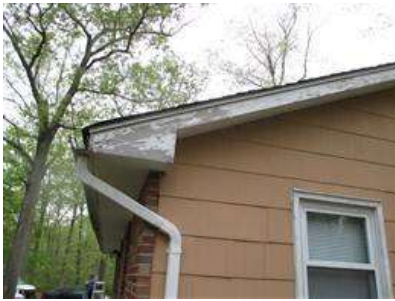
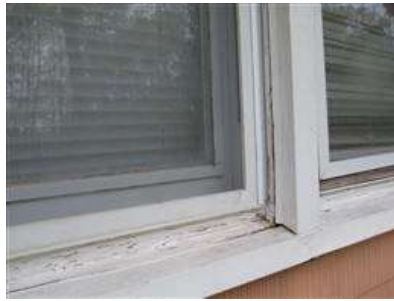
The paint in some areas was failing (e.g. peeling, faded, worn, thinning). Siding and trim with a failing finish can be damaged by moisture. Recommend that a qualified contractor prep (e.g. clean, scrape, sand, prime, caulk) and repaint or restain the building exterior where necessary and per standard building practices. Any repairs needed to the siding or trim should be made prior to this.

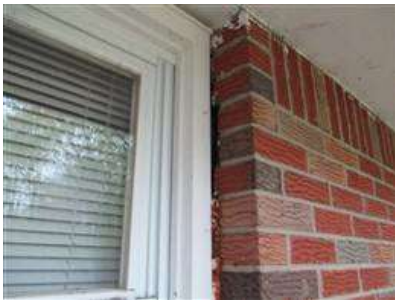
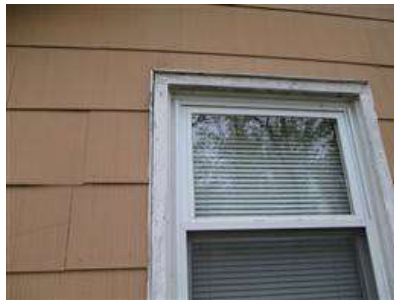
Caulk was missing in some areas. For example, around windows, at wall penetrations. Recommend that a qualified person renew or install caulk as necessary. Where gaps are wider than 1/4 inch, an appropriate material other than caulk should be used. For more information, visit:

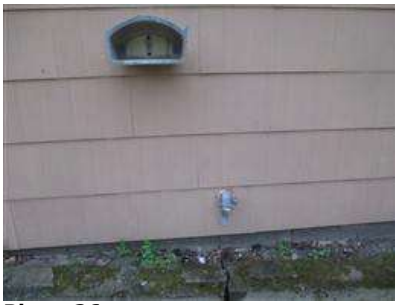
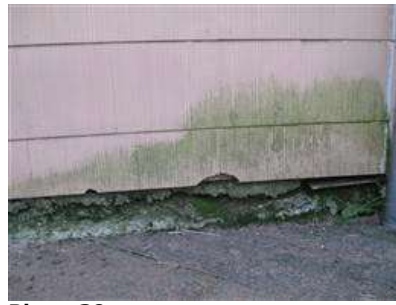
The parging (decorative coating) on one or more foundation walls was damaged or deteriorated. This is not a structural concern, but the client may want this repaired for appearance's sake.

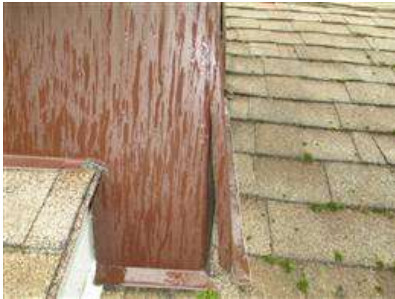
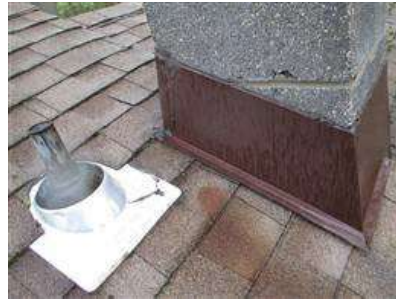
Flashings at the base of the chimney was substandard. Leaks can occur as a result. This is a conducive condition for wood-destroying organisms. Recommend that a qualified contractor evaluate and repair as necessary.

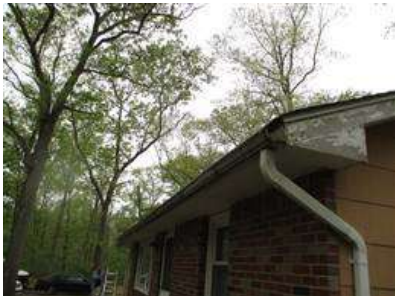
Photo 13

One or more gutter end caps were missing. Rainwater can come in contact with the building exterior or accumulate around the foundation as a result. This is a conducive condition for wood-destroying organisms. Recommend that a qualified person install end caps where missing.

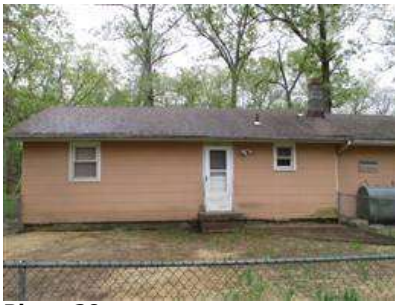
Photo 20

One or more gutters had a substandard slope so that significant amounts of water accumulate in them rather than draining through the downspouts. This can cause gutters to overflow, especially when debris such as leaves or needles has accumulated in them. Rainwater can come in contact with the building exterior or accumulate around the foundation as a result. This is a conducive condition for wood-destroying organisms. Recommend that a qualified person repair as necessary. For example, by correcting the slope in gutters or installing additional downspouts and extensions.

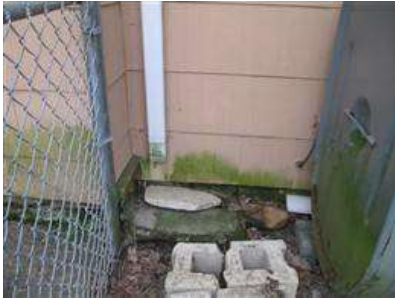
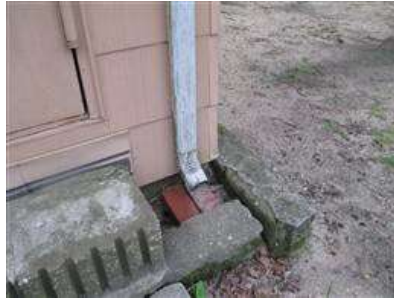
Extensions such as splash blocks or drain pipes for one or more downspouts were missing. Water can accumulate around the building foundation or inside crawl spaces or basements as a result. Recommend that a qualified person install, replace or repair extensions as necessary so rainwater drains away from the structure.

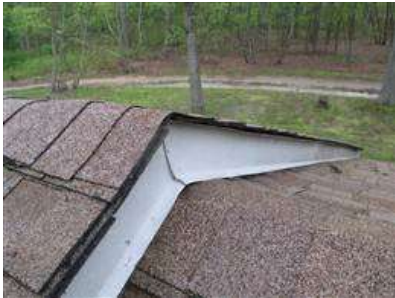
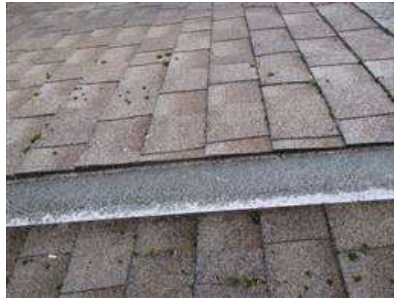
One or more roof flashings were substandard. Leaks can occur as a result. This is a conducive condition for wood-destroying organisms. Recommend that a qualified person repair as necessary.

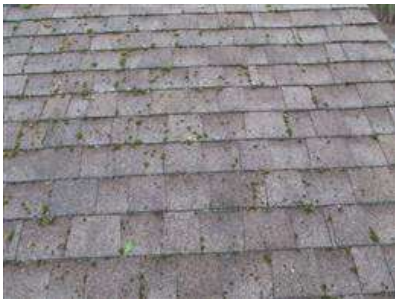
Photo 8

Moss was growing on the roof. As a result, shingles can lift or be damaged. Leaks can result and/or the roof surface can fail prematurely. Efforts should be made to kill the moss during its growing season (wet months). Typically, zinc or phosphate-based chemicals are used for this and must be applied periodically. For information on various moss treatment products and their pros and cons, visit:

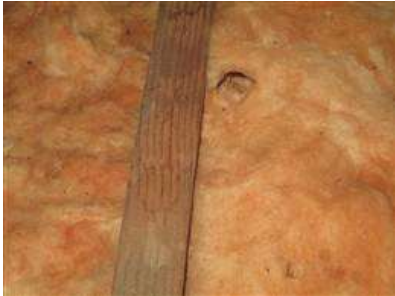
Photo 55

Insulation in the attic was damaged, apparently by rodents (e.g. burrow holes, feces, urine stains). If this report doesn't already recommend replacement of insulation for energy efficiency, the client may want to have insulation replaced for sanitary reasons or to prevent odors.

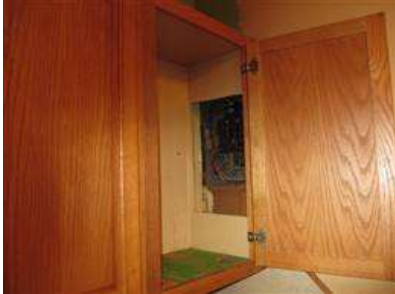
Photo 38

Panel #B was missing the cover. This is a potential shock and fire hazard. Recommend that a qualified electrician evaluate and repair as necessary.

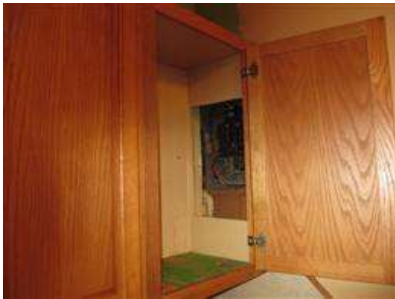
Photo 38

Panel #B was located in a cabinet. This is not an approved location for electric panels. Recommend that a qualified electrician move the panel(s) or make repairs per standard building practices.

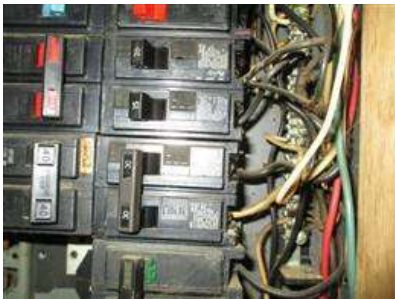
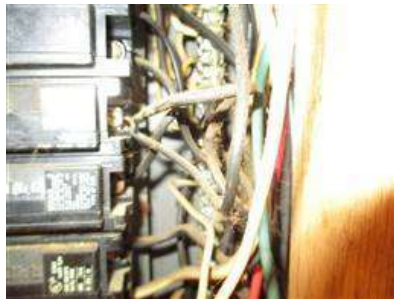
One or more circuit breakers in panel #B were "double tapped," where two or more wires were installed in the breaker's lug. Most breakers are designed for only one wire to be connected. This is a safety hazard since the lug bolt can tighten securely against one wire but leave other(s) loose. Arcing, sparks and fires can result. Recommend that a qualified electrician repair as necessary. For more information, visit: <http://www.google.com/search?q=double+tap+circuit+breaker>

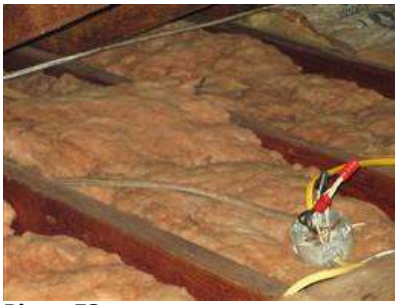
Photo 53

One or more cover plates for switches, receptacles (outlets) or junction boxes were missing or broken. These plates are intended to contain fire and prevent electric shock from occurring due to exposed wires. Recommend that a qualified person install cover plates where necessary.

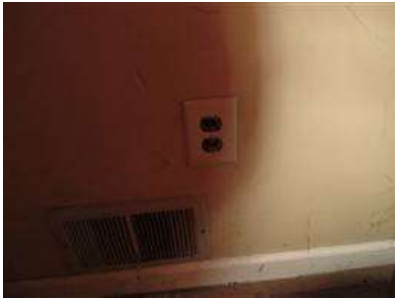
Photo 35

2-slot receptacles (outlets) rather than 3-slot, grounded receptacles were installed in one or more areas. These do not have an equipment ground and are considered unsafe by today's standards. Appliances that require a ground should not be used with 2-slot receptacles. Examples of such appliances include computers and related hardware, refrigerators, freezers, portable air conditioners, clothes washers, aquarium pumps, and electrically operated gardening tools. The client should be aware of this limitation when planning use for various rooms, such as an office. Upgrading to grounded receptacles typically requires installing new wiring from the main service panel or sub-panel to the receptacle(s), in addition to replacing the receptacle(s). Consult with a qualified electrician about upgrading to 3-wire, grounded circuits.

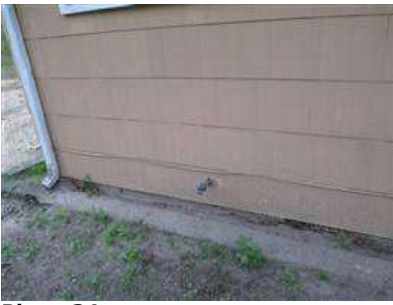
Photo 34

One or more hose bibs (outside faucets) appeared to be inoperable. No water flowed from the bib(s) when turned on. This may be due to a shut-off valve being turned off. Note that the inspector does not operate shut-off valves. Recommend consulting with the property owner about inoperable hose bibs, and if necessary have a qualified plumber make repairs.

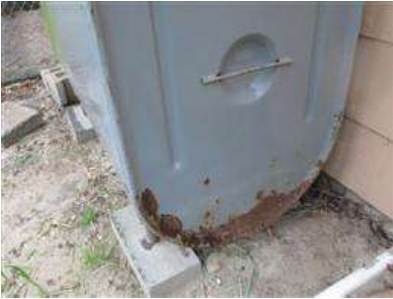
Photo 24

33) 🔍 Significant corrosion was found on the oil storage tank. The tank may need replacing now or in the near future. Recommend that a qualified contractor and/or full-service oil provider evaluate and replace the tank if necessary. If the tank isn't replaced, recommend prepping and painting tank with a rust-preventative paint.

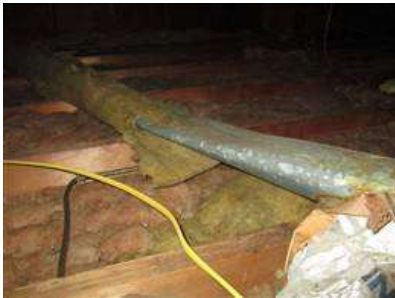
Photo 50

**40) 🔧** One or more heating or cooling ducts were crushed. This can result in reduced energy efficiency. Recommend that qualified HVAC contractor repair or replace ducts or components as necessary.

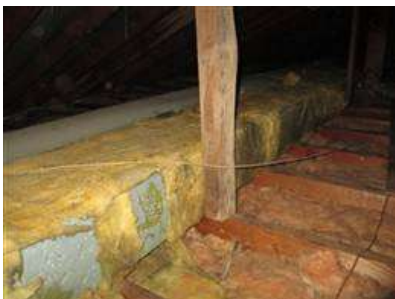
Photo 52

**41) 🔧** One or more heating or cooling ducts in an unconditioned space (e.g. crawl space, attic or basement) were not insulated, or the insulation was damaged or deteriorated. This can result in reduced energy efficiency, moisture inside heating ducts, and/or "sweating" on cooling ducts. Recommend that a qualified person repair per standard building practices. For example, by wrapping ducts in insulation with an R-value of R-8.

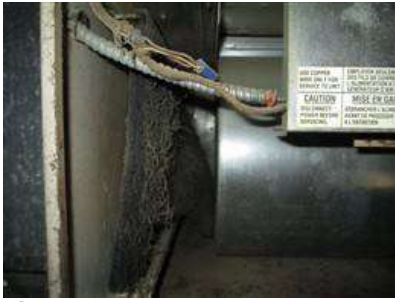
Photo 45

Hold-down devices for one or more heating and/or cooling system air filters were substandard. Unfiltered air can flow through the system (around filters) and reduce indoor air quality. Recommend that a qualified person repair as necessary.

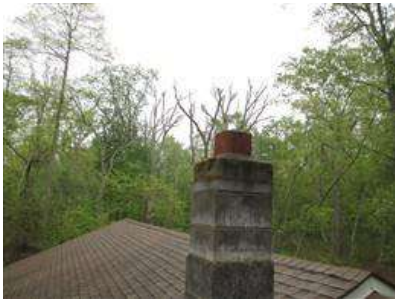
Photo 9

No spark screen or rain cap was installed at one or more chimney flue terminations. Spark screens reduce the chance of embers exiting the flue and causing fires. They also prevent wildlife (e.g. birds, rodents, raccoons) from entering flues. Rain caps prevent water from entering flues, mixing with combustion deposits and creating caustic chemicals which can corrode flues. They also prevent damage to masonry from freeze-thaw cycles and prevent metal components (e.g. dampers, metal firebox liners) from rusting. Recommend that a qualified person install rain caps with spark screens per standard building practices where missing.

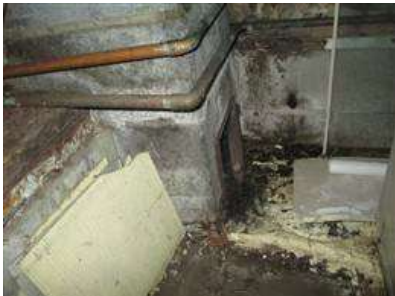
Photo 44

One or more ash clean-out doors were loose, corroded. Recommend that a qualified person repair or replace as necessary.

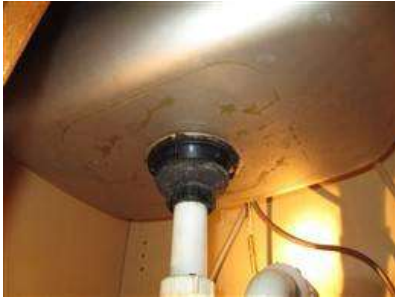
Photo 47

One or more sink drains were leaking. A qualified plumber should repair as necessary.

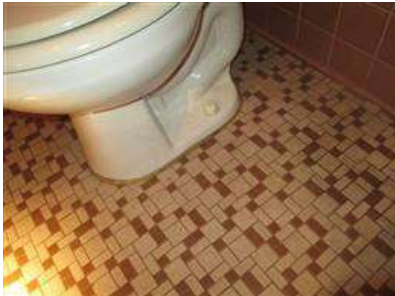
Photo 48

Flooring at the base of the toilet was soft. Recommend that a qualified contractor evaluate and repair as necessary. For example, by removing the toilet, making repairs to the subfloor if necessary, replacing flooring if necessary, and installing a new wax ring when the toilet is reinstalled.

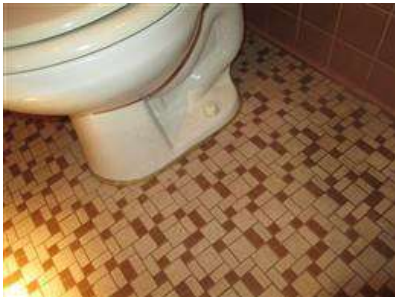
Photo 48

The toilet was loose where it attached to the floor. Leaks can occur. Flooring, the subfloor or areas below may get damaged. Sewer gases can enter living spaces. Recommend that a qualified contractor remove the toilet(s) for further evaluation and repair if necessary. A new wax ring should be installed and toilet(s) should be securely anchored to the floor to prevent movement and leaking.

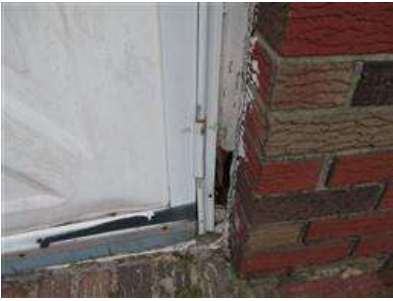
Photo 3

Fungal rot was found at one or more exterior door jambs. Recommend that a qualified person repair as necessary. All rotten wood should be replaced.

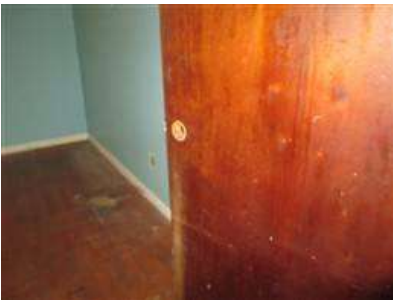
Photo 49

Some interior door hardware (locksets) were missing. Recommend that a qualified person repair or replace as necessary.

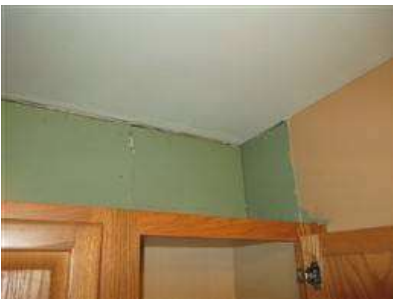
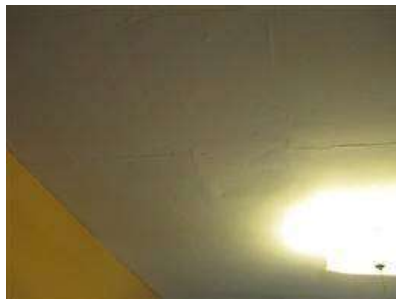
One or more walls, ceilings were damaged, had substandard repairs. Recommend that a qualified person repair as necessary.

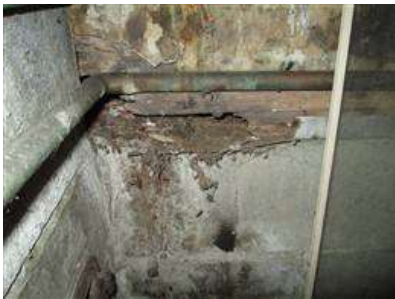
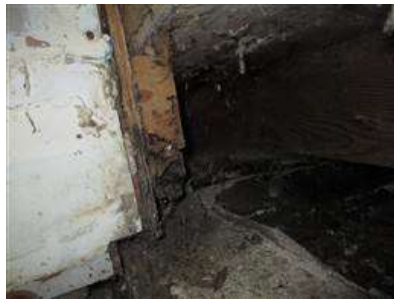
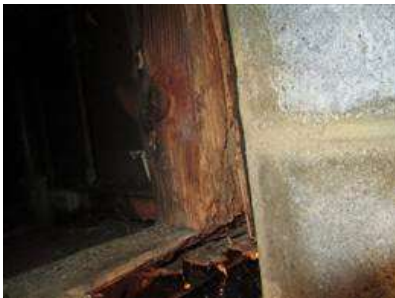
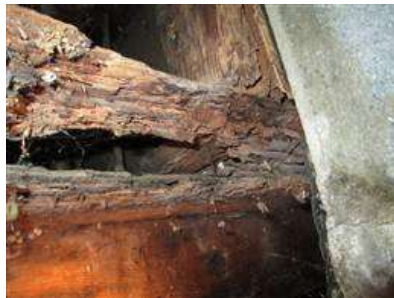
Because of apparent structural damage at location(s) #A, recommend that a qualified contractor evaluate and repair as necessary. All wood significantly damaged by wood-destroying insects or fungal rot should be replaced or removed.

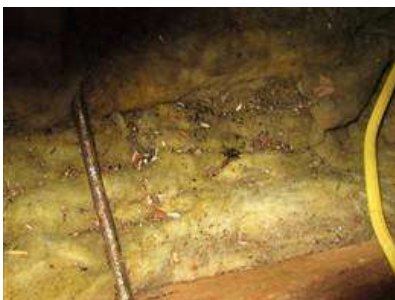
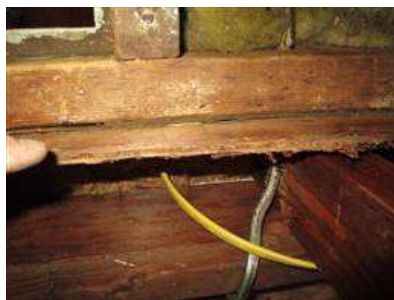
Evidence of active infestation of moisture ants was found at location(s) #B in the form of live insects with . Recommend the following:

- Correct any conducive conditions for wood-destroying organisms mentioned in this report.
- Consult with the property owner about any history of infestation.
- Have a state-licensed pest control operator evaluate further and treat as necessary.
