## General Information

**Report number:** 20240308

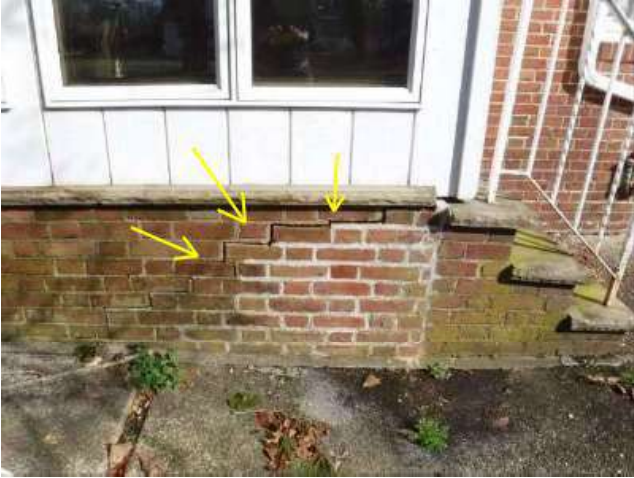
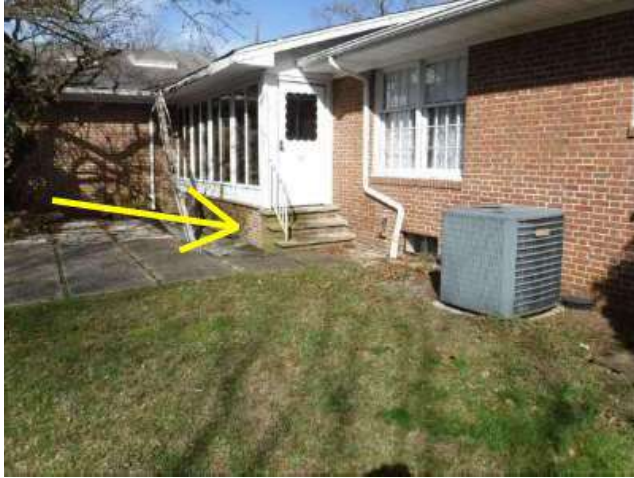
Masonry steps have settled significantly, or significant cracks or deterioration were found. Recommend that a qualified contractor repair or replace steps as necessary.

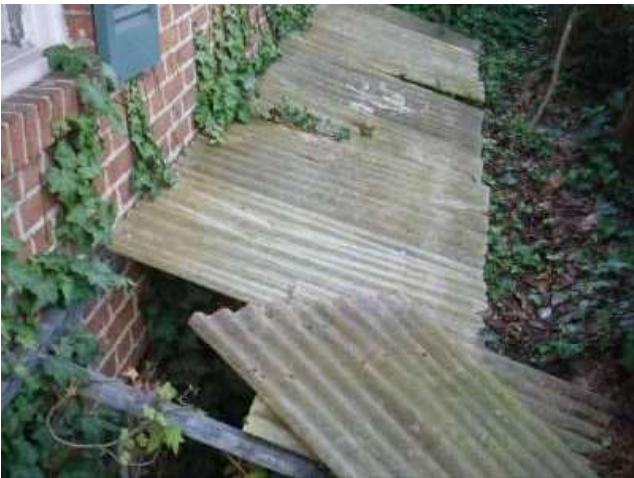
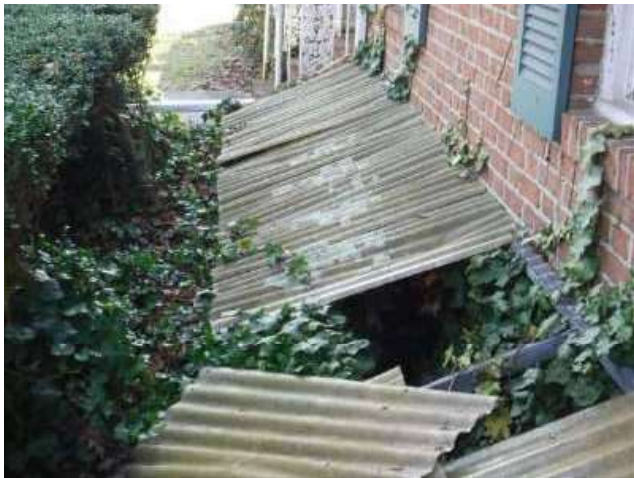
The cover on the retaining wall has deteriorate and needs replacement. The retaining walls appeared to be serviceable, but recommend monitoring them in the future. Further deterioration may occur and retaining walls may need significant repairs or replacement at some point.

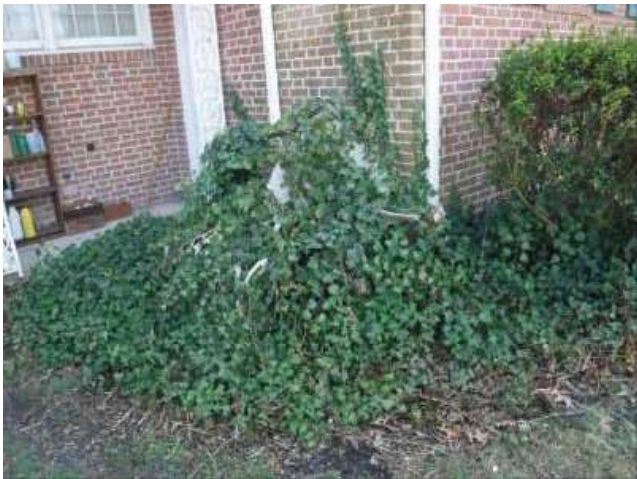
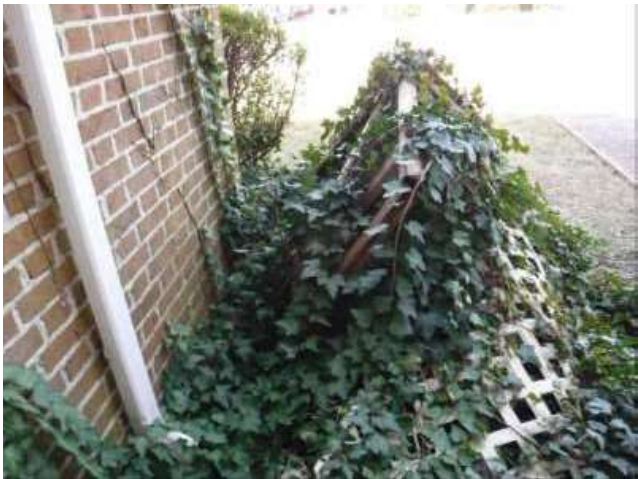
One or more large tree stumps were close to the building exterior. Wood-destroying insects such as carpenter ants nest in such stumps and are more likely to infest the building as a result. Recommend that large tree stumps within a few feet of the building be removed by a qualified tree service contractor.

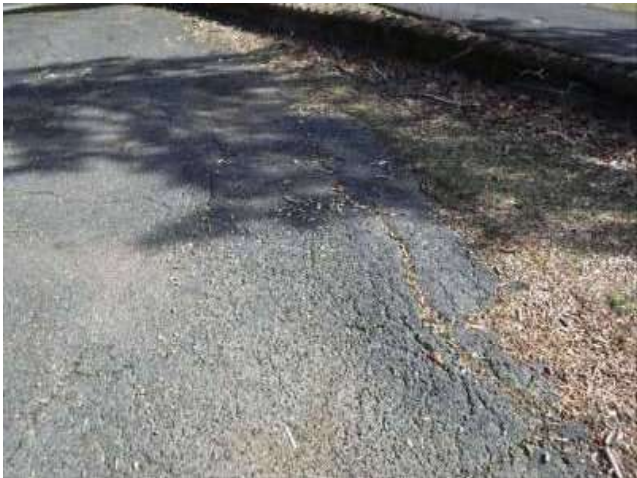
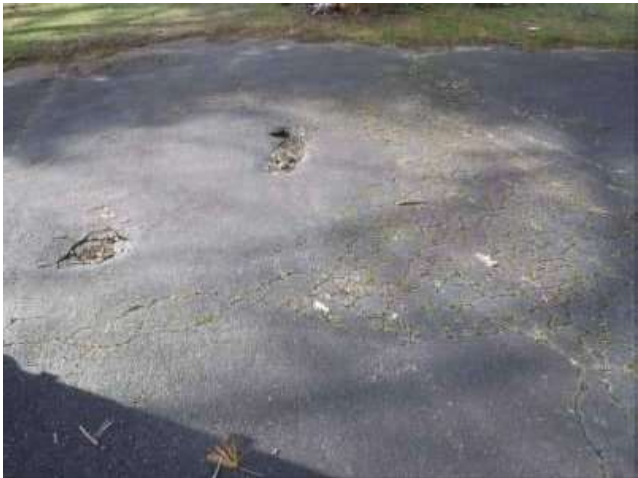
Minor deterioration (e.g. cracks, holes, settlement, heaving) was found in the driveway, but no trip hazards were found. The client may wish to have repairs made for cosmetic reasons.

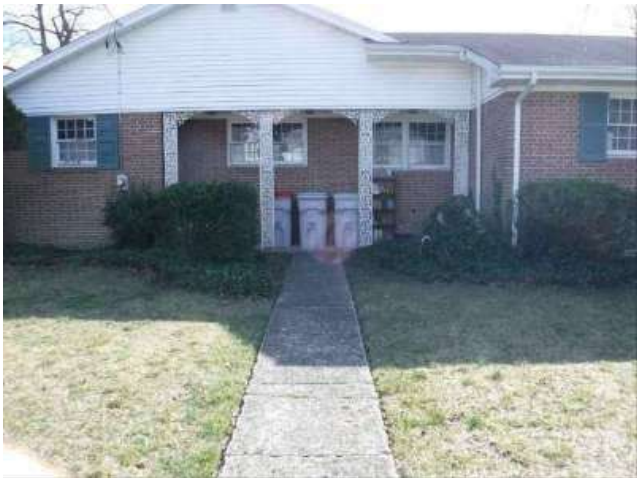
Photo 6-1

Minor deterioration (e.g. cracks, holes, settlement, heaving) was found in sidewalks or patios, but no trip hazards were found. The client may wish to have repairs made for cosmetic reasons.

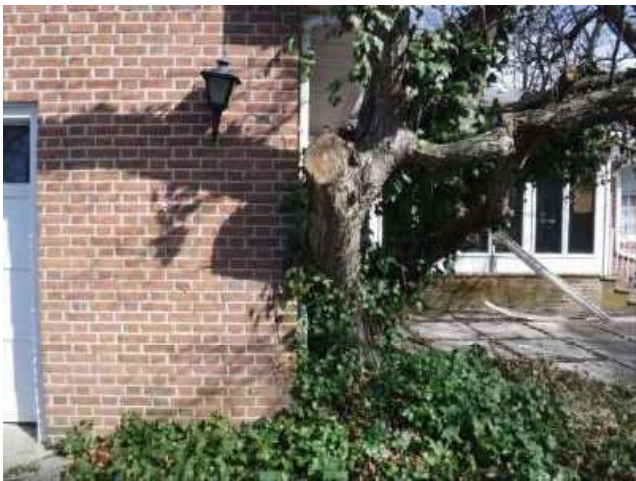
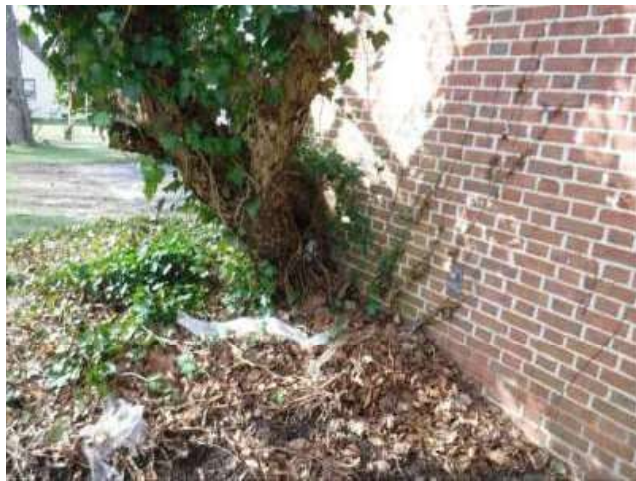
One or more large trees were very close to the foundation. Tree roots can cause significant structural damage to foundations, or may have already caused damage (see other comments in this report). Recommend that a qualified tree service contractor or certified arborist remove trees as necessary to prevent damage to foundations.

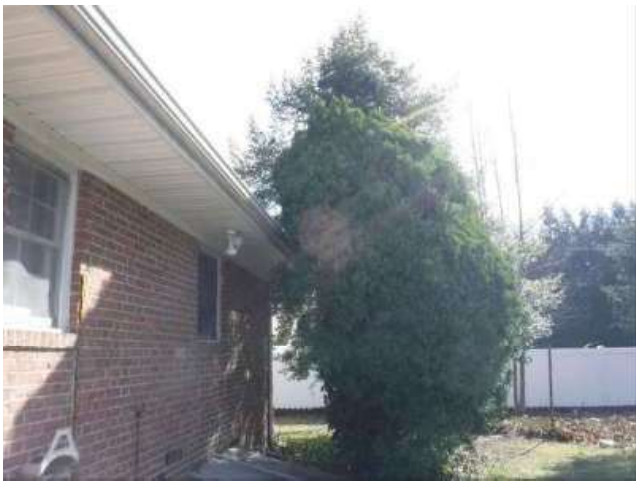
Photo 8-1

Vegetation such as trees, shrubs and/or vines was in contact with or close to the building exterior. Vegetation can serve as a pathway for wood-destroying insects and can retain moisture against the exterior after it rains. This is a conducive condition for wood-destroying organisms. Recommend pruning, moving or removing vegetation as necessary to maintain at least 6 inches of space between it and the building exterior. A 1-foot clearance is better.

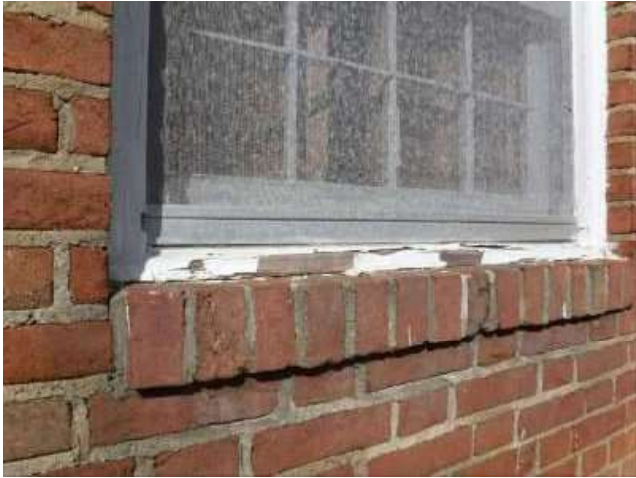
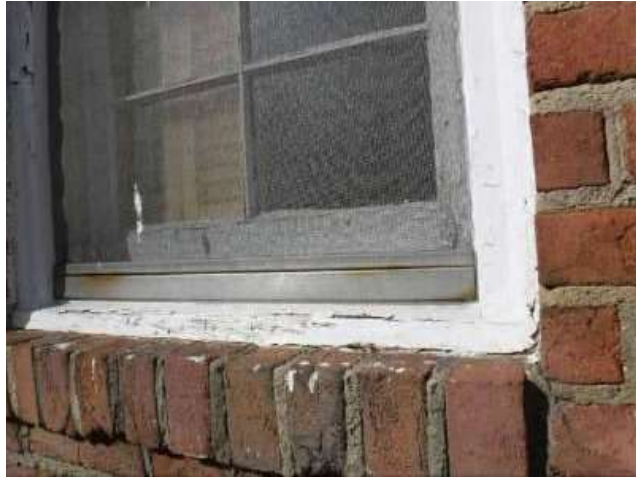
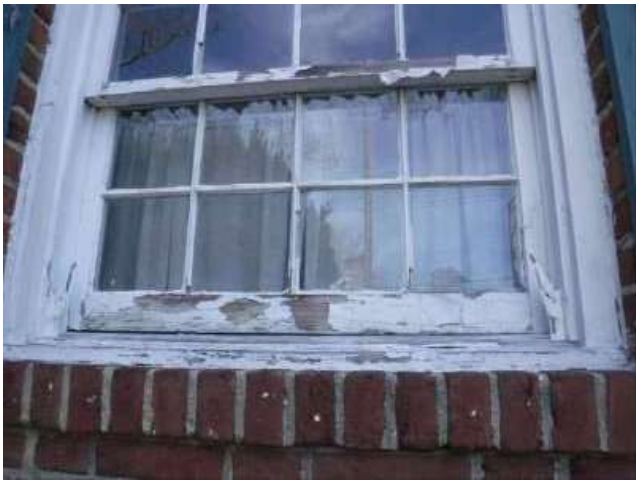
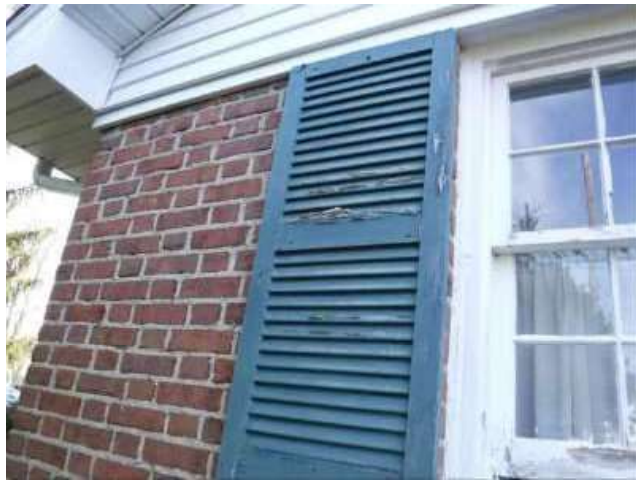
The paint or stain finish over much of the entire structure was failing (e.g. peeling, faded, worn, thinning). Siding and trim with a failing finish can be damaged by moisture. Recommend that a qualified contractor prep (e.g. clean, scrape, sand, prime, caulk) and repaint or restain the entire building exterior per standard building practices. Any repairs needed to the siding or trim should be made prior to this.

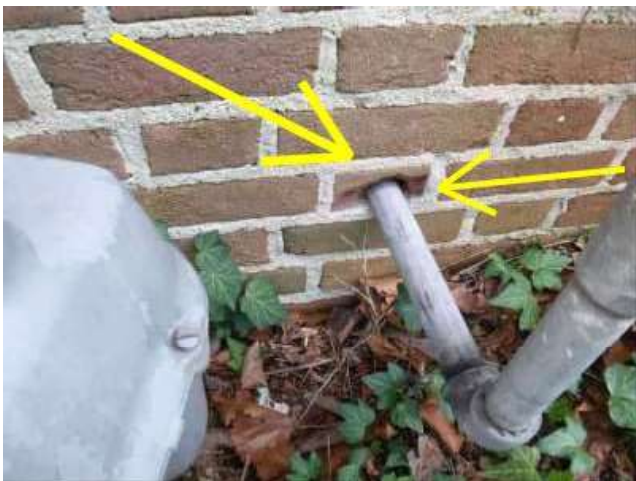
Photo 10-1

Caulk was in some areas. For example, at wall penetrations. Recommend that a qualified person renew or install caulk as necessary. Where gaps are wider than 1/4 inch, an appropriate material other than caulk should be used. For more information, visit: [https://www.reporthost.com/docs/FPL\\_Caulking\\_Ins\\_Outs.pdf](https://www.reporthost.com/docs/FPL_Caulking_Ins_Outs.pdf)

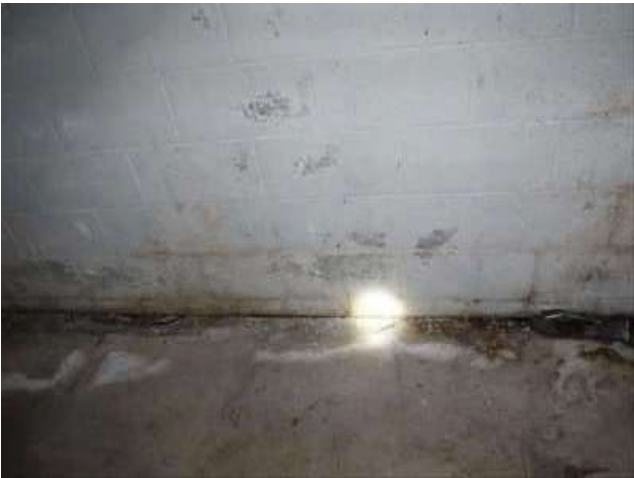
Photo 12-1

Evidence of prior water intrusion was found in one or more sections of the basement. For example, water stains or rust at support post bases, efflorescence on the foundation, etc. Accumulated water is a conducive condition for wood-destroying organisms and should not be present in the basement. Recommend reviewing any disclosure statements available and ask the property owner about past accumulation of water in the basement. The basement should be monitored in the future for accumulated water, especially after heavy and/or prolonged periods of rain. If water is found to accumulate, then recommend that a qualified contractor who specializes in drainage issues evaluate and repair as necessary. Typical repairs for preventing water from accumulating in basements include:

- Repairing, installing or improving rain run-off systems (gutters, downspouts and extensions or drain lines)
- Improving perimeter grading
- Repairing, installing or improving underground footing and/or curtain drains

Ideally, water should not enter basements, but if water must be controlled after it enters the basement, then typical repairs include installing a sump pump.

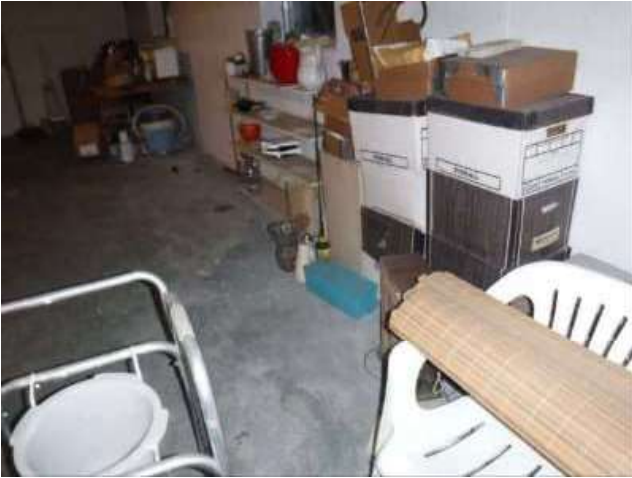
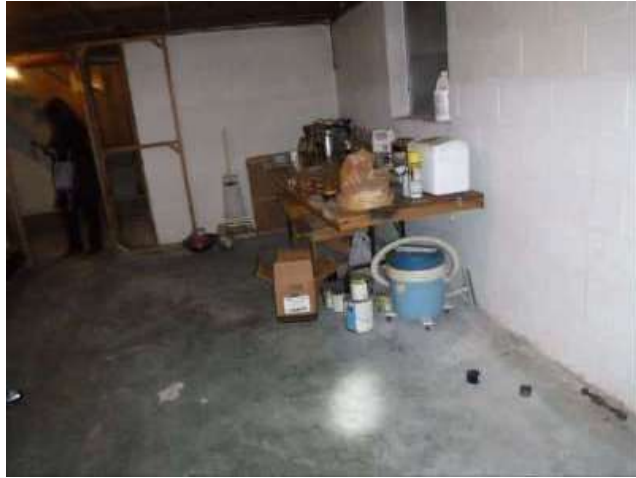
Glass in one or more was cracked, broken and/or missing. Recommend that a qualified contractor replace glass where necessary.

areas were not evaluated due to lack of access from stored items and/or debris. These areas are excluded from the inspection.

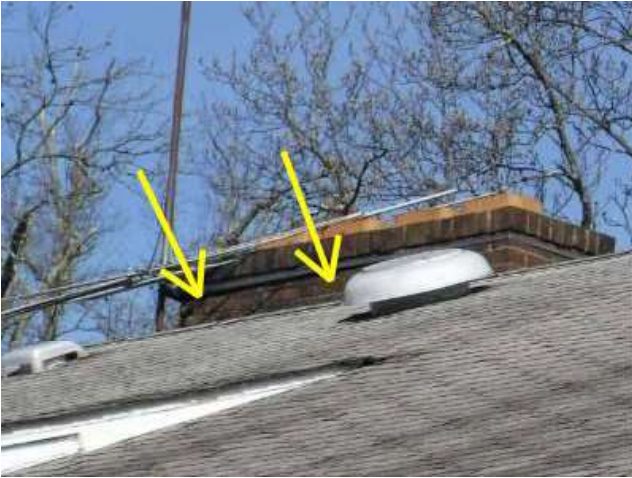
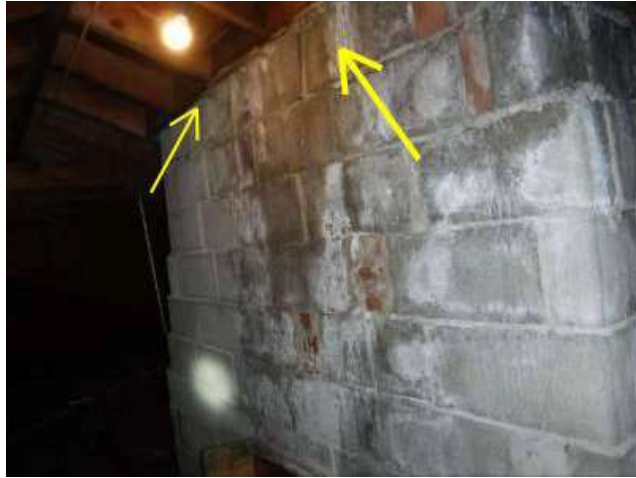
One or more chimneys were wider than 2 feet and no cricket was installed above. A cricket is a peaked saddle behind the chimney that diverts water around the sides of the chimney. Without a cricket, debris such as leaves, needles or moss is likely to accumulate above the chimney, and can cause leaks. At a minimum, monitor this area and its flashings for accumulated debris, and clean debris as necessary. Recommend that a qualified contractor install a cricket per standard building practices.

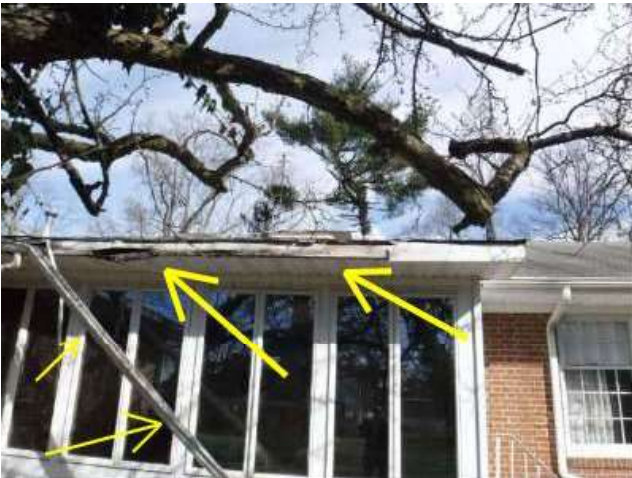
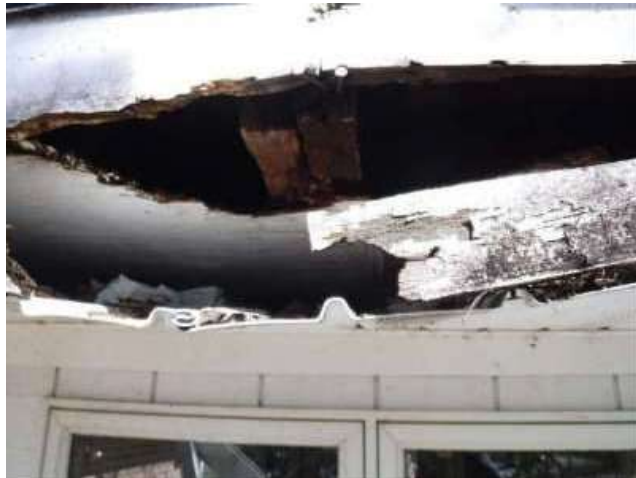
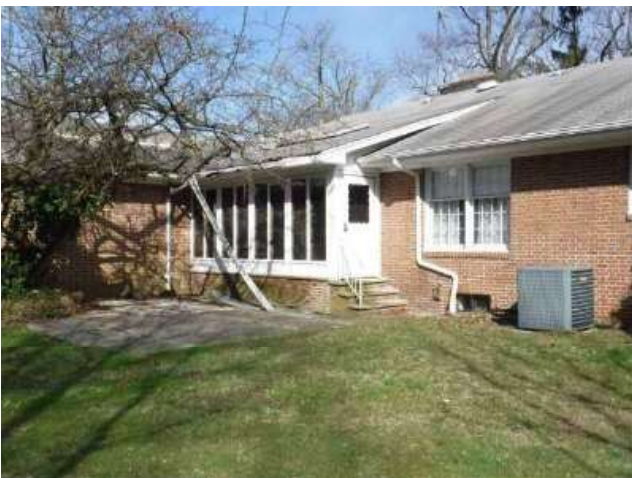
One or more gutters and fascia board were damaged. Rainwater can come in contact with the building exterior or accumulate around the building foundation as a result. This is a conducive condition for wood-destroying organisms. Recommend that a qualified person repair as necessary.

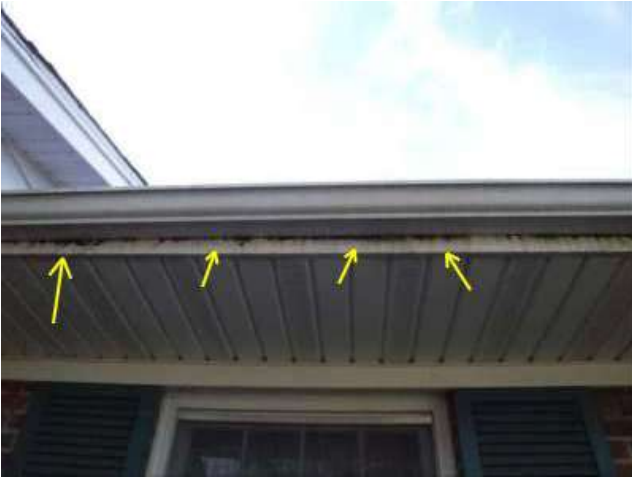
Photo 19-1

Stains were found at the front of one or more gutters and indicate that the gutters have overflowed. If they have overflowed, it's usually due to debris clogging gutters or downspouts. The inspector was unable to verify that the gutters and downspouts drained adequately due to lack of recent, significant rainfall. Monitor the roof drainage system in the future while it's raining to determine if problems exist. Then if necessary, recommend that a qualified person clean, repair or replace gutters, downspouts and/or extensions.

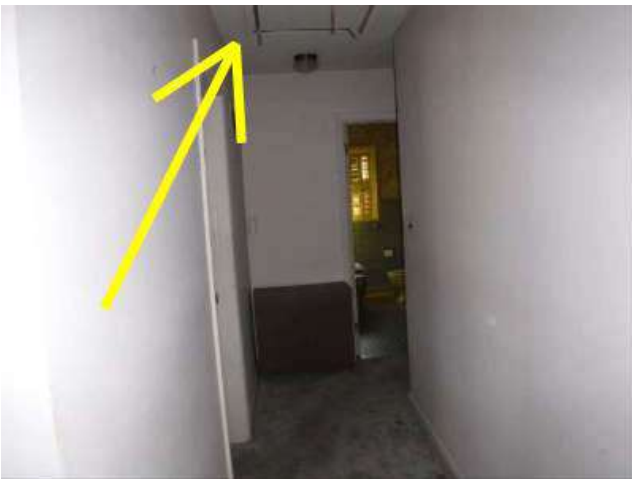
Photo 20-1

The attic access door was not insulated. Weatherstripping was also missing or substandard. Recommend installing weatherstripping and insulation per current standards at hatches or doors for better energy efficiency. For more information, visit:

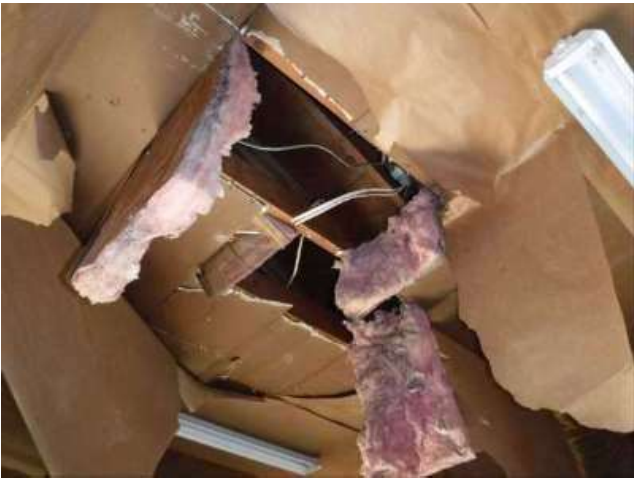
Photo 22-1

One or more holes and/or areas with missing or substandard surface materials were found in the attached garage ceilings. Current standard building practices call for wooden-framed ceilings and walls that divide the house and garage to provide limited fire-resistance rating to prevent the spread of fire from the garage to the house. Recommend that a qualified person repair per standard building practices. For example, by patching openings or holes, firestopping holes or gaps with fire-resistant caulking, and/or installing fire-resistant wall covering (e.g. Type X drywall). For more information, visit: <http://www.google.com/search?q=attached+garage+fire+resistance>

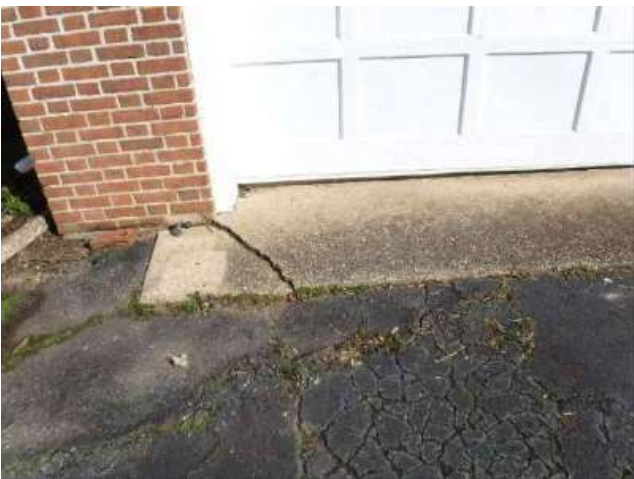
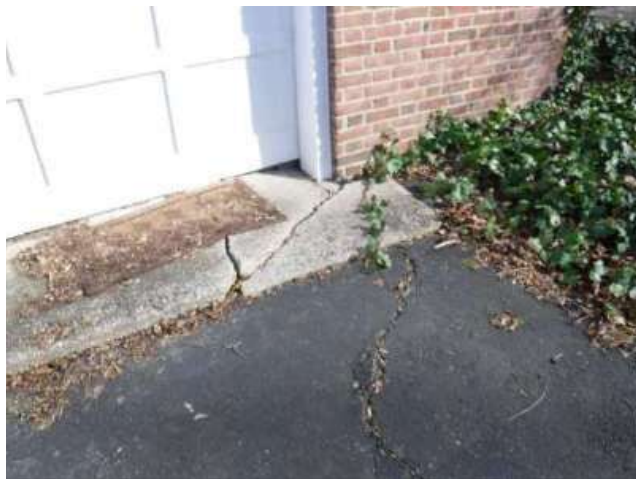
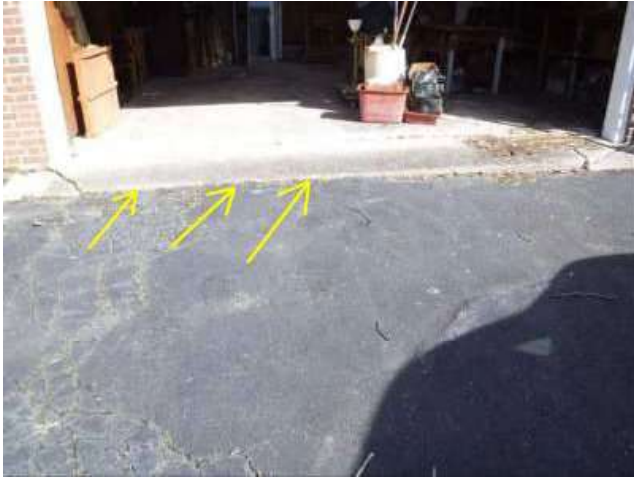
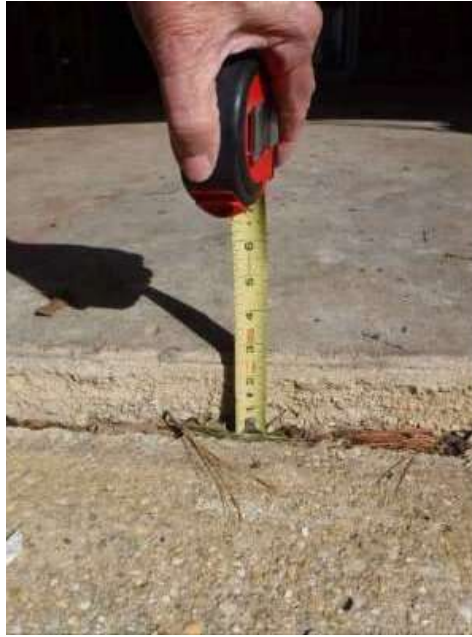
Significant cracks, heaving and/or settlement were found in one or more sections of concrete slab floors. Uneven surfaces can pose a trip hazard. Recommend that a qualified contractor repair or replace concrete slab floors where necessary.

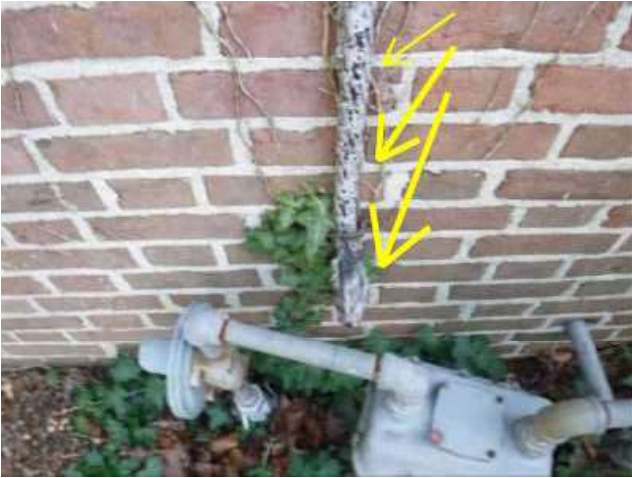
Photo 25-1

The service entrance wire insulation was frayed, damaged or deteriorated. This is a potential shock hazard. Recommend that a qualified electrician evaluate and repair if necessary.

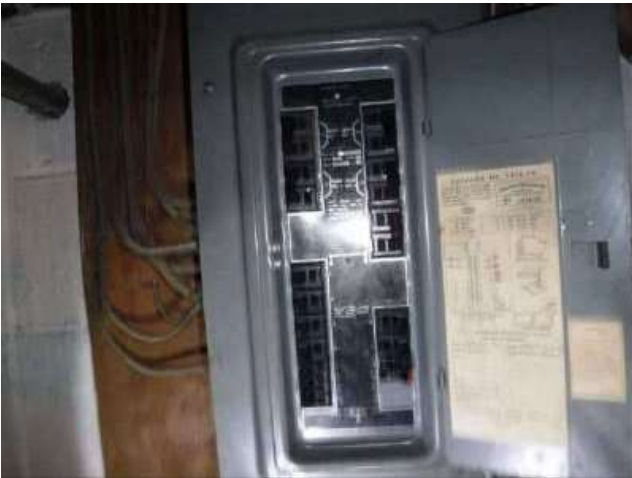
Photo 26-1

Panel #A was manufactured by the Federal Pacific Electric company and used "Stab-Lok" circuit breakers. There is significant evidence that both double and single pole versions of these circuit breakers fail by not tripping when they are supposed to. However, in 2011 the Consumer Products Safety Commission (CPSC) closed an investigation into this product because they did not have enough data to establish that the circuit breakers pose a serious risk of injury to consumers. Regardless, and due to other evidence of safety issues, recommend that a qualified electrician carefully evaluate all Federal Pacific panels and make repairs as necessary. Consider replacing Federal Pacific panels with modern panels that offer more flexibility for new, safer protective technologies like ground fault circuit interrupters (GFCIs) and arc fault circuit interrupters (AFCIs). For more information, visit:

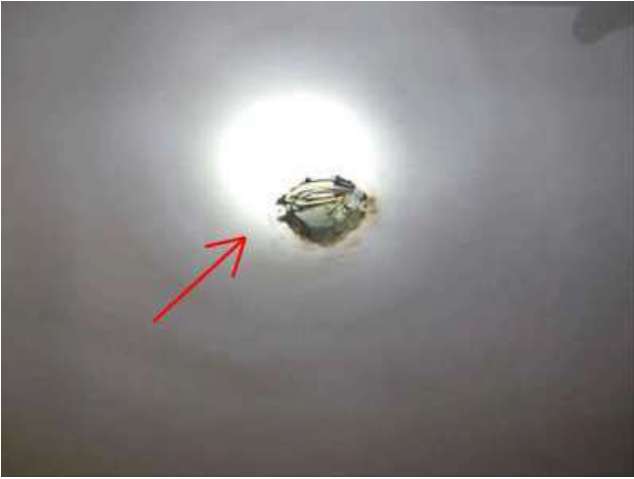
One or more cover plates for switches, receptacles (outlets) or junction boxes were missing or broken. These plates are intended to contain fire and prevent electric shock from occurring due to exposed wires. Recommend that a qualified person install cover plates where necessary.

**Photo 29-1** Dining room

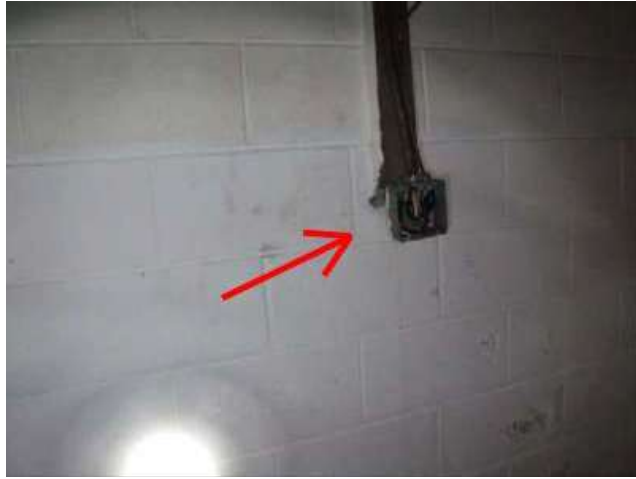
**Photo 29-2** Basement

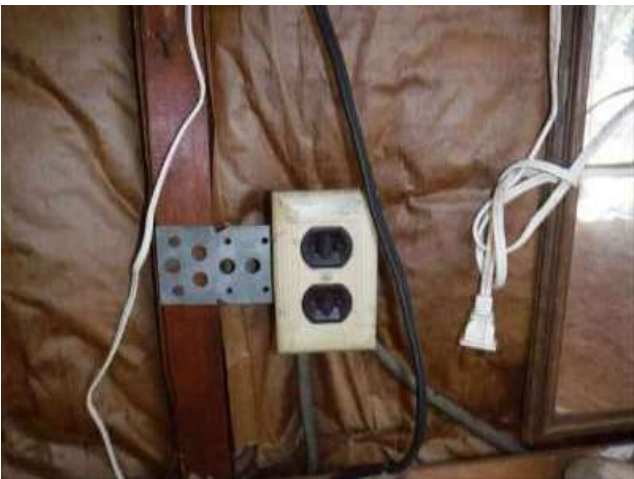
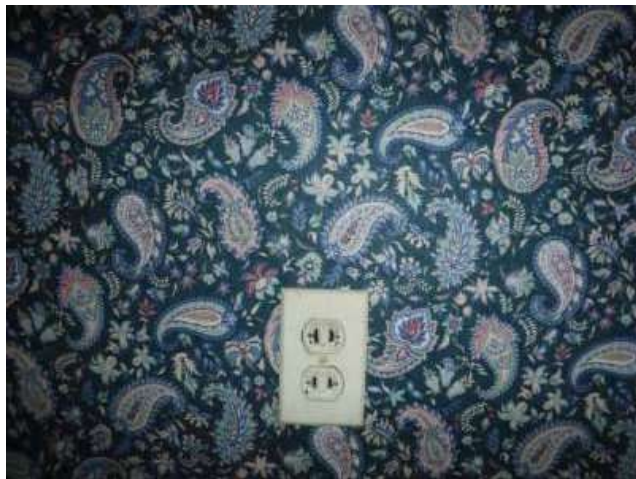
2-slot receptacles (outlets) rather than 3-slot, grounded receptacles were installed in one or more areas. These do not have an equipment ground and are considered unsafe by today's standards. Appliances that require a ground should not be used with 2-slot receptacles. Examples of such appliances include computers and related hardware, refrigerators, freezers, portable air conditioners, clothes washers, aquarium pumps, and electrically operated gardening tools. The client should be aware of this limitation when planning use for various rooms, such as an office. Upgrading to grounded receptacles typically requires installing new wiring from the main service panel or sub-panel to the receptacle(s), in addition to replacing the receptacle(s). Consult with a qualified electrician about upgrading to 3-wire, grounded circuits.

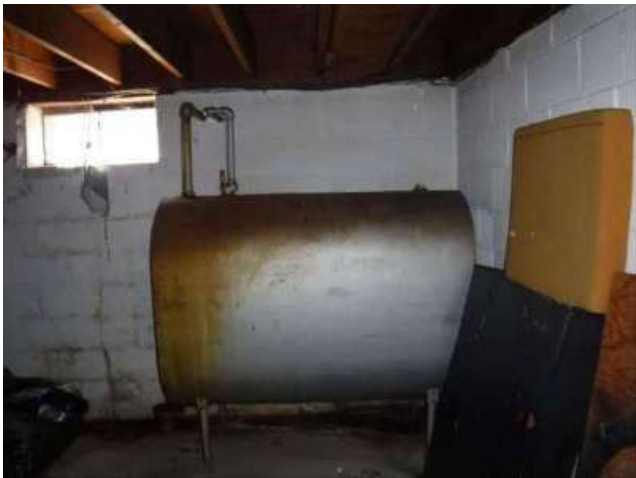
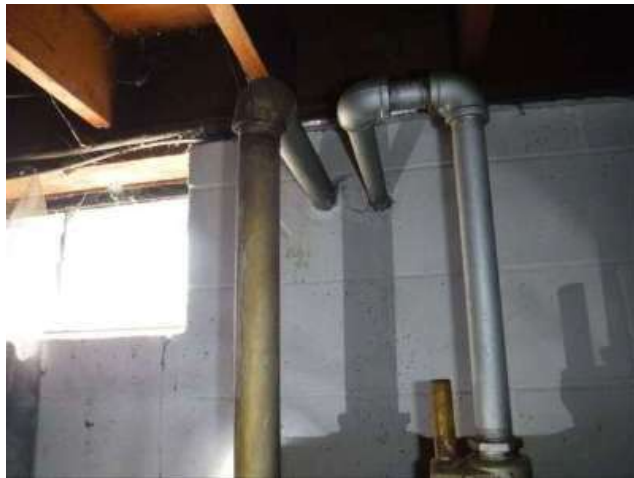
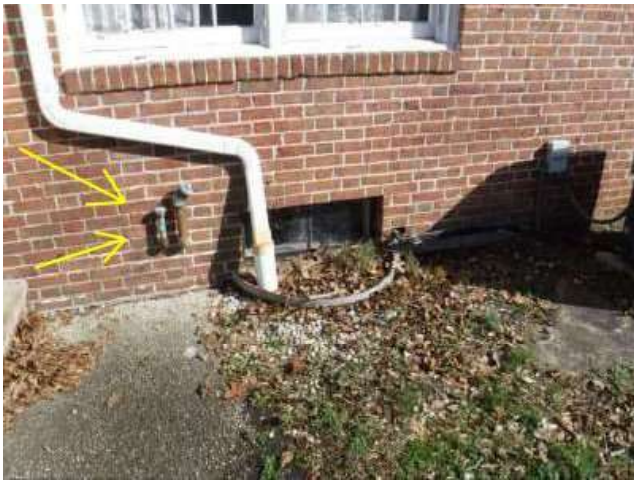
The fill pipe to and abandoned oil storage tank was found. Recommend that a qualified contractor or full-service oil company remove the abandoned fill pipe.

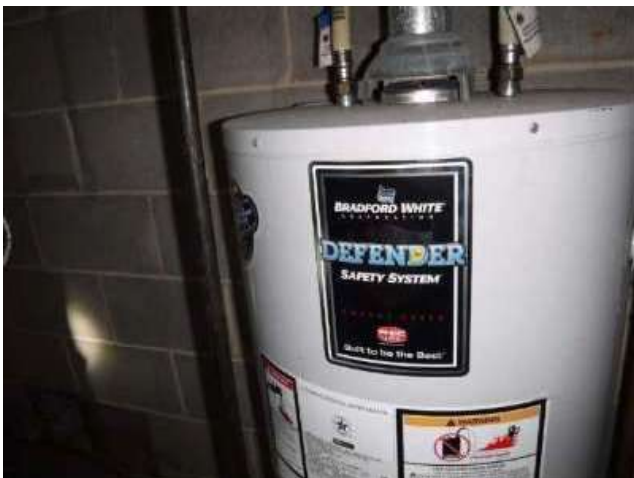
Photo 36-1

36) ⓘ The estimated useful life for most water heaters is 8-12 years. This water heater appeared to be near this age and/or its useful lifespan and may need replacing at any time. Recommend budgeting for a replacement in the near future, or considering replacement now before any leaks occur. The client should be aware that significant flooding can occur if the water heater fails. If not replaced now, consider having a qualified person install a catch pan and drain or a water alarm to help prevent damage if water does leak.

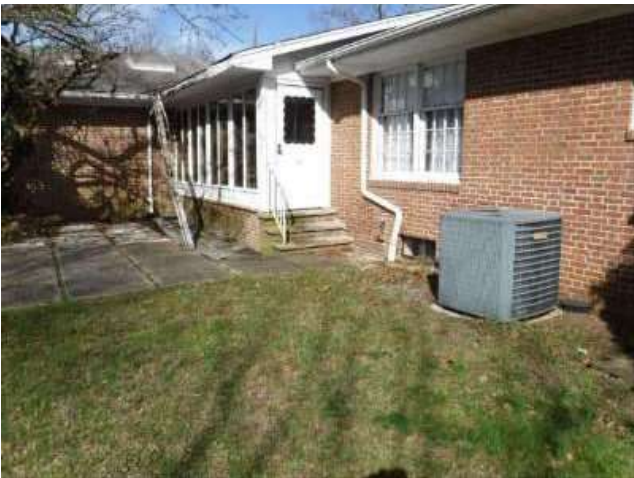
**Photo 37-1**

The estimated useful life for most heat pumps and air conditioning condensing units is 10-15 years. This unit appeared to be near this age and/or its useful lifespan and may need replacing or significant repairs at any time. Recommend budgeting for a replacement in the near future.

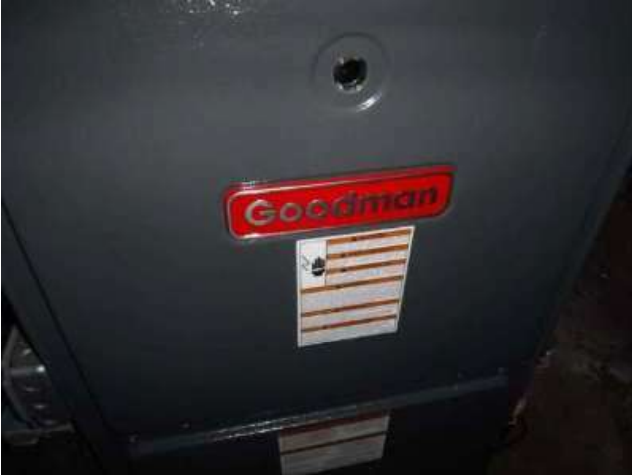
Photo 39-1

The estimated useful life for most forced air furnaces is 15-20 years. This furnace appeared to be near this age and/or its useful lifespan and may

need replacing or significant repairs at any time. Recommend budgeting for a replacement in the near future.

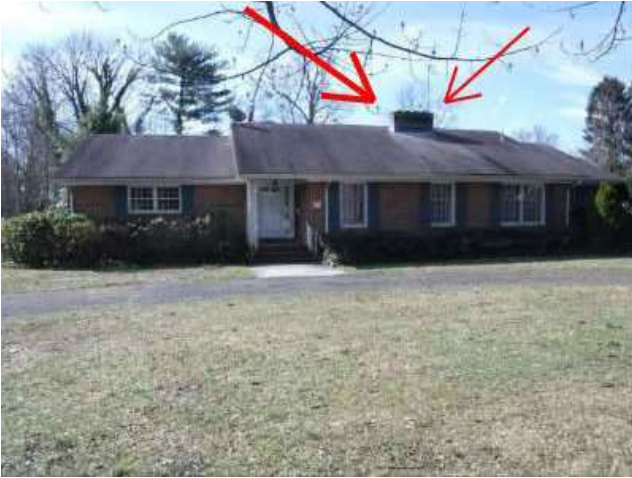
Photo 41-1

No spark screen or rain cap was installed at one or more chimney flue terminations. Spark screens reduce the chance of embers exiting the flue and causing fires. They also prevent wildlife (e.g. birds, rodents, raccoons) from entering flues. Rain caps prevent water from entering flues, mixing with combustion deposits and creating caustic chemicals which can corrode flues. They also prevent damage to masonry from freeze-thaw cycles and prevent metal components (e.g. dampers, metal firebox liners) from rusting. Recommend that a qualified person install rain caps with spark screens per standard building practices where missing.

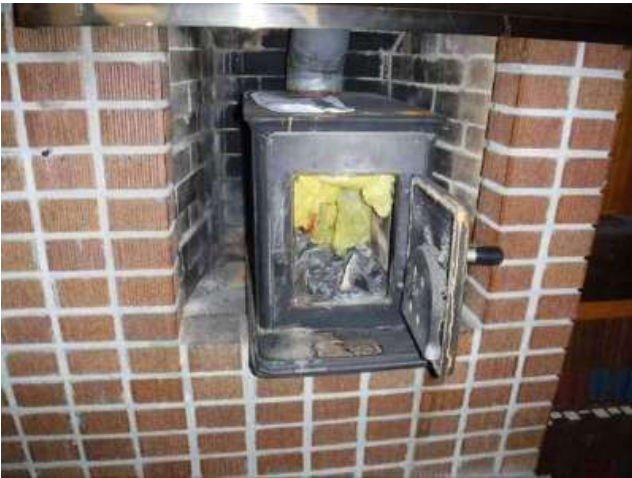
Photo 42-1

One or more wood-burning fireplaces or stoves were found at the property. When such devices are used, they should be professionally inspected and cleaned annually to prevent creosote build-up and to determine if repairs are needed. The National Fire Protection Association states that a "Level 2" chimney inspection should be performed with every sale or transfer of property with a wood-burning device. Recommend consulting with the property owner about recent and past servicing and repairs to all wood-burning devices and chimneys or flues at this property. Recommend that a qualified specialist evaluate all wood-burning devices and chimneys, and clean and repair as necessary. Note that if a wood stove insert is installed, it may need to be removed for such an evaluation. For more information, search for "chimney inspection" at:

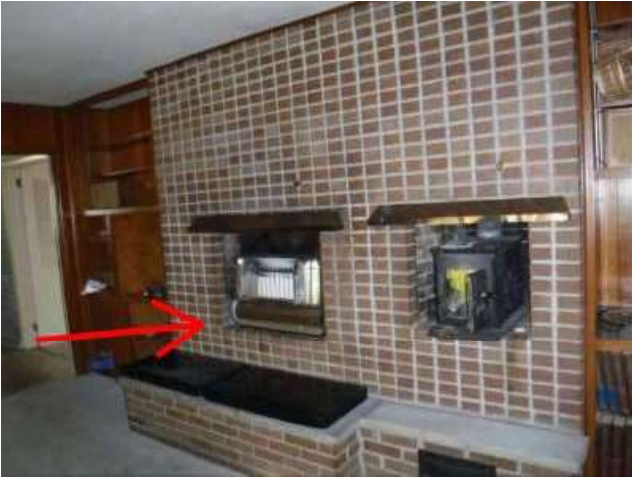
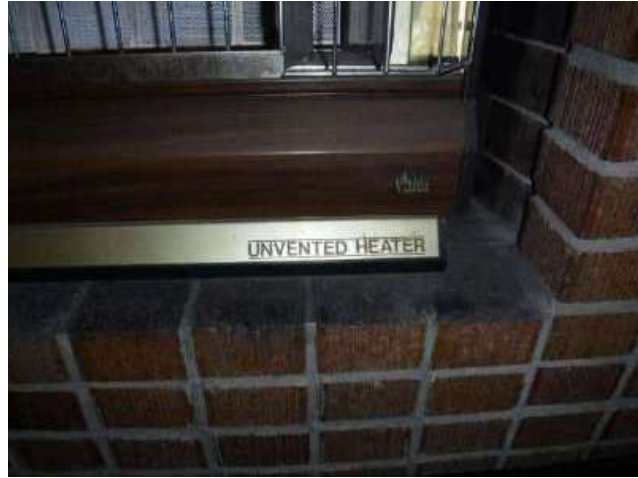
A "vent-free" gas fireplace or stove was installed. The client should be aware that exhaust gases from these appliances are vented directly into the living space where they are located, not outdoors. Exhaust gases can contain carbon monoxide, nitrogen dioxide, sulfur dioxide, particles and other pollutants. They can also contain very high levels of moisture (up to 25%), which can be detrimental to a house over time. Unpleasant odors may be emitted.

Vent-free fireplaces or stoves are not allowed in some municipalities. They must be used exactly as described by the manufacturer, normally for limited times, not in bedrooms and not while occupants are sleeping. They must be serviced periodically. Consult with a qualified HVAC contractor knowledgeable of local codes, and that this appliance be evaluated. For more information, visit:

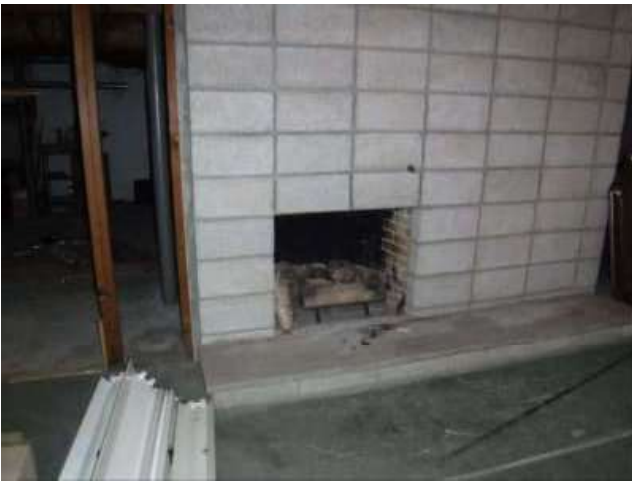
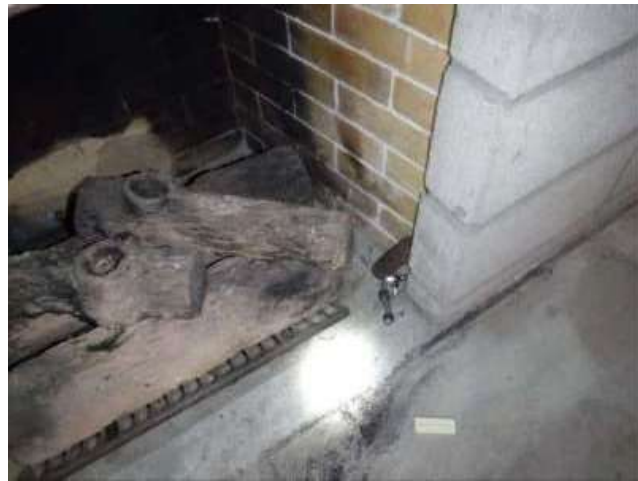
44) A wood burning fireplace has been converted to use gas logs, and no glass doors were installed on the fireplace. For gas conversions like this, the fireplace damper should be modified so it is permanently open to prevent combustion gases from the pilot light and main burners accumulating in living spaces. Since the damper is always open, unconditioned air from outside can enter living spaces through the chimney, and conditioned air from inside can exit through the chimney. This can result in higher heating and cooling costs. Recommend that a qualified person install glass doors on the fireplace per standard building practices.

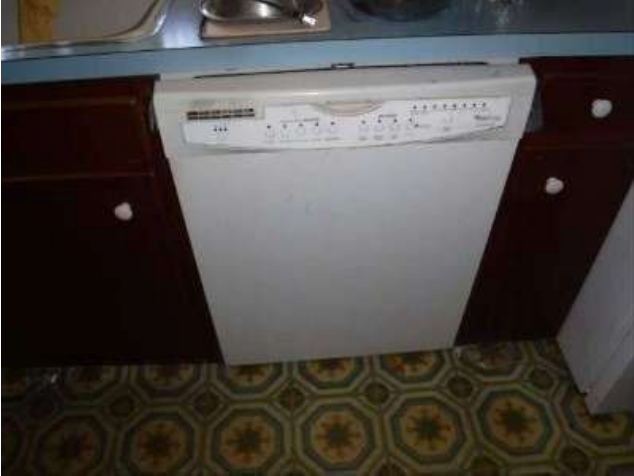
Photo 46-1

The dishwasher was malfunctioning. Recommend that a qualified specialist evaluate and repair or replace as necessary.

electrical problem

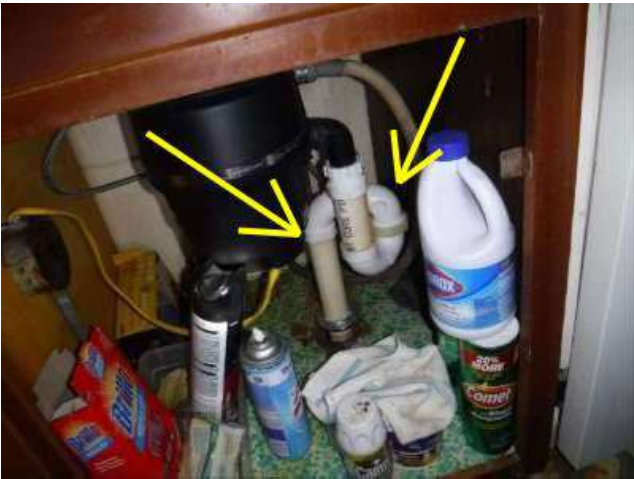
Photo 47-1

The kitchen sink drain pipe used an S-trap rather than a P-trap, or no P-trap was visible. Siphons and sudden flows of water in S-Traps can drain all the water out of the trap, leaving it dry. Sewer gases can then enter living areas. Recommend that a qualified plumber repair per standard building practices.

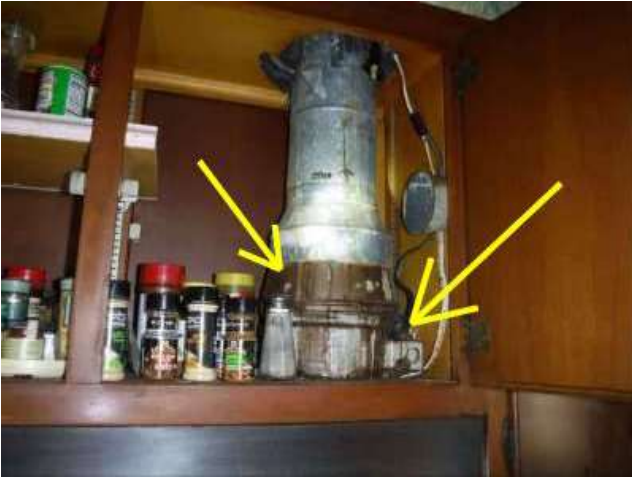
Photo 48-1

One or more filters for the cooktop exhaust fan were missing. Recommend replacing filters as necessary.

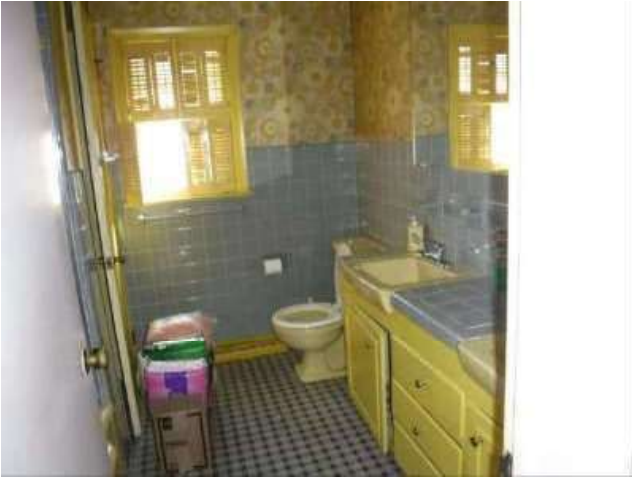
Photo 51-1

51) The bathroom with a shower or bathtub at location #B didn't have an exhaust fan installed. Moisture can accumulate and result in mold, bacteria or fungal growth. Even if the bathroom has a window that opens, it may not provide adequate ventilation, especially during cold weather when windows are closed or when wind blows air into the bathroom. Recommend that a qualified contractor install exhaust fans per standard building practices where missing in bathrooms with showers or bathtubs.

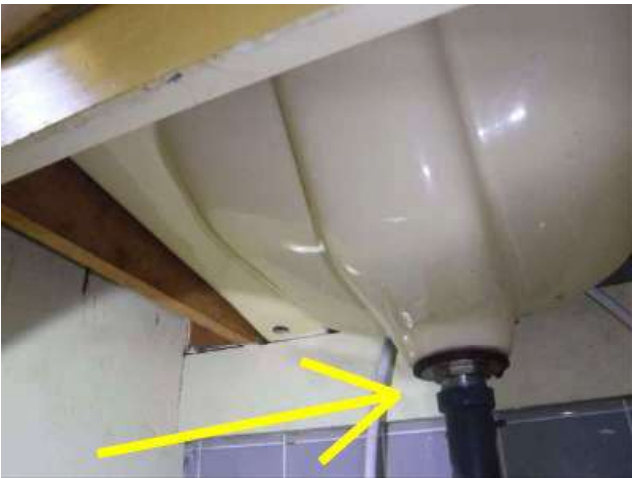
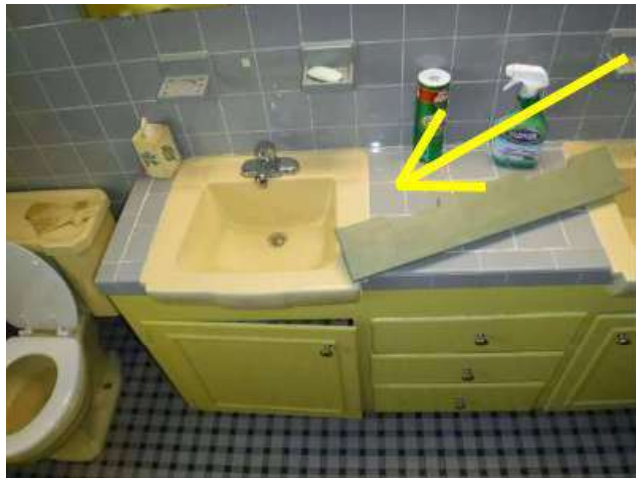
One or more sink drains were leaking at location #B. A qualified person should repair as necessary.

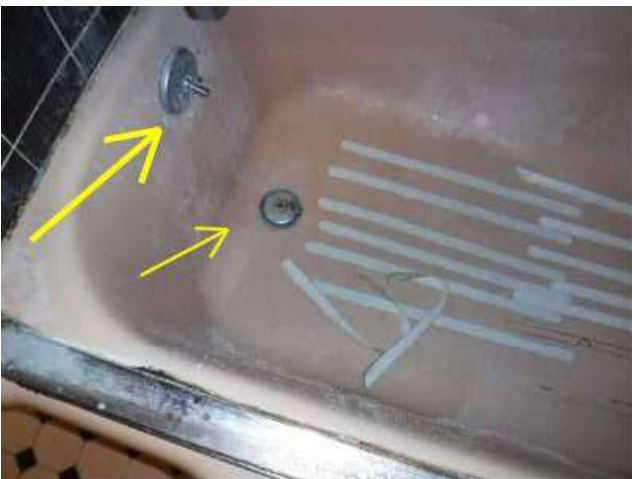
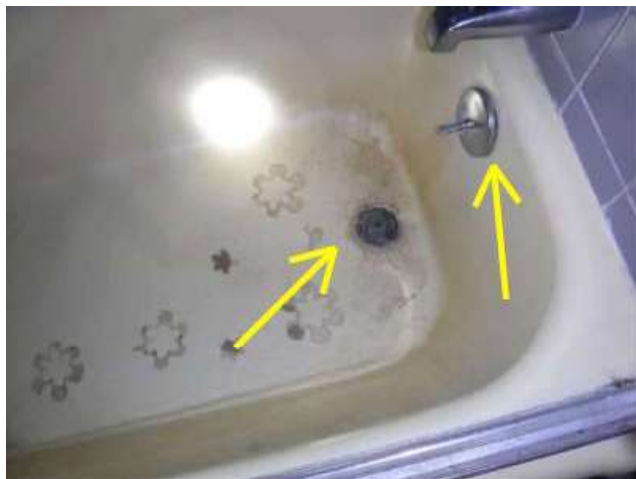
The bathtub drain stopper mechanism at location(s) #A and B was inoperable. Recommend that a qualified person repair or replace as necessary.

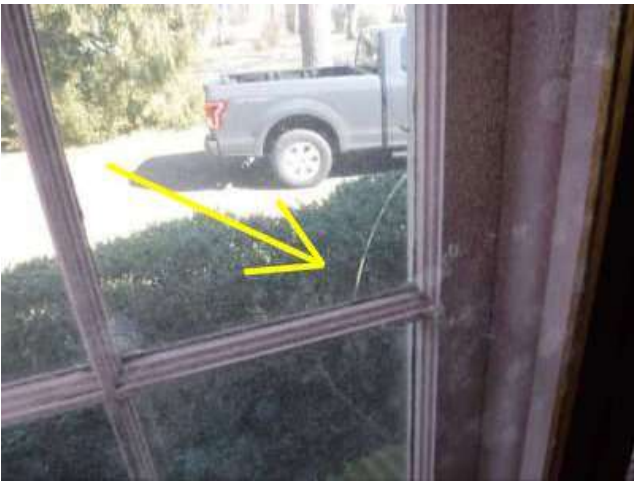
**Photo 56-1**

Glass in one or more windows was cracked, broken and/or missing. Recommend that a qualified contractor replace glass where necessary.

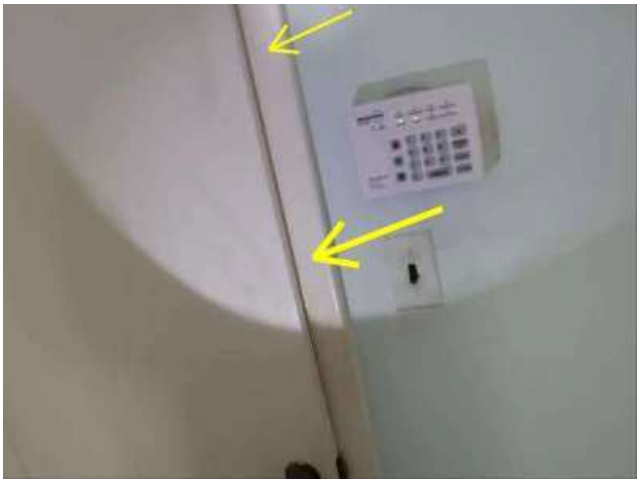
Photo 57-1

One or more interior doors were sticking in the door jamb and were difficult to operate. Recommend that a qualified person repair as necessary. For example, by trimming doors.

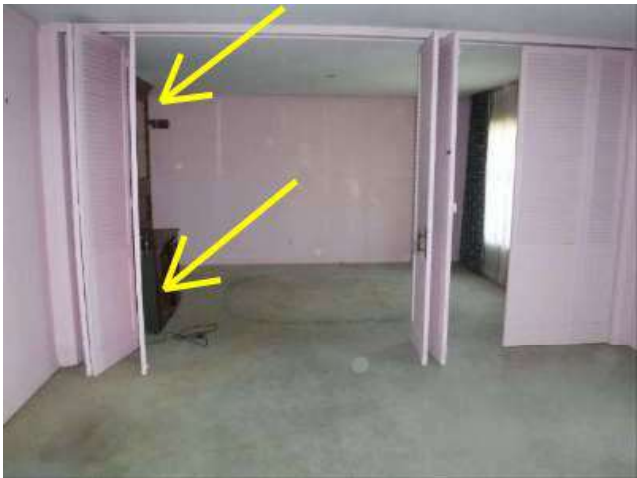
Photo 58-1

58) One or more bifold doors were off their track(s) or difficult to operate. Recommend that a qualified person repair as necessary.
