## General Information

**Report number:** 20240308

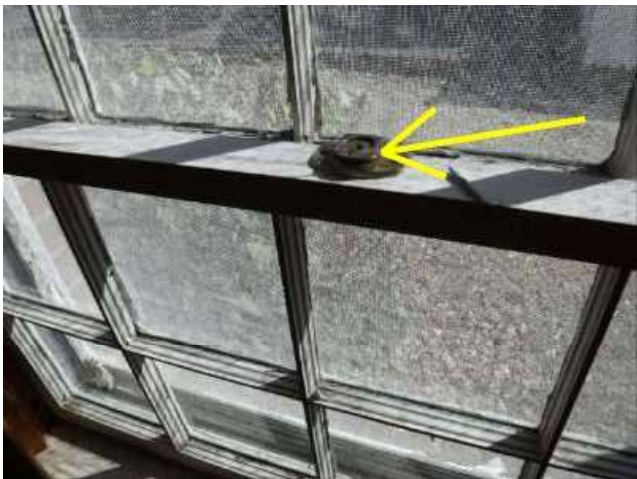
Photo 59-1

59) Lock mechanisms on one or more windows were damaged and/or difficult to operate. This can pose a security risk. Recommend that a qualified person repair as necessary.

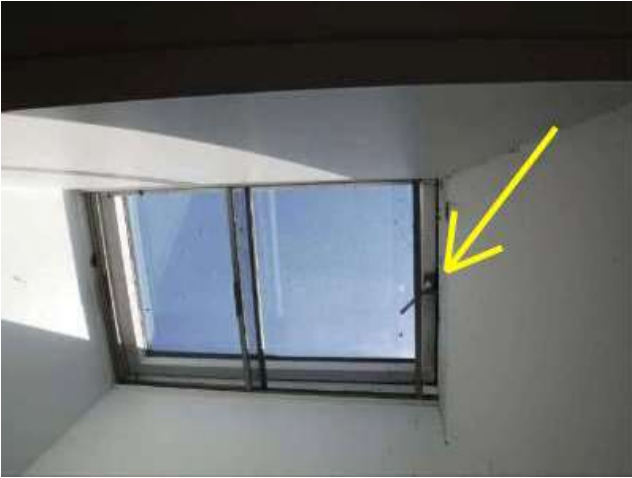
**Photo 60-1**

60) One or more skylights wouldn't open or close. Ventilation may be compromised. Recommend that a qualified person repair as necessary.

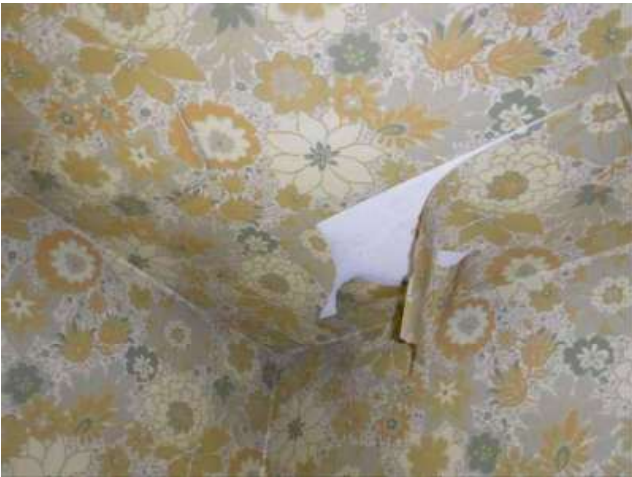
**Photo 65-1**

65) ⓘ Wallpaper in one or more areas was peeling.
