Report number: 20180425

Type of building: Single family

Age of main building: 51 yrs Built 1967

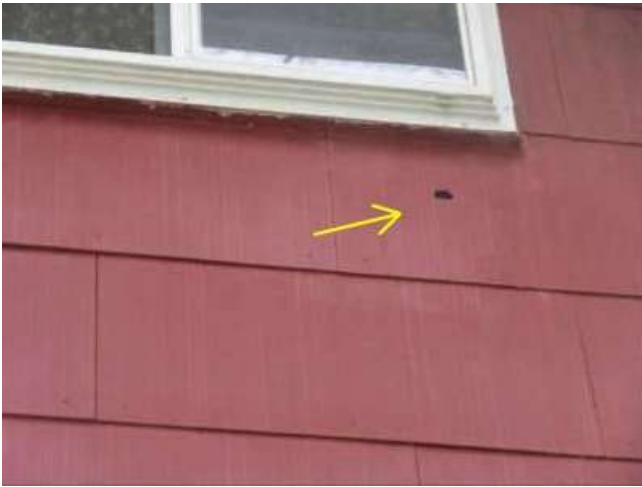
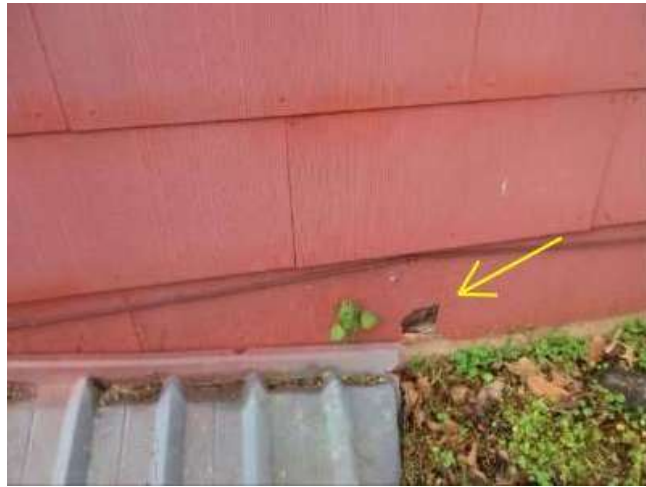
Some sections of siding and/or trim were damaged. Recommend that a qualified person repair, replace or install siding or trim as necessary.

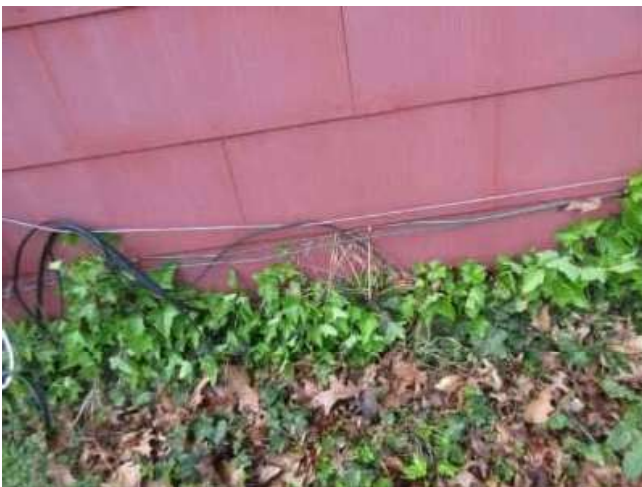
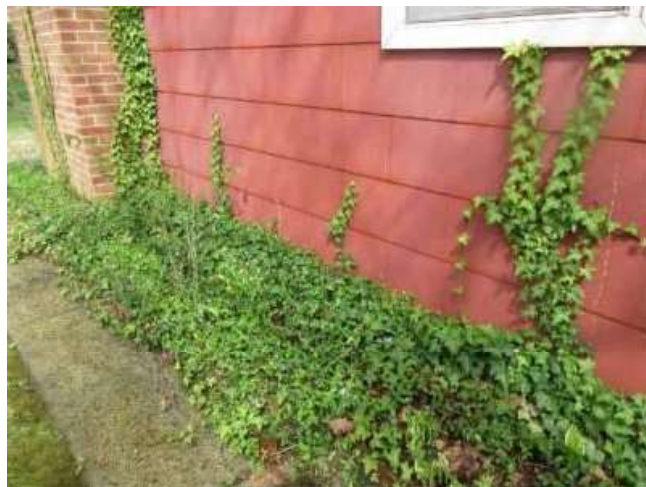
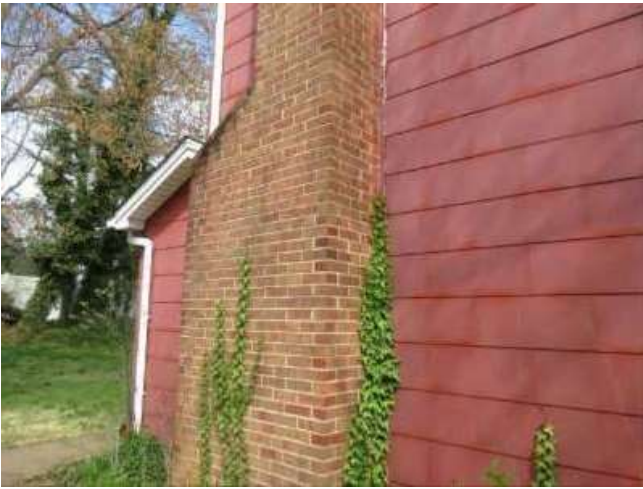
Vegetation such as trees, shrubs and/or vines was in contact with or close to the building exterior. Vegetation can serve as a pathway for wood-destroying insects and can retain moisture against the exterior after it rains. This is a conducive condition for wood-destroying organisms. Recommend pruning, moving or removing vegetation as necessary to maintain at least 6 inches of space between it and the building exterior. A 1-foot clearance is better.

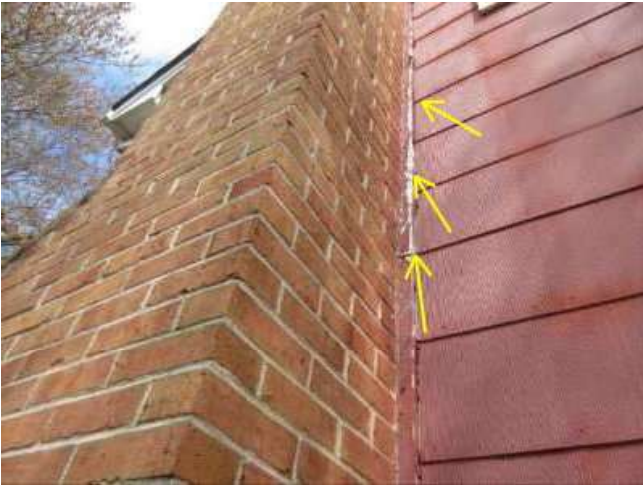
**Photo 5-1**

The paint or stain finish in some areas was failing (e.g. peeling, faded, worn, thinning). Siding and trim with a failing finish can be damaged by moisture. Recommend that a qualified contractor prep (e.g. clean, scrape, sand, prime, caulk) and repaint or restain the building exterior where necessary and per standard building practices. Any repairs needed to the siding or trim should be made prior to this.

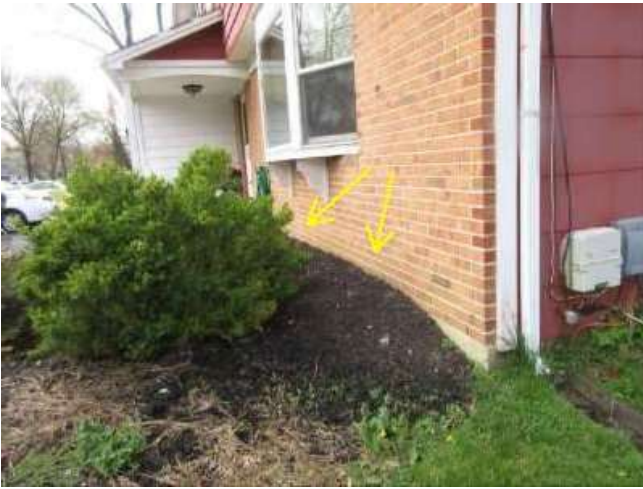
Photo 6-1

Soil was in contact with or less than 4 inches from brick, stone or faux stone veneer. For most residential installations of this type of veneer, this is a conducive condition for wood-destroying organisms. Weep holes may be covered. Condensed water behind the veneer may not be able to escape, and moisture can accumulate in the wood structure behind. Recommend grading and/or removing soil as necessary to maintain a 4-inch clearance.

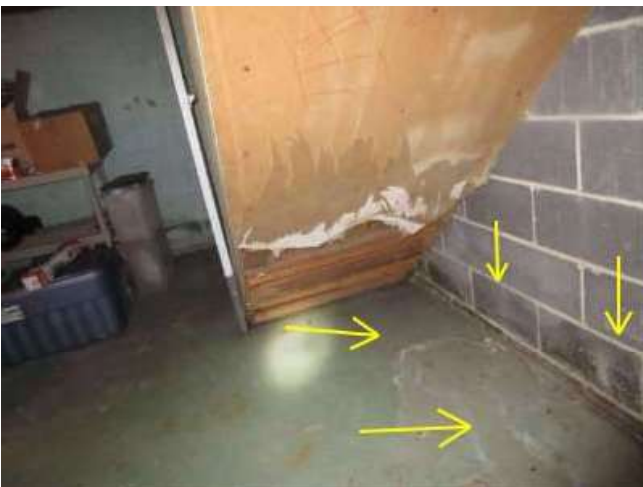
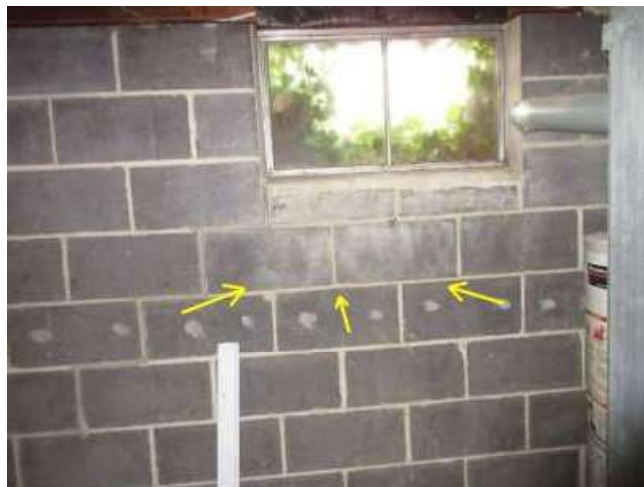
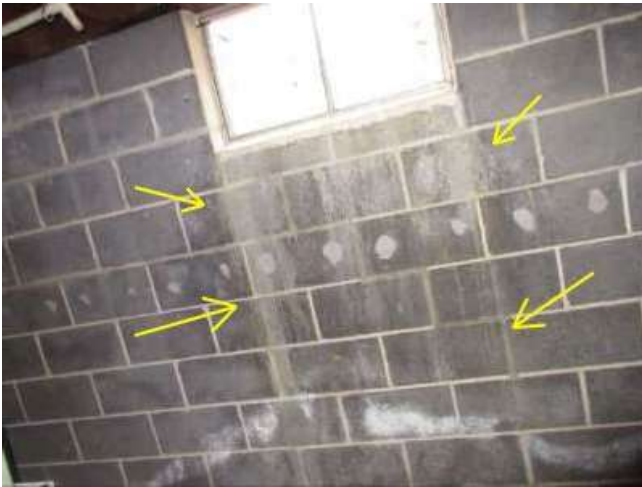
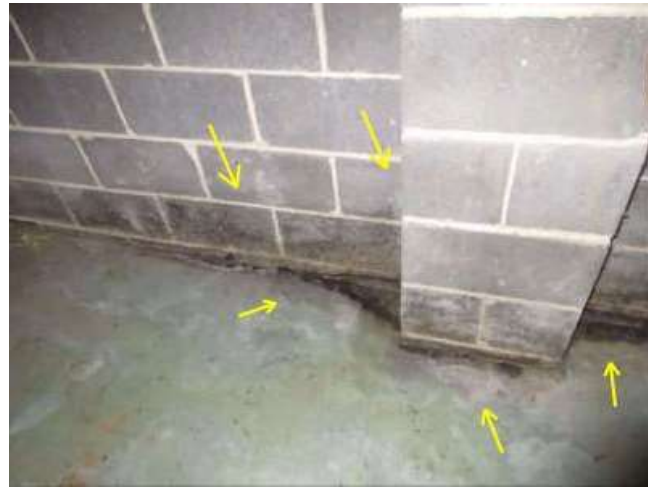
Evidence of prior water intrusion was found in one or more sections of the basement. For example, water stains or rust at support post bases, efflorescence on the foundation, etc. Accumulated water is a conducive condition for wood-destroying organisms and should not be present in the basement. Recommend reviewing any disclosure statements available and ask the property owner about past accumulation of water in the basement. The basement should be monitored in the future for accumulated water, especially after heavy and/or prolonged periods of rain. If water is found to accumulate, then recommend that a qualified contractor who specializes in drainage issues evaluate and repair as necessary.

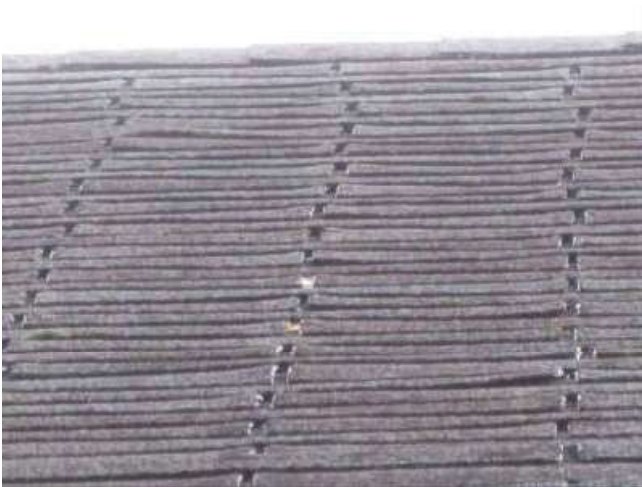
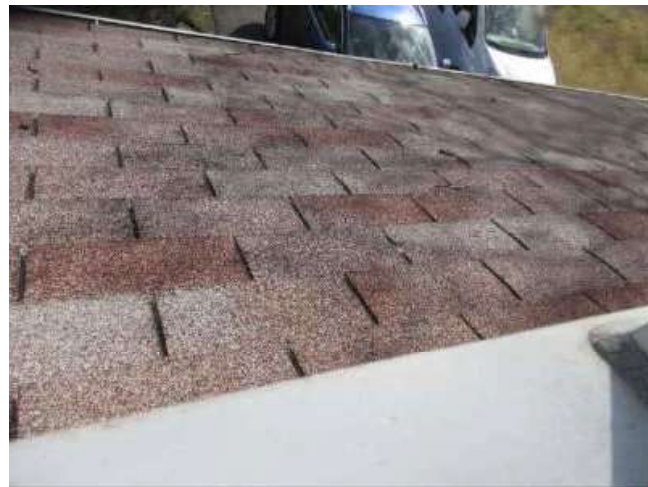
The roof surface appeared to be near the end of its service life and will likely need replacing in the near future even if repairs are made now. Recommend discussing replacement options with a qualified contractor, and budgeting for a replacement roof surface in the near future.

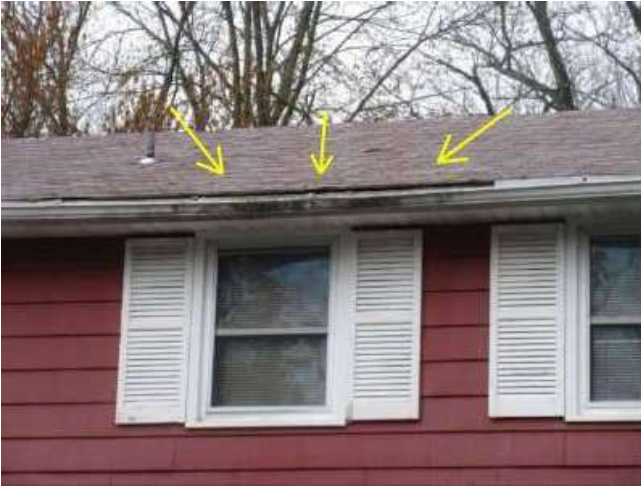
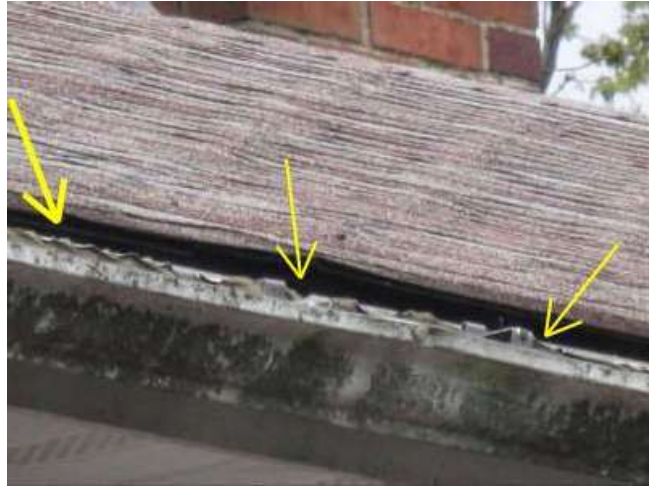
One or more gutters were loose, sagging, leaking and/or damaged with water leaking. Rainwater can come in contact with the building exterior or accumulate around the foundation as a result. The edge of the roof structure can become damaged by rot or water. This is a conducive condition for wood-destroying organisms. Recommend that a qualified person evaluate and repair as necessary.

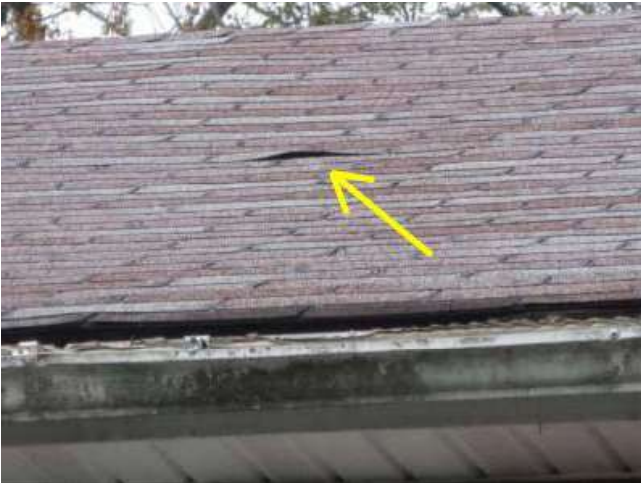
Photo 12-1

One or more roofing nails weren't fully seated and shingles were lifting or nail heads were protruding through shingle surfaces. The nails may have loosened, or were not pounded in fully when installed. Shingles are likely to be wind damaged, and leaks can occur as a result. This is a conducive condition for wood-destroying organisms. Recommend that a qualified contractor repair as necessary. For example, by replacing shingles.

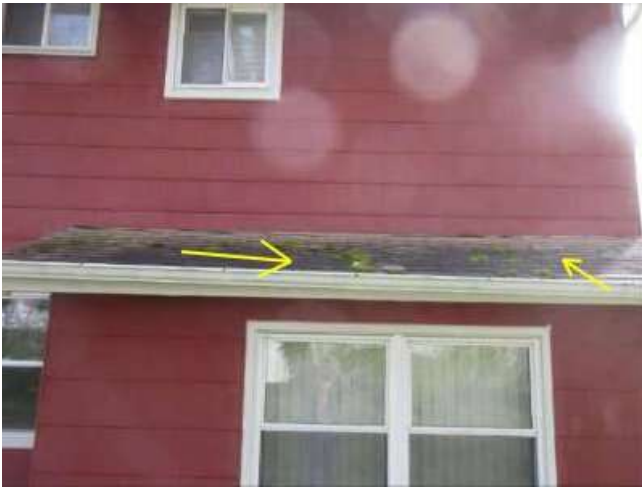
Photo 14-1

Moss was growing on the roof. As a result, shingles can lift or be damaged. Leaks can result and/or the roof surface can fail prematurely. Efforts should be made to kill the moss during its growing season (wet months). Typically, zinc or phosphate-based chemicals are used for this and must be applied periodically. For information on various moss treatment products and their pros and cons, visit:

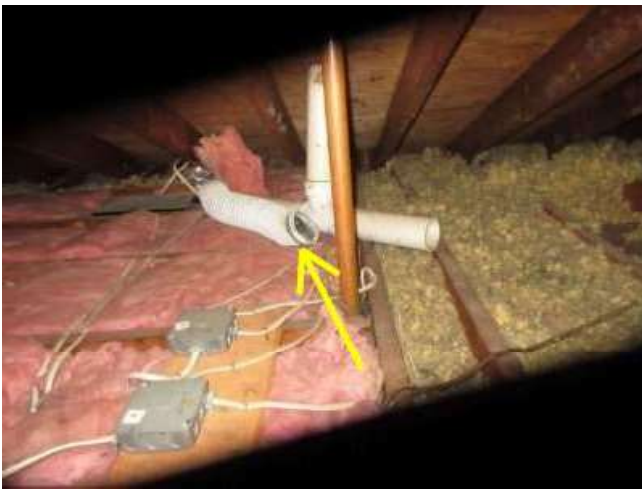
Photo 15-1

One or more exhaust fan ducts in the attic were not attached to a vent hood or cap. As a result, conditioned air will enter the attic when the fan is operated. Ducts terminating near an attic vent but without a dedicated vent hood or cap will likely blow conditioned air back into the attic. This can result in excessive moisture in the attic. Recommend that a qualified contractor repair per standard building practices, so exhaust fan ducts are permanently fastened to vent hoods or caps.

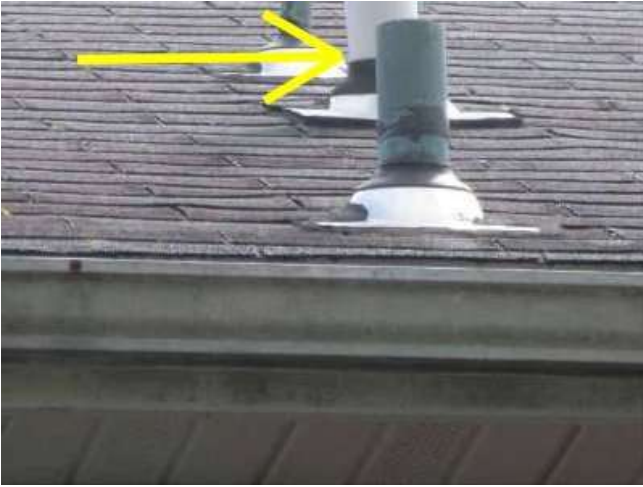
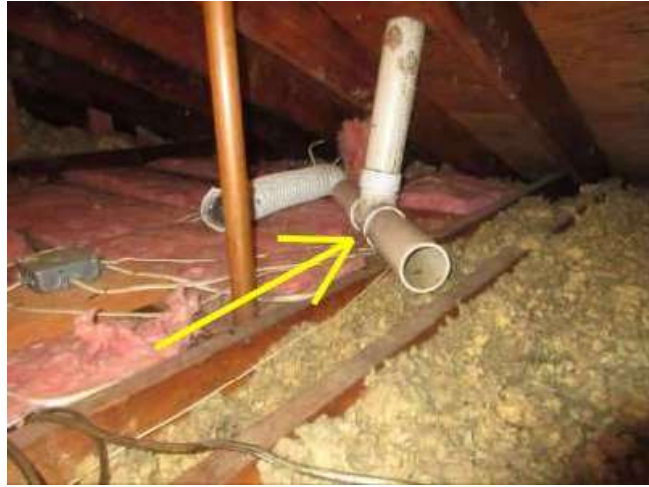
A vent pipe through the roof did not appear to have any function and could allow rainwater to enter the attic. Recommend asking the homeowner about the function of this and have a professional repair undertaken

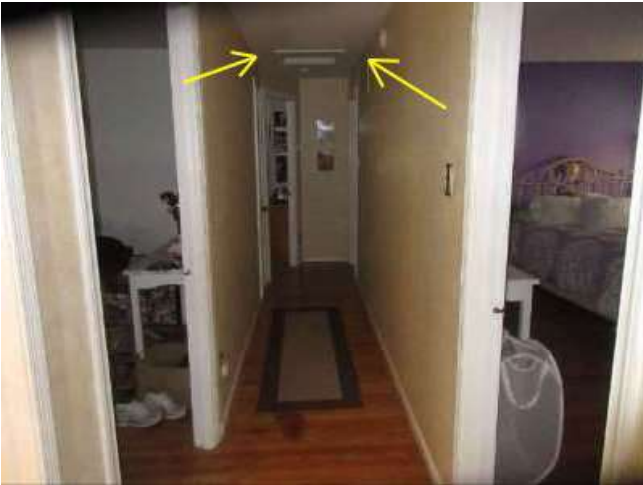
Photo 17-1

One or more attic access hatches or doors were not insulated, or had substandard insulation. Weatherstripping was also missing or substandard. Recommend installing weatherstripping and insulation per current standards at hatches or doors for better energy efficiency. For more information, visit: <http://www.reporthost.com/docs/atticaccess.pdf>

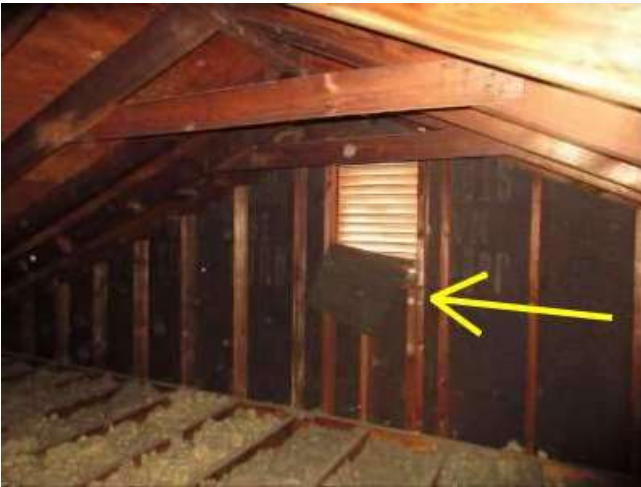
Photo 18-1

One or more attic or roof vent screens were missing, deteriorated or substandard. Recommend that a qualified person replace or repair screens as necessary to prevent birds or vermin from entering the attic.

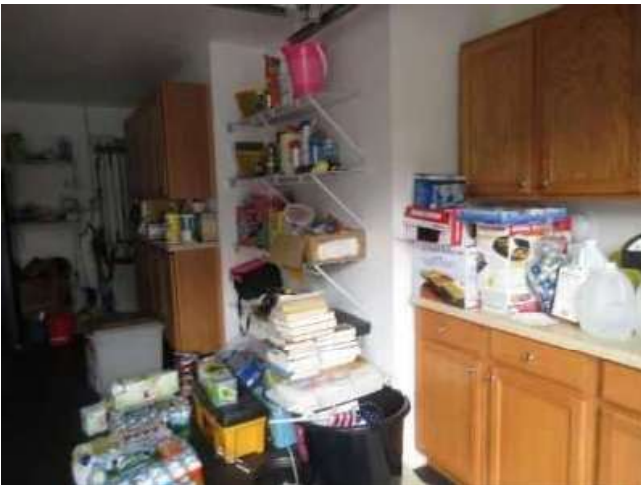
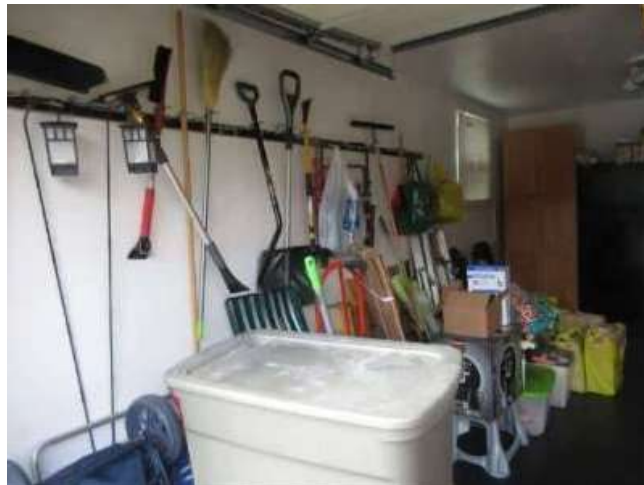
Many floor areas were obscured by stored items and couldn't be fully evaluated.

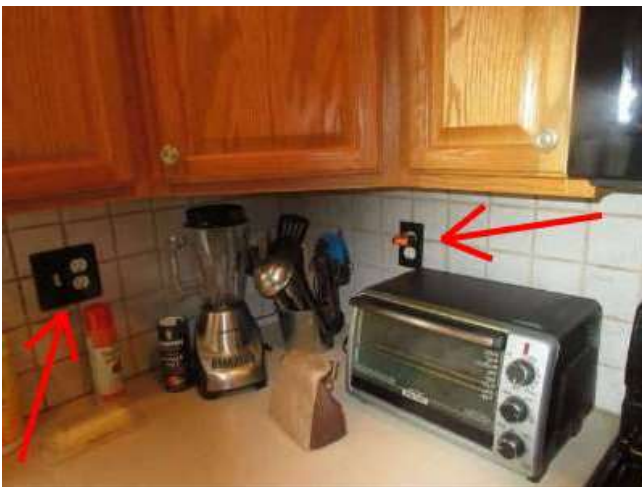
Photo 21-1

One or more electric receptacles (outlets) at the kitchen had no visible ground fault circuit interrupter (GFCI) protection, or the inspector was unable to determine if GFCI protection was present. If not GFCI-protected, receptacles in wet areas pose a shock hazard. Recommend that a qualified electrician evaluate and install GFCI protection if necessary and per standard building practices. General guidelines for GFCI-protected receptacles include the following locations:

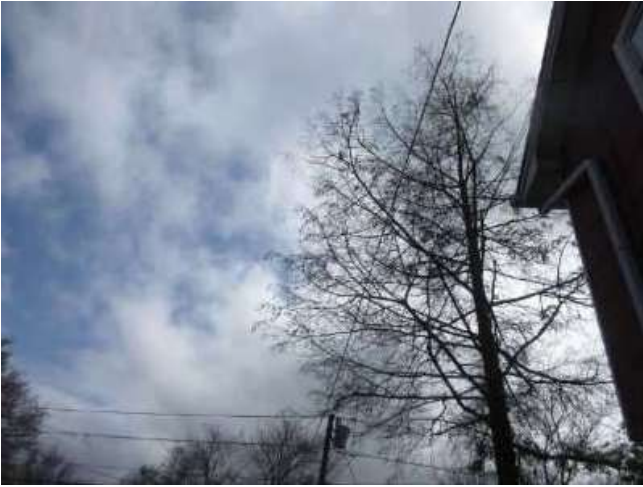
Photo 22-1

The service drop wires were in contact with trees or vegetation. This can result in damage to wiring insulation or broken wires during high winds. Recommend pruning trees or vegetation as necessary. The utility company may prune trees at no charge.

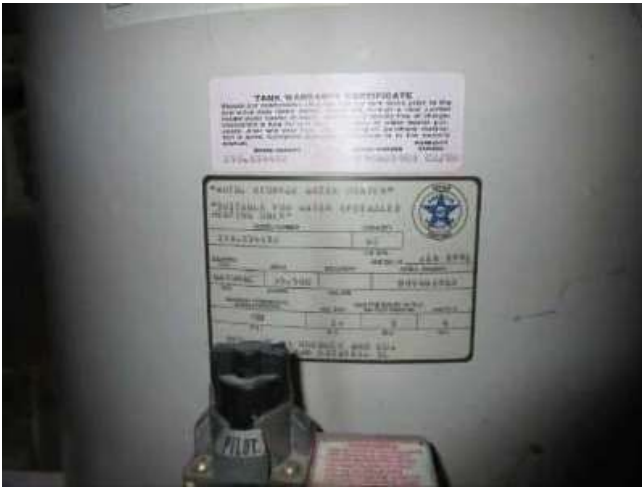
Photo 25-1

25) **i** The estimated useful life for most water heaters is 8-12 years. This water heater appeared to be beyond this age and/or its useful lifespan and may need replacing at any time. Recommend budgeting for a replacement in the near future, or considering replacement now before any leaks occur. The client should be aware that significant flooding can occur if the water heater fails. If not replaced now, consider having a qualified person install a catch pan and drain or a water alarm to help prevent damage if water does leak.

23 Yrs old

Mfg 1995

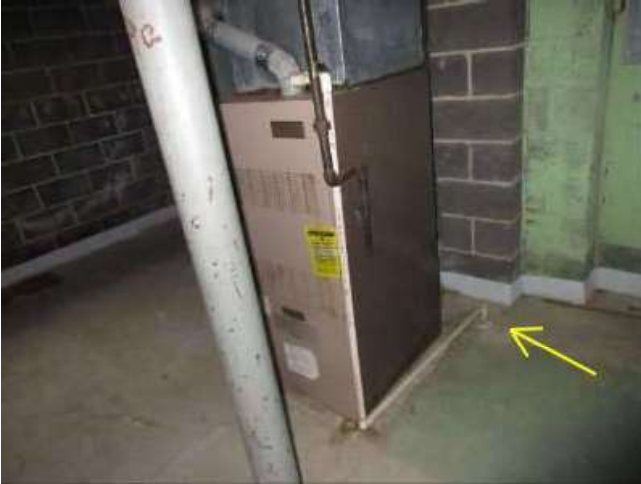
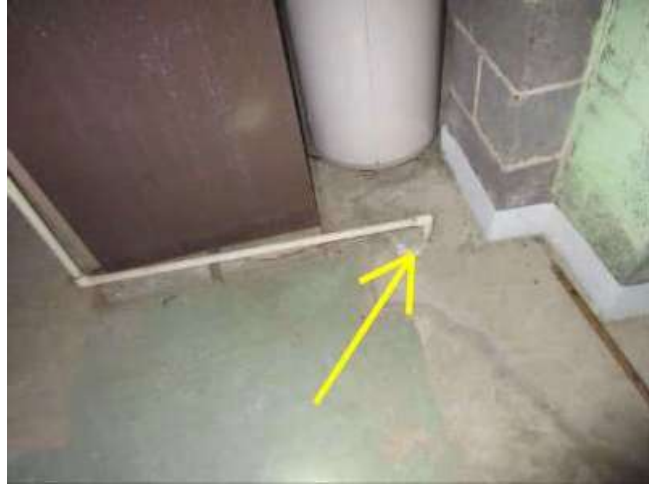
29) The air handler's primary condensate drain line was routed so it drains into the the foundation. Significant amounts of water can be produced by

this system. Recommend repairing as necessary so condensate water drains well away from the foundation.

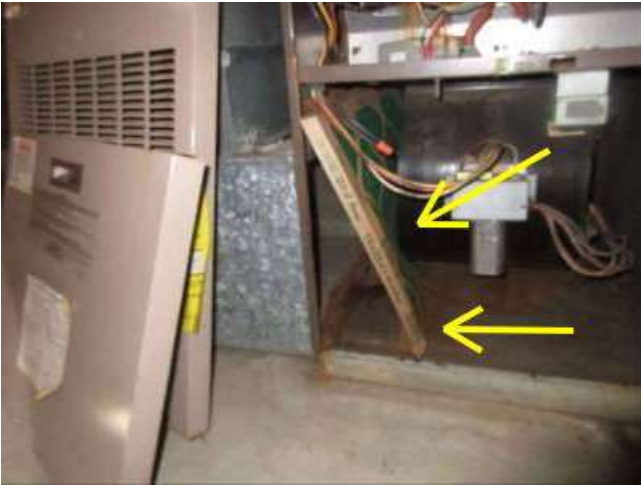
Photo 30-1

Hold-down devices for one or more heating and/or cooling system air filters were missing. Unfiltered air can flow through the system (around filters) and reduce indoor air quality. Recommend that a qualified person repair as necessary.

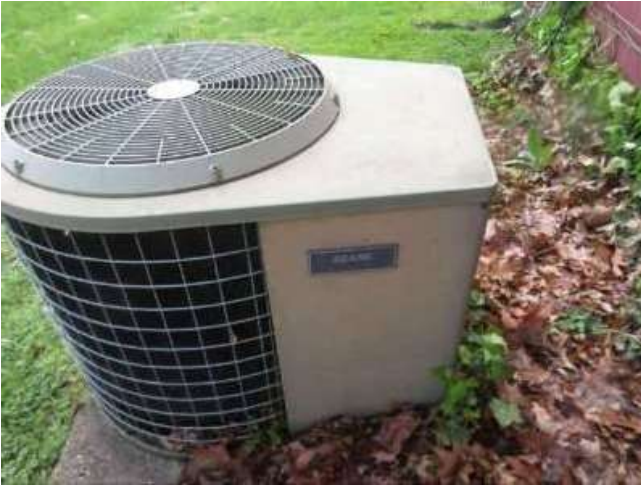
Photo 31-1

Vegetation such as trees, shrubs and/or vines were too close to the heat pump or air conditioning condensing unit. There should be at least 12 inches of clearance on all sides and at least 4-6 feet above. Inadequate clearance around and above can result in reduced efficiency, increased energy costs and/or damage to equipment. Recommend pruning and/or removing vegetation as necessary.

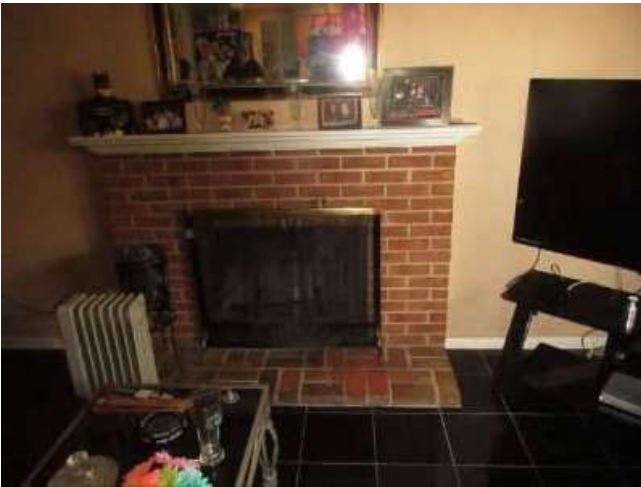
Photo 34-1

One or more wood-burning fireplaces or stoves were found at the property. When such devices are used, they should be professionally inspected and cleaned annually to prevent creosote build-up and to determine if repairs are needed. The National Fire Protection Association states that a "Level 2" chimney inspection should be performed with every sale or transfer of property with a wood-burning device. Recommend consulting with the property owner about recent and past servicing and repairs to all wood-burning devices and chimneys or flues at this property. Recommend that a qualified specialist evaluate all wood-burning devices and chimneys, and clean and repair as necessary. Note that if a wood stove insert is installed, it may need to be removed for such an evaluation. For more information, search for "chimney inspection" at:

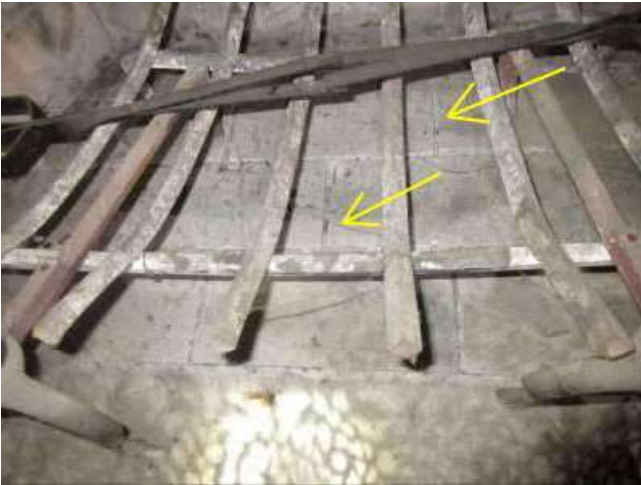
Photo 35-1

The fireplace's firebox was significantly deteriorated. For example, loose, cracked, pitted or broken firebricks, gaps between bricks and/or missing mortar. Heat from the fireplace may penetrate the firebox. This is a potential fire hazard. Recommend that a qualified contractor repair as necessary.

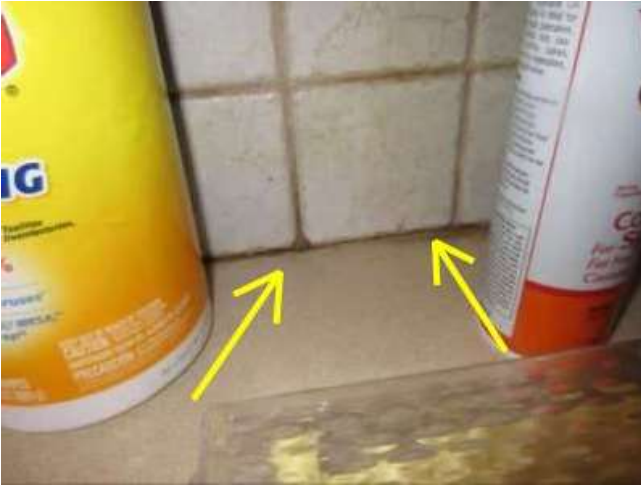
Photo 36-1

Gaps, no caulk, or substandard caulking were found between countertops and backsplashes. Water may penetrate these areas and cause damage. Recommend that a qualified person repair as necessary. For example, by installing caulk.

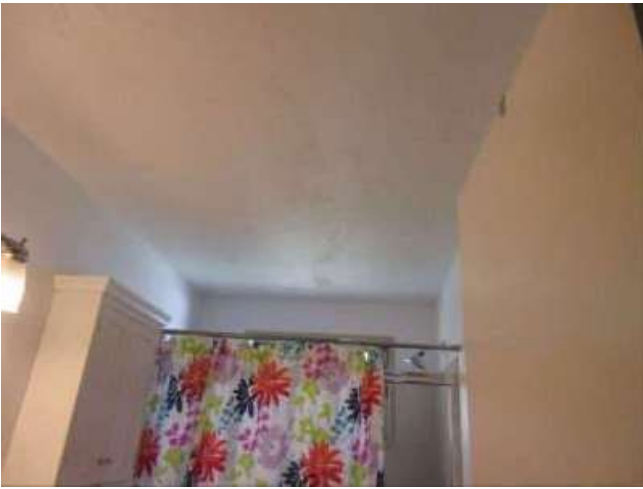
**Photo 38-1**

38) The bathroom with a shower or bathtub at location(s) #C didn't have an exhaust fan installed. Moisture can accumulate and result in mold, bacteria or fungal growth. Even if the bathroom has a window that opens, it may not provide adequate ventilation, especially during cold weather when windows are closed or when wind blows air into the bathroom. Recommend that a qualified contractor install exhaust fans per standard building practices where missing in bathrooms with showers or bathtubs.

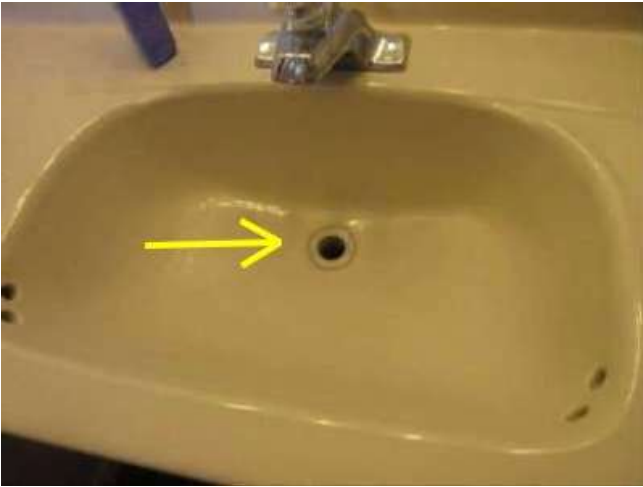
**Photo 39-1**

The sink drain stopper mechanism at location(s) #C was . Recommend that a qualified person repair or replace as necessary.

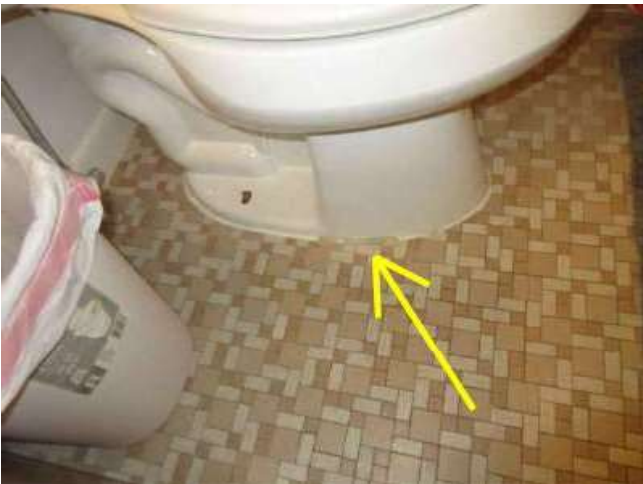
**Photo 40-1**

No caulk was installed around the base of the toilet at location(s) #C where fastened to the floor. Caulk should be applied approximately 3/4 of the way around the toilet base at the front for sanitary purposes and to prevent water intrusion. The back should be left uncaulked so water can escape if a leak ever occurs. Recommend that a qualified person caulk around the toilet base(s) per standard building practices.

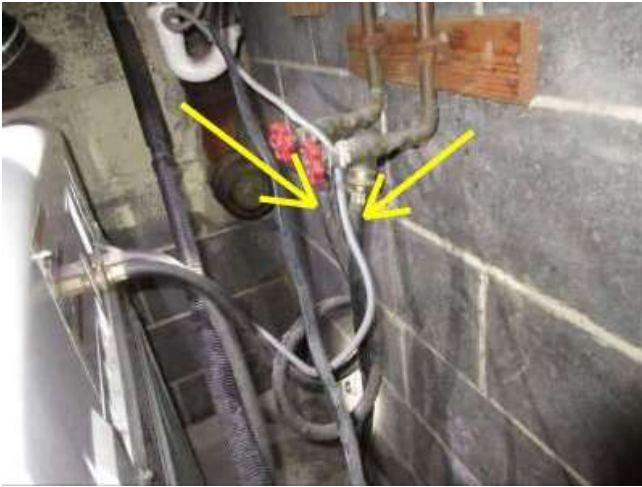
Photo 41-1

Rubber water supply hoses were installed at the clothes washer. These hoses are prone to bursting when deteriorated, which can result in flooding and significant water damage. Recommend upgrading to braided, stainless steel hoses.

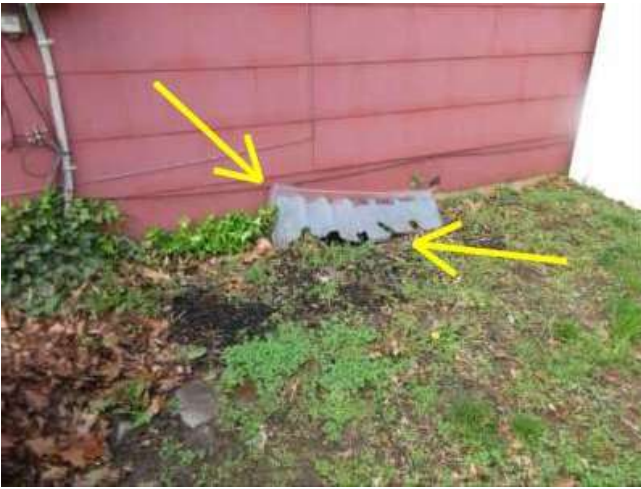
Photo 42-1

One or more windows were at or below grade with damaged wells. Wells should be installed when windows are at or near grade to prevent soil from contacting the structure and causing fungal rot or moisture problems. This is a conducive condition for wood-destroying organisms. Recommend that a qualified person install, replace or repair window wells per standard building practices.

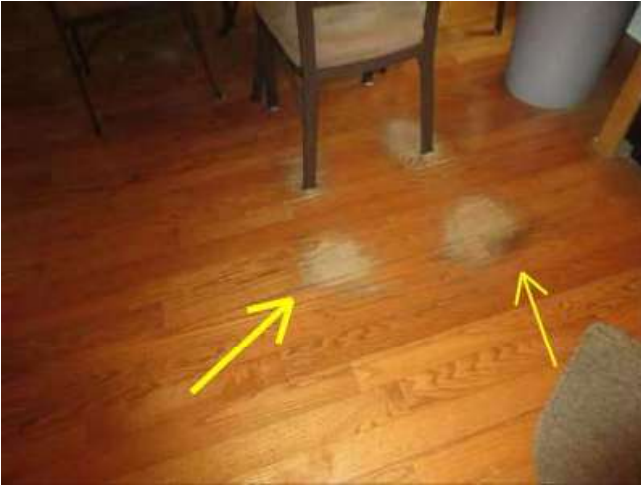
Photo 43-1

Wood flooring in one or more areas was significantly worn, deteriorated or damaged. Recommend that a qualified contractor refinish wood flooring as necessary.
