General Information

Report number: 20140302

Type of building: Single family

Age of main building: 61yrs. Built 1952

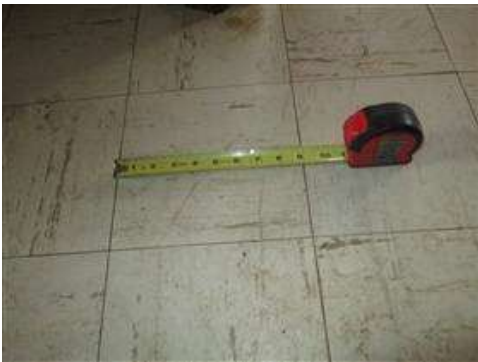
Photo 1-1

Structures built prior to the mid 1980s may contain lead and/or asbestos. Lead is commonly found in paint and in some plumbing components. The EPA does not recognize newer coats of paint as encapsulating older coats of lead-based paint. Asbestos is commonly found in various building materials such as insulation, siding, and/or floor and ceiling tiles. Laws were passed in 1978 to prohibit usage of lead and asbestos, but stocks of materials containing these substances remained in use for a number of years thereafter. Both lead and asbestos are known health hazards. Evaluating for the presence of lead and/or asbestos is beyond the scope of this inspection. Any mention of these materials in this report is made as a courtesy only, and meant to refer the client to a specialist. Consult with specialists as necessary, such as industrial hygienists, professional labs and/or abatement specialists for this type of evaluation. For information on lead, asbestos and other hazardous materials in homes, visit:

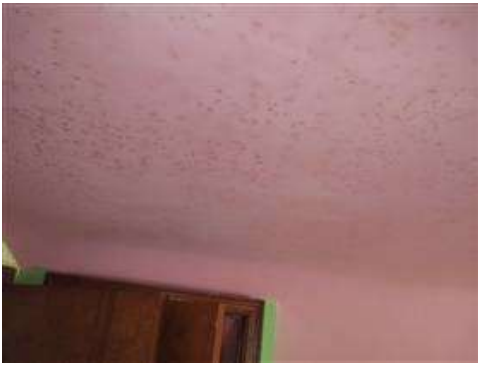
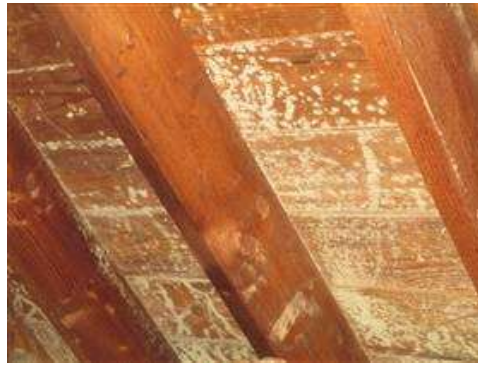
Microbial growths were found at one or more locations in interior rooms and the attic. It is beyond the scope of this inspection to identify what substance or organism this staining is. However such staining is normally caused by excessively moist conditions, which in turn can be caused by plumbing or building envelope leaks and/or substandard ventilation. These conducive conditions should be corrected before making any attempts to remove or correct the staining. Normally affected materials such as drywall are removed, enclosed affected spaces are allowed to dry thoroughly, a mildewcide may be applied, and only then is drywall reinstalled. For evaluation and possible mitigation, consult with a qualified industrial hygienist or mold/moisture mitigation specialist. For more information, visit:

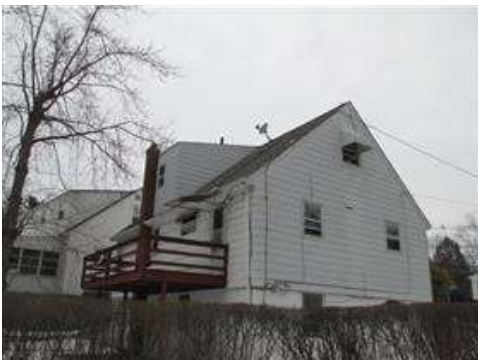
Photo 6-1

Based on non-standard construction observed, the addition of the Deck to this property may have been made without the owner having attained permits or inspections from the municipality. Work may have been performed by someone other than a qualified contractor or person. Consult with the property owner about this, and if necessary research permits.

At worst case, if substantial work was performed without permits, this knowledge must be disclosed when the building is sold in the future. This can adversely affect future sales. Also, the local municipality could require costly alterations to bring the building into legal compliance or even require that the additions or modifications be removed.

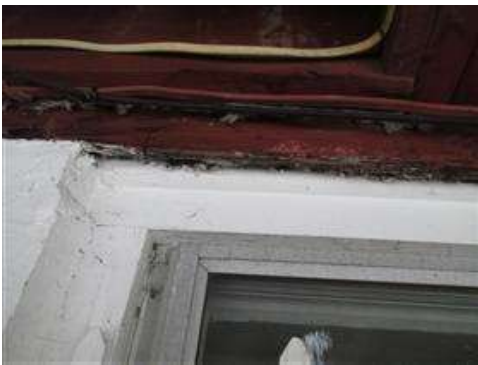
Photo 7-1

Flashing appeared to be missing from above the deck ledger boards, or could not be verified. Missing flashing at this location can cause moisture to accumulate between the ledger boards and the building. Fungal rot may occur in this area and cause the ledger board fasteners to fail. The deck may separate from the building in this event. This is a potential safety hazard. Recommend that a qualified contractor install flashing above ledger boards per standard building practices. For more information, visit:

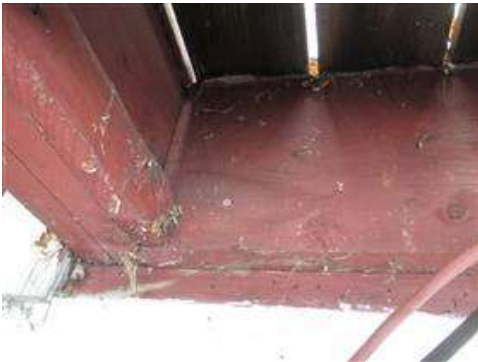
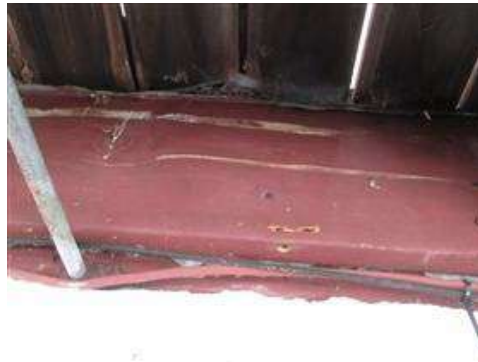
The deck ledger boards were nailed to the building rather than being attached by lag screws or bolts. As a result, decks or porches may separate from the building and collapse. This is a potential safety hazard. Lag screws or bolts, minimum 1/2 inch in diameter, should be installed to securely attach ledger boards to the main structure. Recommend that a qualified person install fasteners per standard building practices. For more information, visit:

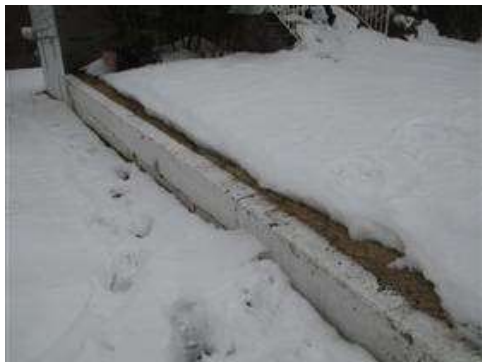
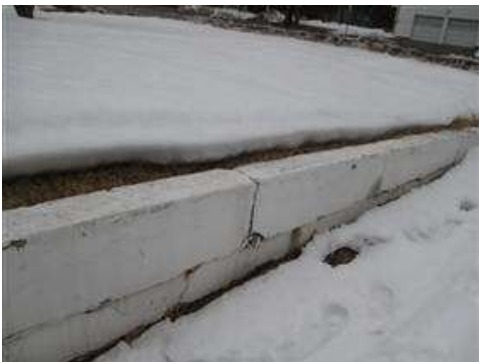
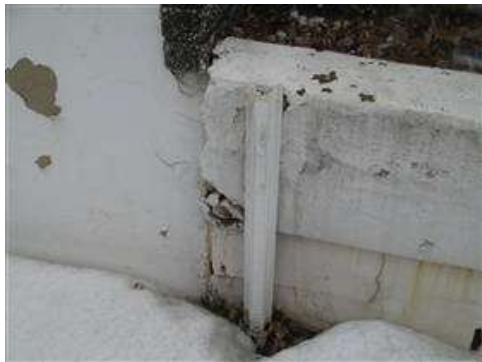
Significant cracks, deterioration, leaning and/or bowing were found in the driveway retaining wall. Recommend that a qualified contractor evaluate and repair or replace sections as necessary. Note that some retaining walls, based on their height or size, may require evaluation by a structural engineer.

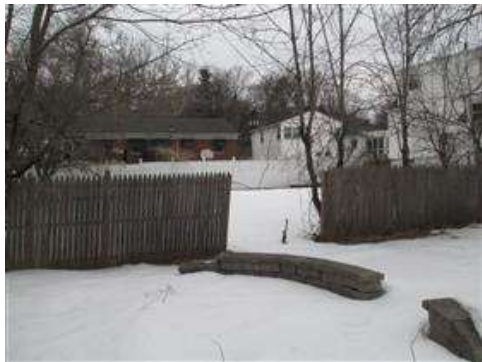
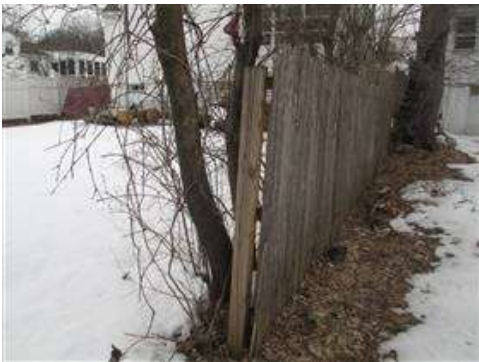
One or more fences were damaged or deteriorated and need repair.

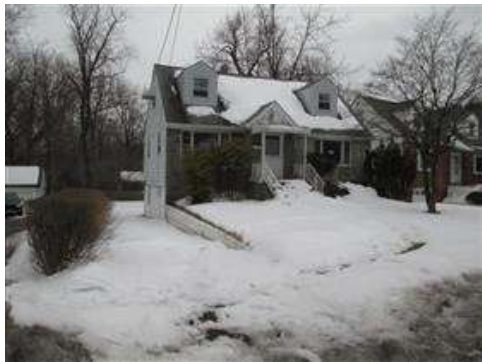
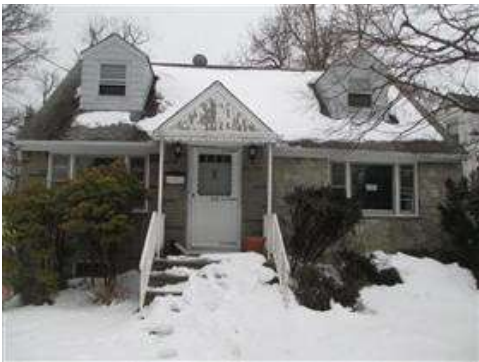
Most areas of the driveway were obscured by snow and couldn't be fully evaluated. Most sidewalks were obscured by snow and couldn't be fully evaluated.

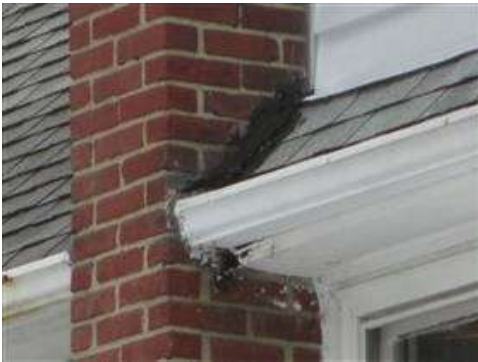
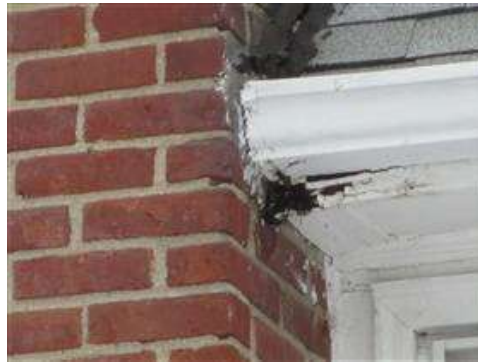
Fungal rot was found at one or more soffits, fascia. Recommend that a qualified person repair as necessary. All rotten wood should be replaced.

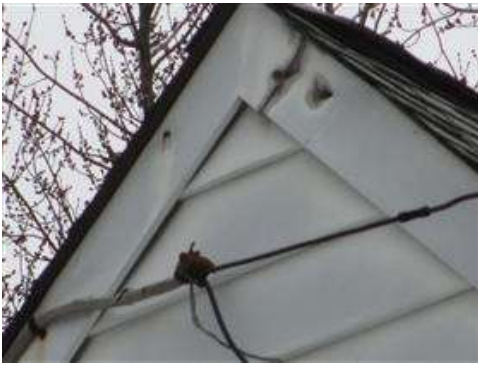
**Photo 14-1**

sections of siding and/or trim were damaged. Recommend that a qualified person repair, replace or install siding or trim as necessary.

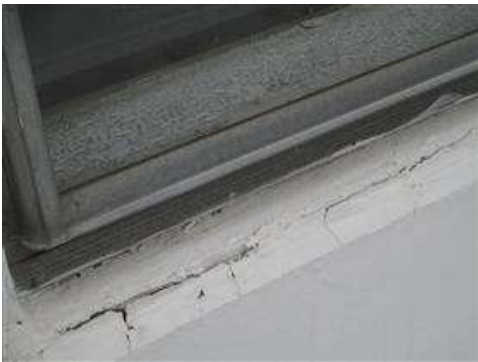
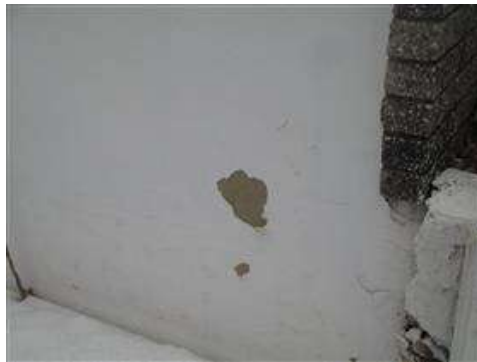
The paint or stain finish in some areas was failing (e.g. peeling, faded, worn, thinning). Siding and trim with a failing finish can be damaged by moisture. Recommend that a qualified contractor prep (e.g. clean, scrape, sand, prime, caulk) and repaint or restain the building exterior where necessary and per standard building practices. Any repairs needed to the siding or trim should be made prior to this.

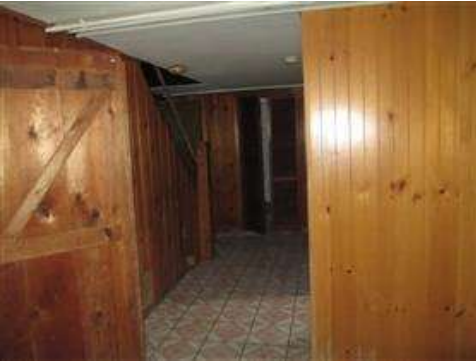
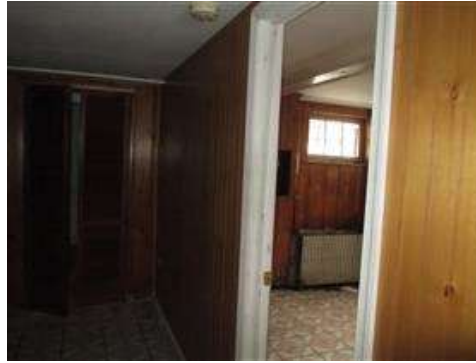
Most foundation walls below the house were obscured by finished walls and ceilings. The inspector was unable to evaluate these areas. They are excluded from this inspection.

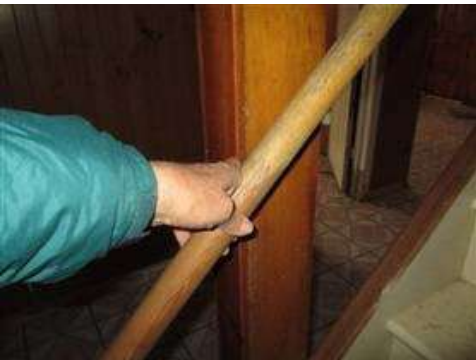
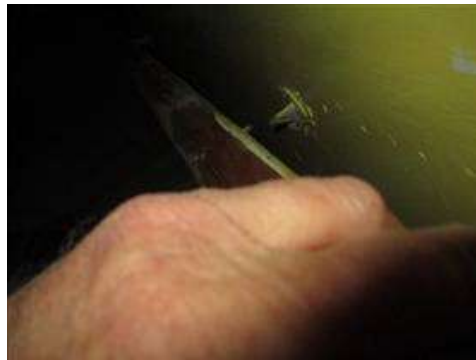
17) 🛠️🔪 Handrail at basement flight of stairs was loose & damaged. This is a safety hazard. Recommend that a qualified person repair as necessary.

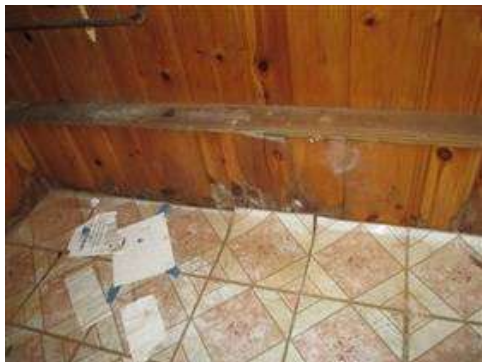
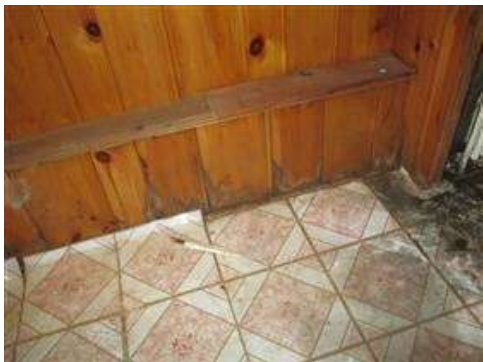
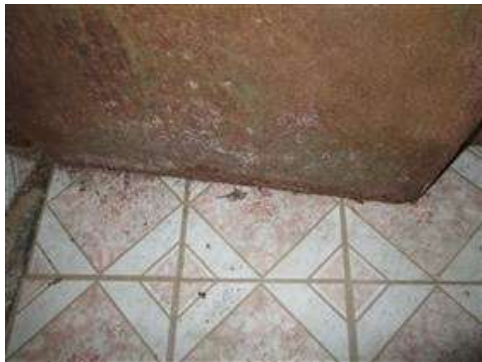
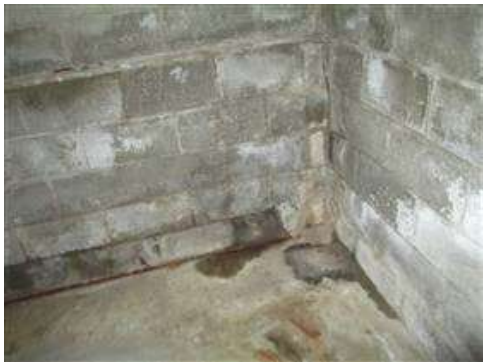
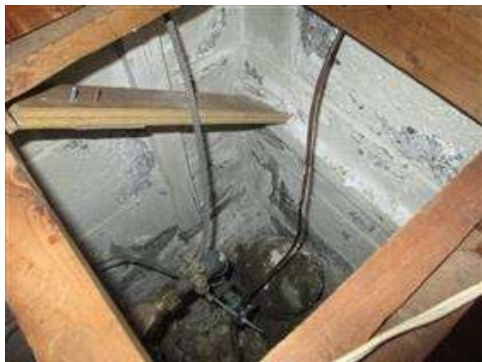
18) 🔍💧🔧 Evidence of prior water intrusion was found in one or more sections of the basement. For example, water stains or rust at support post bases, efflorescence on the foundation, etc. Accumulated water is a conducive condition for wood-destroying organisms and should not be present in the basement. Recommend reviewing any disclosure statements available and ask the property owner about past accumulation of water in the basement. The basement should be monitored in the future for accumulated water, especially after heavy and/or prolonged periods of rain. If water is found to accumulate, then recommend that a qualified contractor who specializes in drainage issues evaluate and repair as necessary. Typical repairs for preventing water from accumulating in basements include:

- Repairing, installing or improving rain run-off systems (gutters, downspouts and extensions or drain lines)
- Improving perimeter grading
- Repairing, installing or improving underground footing and/or curtain drains

Ideally, water should not enter basements, but if water must be controlled after it enters the basement, then typical repairs include installing a sump pump.

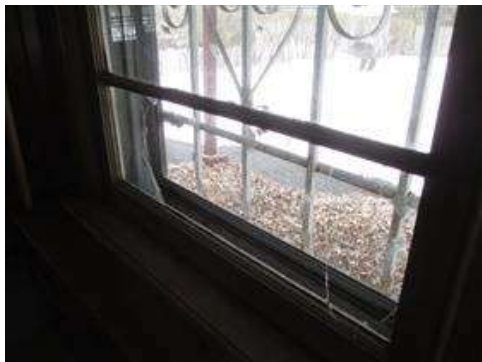
Photo 19-1

Glass in one or more window was cracked, broken and/or missing. Recommend that a qualified contractor replace glass where necessary.

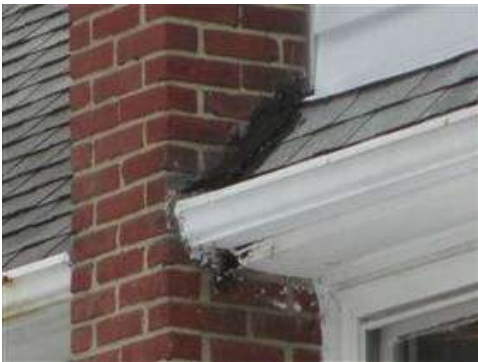
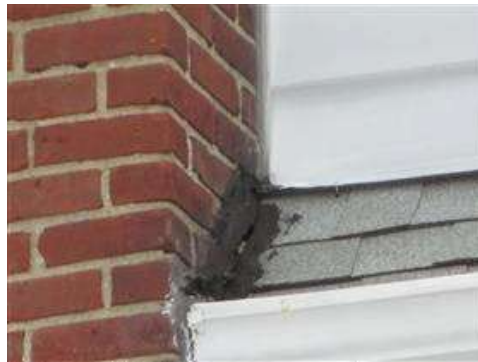
Flashing at the base of the chimney was missing, damaged, deteriorated, corroded or substandard. Leaks have occur as a result. This is a conducive condition for wood-destroying organisms. Recommend that a qualified contractor evaluate and repair as necessary.

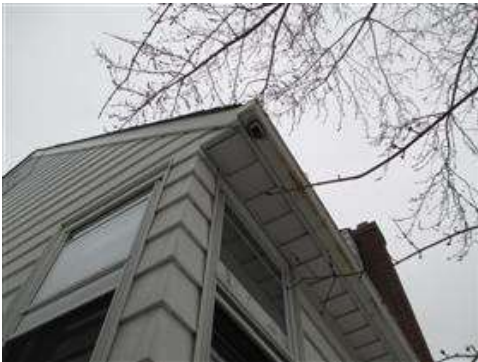
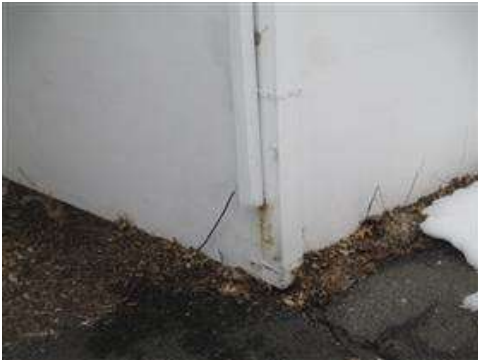
One or more gutters, downspouts were incomplete, missing, leaking, damaged. Rainwater can come in contact with the building exterior or accumulate around the building foundation as a result. This is a conducive condition for wood-destroying organisms. Recommend that a qualified person repair as necessary.

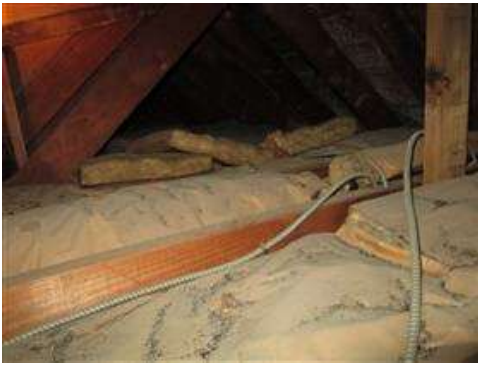
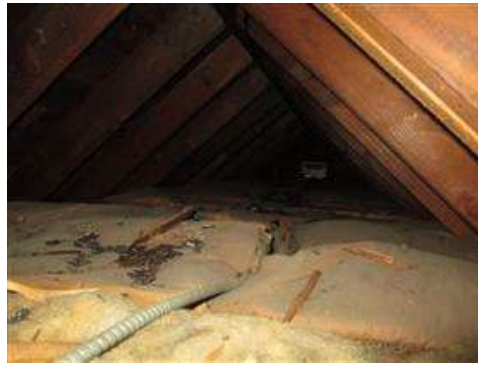
24) The facing on fiberglass batt insulation in the attic was exposed. In most cases, the facing is flammable and poses a fire hazard. Also, the facing typically acts as a vapor barrier, and if located away from the interior surfaces can trap moisture from condensation in the cavity between the facing and the interior spaces. This can be a conducive condition for wood-destroying organisms. Recommend that a qualified person repair as necessary. For example, by reinstalling or replacing insulation per standard building practices and per the manufacturer's instructions.

Note that the inspector was unable to evaluate areas obscured by insulation to determine if any damage (e.g. rot, insect infestation) has already occurred due to moisture accumulation. When insulation repairs are made, recommend that the exposed structure be evaluated and repairs made if necessary.

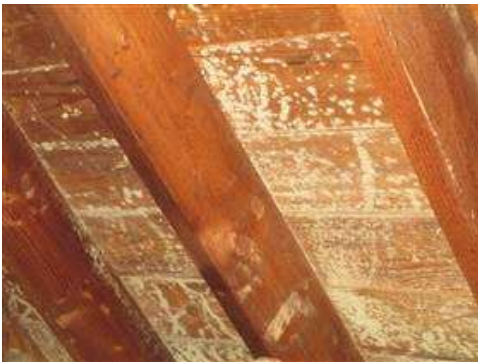
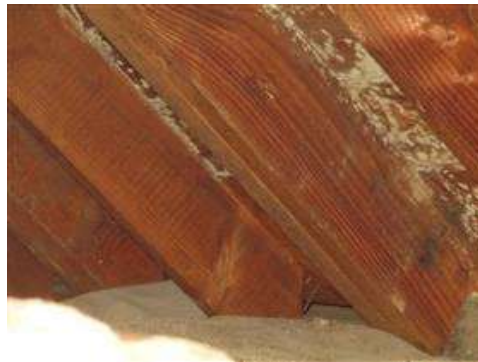
Microbial staining was visible on roof sheathing in the attic. Such staining usually occurs due to elevated humidity in the attic, and subsequent elevated moisture levels in the sheathing. However, ongoing ventilation and/or insulation issues can also result in humid conditions. Please note any other comments in this report related to ventilation, insulation and/or moisture levels in the attic, and make any related recommended corrections. After issues related to the moisture conditions have been corrected, the clients may or may not wish to have mitigation work performed for the biological staining. Typically mold abatement specialists perform such work and may do the following:

- Remove affected attic insulation
- Clean microbial staining from wood surfaces
- Treat wood surfaces with mildewcides
- Prime wood with special primers
- Install new attic insulation

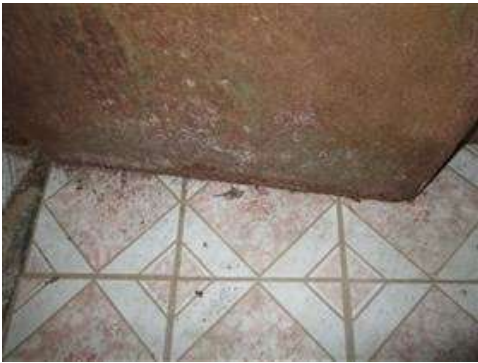
Photo 27-1

No threshold was installed at the base of the door between the garage and the house. House to garage doors prevent fire and fumes from spreading from the garage to the house. Thresholds prevent fire and fumes from spreading underneath the door. This is a potential safety hazard. Recommend that a qualified person install a threshold per standard building practices.

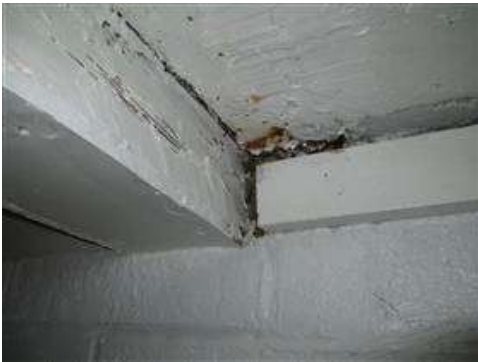
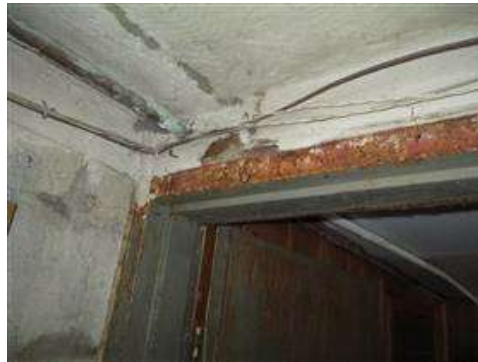
One or more gaps, holes, areas with missing or substandard surface materials were found in the attached garage walls or ceilings. Current standard building practices call for wooden-framed ceilings and walls that divide the house and garage to provide limited fire-resistance rating to prevent the spread of fire from the garage to the house. Recommend that a qualified person repair per standard building practices. For example, by patching openings or holes, firestopping holes or gaps with fire-resistant caulking, and/or installing fire-resistant wall covering (e.g. Type X drywall). For more information, visit:

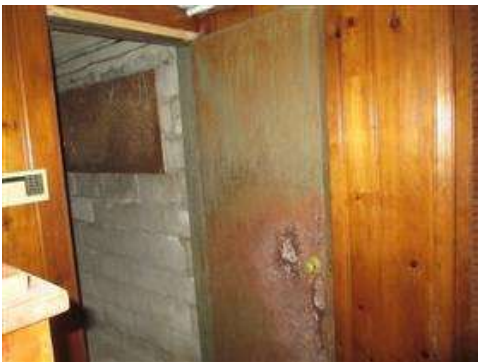
Photo 29-1

The self-closing device on the door between the garage and the house didn't close and latch the door. These devices are installed to keep the door closed to prevent possible fire and fumes from the garage from spreading to the house. Recommend that a qualified person repair as necessary.

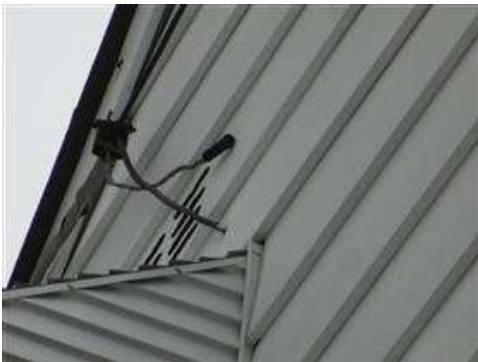
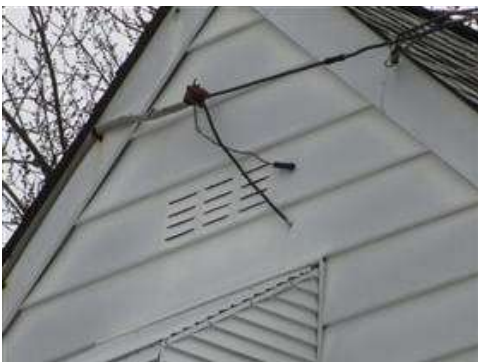
The wire holder (e.g. brackets or fasteners) for the service entrance wires was loose. This is a potential shock and fire hazard. The service drop wires had no drip loop where they attached to the service mast, or the drip loop was substandard. This can result in water entering electric panels, and is a potential shock hazard. The service entrance wire insulation was frayed, damaged or deteriorated. This is a potential shock hazard. Splices in service conductors at the service mast head were exposed. Splices should be covered with plastic insulators or tape to prevent exposed, energized wires. This is a potential shock hazard. Recommend that a qualified electrician repair per standard building practices.

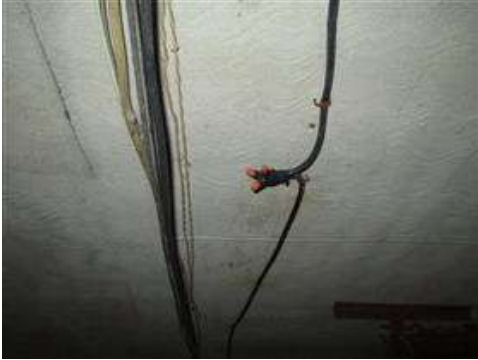
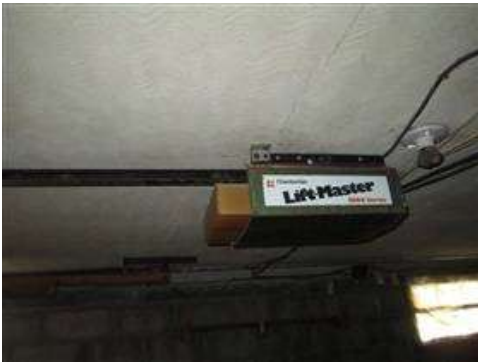
Substandard wiring was found in the garage. For example, exposed wiring, exposed splices. This is a safety hazard. Extension

cords were being used as permanent wiring at one or more locations. They should only be used for portable equipment on a temporary basis. Using extension cords as permanent wiring is a potential fire and shock hazard, and indicates that wiring is inadequate and needs updating. Recommend that a qualified electrician repair per standard building practices and eliminate extension cords for permanently installed equipment.

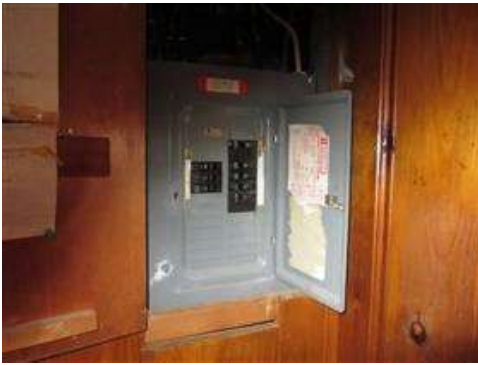
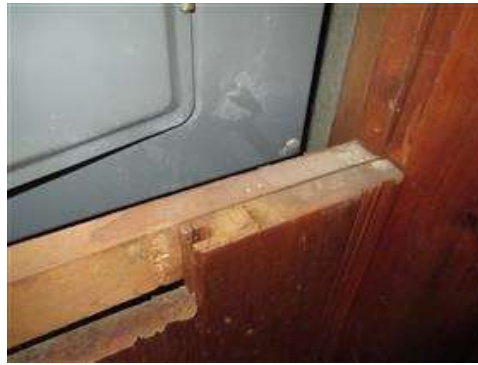
Panel had inadequate working space. This is a safety hazard when opening or working in panels. Electric panels should have the following clearances:

- An open area 30 inches wide by 3 feet deep in front of the panel
- 6 feet 3 inches of headroom in front of the panel
- The wall below the panel is clear to the floor
- The center of the grip of the operating handle of the switch or circuit breaker not more than 6 feet 7 inches above the floor or working platform

Recommend that a qualified contractor repair or make modifications per standard building practices. If panels must be opened for repairs, then a qualified electrician should perform repairs.

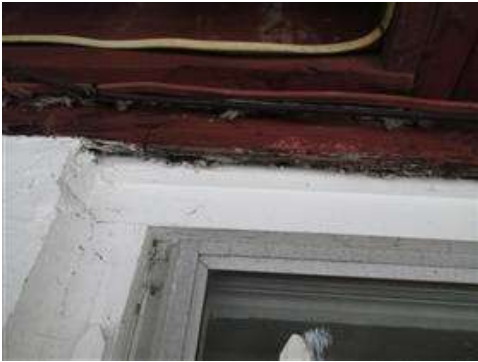
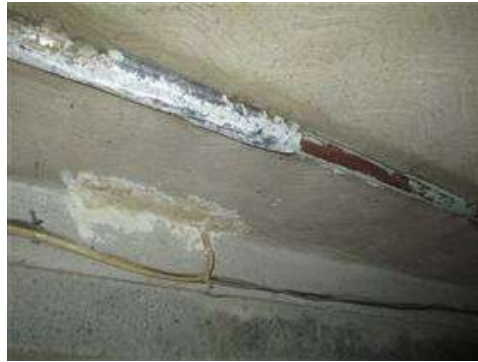
Non-metallic sheathed wiring was installed at one or more locations, and was subject to damage such as on easily accessible wall or ceiling surfaces. The insulation can be damaged by objects coming in contact with it, resulting in exposed, energized wires. Also, copper conductors can break after being repeatedly moved or bent. This is a potential shock or fire hazard. Recommend that a qualified electrician repair per standard building practices. For example, by installing protective conduit or re-routing wires through walls or ceilings.

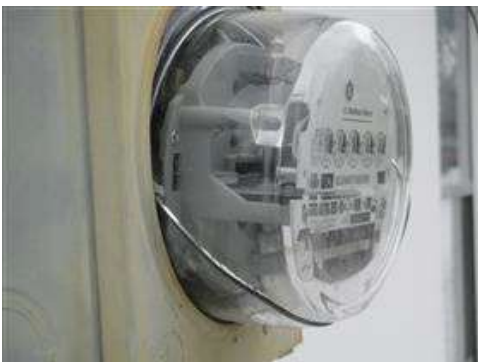
Photo 36-1

The electric meter seal was broken. The utility company installs these seals to prevent tampering with the meter or tapping into the electric supply before the meter. Consult with the property owner about this and/or contacting the utility company to have the seal reinstalled.

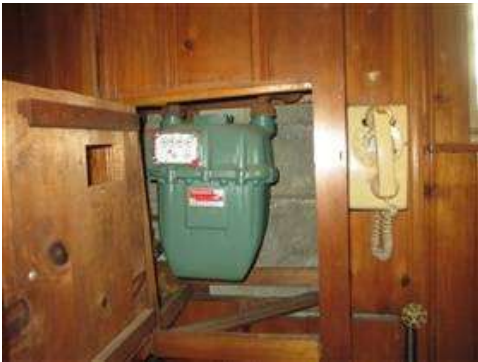
Photo 38-1

The gas meter was located under a combustible structure. This is prohibited and is a potential explosion and fire hazard. Recommend that repairs or modifications be made as necessary to maintain clearances per standard building practices, and by a qualified contractor or the gas utility company if necessary.

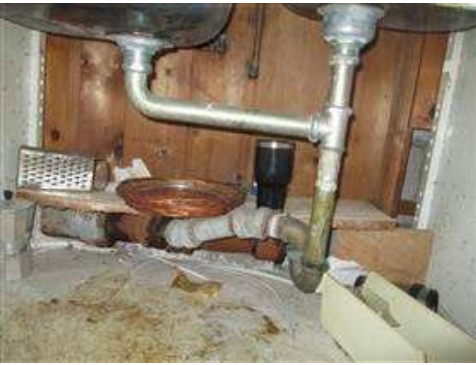
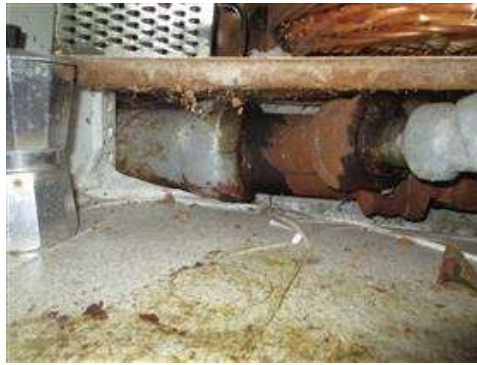
Stains were found in one or more sections of waste lines, but no active leaks were found near the stains. This may indicate that past leaks have occurred. Consult with the property owner about this, and either monitor these areas in the future for leaks or have a qualified plumber evaluate and repair as necessary.

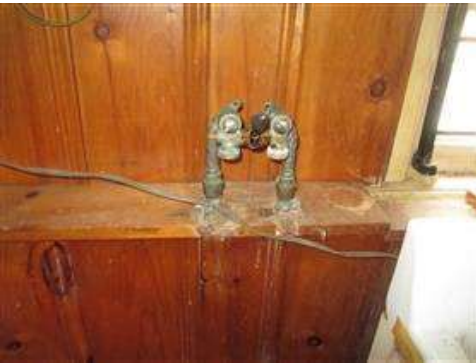
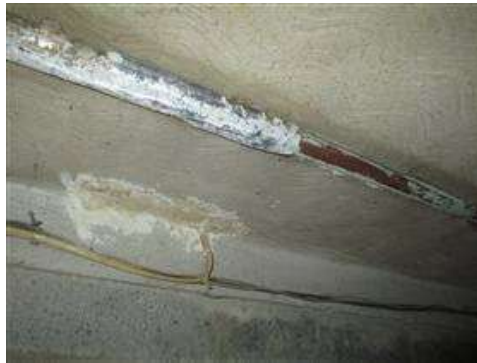
Significant corrosion was found in many water supply pipes or fittings. Leaks can occur as a result. Recommend that a qualified plumber evaluate and replace components as necessary.

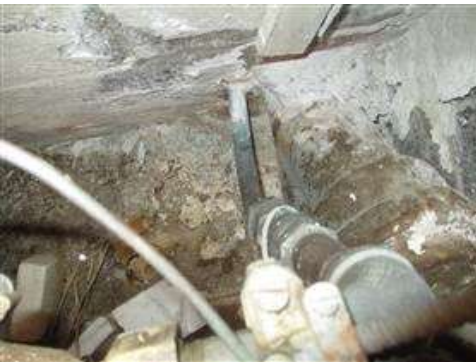
Photo 42-1

The copper water service pipe was embedded in concrete or masonry where it was routed through the foundation, and no protection from damage due to thermal expansion was visible. Copper pipes embedded in concrete or masonry should be wrapped with an approved tape or installed through a sleeve for abrasion protection. Recommend that a qualified contractor repair per standard building practices.

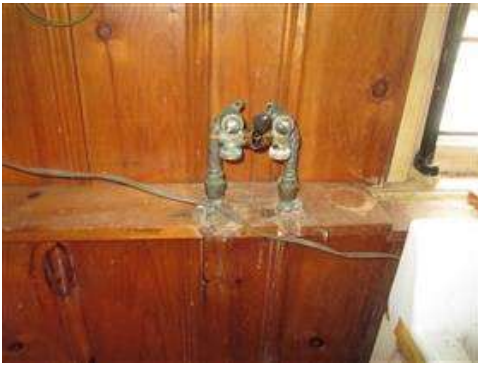
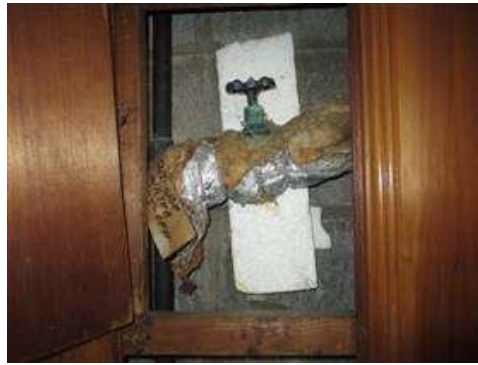
Significant corrosion or rust was found at one or more water supply valves. This can indicate past leaks, or that leaks are likely to occur in the future. Recommend that a qualified plumber repair as necessary. For example, by replacing valves or fittings.

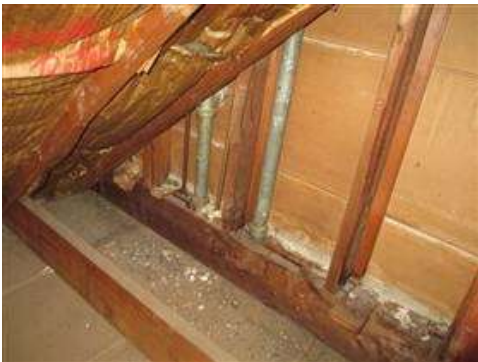
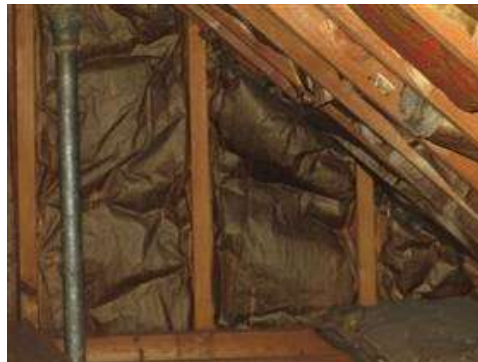
Some or all of the water supply/drain pipes were made of galvanized steel. Based on the age of this structure and the 40-60 year useful life of this piping, it will likely need replacing in the future. Leaks can develop, flooding and/or water damage may occur, flow can be restricted due to scale accumulating inside the piping, and water may be rusty. Note that it is beyond the scope of this inspection to determine what percentage of the piping is older, galvanized steel, as much of it is concealed in wall, floor and/or ceiling cavities. Recommend the following:

- That a qualified plumber evaluate to better understand or estimate the remaining life
- Consulting with a qualified plumber about replacement options and costs
- Budget for replacement in the future
- Monitor these pipes for leaks and decreased flow in the future
- Consider replacing old, galvanized steel piping proactively

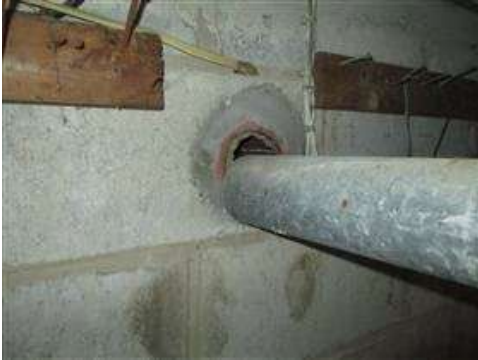
Photo 46-1

The draft hood for the water heater flue was loose. One or more flue pipe sections or connections were loose, corroded, damaged. This is a potential safety hazard due to the risk of exhaust gases entering living spaces. A qualified person should repair per standard building practices.

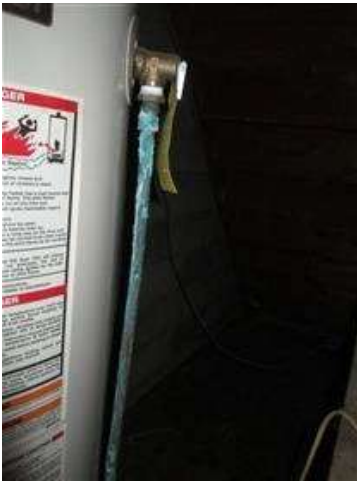
Photo 48-1

The temperature-pressure relief valve was leaking. Recommend that a qualified plumber repair as necessary. For example, by replacing the valve.

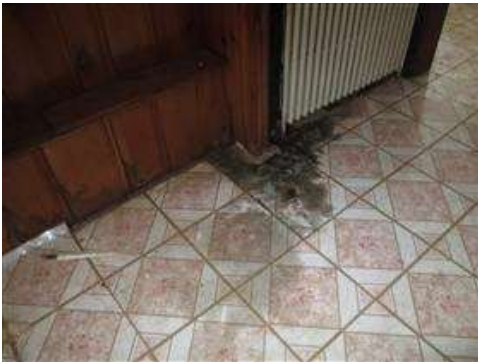
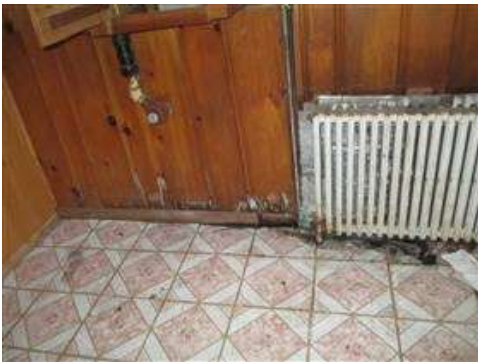
Corrosion or rust was found in one or more distribution supply pipes, valves, fittings. This can indicate past leaks, or that leaks are likely to occur in the future. Recommend that a qualified heating contractor or plumber evaluate and repair as necessary.

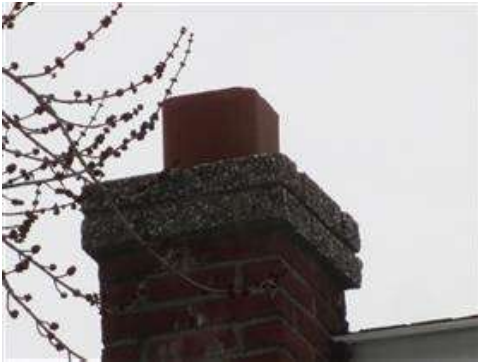
Photo 53-1

No spark screen or rain cap was installed at one or more chimney flue terminations. Spark screens reduce the chance of embers exiting the flue and causing fires. They also prevent wildlife (e.g. birds, rodents, raccoons) from entering flues. Rain caps prevent water from entering flues, mixing with combustion deposits and creating caustic chemicals which can corrode flues. They also prevent damage to masonry from freeze-thaw cycles and prevent metal components (e.g. dampers, metal firebox liners) from rusting. Recommend that a qualified person install rain caps with spark screens per standard building practices where missing.

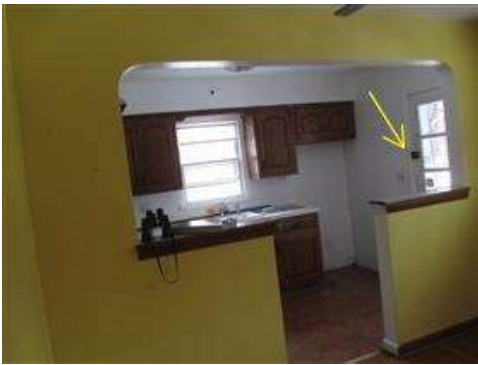
Photo 56-1

One or more exterior doors had double-cylinder deadbolts installed, where a key is required to open them from both sides. This can be a safety hazard in the event of an emergency because egress can be obstructed or delayed. Recommend replacing double-cylinder deadbolts with single-cylinder deadbolts where a handle is installed on the interior side.

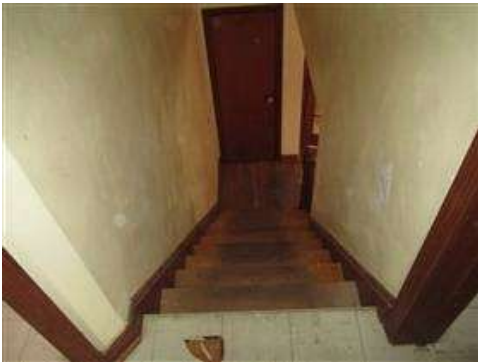
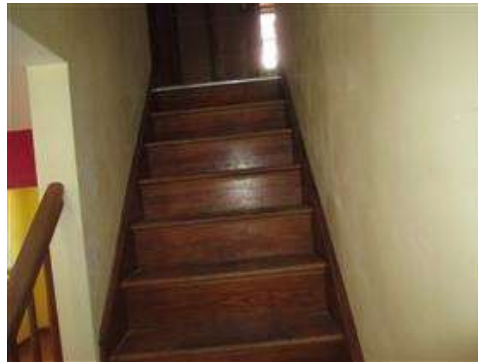
Handrails at one or more flights of stairs were missing. This is a potential fall hazard. Handrails should be installed at stairs with four or more risers or where stairs are greater than 30 inches high. Recommend that a qualified contractor install handrails where missing and per standard building practices.
