General Information

Report number: 20170903

Type of building: Single family

Age of main building: 56 yrs Built 1961

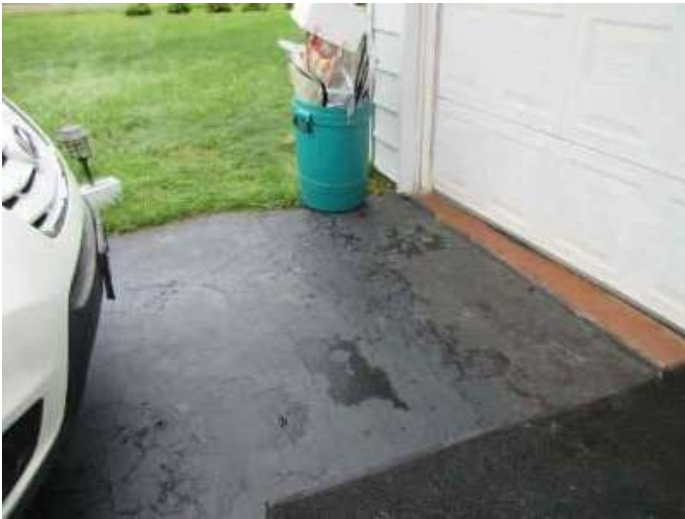
Photo 2-1

Minor deterioration (e.g. cracks, holes, settlement, heaving) was found in the driveway, but no trip hazards were found. The client may wish to have repairs made for cosmetic reasons.

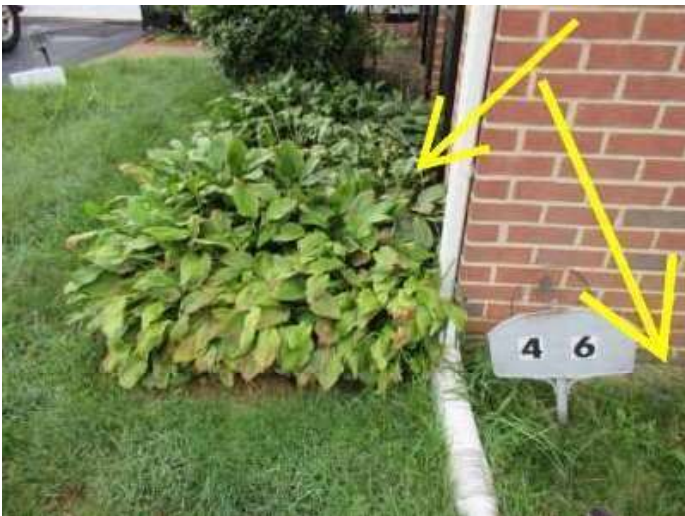
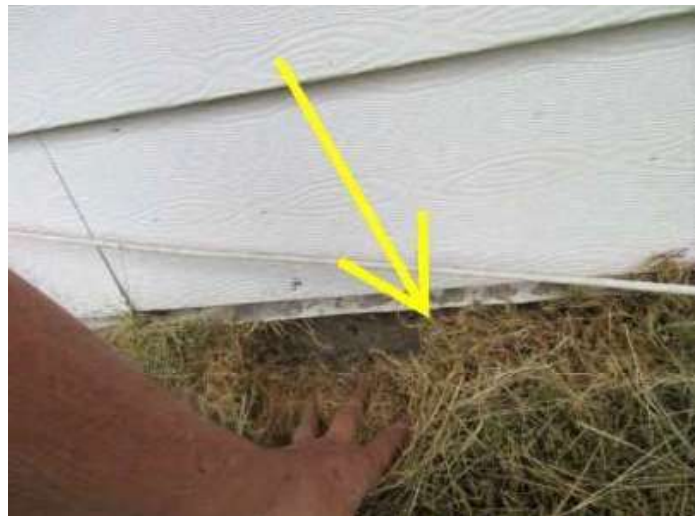
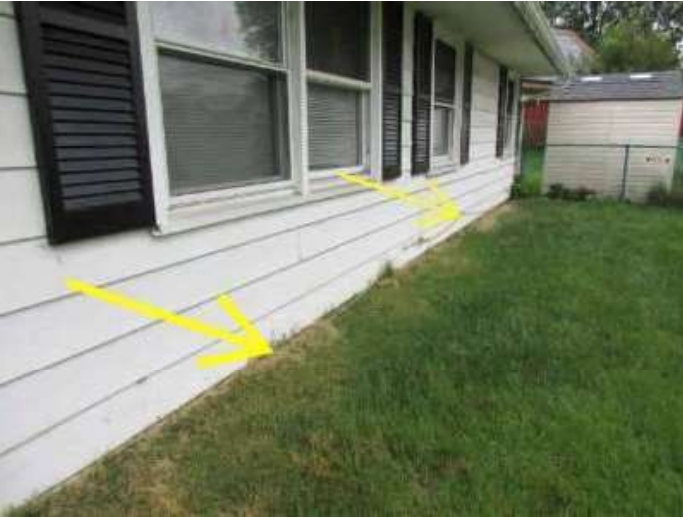
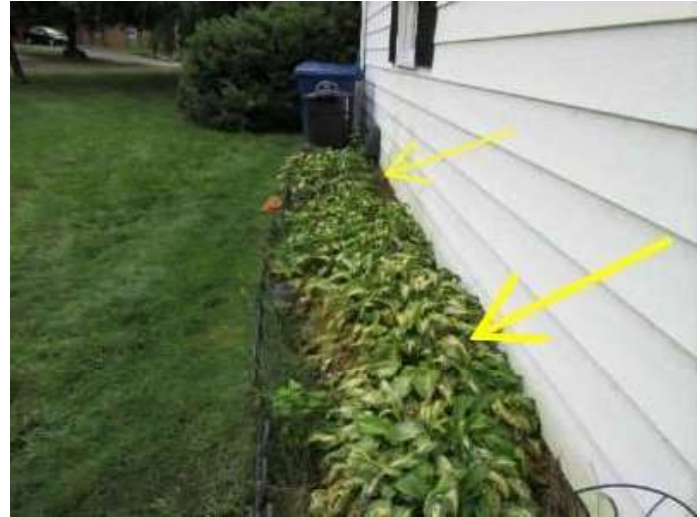
Vegetation was in contact with or close to the building exterior. Vegetation can serve as a pathway for wood-destroying insects and can retain moisture against the exterior after it rains. This is a conducive condition for wood-destroying organisms. Recommend pruning, moving or removing vegetation as necessary to maintain at least 6 inches of space between it and the building exterior. A 1-foot clearance is better.

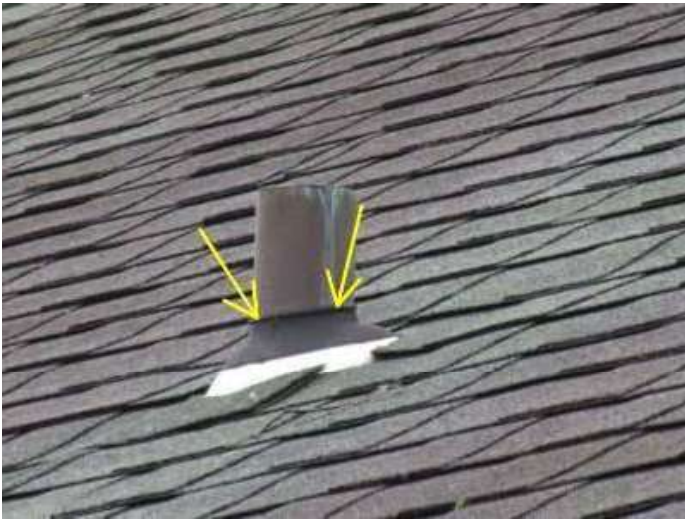
Photo 4-1

One or more rubber or neoprene pipe flashings were split or cracked. Leaks can occur as a result. This is a conducive condition for wood-destroying organisms. Recommend that a qualified contractor replace flashings where necessary.

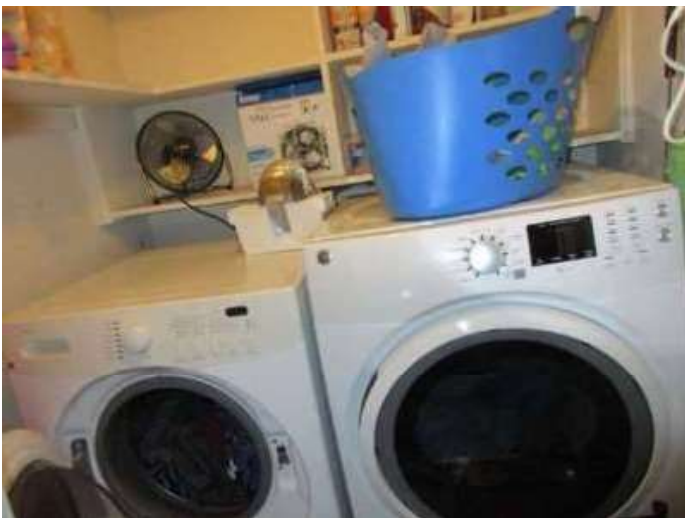
Photo 5-1

Attic access point #B was inaccessible because laundry machines were blocking it. These areas were not evaluated and are excluded from this inspection.

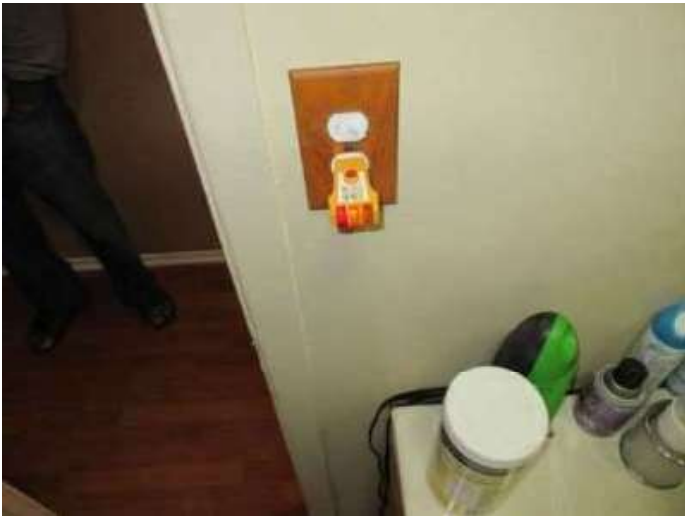
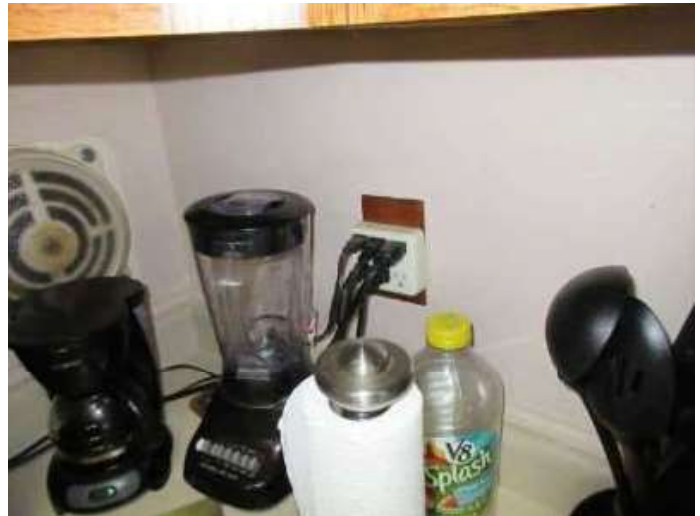
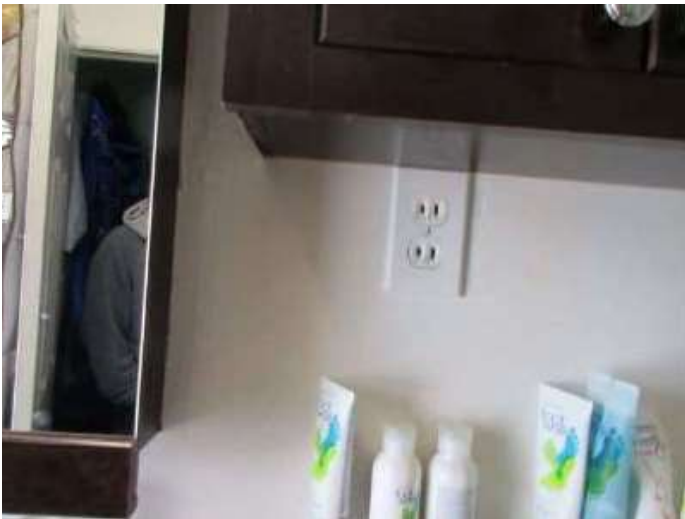
One or more electric receptacles (outlets) at the kitchen and/or bathroom(s) had no visible ground fault circuit interrupter (GFCI) protection, or the inspector was unable to determine if GFCI protection was present. If not GFCI-protected, receptacles in wet areas pose a shock hazard. Recommend that a qualified electrician evaluate and install GFCI protection if necessary and per standard building practices. General guidelines for GFCI-protected receptacles include the following locations:

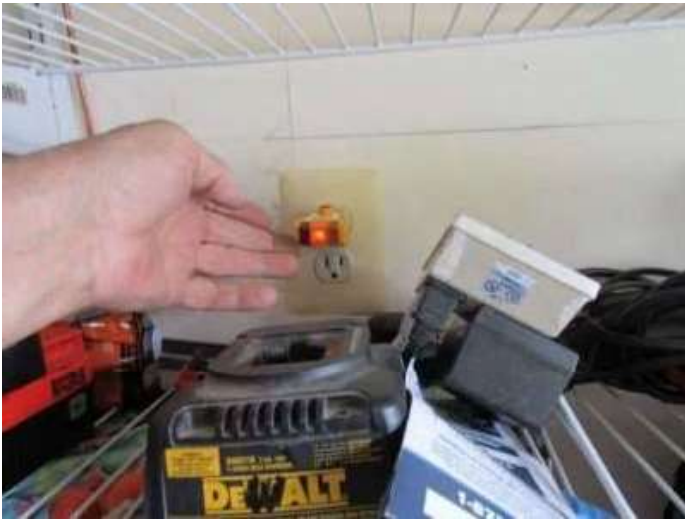
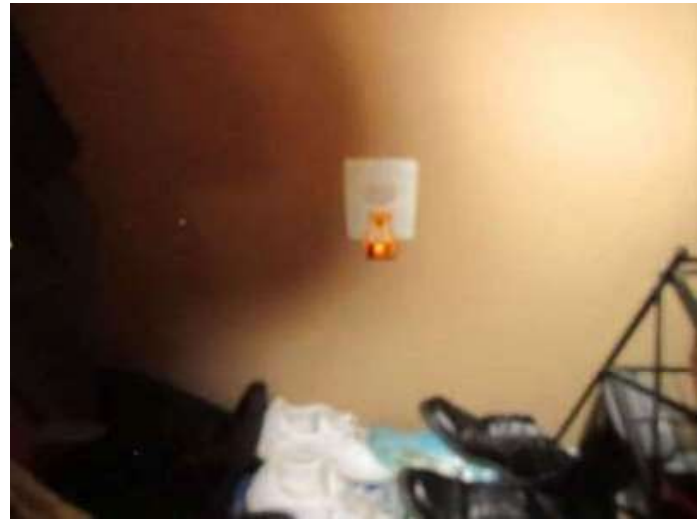
One or more electric receptacles (outlets) had reverse-polarity wiring, where the hot and neutral wires were reversed. This is a shock hazard. Recommend that a qualified electrician repair as necessary. For more information, visit:

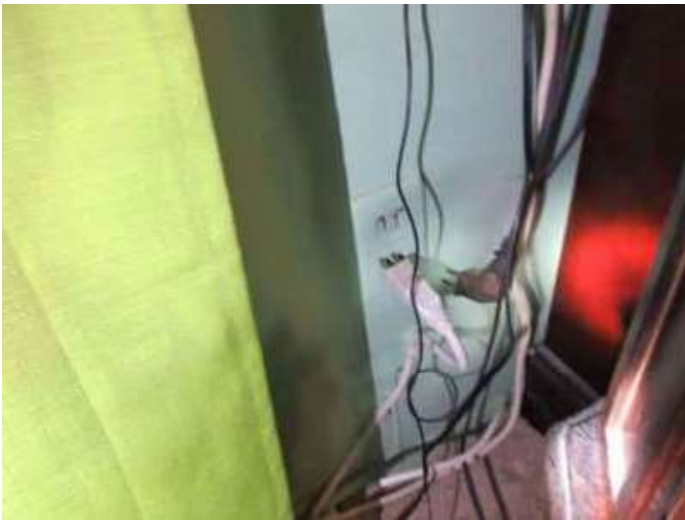
Photo 10-1

2-slot receptacles (outlets) rather than 3-slot, grounded receptacles were installed in one or more areas. These do not have an equipment ground and are considered unsafe by today's standards. Appliances that require a ground should not be used with 2-slot receptacles. Examples of such appliances include computers and related hardware, refrigerators, freezers, portable air conditioners, clothes washers, aquarium pumps, and electrically operated gardening tools. The client should be aware of this limitation when planning use for various rooms, such as an office. Upgrading to grounded receptacles typically requires installing new wiring from the main service panel or sub-panel to the receptacle(s), in addition to replacing the receptacle(s). Consult with a qualified electrician about upgrading to 3-wire, grounded circuits.

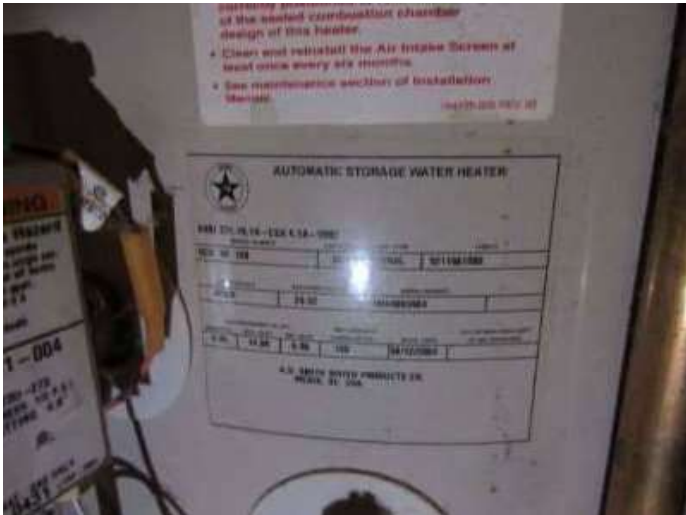
Photo 11-1

The estimated useful life for most water heaters is 8-12 years. This water heater appeared to be near this age and/or its useful lifespan and may need replacing at any time. Recommend budgeting for a replacement in the near future, or considering replacement now before any leaks occur. The client should be aware that significant flooding can occur if the water heater fails. If not replaced now, consider having a qualified person install a catch pan and drain or a water alarm to help prevent damage if water does leak.

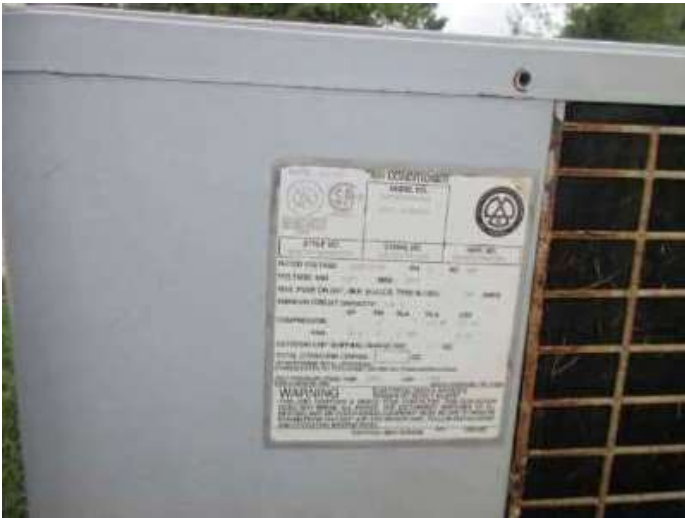
Photo 12-1

The estimated useful life for most heat pumps and air conditioning condensing units is 10-15 years. This unit, while still working, appeared to be beyond this age and/or its useful lifespan and may need replacing or significant repairs at any time. Recommend budgeting for a replacement in the near future.

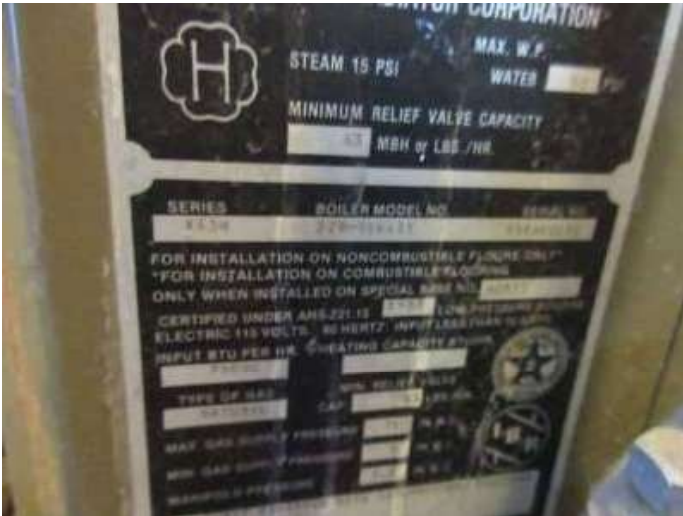
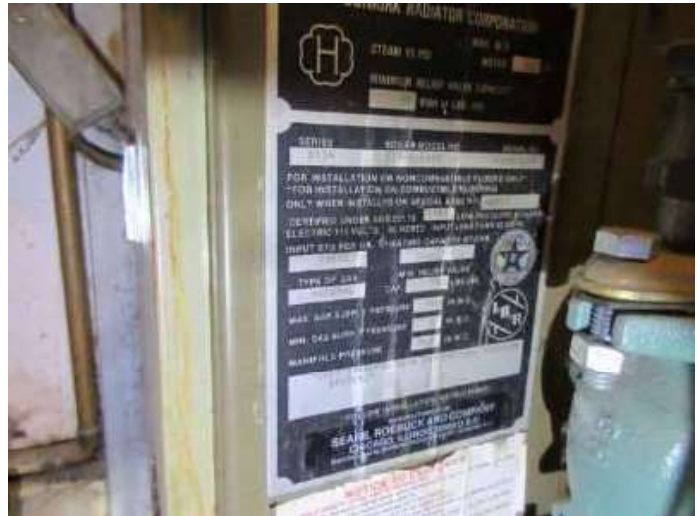
The estimated useful life for most cast iron boilers is 30 years. This boiler, while still working, appeared to be near this age and/or its useful lifespan and may need replacing or significant repairs at any time. Recommend budgeting for a replacement in the near future.

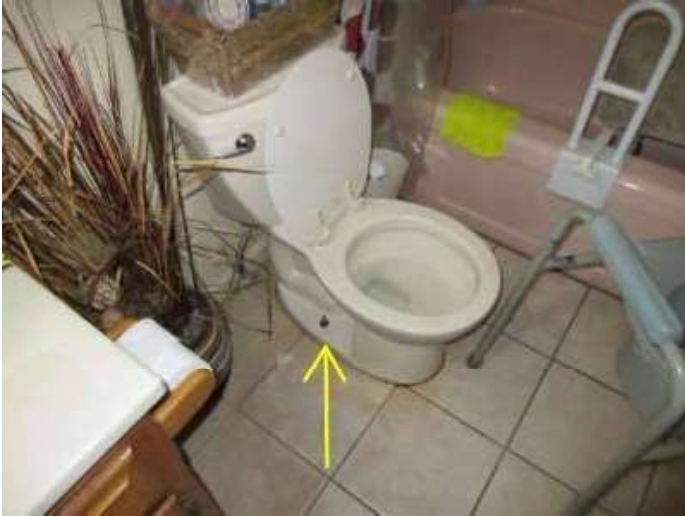
**Photo 18-1**

The toilet at location #A was loose where it attached to the floor. Leaks can occur. Flooring, the subfloor or areas below may get damaged. Sewer gases can enter living spaces. Recommend that a qualified contractor remove the toilet(s) for further evaluation and repair if necessary. A new wax ring should be installed and toilet(s) should be securely anchored to the floor to prevent movement and leaking.

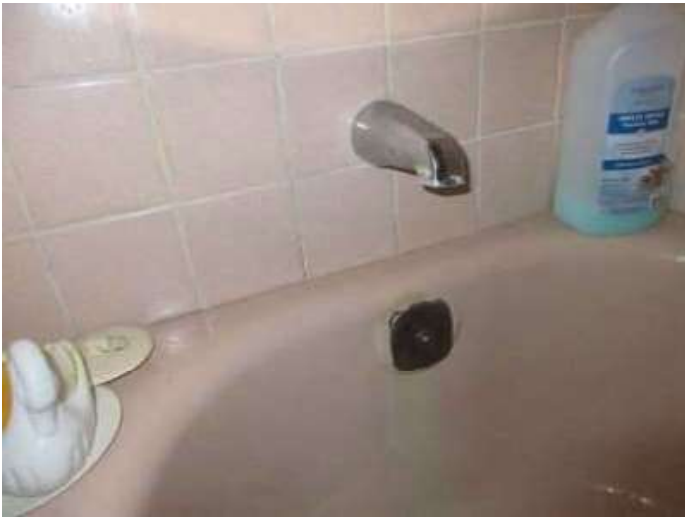
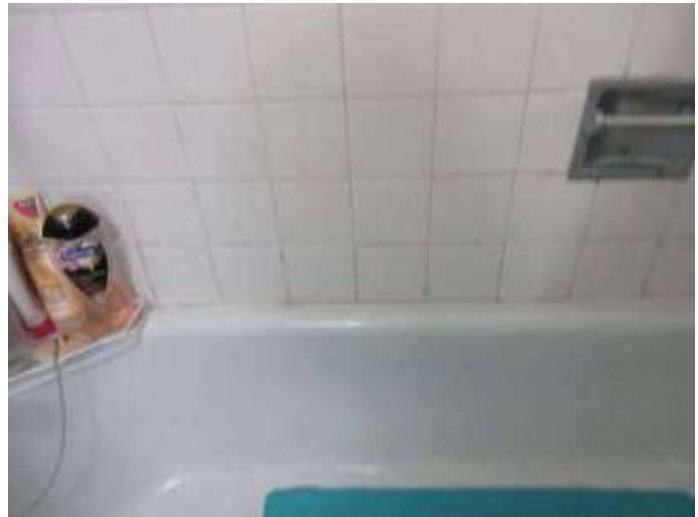
Gaps, no caulk, or substandard caulking were found between the bathtub and the walls at location(s) #A and B. Water may penetrate these areas and cause damage. Recommend that a qualified person re-caulk or install caulking as necessary.

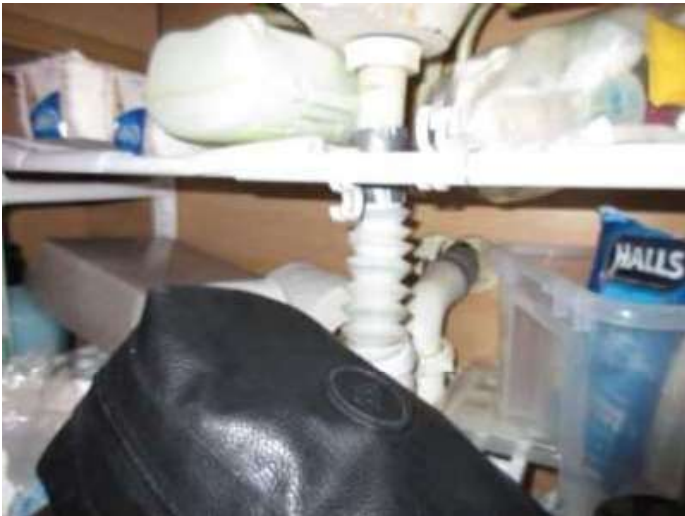
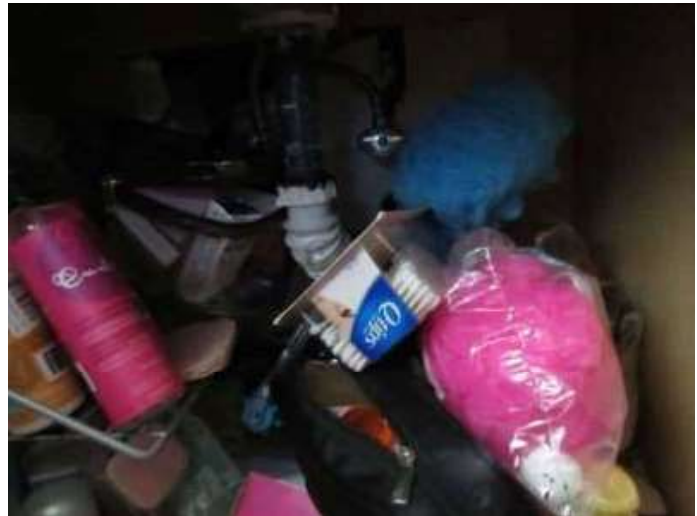
Substandard repairs were found at the sink drain at location(s) #A and B (e.g. tape, sealant, non-standard components). Recommend that a qualified plumber repair per standard building practices.
