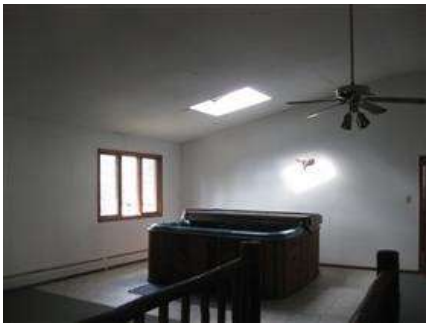
Photo 85

A hot tub was installed. Hot tubs, related equipment and supply hookups are specialty systems and are excluded from this inspection. Comments in this report related to this system are made as a courtesy only and are not meant to be a substitute for a full evaluation by a qualified specialist. Regular maintenance is required, and safety issues may exist. Recommend that a qualified specialist evaluate and, if needed, maintain or repair.

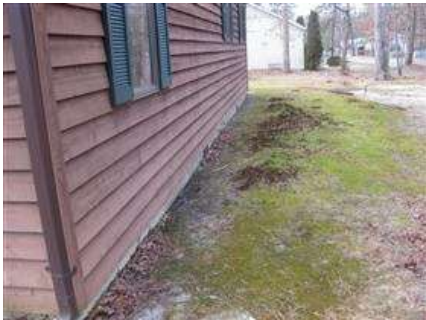
Photo 19

The soil or grading sloped down towards building perimeters in one or more areas. This can result in water accumulating around building foundations or underneath buildings. It is a conducive condition for wood-destroying organisms. Recommend grading soil so it slopes down and away from buildings with a slope of at least 1 inch per horizontal foot for at least 6 feet out from buildings.

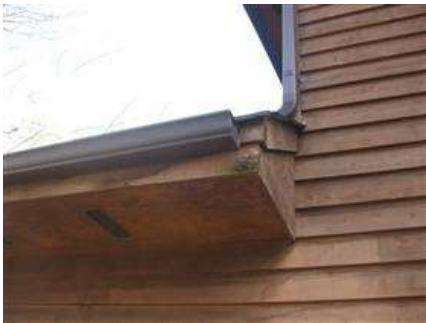
Photo 23

Some sections of siding and/or trim were deteriorated, damaged. Recommend that a qualified person repair, replace or install siding or trim as necessary.

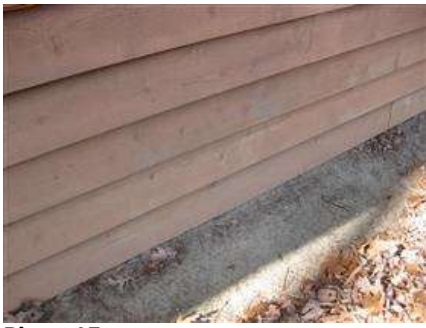
Photo 15

Soil was in contact with or less than 6 inches from siding, trim or structural wood. This is a conducive condition for wood-destroying organisms. Recommend grading or removing soil as necessary to maintain a 6-inch clearance. If not possible, then recommend replacing untreated wood with pressure-treated wood. Installation of borate-based products such as Impel rods can also reduce the likelihood of rot or infestation if soil cannot be removed. Note that damage from fungal rot and/or insects may be found when soil is removed, and repairs may be necessary.

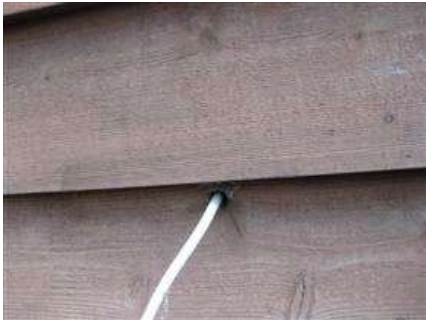
Photo 24

Caulk was missing in some areas. For example, at wall penetrations. Recommend that a qualified person renew or install caulk as necessary. Where gaps are wider than 1/4 inch, an appropriate material other than caulk should be used. For more information, visit: [http://www.reporthost.com/docs/FPL\\_Caulking\\_Ins\\_Out.pdf](http://www.reporthost.com/docs/FPL_Caulking_Ins_Out.pdf)

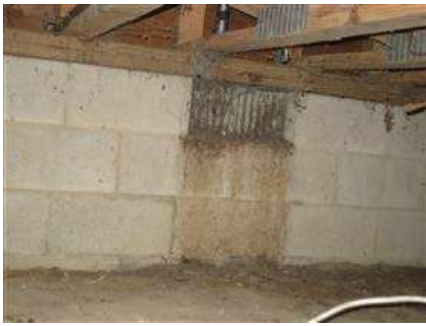
Evidence of prior water intrusion or accumulation was found in one or more sections of the crawl space. For example, sediment stains on the vapor barrier or foundation, and/or efflorescence on the foundation. Accumulated water is a conducive condition for wood-destroying organisms and should not be present in the crawl space. Recommend that the client review any disclosure statements available and ask the property owner about past accumulation of water in the crawl space. The crawl space should be monitored in the future for accumulated water, especially after heavy and/or prolonged periods of rain. If water is found to accumulate, then recommend that a qualified contractor who specializes in drainage issues evaluate and repair as necessary. Typical repairs for preventing water from accumulating in crawl spaces include:

**Photo 34**  
East side

- Repairing, installing or improving rain run-off systems (gutters, downspouts and extensions or drain lines)
- Improving perimeter grading
- Repairing, installing or improving underground footing and/or curtain drains

Ideally, water should not enter crawl spaces, but if water must be controlled after it enters the crawl space, then typical repairs include installing trenches, gravity drains and/or sump pump(s) in the crawl space.

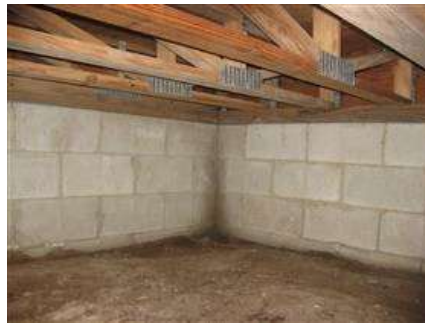
**Photo 37**  
Northeast corner

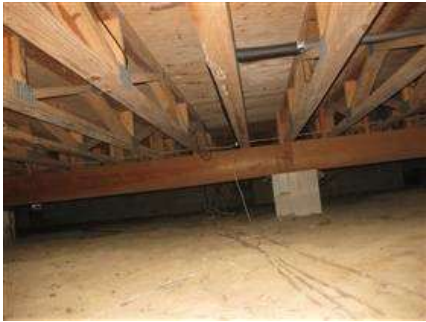
**Photo 31**

No vapor barrier was installed in the crawl space. This is a conducive condition for wood-destroying organisms due to the likelihood of water evaporating from the soil below up into the structure. A 6 mil black plastic sheet should be placed over all exposed soil with seams overlapped to 24 inches, and not in contact with any wood structural components. The sheeting should be held in place with bricks or stones, not wood. Recommend that a qualified contractor install a vapor barrier per standard building practices.

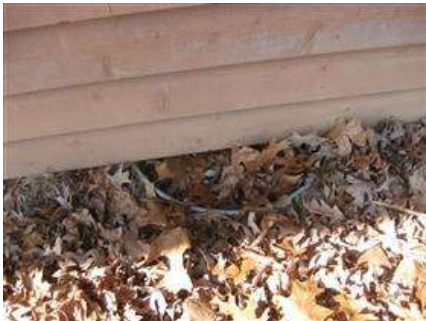
**Photo 16**

One or more crawl space vents were blocked by debris. This restricts ventilation in the crawl space and can result in increased levels of moisture inside. This is a conducive condition for wood-destroying organisms. Materials or items blocking vents should be removed as necessary.

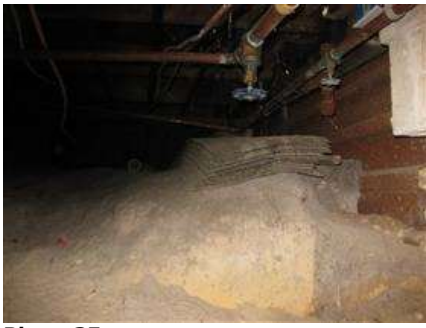
Photo 35

Some sections of the crawl space at location were not evaluated due to lack of access because the vertical height was under 18 inches, ducts or pipes were blocking.

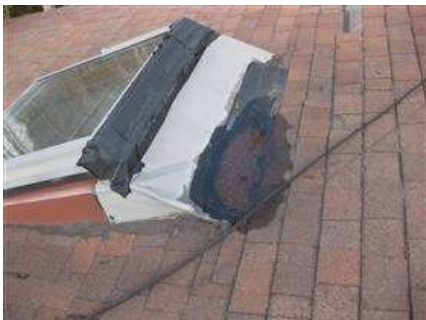
Photo 4

The skylight appeared to have an active leak. This is a conducive condition for wood-destroying organisms. Recommend that a qualified contractor evaluate and repair as necessary.

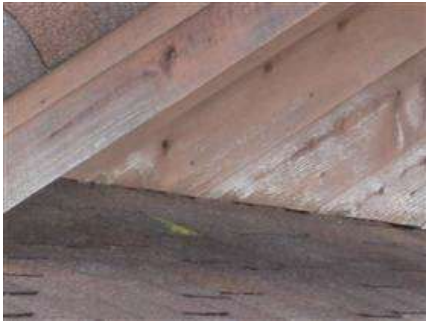
Photo 12

The siding on one or more exterior walls was in contact with or too close to roof surfaces below. This is a conducive condition for wood-destroying organisms. There should be a gap of 1 1/2 to 2 inches between a roof surface and siding above. The gap is meant to prevent water from wicking up into the bottom edge of the siding and causing fungal rot, or damaging the siding. There may also be inadequate space for additional layers of roofing materials in the future. Recommend that a qualified contractor repair per standard building practices. For example, by trimming the siding.

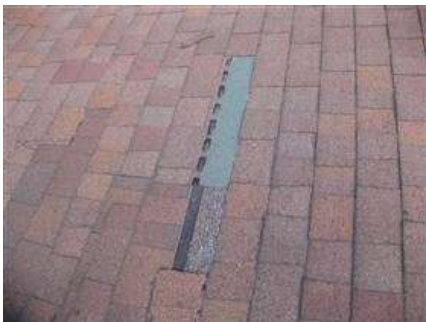
Photo 7

Some composition shingles were missing, damaged. Leaks can occur as a result. This is a conducive condition for wood-destroying organisms. Recommend that a qualified contractor repair as necessary. For example, by replacing shingles.

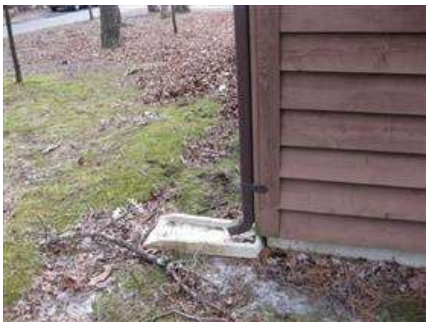
Photo 18

Extensions such as splash blocks or drain pipes for one or more downspouts were poorly sloped. Water can accumulate around the building foundation or inside crawl spaces or basements as a result. Recommend that a qualified person install, replace or repair extensions as necessary so rainwater drains away from the structure.

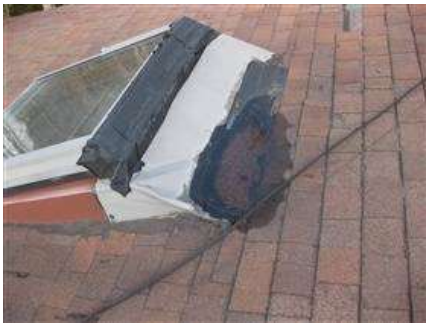
Photo 4

One or more roof flashings were substandard. Leaks can occur as a result. This is a conducive condition for wood-destroying organisms. Recommend that a qualified person repair as necessary.

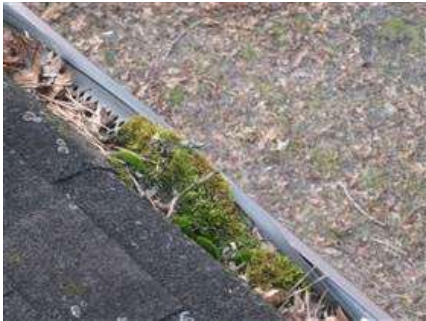
Photo 9

Significant amounts of debris have accumulated in one or more gutters or downspouts. Gutters can overflow and cause water to come in contact with the building exterior, or water can accumulate around the foundation. This is a conducive condition for wood-destroying organisms. Recommend cleaning gutters and downspouts now and as necessary in the future.

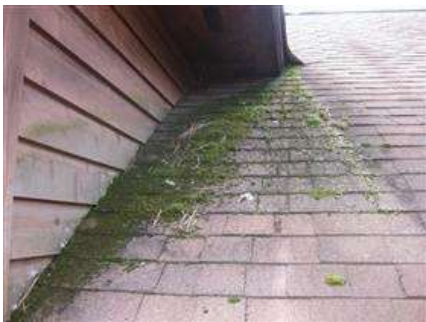
Photo 2

Moss was growing on the roof. As a result, shingles can lift or be damaged. Leaks can result and/or the roof surface can fail prematurely. Efforts should be made to kill the moss during its growing season (wet months). Typically, zinc or phosphate-based chemicals are used for this and must be applied periodically. For information on various moss treatment products and their pros and cons, visit:

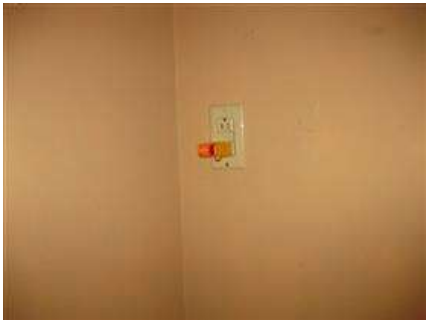
One or more ground fault circuit interrupter (GFCI) receptacles (outlets) wouldn't trip at the bathroom(s). This is a potential shock hazard. Recommend that a qualified electrician evaluate and repair as necessary.

**Photo 82**  
2nd floor bathroom

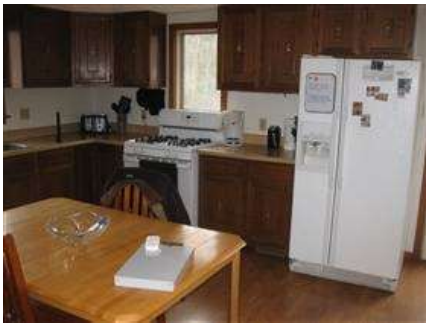
**Photo 102**

One or more electric receptacles (outlets) at the kitchen and the 1st floor bathroom (with shower only) had no visible ground fault circuit interrupter (GFCI) protection. If not GFCI-protected, receptacles in wet areas pose a shock hazard. Recommend that a qualified electrician evaluate and install GFCI protection if necessary and per standard building practices. General guidelines for GFCI-protected receptacles include the following locations:

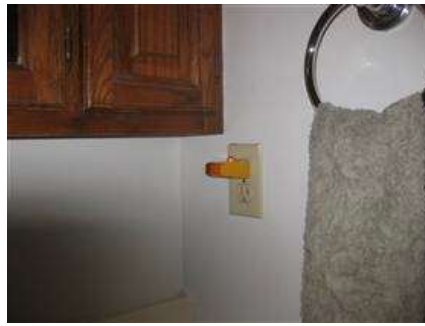
**Photo 95**  
1st floor 3/4 bath

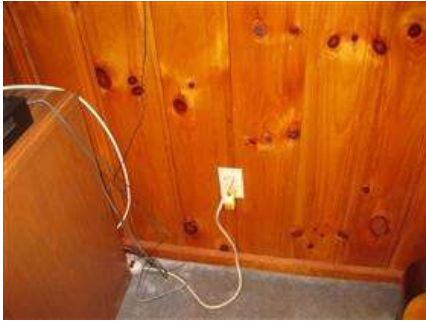
One or more electric receptacles (outlets) and/or the boxes in which they were installed were loose and/or not securely anchored. Wire conductors can be damaged due to repeated movement and/or tension on wires, or insulation can be damaged. This is a shock and fire hazard. Recommend that a qualified electrician repair as necessary.

**Photo 53**  
Living Room

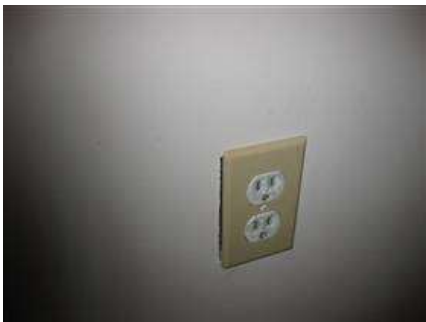
One or more cover plates for switches, receptacles (outlets) or junction boxes were missing, broken or undersized. These plates are intended to contain fire and prevent electric shock from occurring due to exposed wires. Recommend that a qualified person install cover plates where necessary.

**Photo 69**  
Master Bedroom

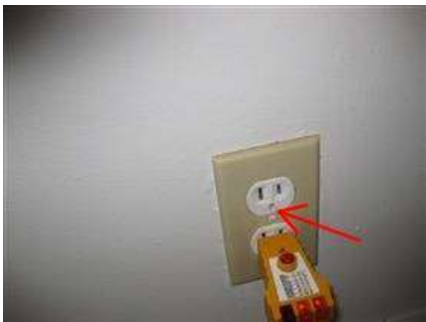
One or more receptacles (outlets) had a prong from a plug broken off in a slot, or slot(s) were clogged with foreign objects. Recommend that a qualified electrician replace such receptacles as necessary.

**Photo 67**  
Front North Bedroom

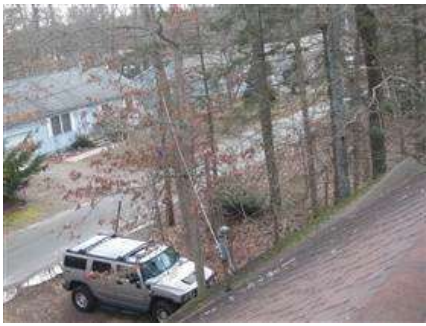
Photo 13

The service drop wires were in contact with trees or vegetation. This can result in damage to wiring insulation or broken wires during high winds. Recommend pruning trees or vegetation as necessary. The utility company may prune trees at no charge.

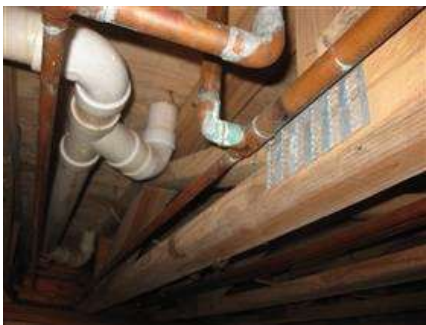
Photo 32

Significant corrosion was found in some water supply pipes or fittings. Leaks can occur as a result. Recommend that a qualified plumber evaluate and replace components as necessary.

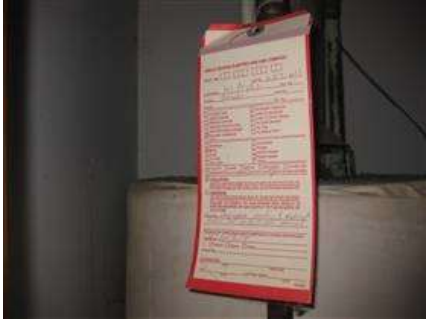
Photo 47

Red Tagged by PSE&G for improper venting and materials

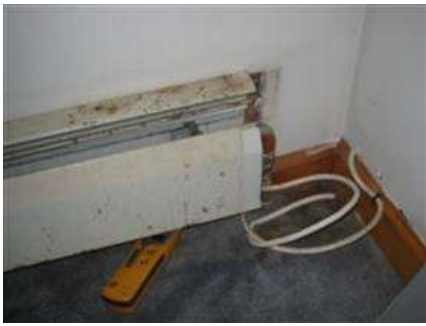
Corrosion or rust was found in one or more distribution supply pipes, fittings. This can indicate past leaks, or that leaks are likely to occur in the future. Recommend that a qualified heating contractor or plumber evaluate and repair as necessary.

**Photo 41**  
Front room near electric circuit box

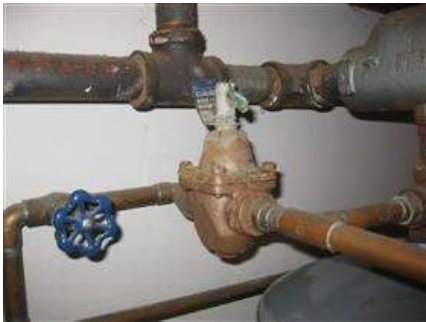
**Photo 45**

37) 🔧🔍 Corrosion or rust was found in one or more fittings or valves. Recommend that a qualified heating contractor or plumber evaluate and repair as necessary.

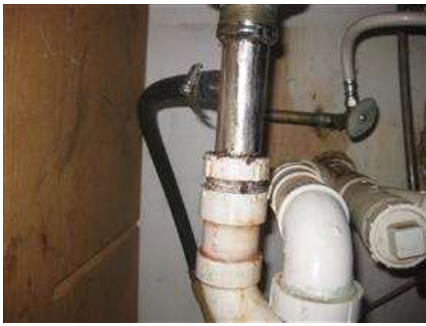
Photo 99

38) 🔧💧 One or more sink drains were leaking. A qualified plumber should repair as necessary.

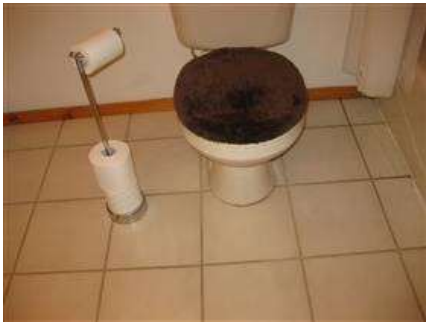
The toilets at locations #A & D were loose where it attached to the floor. Leaks can occur. Flooring, the subfloor or areas below may get damaged. Sewer gases can enter living spaces. Recommend that a qualified contractor remove the toilets for further evaluation and repair if necessary. A new wax ring should be installed and toilets should be securely anchored to the floor to prevent movement and leaking.

Photo 75  
Master bath

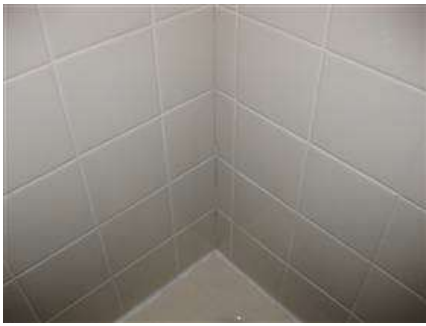
Tile and/or grout in the bathtub surround at location #B was deteriorated (e.g. loose or cracked tiles, missing grout) or substandard. Water can damage the wall structure as a result. Recommend that a qualified contractor repair as necessary.

**Photo 76**  
1st floor Fulll bath

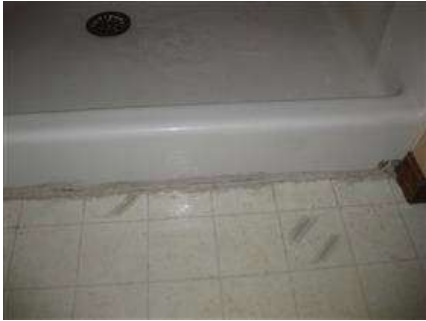
42) 🛠️💧 Gaps, no caulk, or substandard caulking were found between the shower enclosure and the floor at locations #C & D. Water can penetrate these areas and cause damage. Recommend that a qualified person re-caulk or install caulking as necessary.

**Photo 93**  
2nd floor 3/4/ bath

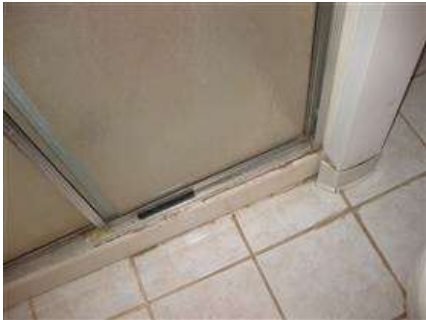
43) 🛠️💧 Water leaked from gaps at the shower door at location #D when the shower was operated. Recommend that a qualified person repair as necessary.

**Photo 97**  
1st floor 3/4 bath

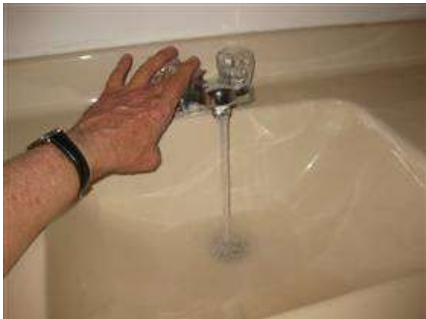
44) 🛠️ The sink drain stopper mechanisms at locations #B & C were inoperable. Recommend that a qualified person repair or replace as necessary.

**Photo 78**  
1st floor full bath

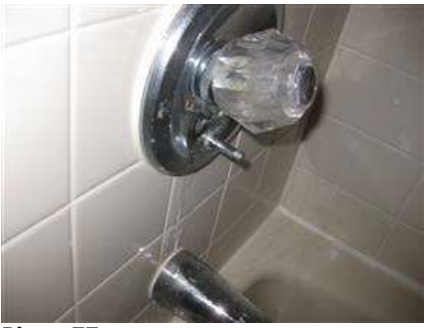
45) 🛠️ The bathtub faucet at location #B leaked when operated. Recommend that a qualified plumber repair as necessary.

**Photo 77**  
1st floor full bath

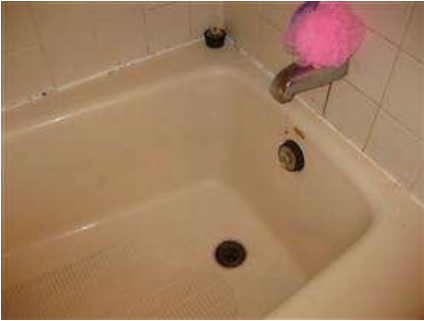
The bathtub drain stopper and overflow mechanism at location #A was missing. Recommend that a qualified person repair or replace as necessary.

**Photo 74**  
Master bath

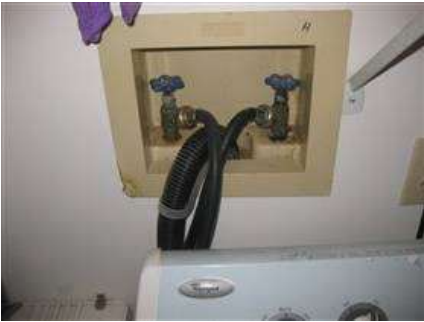
**Photo 63**

Rubber water supply hoses were installed at the clothes washer. These hoses are prone to bursting when deteriorated, which can result in flooding and significant water damage. Recommend upgrading to braided, stainless steel hoses.

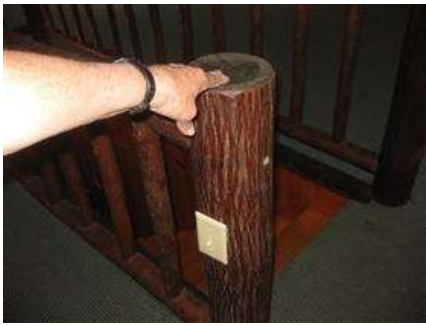
Guardrails at one or more locations with drop-offs higher than 30 inches were loose, and pose a fall hazard. Recommend that a qualified person repair guardrails as necessary.

**Photo 86**  
2nd floor

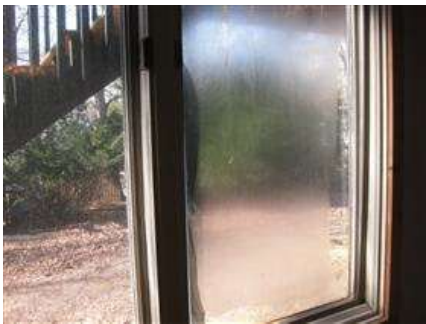
Be aware that evidence of failed seals or desiccant may be more or less visible depending on the temperature, humidity, sunlight, etc. Windows or glass-paneled doors other than those that the inspector identified may also have failed seals and need glass replaced. It is beyond the scope of this inspection to identify every window with failed seals or desiccant.

**Photo 61**  
1st floor rear bedroom

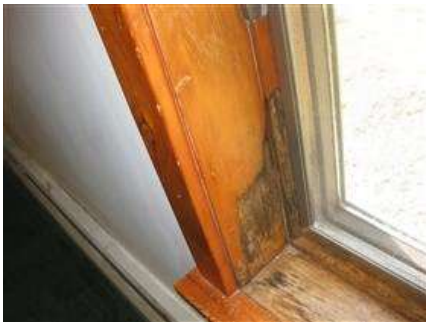
Water stains or evidence of leaking was found at one or more windows. Recommend that a qualified contractor evaluate and repair as necessary.

**Photo 71**  
Master bedroom

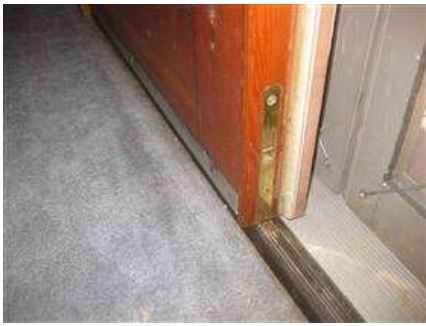
Some exterior door hardware, including latches were damaged. Recommend that a qualified person repair or replace as necessary.

**Photo 43**  
Pin on bottom of double door.

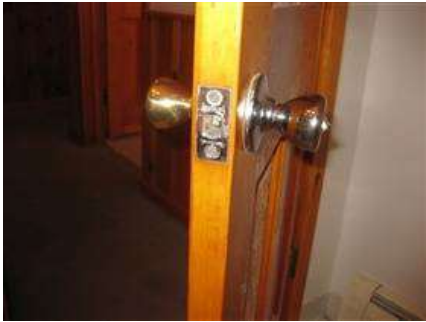
Some interior door hardware (locksets) were damaged. Recommend that a qualified person repair or replace as necessary.

**Photo 98**  
1st floor 3/4 bath

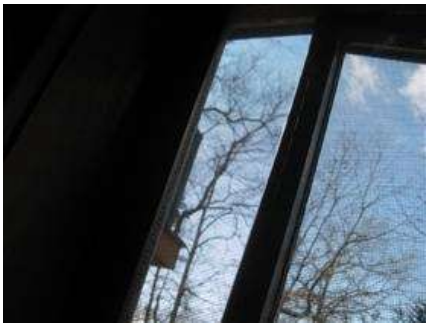
One or more windows that were designed to open and close were difficult to open and close. Recommend that a qualified person repair windows as necessary so they open and close easily.

**Photo 72**  
Master bedroom. Off track.

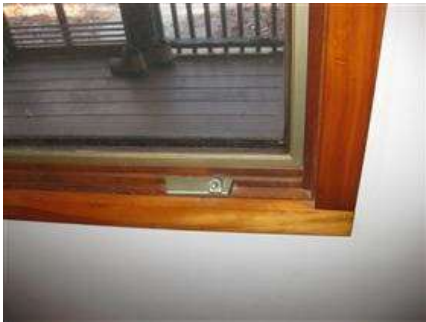
**Photo 57**

Crank handles at some windows were missing, stripped, loose, broken. Recommend that a qualified person replace handles or make repairs as necessary.

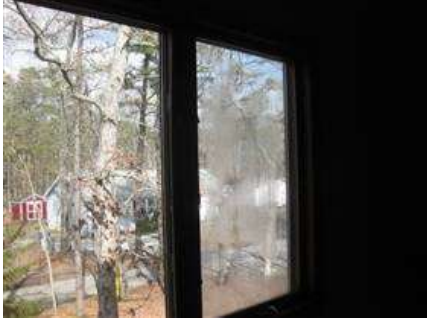
**Photo 80**

Glass in one or more windows was cracked, broken and/or missing. Recommend that a qualified contractor replace glass where necessary.

2nd floor north bedroom

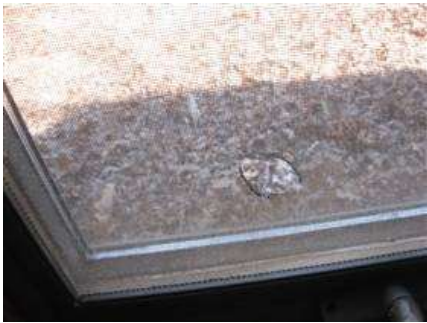
**Photo 52**

One or more window screens were damaged or deteriorated. These window(s) may not provide ventilation during months when insects are active. Recommend replacing window screens as necessary.

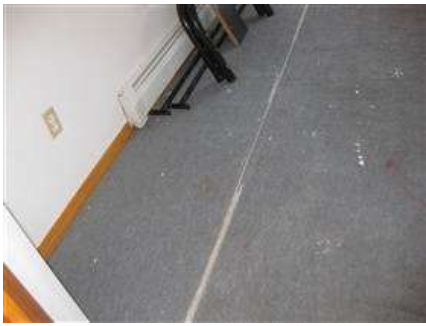
**Photo 65**

Carpeting in one or more areas was damaged or deteriorated. Recommend that a qualified contractor replace as necessary.

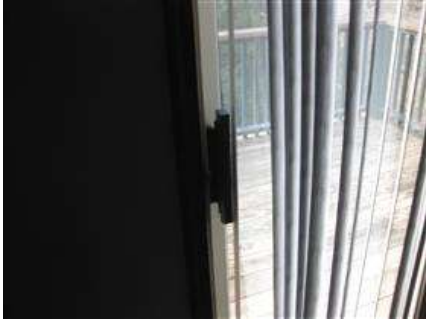
**Photo 92**

Second floor sliding glass doors were difficult to open or close. Recommend that a qualified person maintain, repair or replace door(s) as necessary. Often, cleaning the track and applying a lubricant will help.

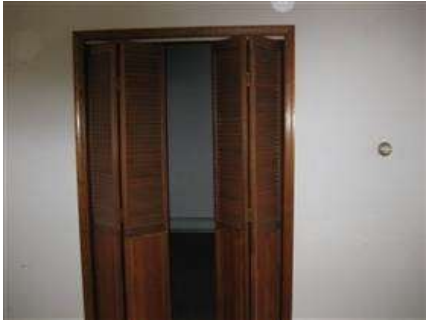
**Photo 83**

Second floor bi-fold doors were off their track(s) or difficult to operate. Recommend that a qualified person repair as necessary.

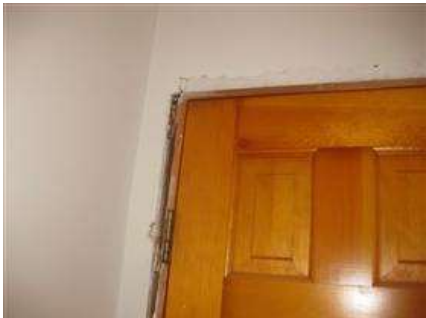
**Photo 59**

Trim was missing in one or more areas. Recommend that a qualified person repair as necessary.

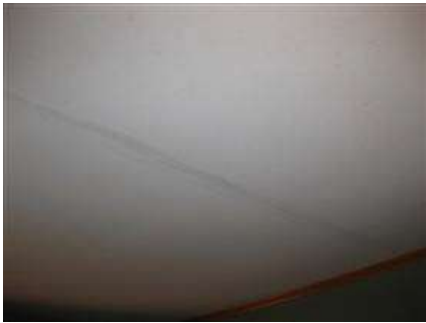
**Photo 50**

**64)** 🔍 Patches or evidence of prior repairs were found in one or more ceilings. Recommend asking the property owner about the repairs (e.g. why necessary, whether prior leaks have occurred).

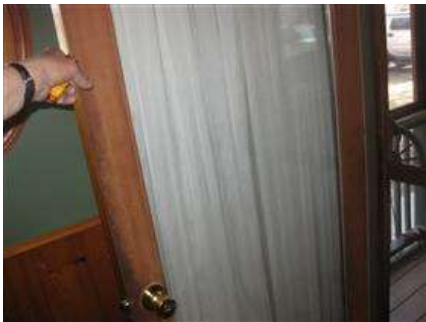
**65)** ⓘ One or more hinged exterior doors had no deadbolt lock installed and relied solely on the entry lockset for security. Recommend installing locksets on exterior doors where missing for added security.

**Photo 51**  
Front door

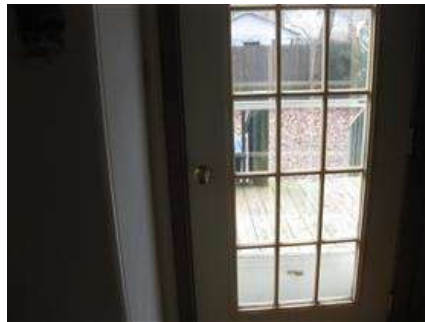
**Photo 103**  
Kitchen door.

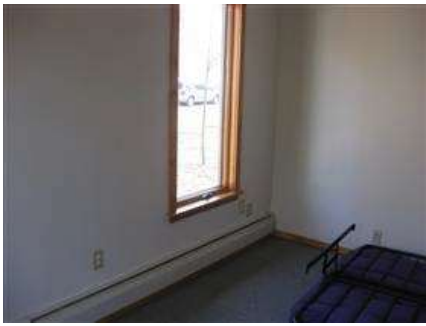
**66)** ⓘ Screens were missing from some windows. These windows may not provide ventilation during months when insects are active.

**Photo 66**  
Front North bedroom
