## CASE STUDY

### Birchwood 33 renovation

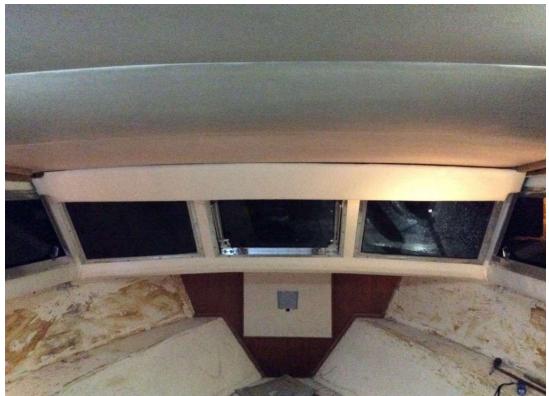
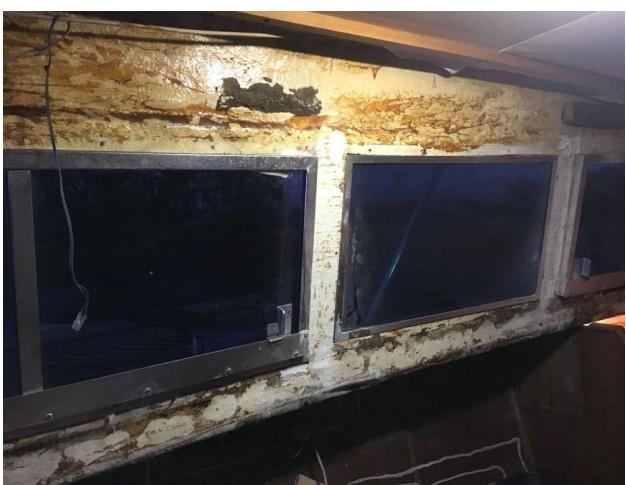
Whilst working on renovating his Birchwood 33, Simon Butler of Boat-Shift Marine Transport Ltd, noticed several leaks from windows in the front cabin. Upon stripping out the linings, it became clear that he had a few issues to deal with. First, the fixed windows appeared to have rubber seal degradation.

He spent 4 hours taking the port side mid cabin window out of the boat to strip and replace the seal. Luckily there was no grp damage but it was difficult to remove. This

window was stripped down and the rubber seal replaced using an extrusion from Seals-Direct. Once this was done he refitted it to the boat.

He started by doing the inside first, that way when the inside was done and he moved to do outside, he removed the film, cut out all the old rubber trim and re-sealed it in one go, without any risk of trapping water.

To help ease the removal of the rubber he used a very long handle adjustable blade knife and a hack saw blade with a hook ground out of one of the holes in the end.

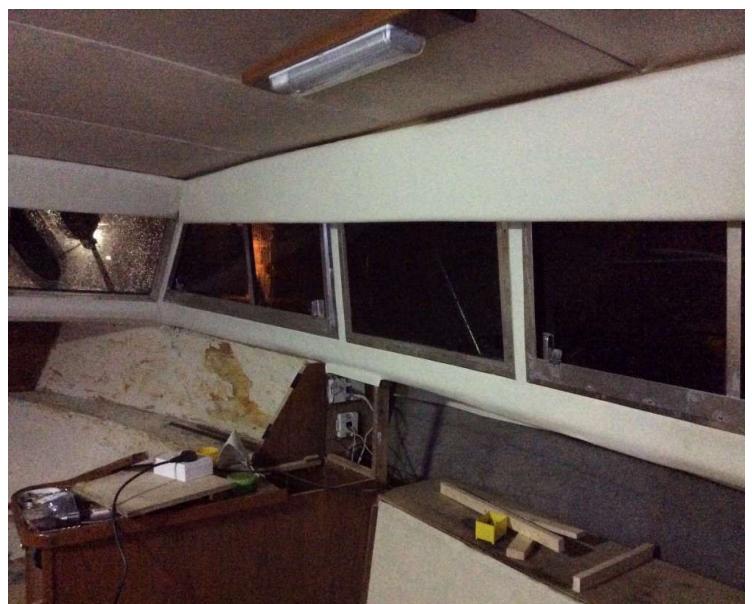
However, the water ingress had damaged the soft linings and timber supports so Simon stripped off all the linings. This meant taking out all the window inter-screws to remove the lining. Doing this revealed another problem. This boat has window covers made with turnbuckle fasteners. These fasteners had been riveted to the superstructure.... in the middle of the rivets was a little hole. This is where a lot of the water ingress originated! These were ground back and filled with gelcoat. *(These would be aircraft style rivets where the mandrel pulls through the hole expanding the rivet into place but leaving a hole. Break stem rivets - 'Pop' - will leave the mandrel [nail] in place.)*

All the window areas were cleaned off and retrimmed in foam backed vinyl, together with the ceiling lining under the V berth. Curtain pelmets were retrimmed in leather to match and all refitted.

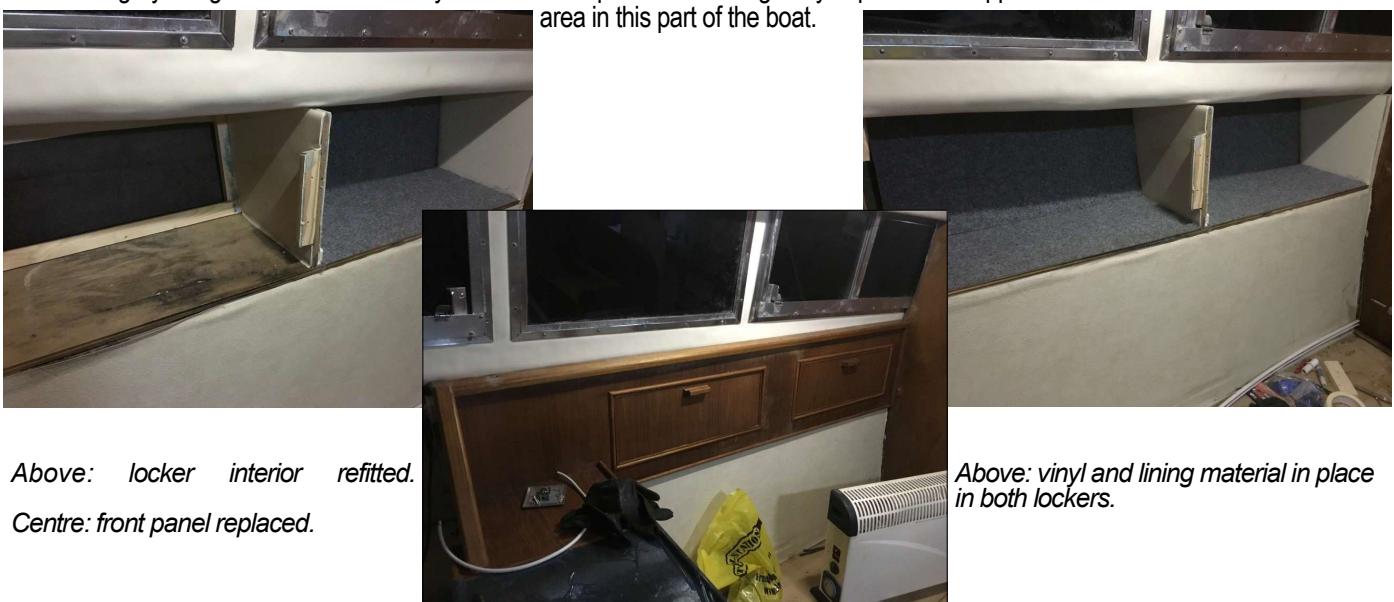
On the starboard side where the galley is usually situated on a Birchwood 33, Simon has a small sofa. Behind and above this is a panel with two drop down locker doors. These were not fitting correctly with the front panel being poorly installed and the leaking windows having damaged some of the wooden fixing supports.

Above: locker interior refitted.

Centre: front panel replaced.

Above: vinyl and lining material in place in both lockers.

Simon replaced the damaged timbers and refitted the locker separating the bulkhead. He then trimmed them out with foam backed vinyl and some grey lining material and securely fitted the front panel. This has greatly improved the appearance and usefulness of the locker area in this part of the boat.

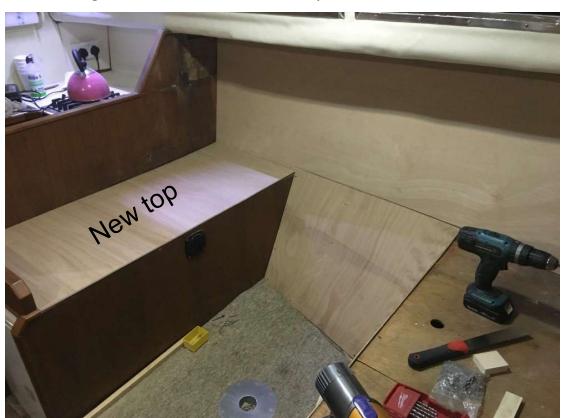
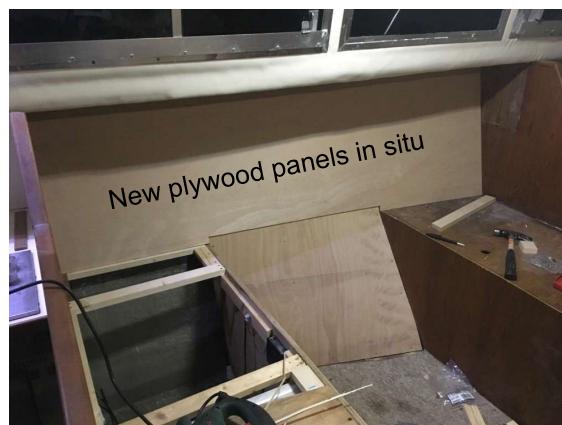
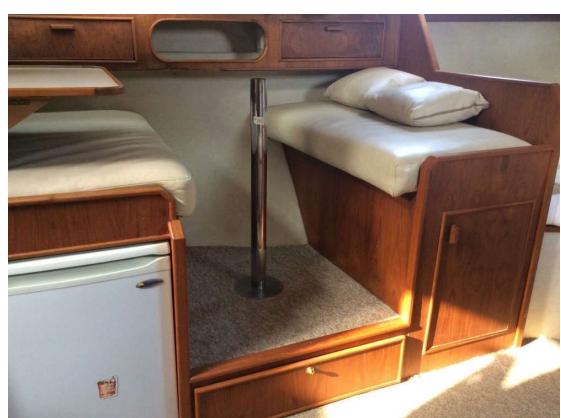
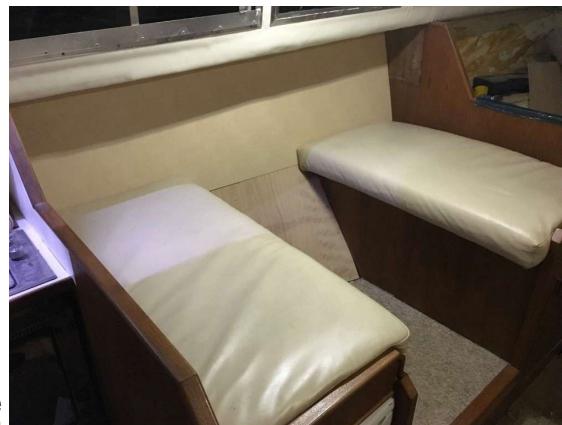
All the wood was beyond repair and the joinery work was disappointing (as it turned out, along with most of the other woodwork inside!)

He removed the unit and some foam backed vinyl to expose the original panel lining which, sadly was not really in any fit state to continue its purpose. Once this was removed the hull appeared and the supports for the new plywood panels were revealed. As this under deck unit takes away quite a lot of space if the seating area is also used

Once the panels were shaped and dry fitted, he removed them and covered them in new leather trim, purchased to match all the interior seat areas. A new top was made for the aft most seating area and a locker lid cut in to access under seat storage.

Once this cabin is finished the carpet will be laid up to the line of the seating against the hull. (Seen as bare ply in the pic left).

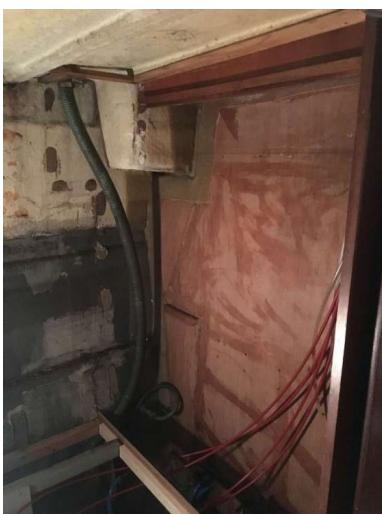
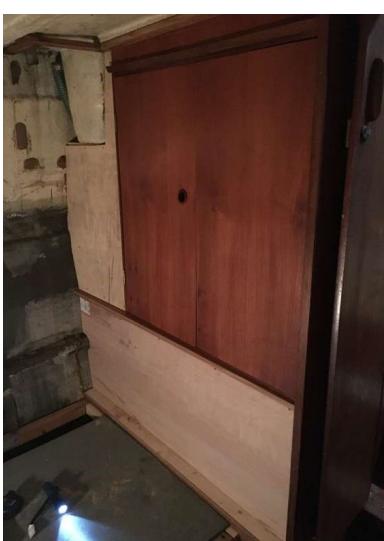
Once the cushions were out and in their respective positions in the bow Simon investigated this "wet wonderland." There was no sign of water ingress. Peering gently behind the bed side panels his thought of a 'quick tidy' in the aft cabin soon became a fading light. The support beam fibre-glassed into the side of the hull had a puddle of water on top. But he couldn't immediately see from where it was originating. He assumed that - after all the issues in the forward cabin - it had to be the windows. But it wasn't.

Pulling away the loose foam backed side lining material in front of the window revealed more soggy wet mess. Then, higher into the roof linings these were all soaking wet. He ripped out the roof linings. After about an hour or so of stripping everything out, he finally found the culprit. The aft deck handrail support at the front of the cabin roof was seriously leaking. This was mainly due to the fact that two of the four mounting screws weren't tight! Water was pouring in!

Having removed the side linings it became clear the damage was extensive. The forward end bulkhead in the cabin was totally blown, rotten away and brittle. All that was left was to keep removing things until solid and dry wood was found. Thankfully all the bunk panels and supports were good, and it was really only the bulkhead with the wardrobe door that had suffered.

Simon removed the handrails causing the leaks, cleaned them and resealed. Most were accessible by one arm out of the window holding a screwdriver whilst the other hand had a spanner on the nut underneath!
