THERMAL DRONE ROOF REPORT

Hochunk Nation - Hochunk Cinema

LIDAR Drone Services

Capture Date: 02/19/24
Created Date: 02/23/24

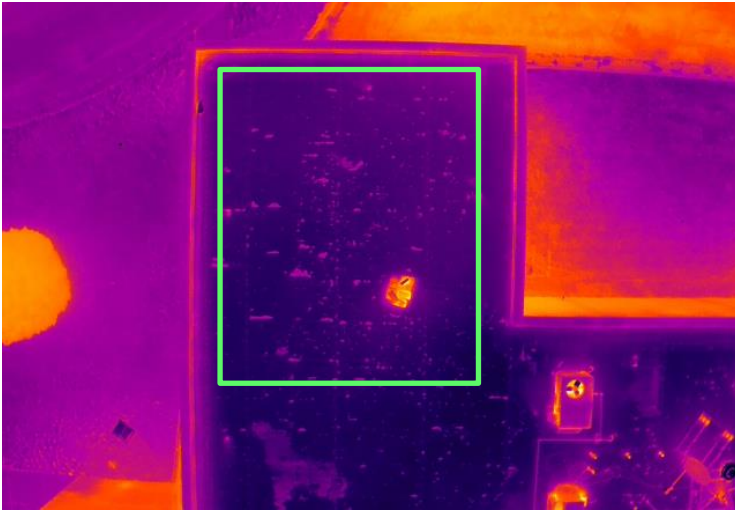
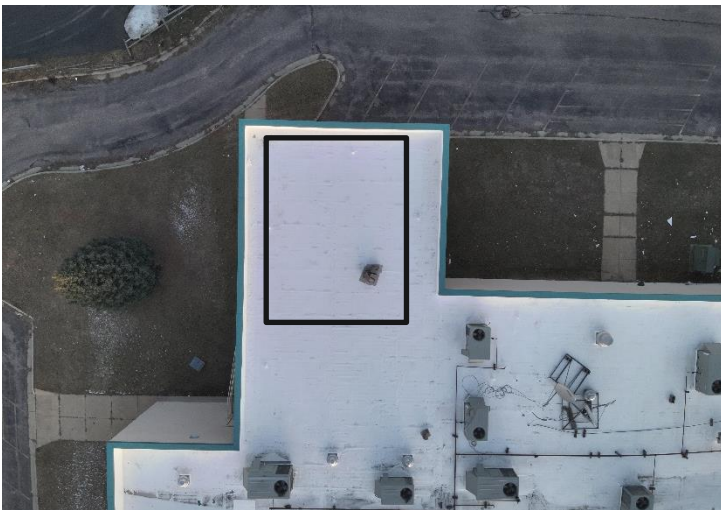
Anomaly - Section 1

An anomaly was detected indicating possible moisture intrusion. Further investigation is recommended.

NOTE: The “bubbles” could be things such as air, vapor, condensation, glue, moisture, or the roof needing thermal cycling due to it being new and will stretch out over time.

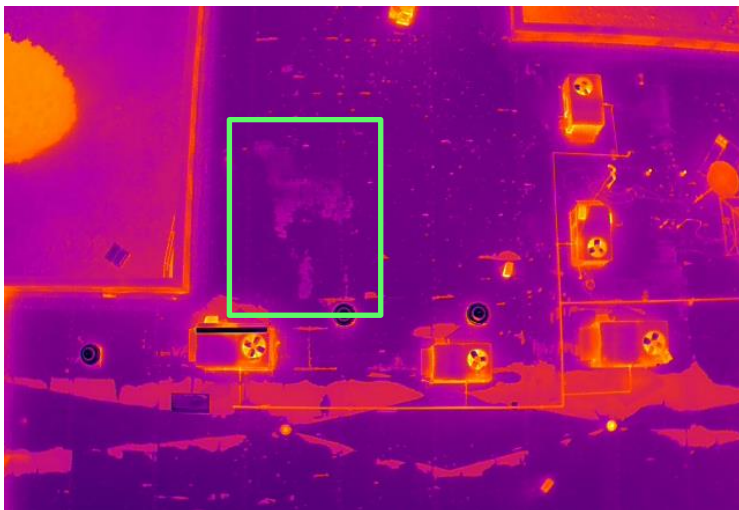
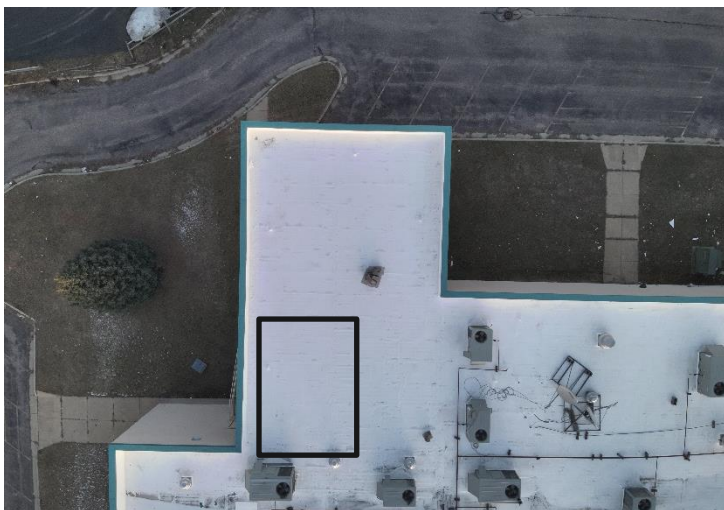
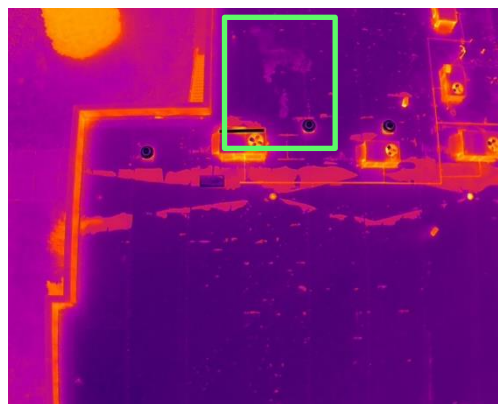
Anomaly - Section 2

An anomaly was detected indicating possible moisture intrusion. Further investigation is recommended.

NOTE: This is one area of greater concern. Check all flashings and penetrations in that immediate vicinity.

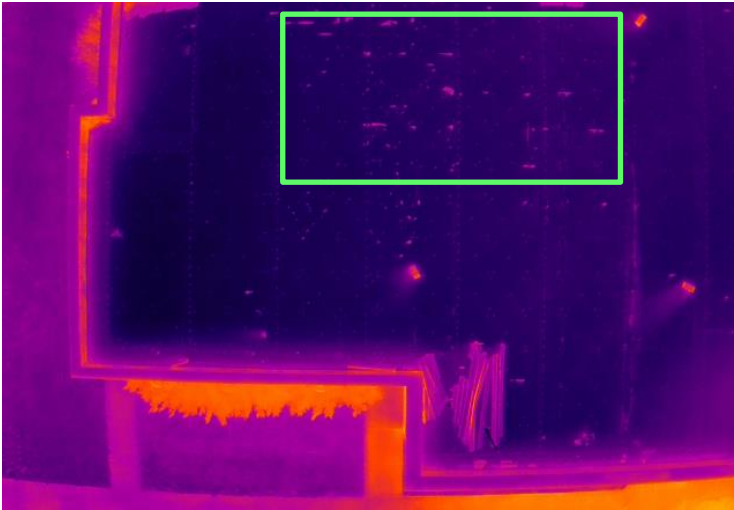
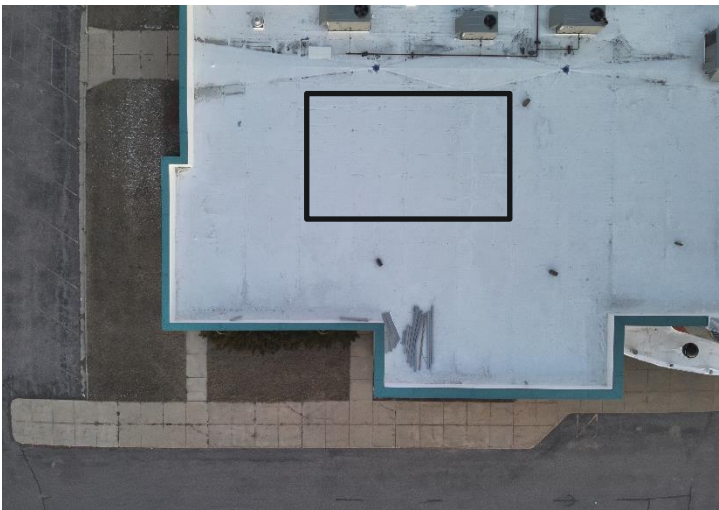
Anomaly - Section 3

An anomaly was detected indicating possible moisture intrusion. Further investigation is recommended.

NOTE: The “bubbles” could be things such as air, vapor, condensation, glue, moisture, or the roof needing thermal cycling due to it being new and will stretch out over time.

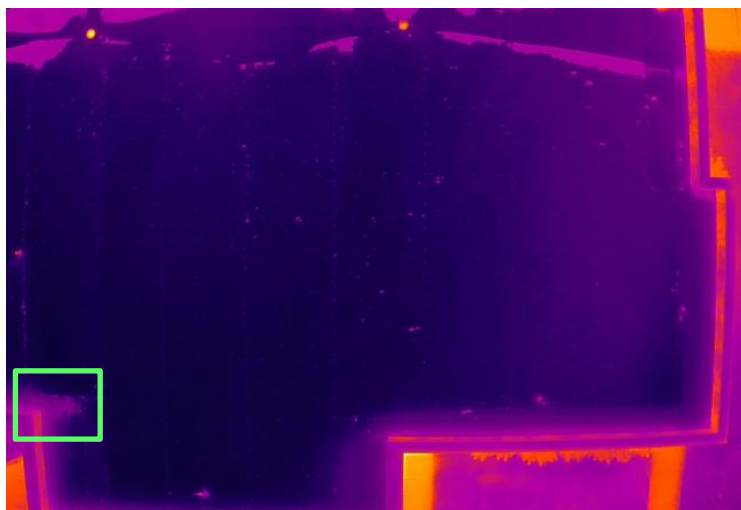
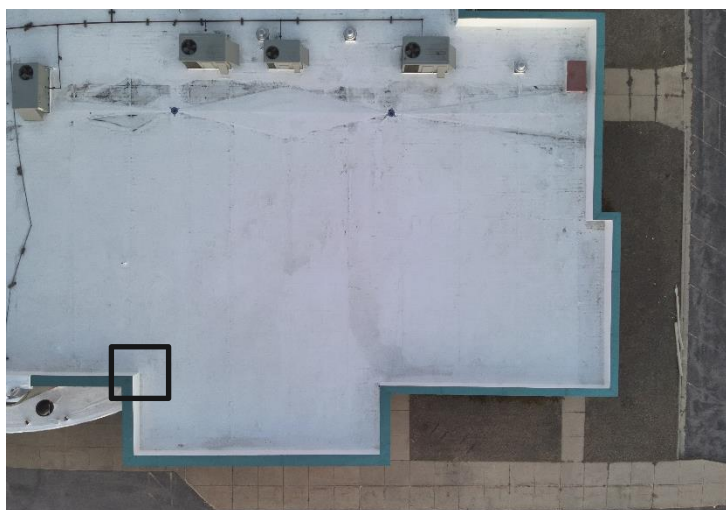
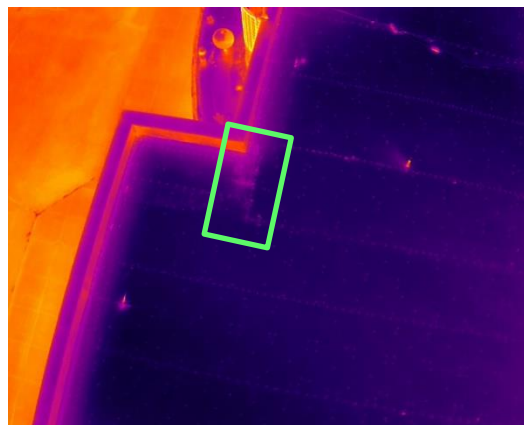
Anomaly - Section 4

An anomaly was detected indicating possible moisture intrusion. Further investigation is recommended.

NOTE: Another area of concern that may be moisture intrusion.

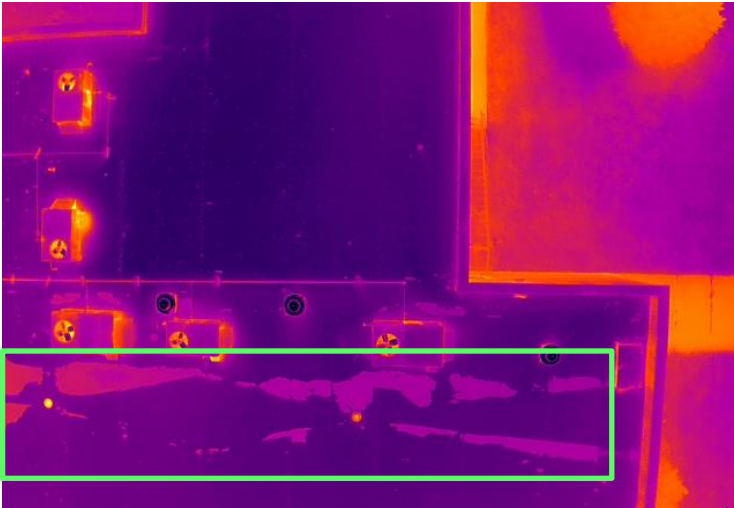
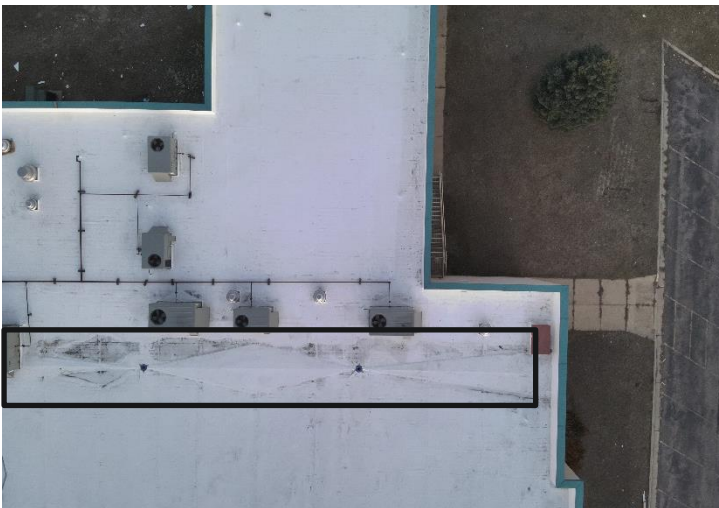
Anomaly - Section 5

Ice and surface water build up next to drainage pathway crickets.

NOTE: Severe ice and water build up next to roofing crickets. Unable to detect any readings below surface ice and water.

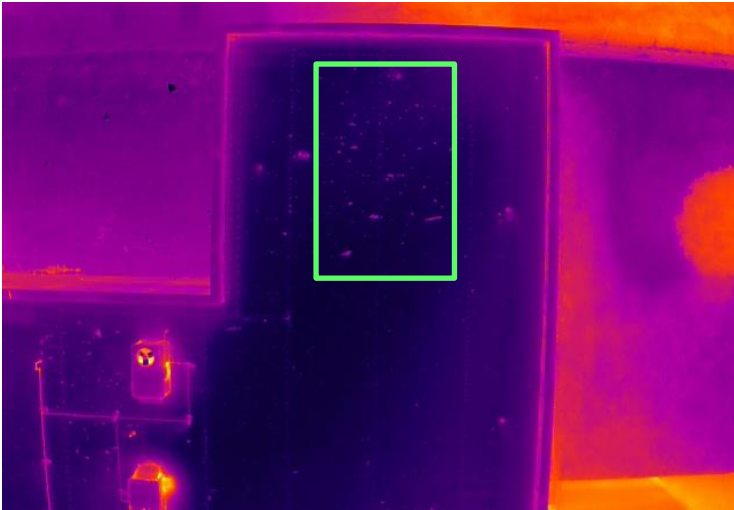
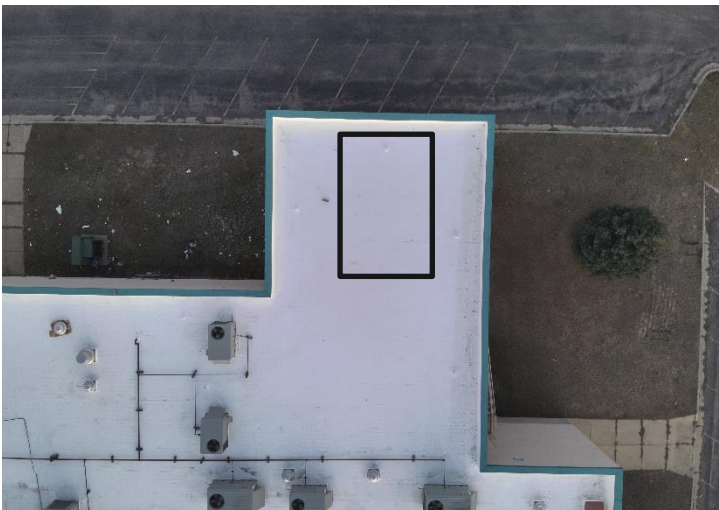
Anomaly - Section 6

An anomaly was detected indicating possible moisture intrusion. Further investigation is recommended.

NOTE: The “bubbles” could be things such as air, vapor, condensation, glue, moisture, or the roof needing thermal cycling due to it being new and will stretch out over time.

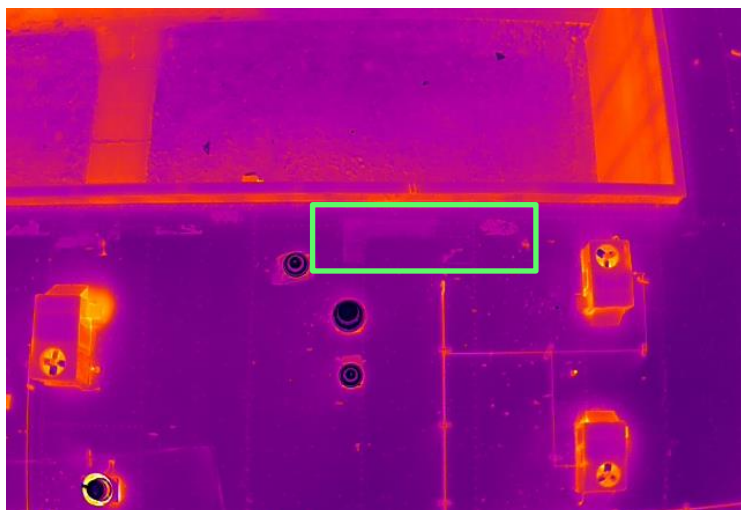
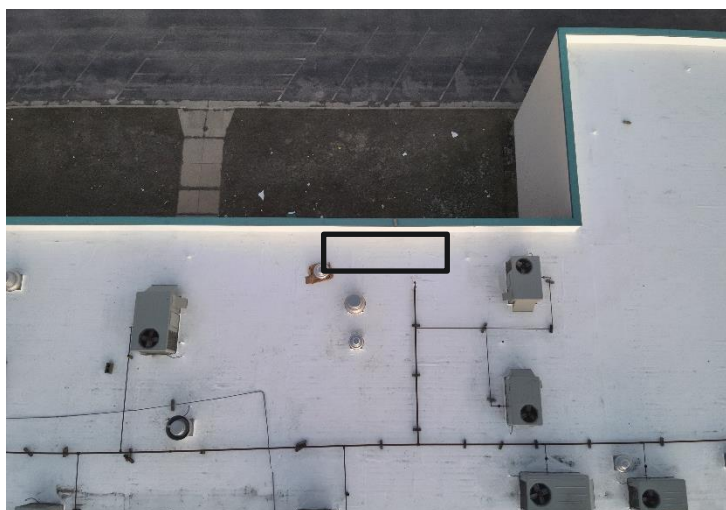
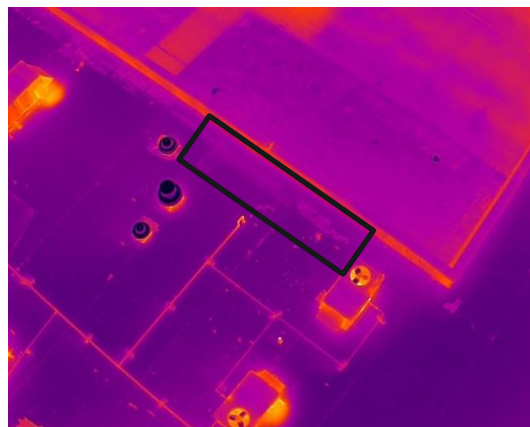
Anomaly - Section 7

An anomaly was detected indicating possible moisture intrusion. Further investigation is recommended.

NOTE: Area of concern that may be moisture intrusion.

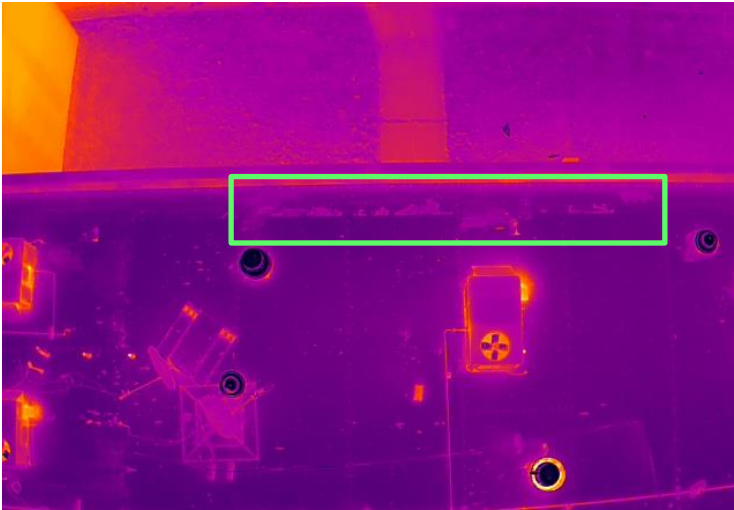
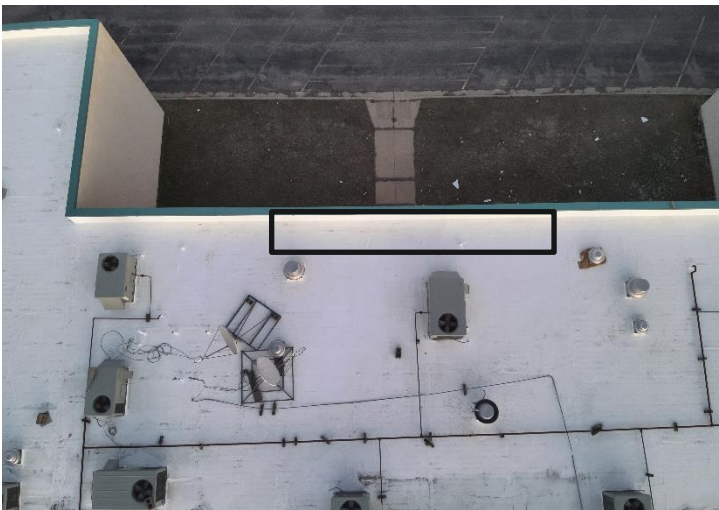
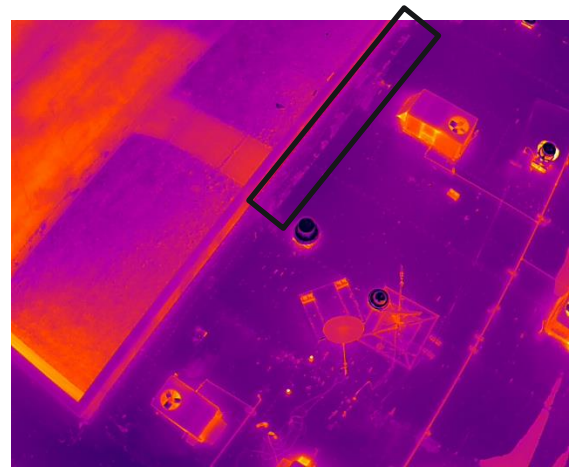
Anomaly - Section 8

An anomaly was detected indicating possible moisture intrusion. Further investigation is recommended.

NOTE: Another area of concern that may be moisture intrusion.
