# RAPID RESPONSE REPORT

Your Company  
- Your Site Name

## LIDAR Drone Services

# LIDAR Drone Services - Rapid Response Report

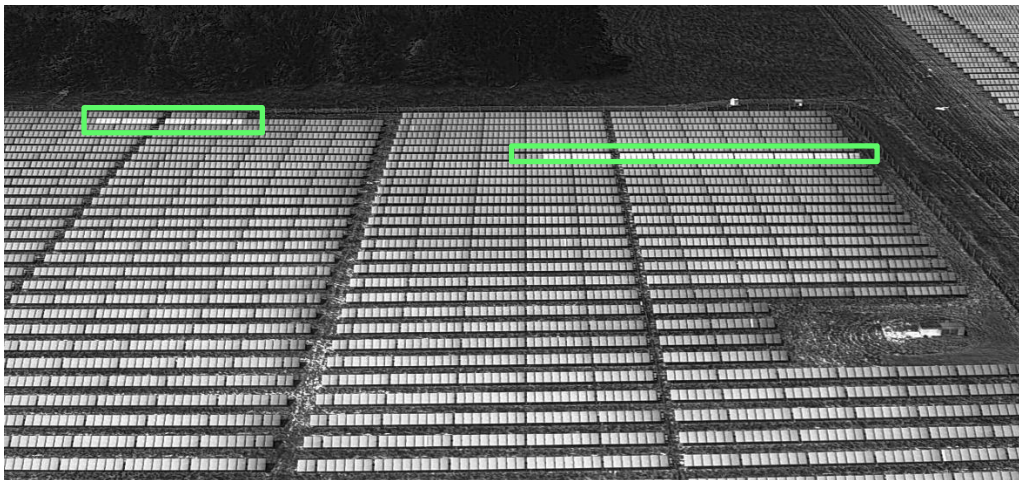
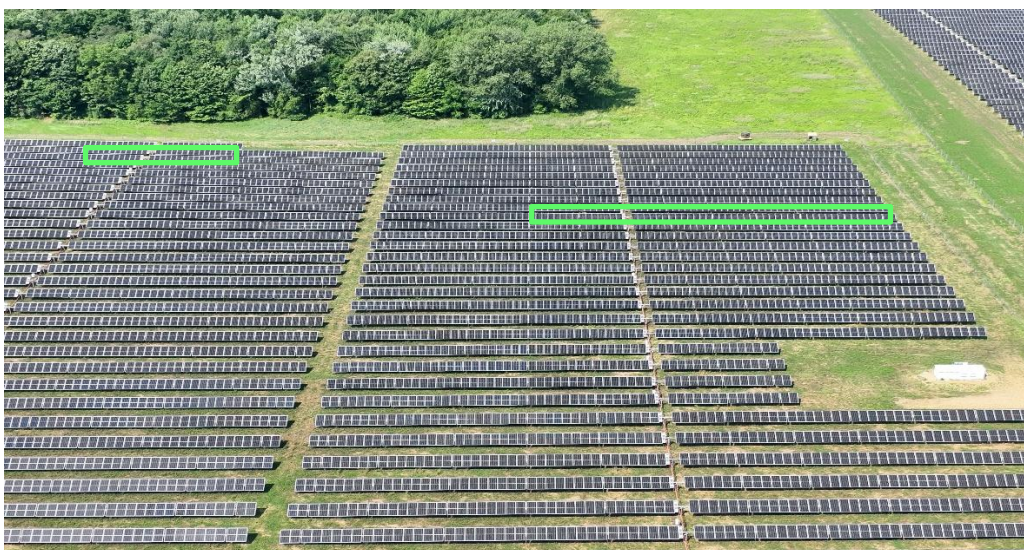
## Invertor - 1

Multiple anomalies were detected indicating possible defective string issues in the section block of invertor 1.

Block 1, Section 4, Row 2, String 1.3.4.4  
Block 1, Section 3, Row 7, String 1.2.3.4; & 1.2.3.5

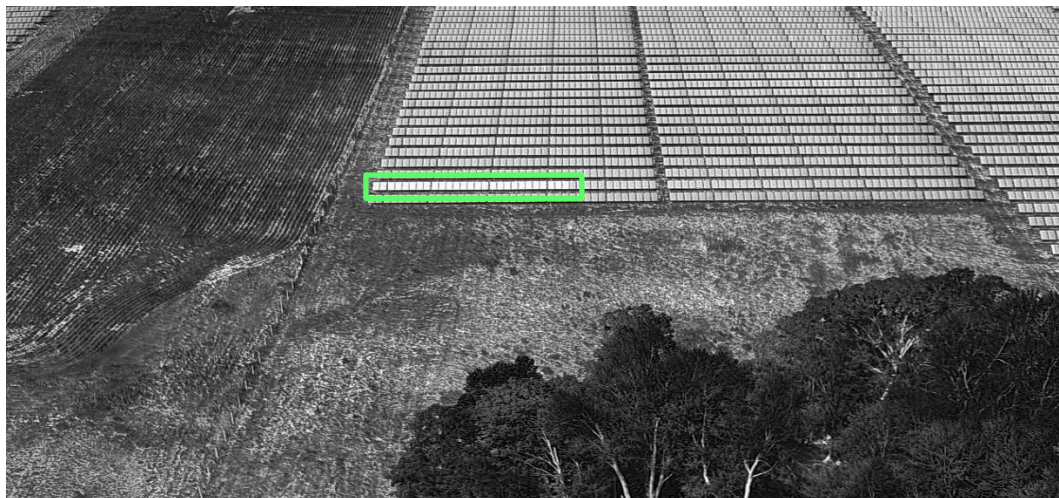
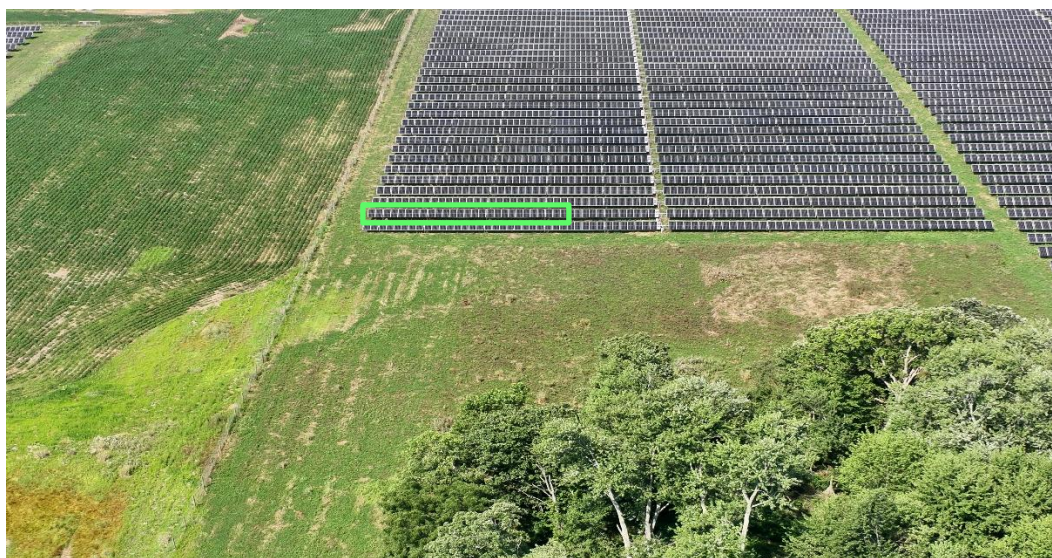
## Invertor 2

Multiple anomalies were detected indicating possible defective string issues in the section block of invertor 2.

Block 2, Section 2, Row 41, String: 2.2.1.7

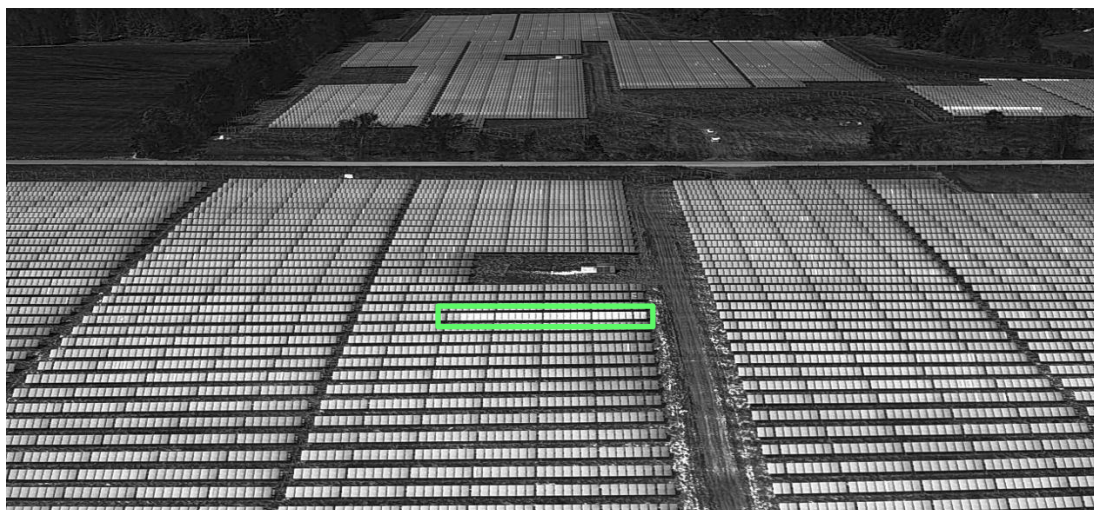
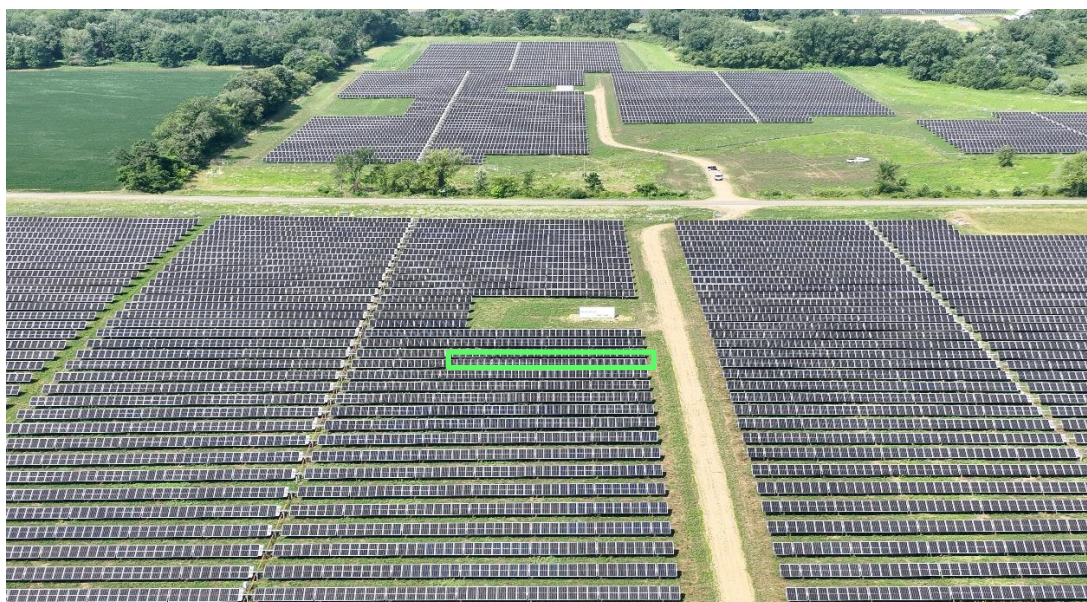
## Invertor 3

Multiple anomalies were detected indicating possible defective string issues in the section block of invertor 3.

Block 3, Section 3, Row 14, String: 3.2.4.5

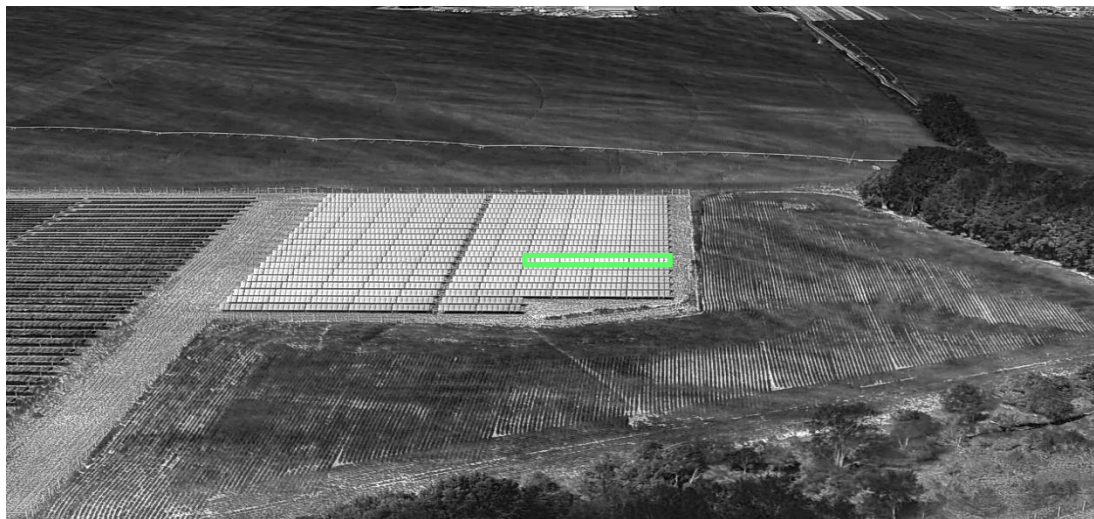
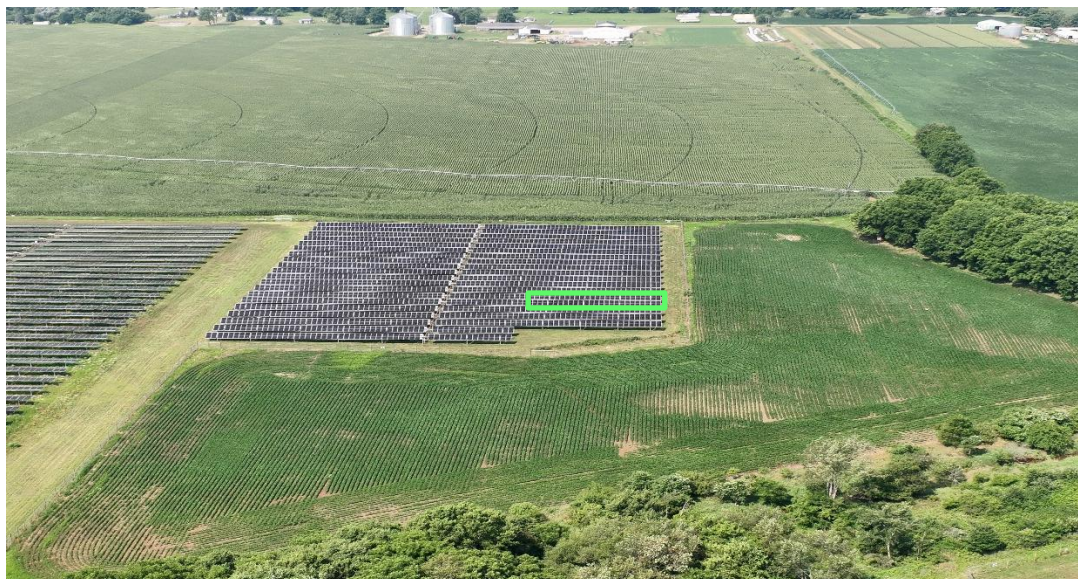
## Invertor 4

Multiple anomalies were detected indicating possible defective string issues in the section block of invertor 4.

Block 4, Section 1, Row 13, String: 4.1.3.4

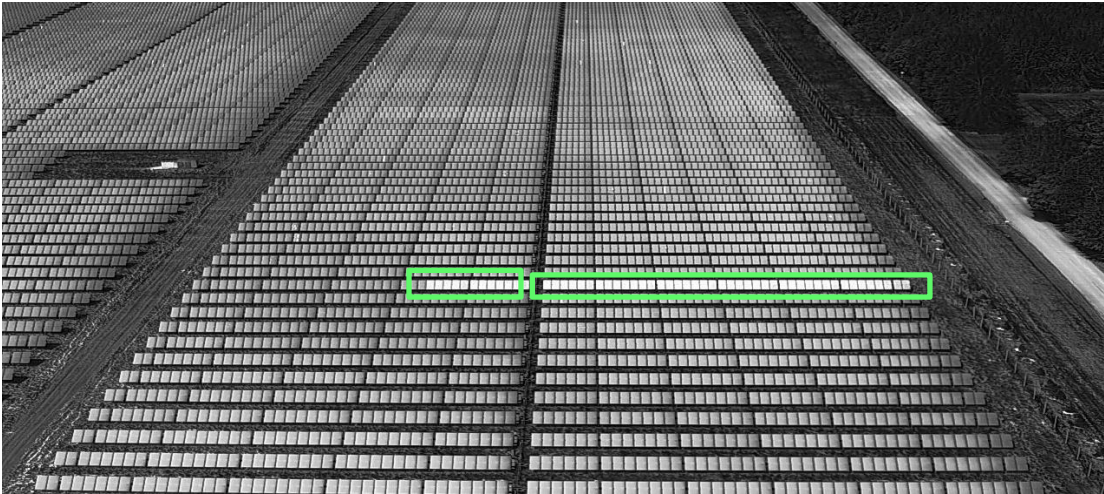
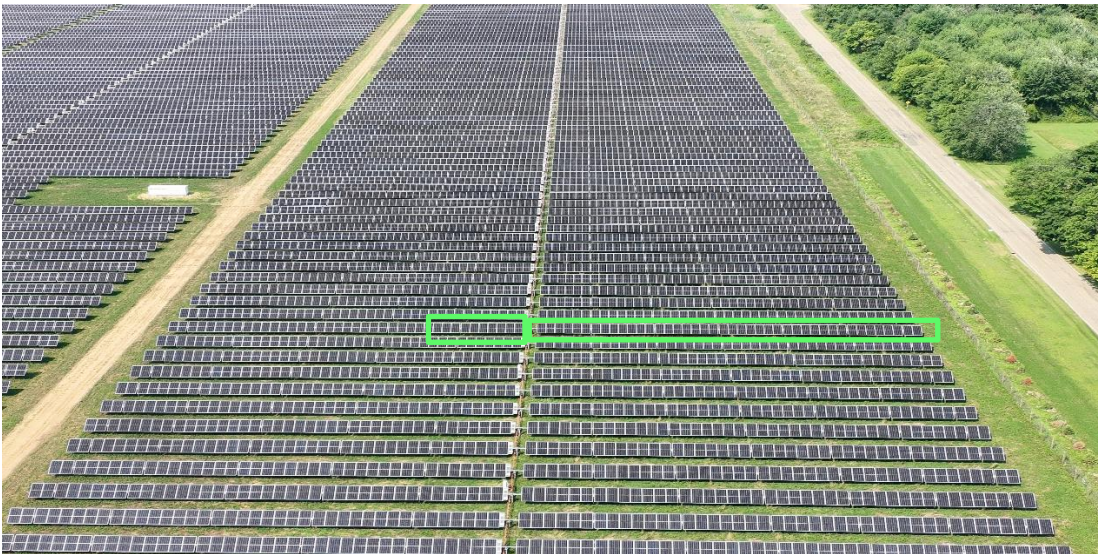
## Invertor 5

Multiple anomalies were detected indicating possible defective string issues in the section block of invertor 5.

Block 4, Section 1, Row 65, String: 4.1.3.4

Block 4, Section 2, Row 65, String: 4.2.7.8
