THERMAL DRONE ROOF REPORT

Saginaw Chippewa Tribe - Soaring Eagle Casino

LIDAR Drone Services

Capture Date: 02/12/24
Created Date: 02/14/24

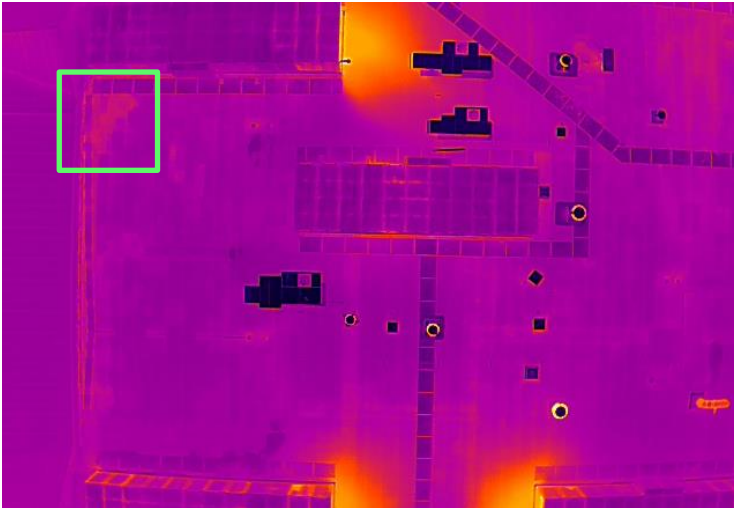
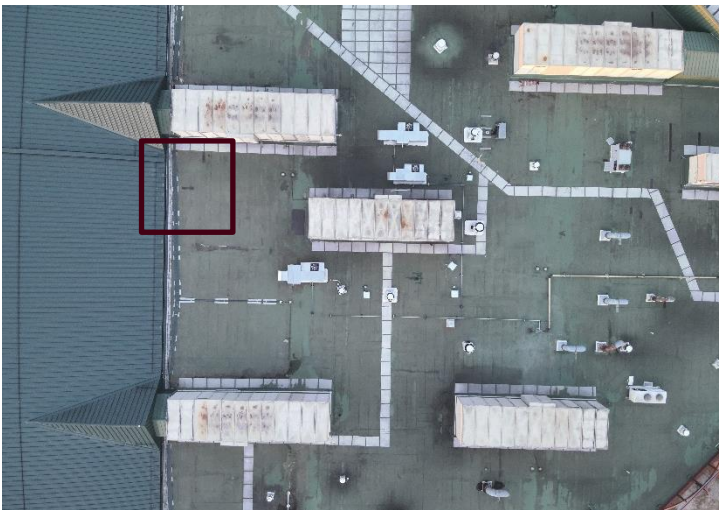
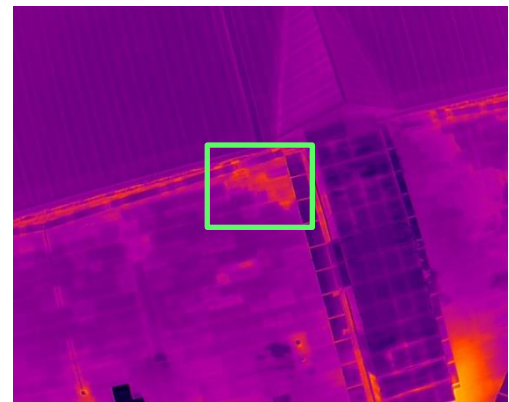
Anomaly - Section A2

An anomaly was detected indicating possible moisture intrusion. Further investigation is recommended.

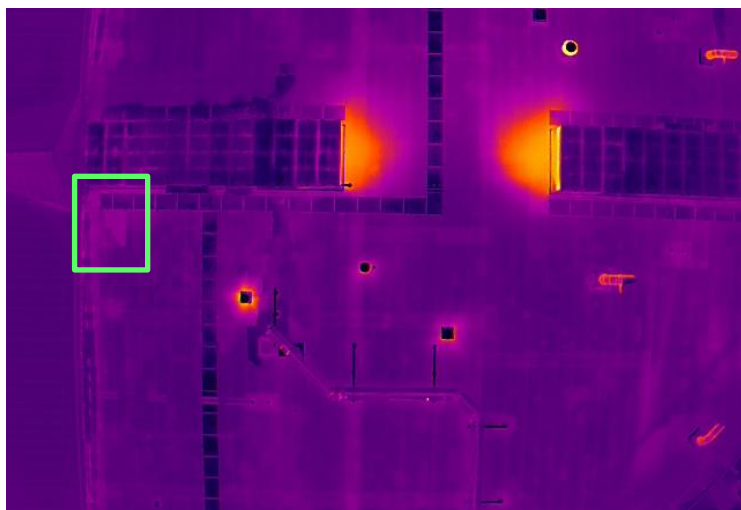
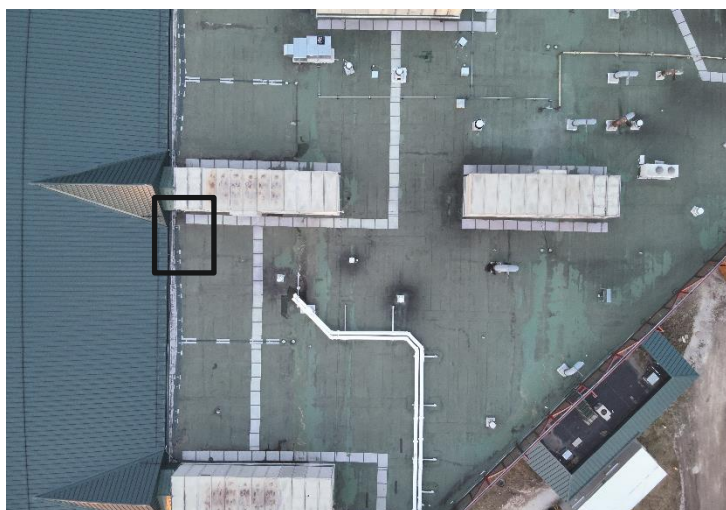
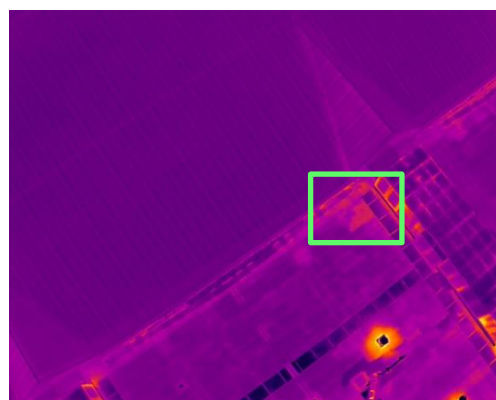
Anomaly - Section A3

An anomaly was detected indicating possible moisture intrusion. Further investigation is recommended.

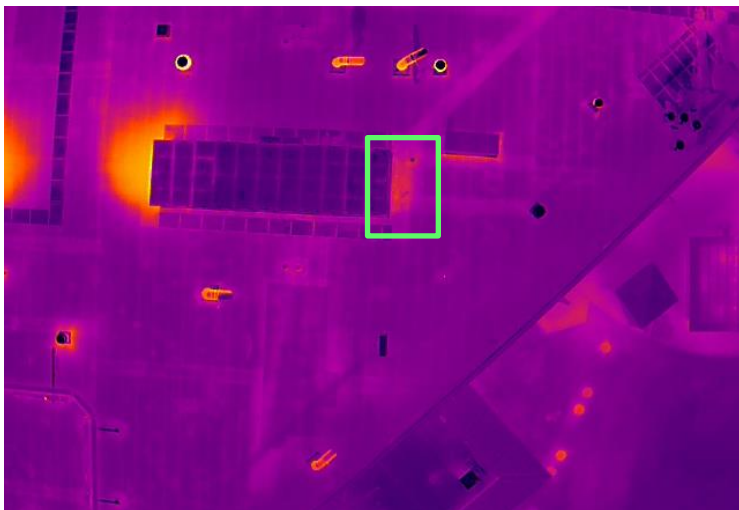
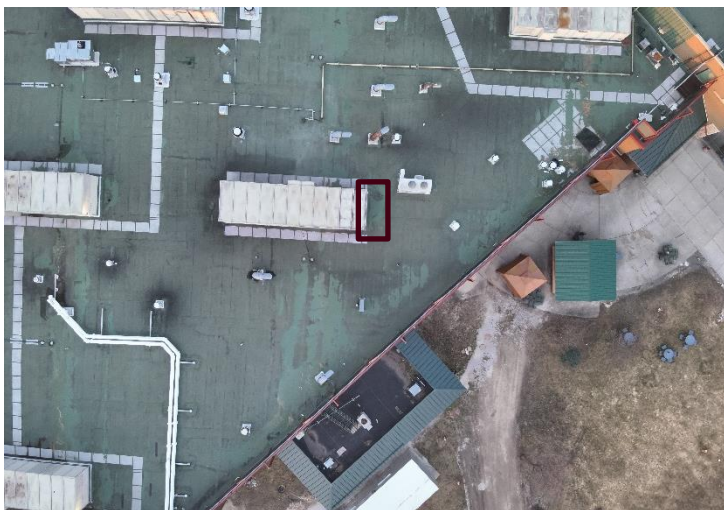
Anomaly - Section A5

An anomaly was detected indicating possible moisture intrusion. Further investigation is recommended.

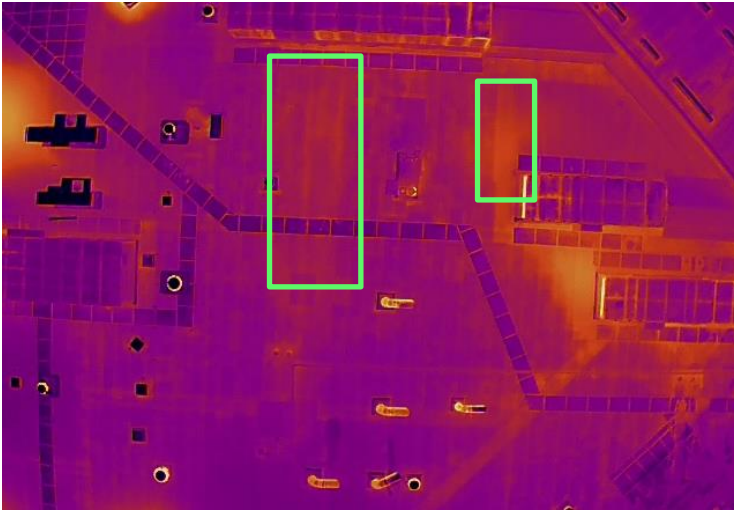
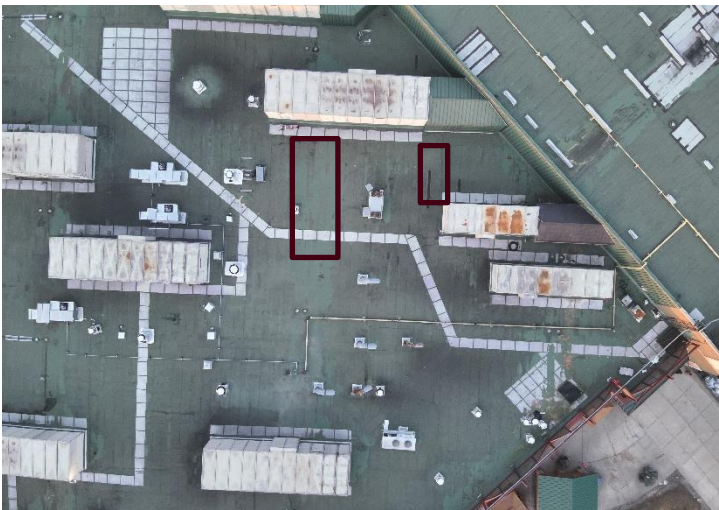
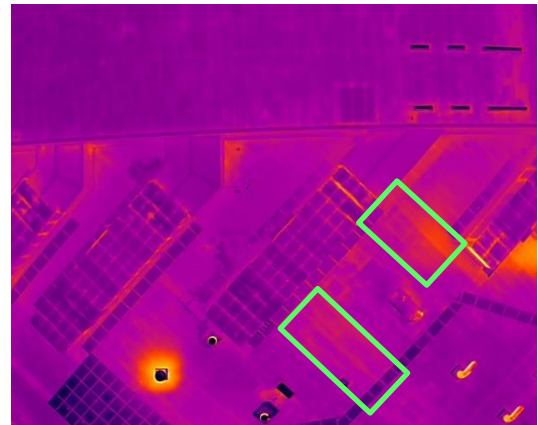
Anomaly - Section A6

An anomaly was detected indicating possible moisture intrusion. Further investigation is recommended.

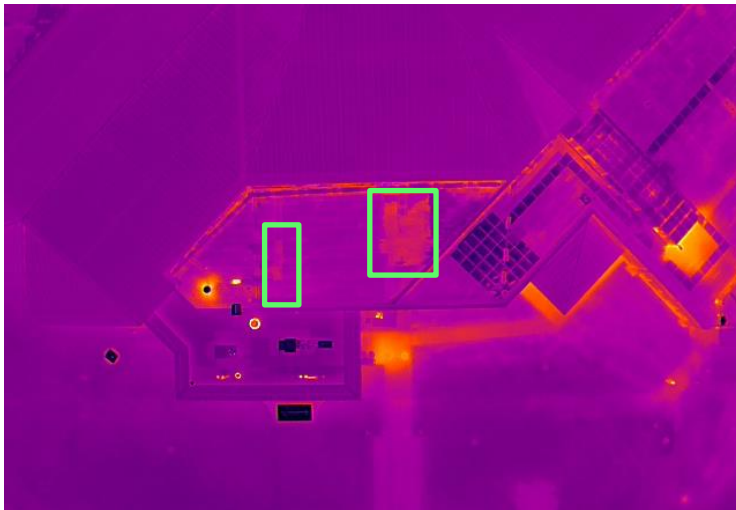
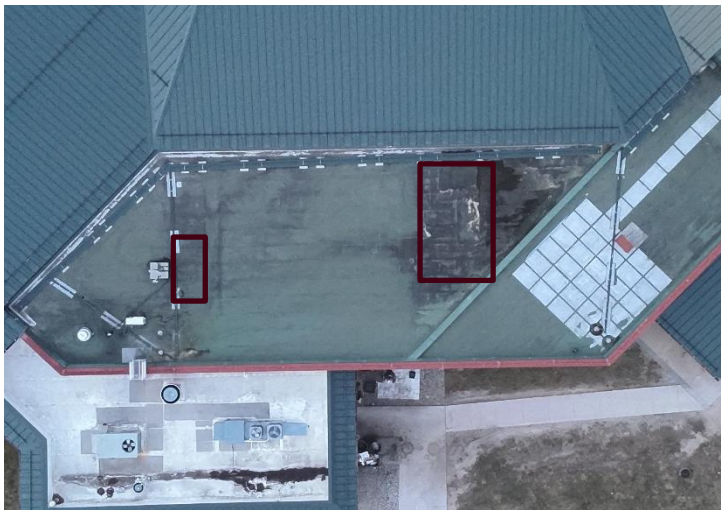
Anomaly - Section A9

An anomaly was detected indicating possible moisture intrusion. Further investigation is recommended.

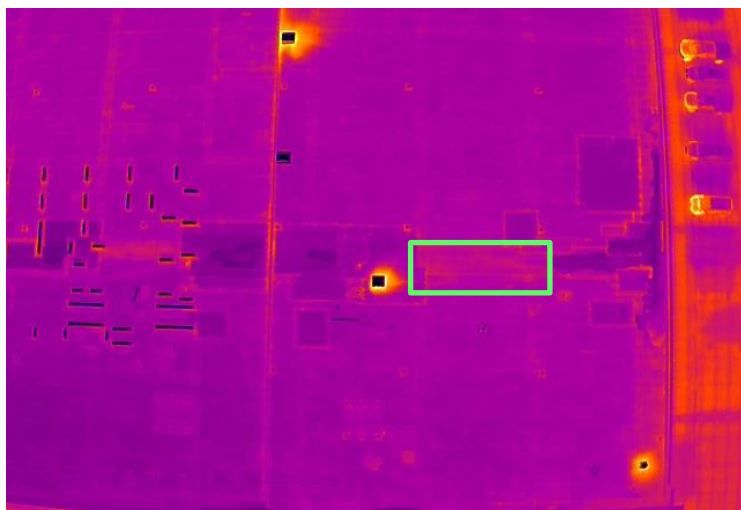
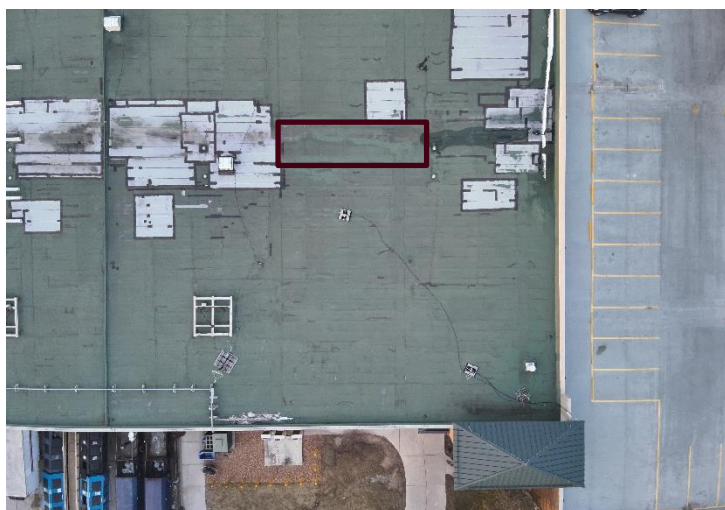
Anomaly - Section B1

An anomaly was detected indicating possible moisture intrusion. Further investigation is recommended.

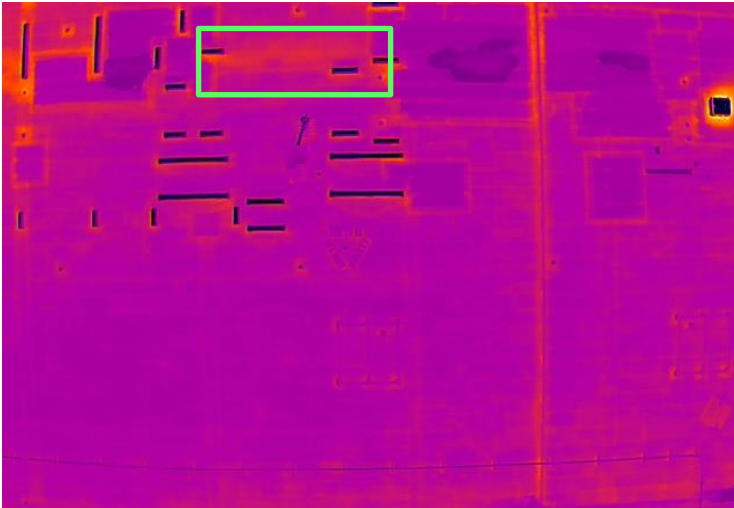
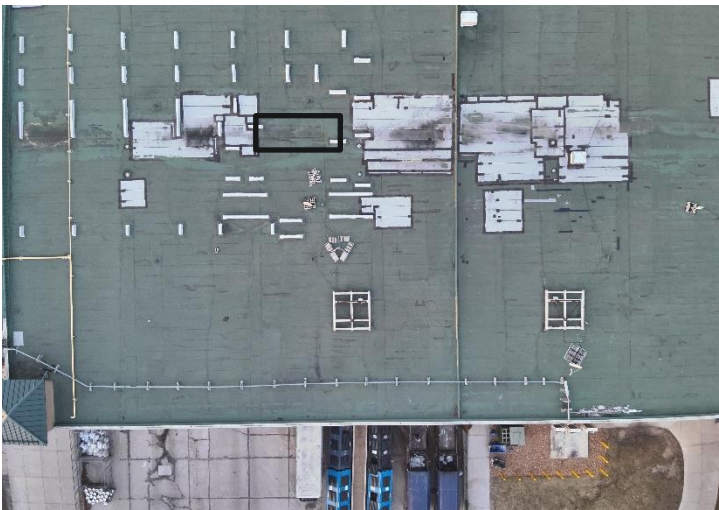
Anomaly - Section B2

An anomaly was detected indicating possible moisture intrusion. Further investigation is recommended.

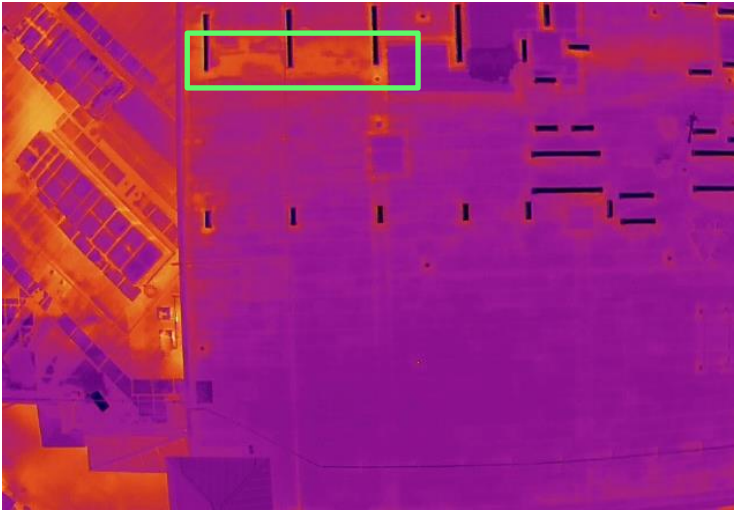
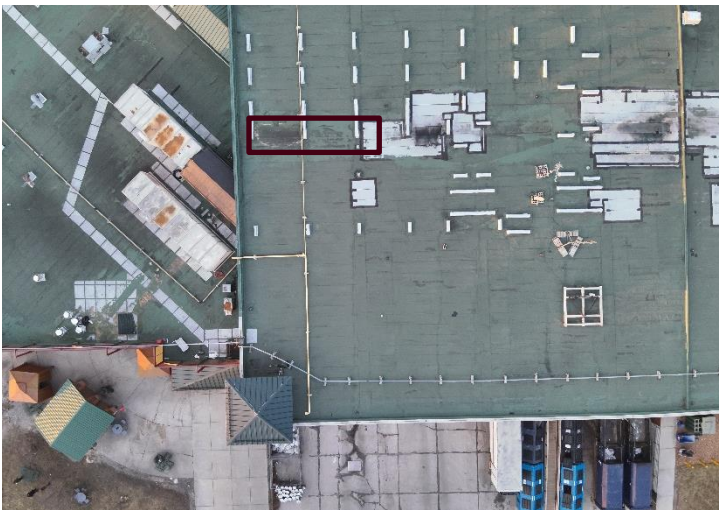
Anomaly - Section B3

An anomaly was detected indicating possible moisture intrusion. Further investigation is recommended.

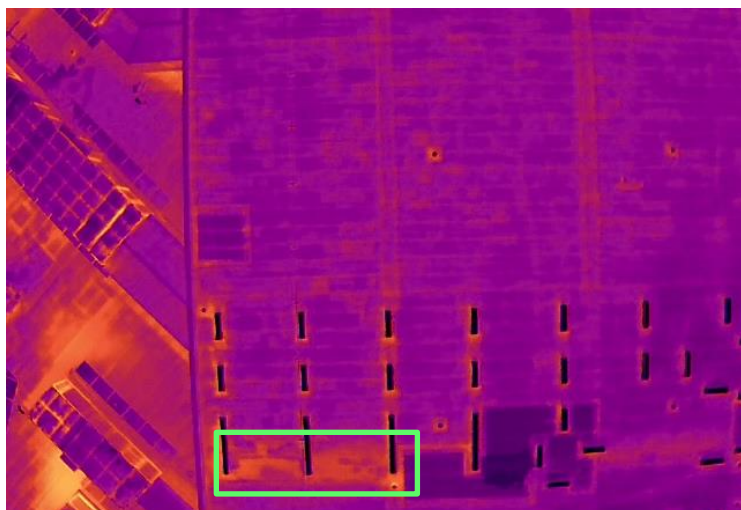
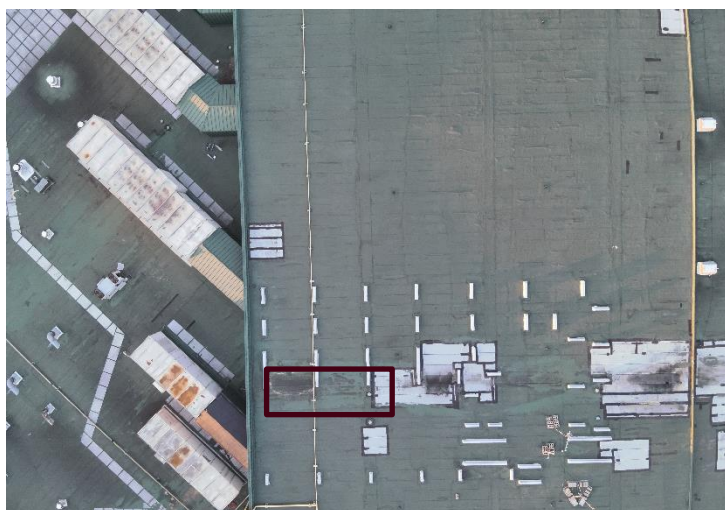
Anomaly - Section B4

An anomaly was detected indicating possible moisture intrusion. Further investigation is recommended.

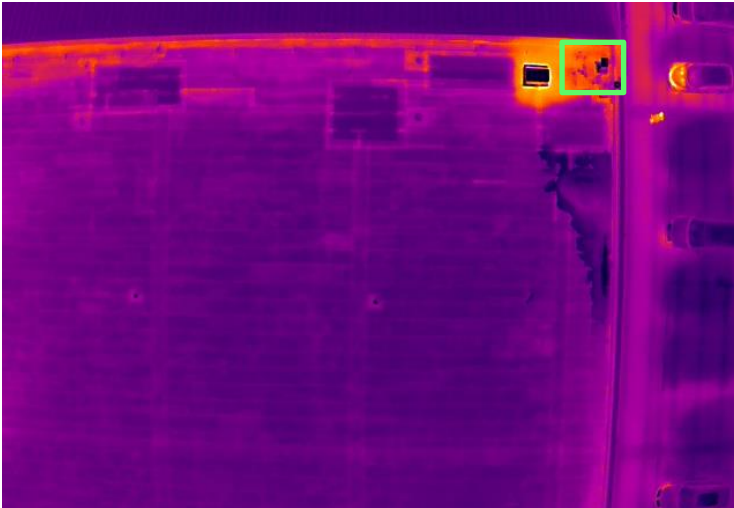
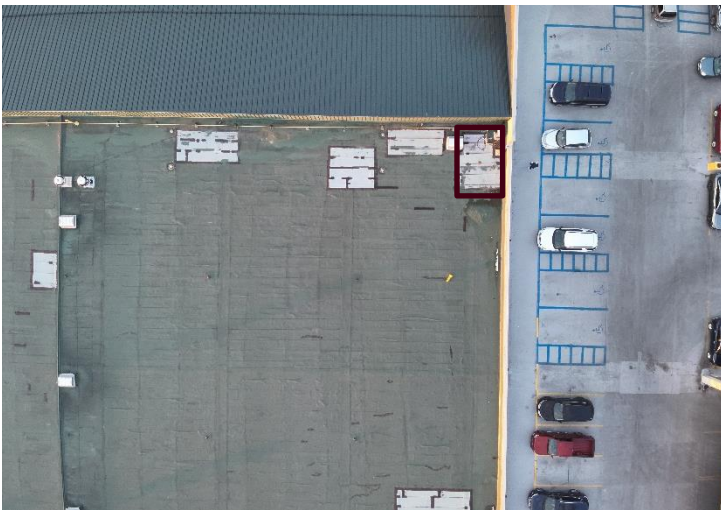
Anomaly - Section B7

An anomaly was detected indicating possible moisture intrusion. Further investigation is recommended.
