*Integrity Inspections, LLC
521 S Woodlawn
Wichita, KS 67218
Contact@IntegrityInspectKS.com*

Home Inspection Report

123 Main St
Wichita, KS

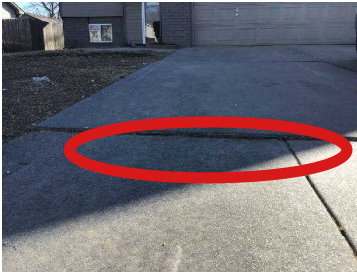
1. Driveway: Concrete - Minor elevation changes in driveway.

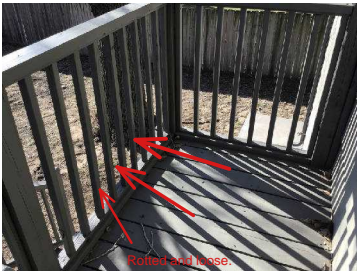
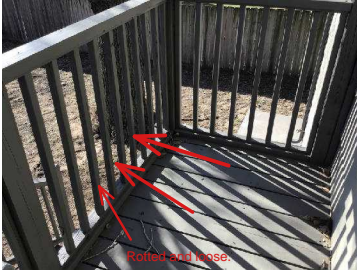
5. Deck: Painted wood - Recommend repair and/or replacement

1. Deck: Painted wood - **Recommend repair and/or replacement**

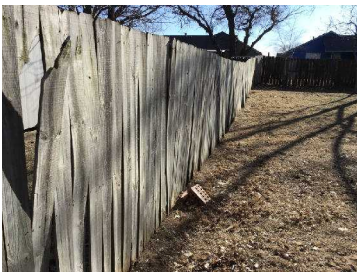
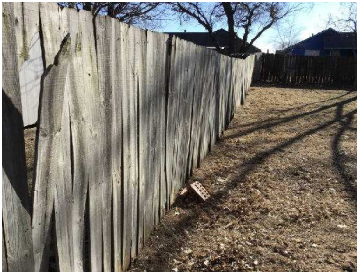
8. Fences: East Fence is still functional but requires replacement of a few boards. Confirm with current owner on who owns this portion of the fence.

2. Fences: **East Fence is still functional but requires replacement of a few boards. Confirm with current owner on who owns this portion of the fence.**

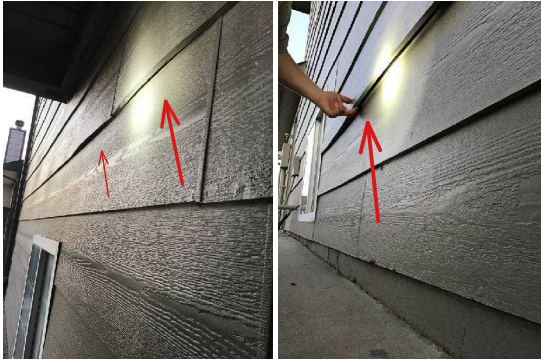
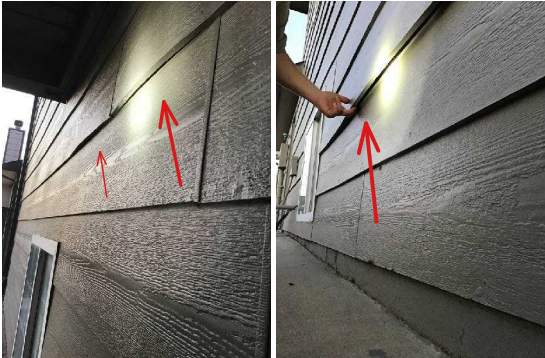
1. Type: Wood - **Bulging siding under deck. Require further evaluation by licensed contractors. Gaps in siding and not properly sealed or secured on West side of home.**

1. North, South, East, West Exterior Surface Type: Wood - **Bulging siding under deck. Require further evaluation by licensed contractors. Gaps in siding and not properly sealed or secured on West side of home.**

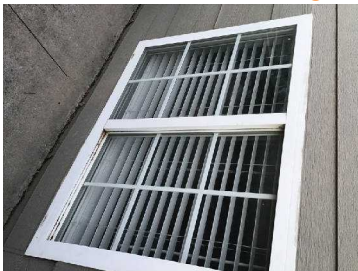
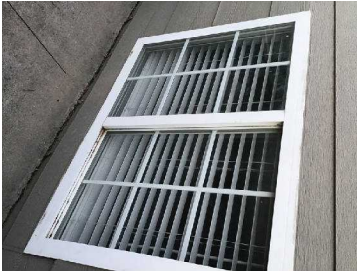
2. Trim:
3. Fascia:
4. Soffits:
5. Door Bell:
6. Entry Doors: Metal
7. Patio Door:
8. Windows: Vinyl slider
9. Window Screens: **Missing screens on west and south basement windows**

3. Window Screens: **Missing screens on west and south basement windows**

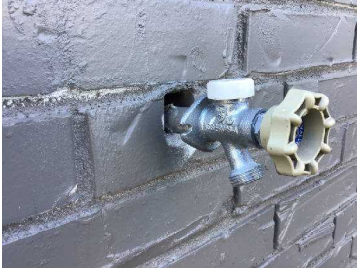
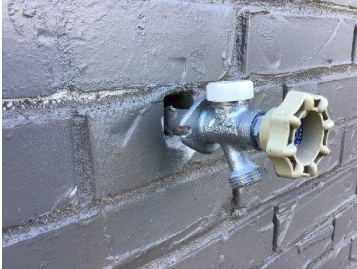
13. Hose Bibs: **Hose bib requires sealing and attached to the home. The lack of sealant may lead to potential water damage. A licensed plumber is recommended to evaluate and estimate repairs**

2. Hose Bibs: **Hose bib requires sealing and attached to the home. The lack of sealant may lead to potential water damage. A licensed plumber is recommended to evaluate and estimate repairs**

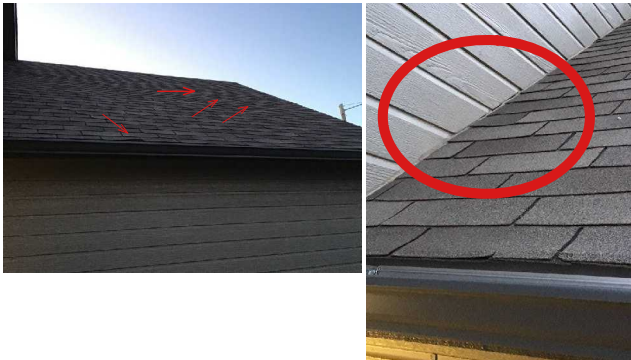
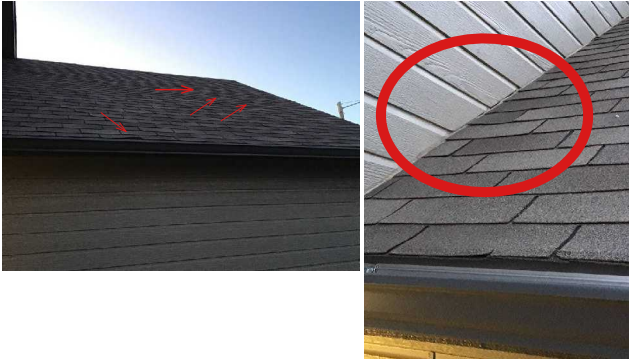
2. Material: Asphalt shingle - *Several curled shingles. Additional sealing/flashing required on roof surface above garage. qualified roofing contractor is recommended to evaluate and estimate repairs*

4. Main Roof Surface Material: Asphalt shingle - **Several curled shingles. Additional sealing/flashing required on roof surface above garage. qualified roofing contractor is recommended to evaluate and estimate repairs**

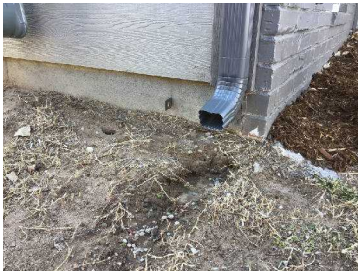
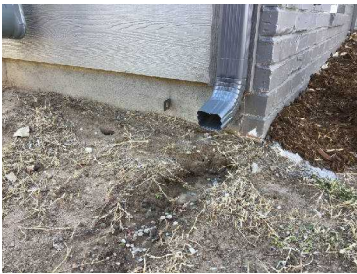
9. Gutters: Aluminum - *Recommend install of water divers at the base of each downspout.*

5. Gutters: Aluminum - Recommend install of water divers at the base of each downspout.

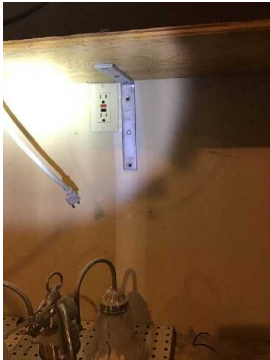
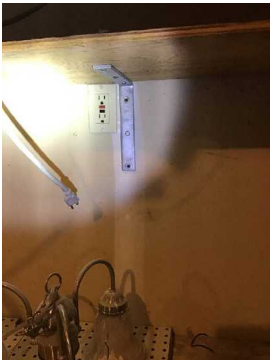
1. Type of Structure: Attached Car Spaces: 2
2. Garage Doors: Metal
3. Door Operation: Mechanized - Door operated as it should. Safety switch at the base of the door also tested good.
4. Door Opener: Lift Master
5. Exterior Surface: Wood
6. Roof: Asphalt shingle
7. Roof Structure: 2x6 Truss
8. Service Doors: Metal
9. Ceiling: Drywall
10. Walls: Wood Paneling
11. Floor/Foundation: Poured concrete
12. Hose Bibs:
13. Electrical: 110 VAC GFCI - **Faulty GFCI outlet on south wall-Recommend replacement by a licensed electrician.**

3. Attached Garage Electrical: 110 VAC GFCI - **Faulty GFCI outlet on south wall-Recommend replacement by a licensed electrician.**

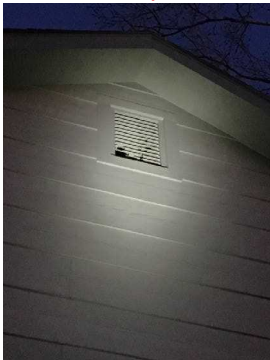
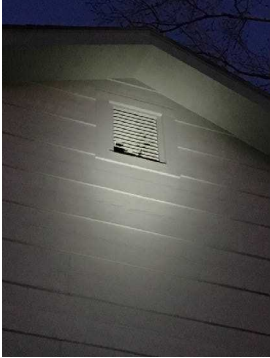
- 1. Method of Inspection: In the attic
- 2. Unable to Inspect:
- 3. Roof Framing: 2x4 Truss
- 4. Sheathing: Particle board
- 5. Ventilation: Attic vent damaged. **A qualified roofing contractor is recommended to evaluate and estimate repairs**

4. Main -Access through Master Bedroom Closet and garage Attic Ventilation: Attic vent damaged. **A qualified roofing contractor is recommended to evaluate and estimate repairs**

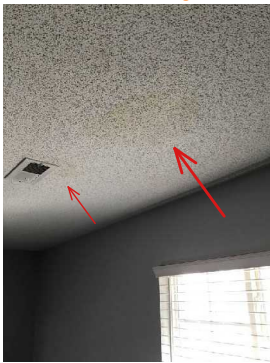
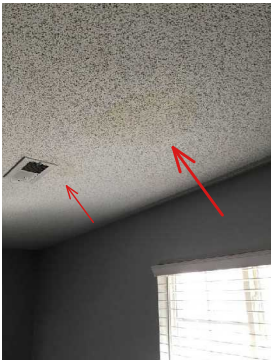
1. Unable to Inspect:
 2. Ceiling: Texture paint - **Water stains present. No active leak observed during inspection. This stain is located directly below kitchen sink and dishwasher.**

6. Basement Ceiling: Texture paint - Water stains present. No active leak observed during inspection. This stain is located directly below kitchen sink and dishwasher.

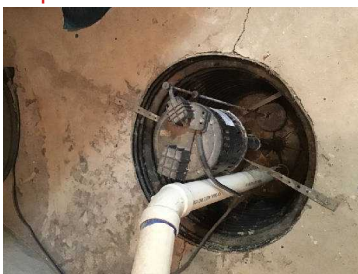
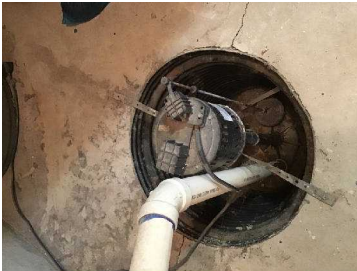
3. Walls: Paint
 4. Floor: Carpet
 5. Floor Drain: Covered
 6. Doors: Hollow wood
 7. Windows: Vinyl slider
 8. Electrical: 110 VAC
 9. Smoke Detector: Battery operated
 10. HVAC Source: Heating system register
 11. Vapor Barrier:
 12. Insulation: Unable to inspect due to basement being finished.
 13. Sump Pump: Submerged - **Inoperative at time of inspection. Pump was not plugged in and pump pit was dry. The sump pump did not have a visible back flow device in place at the time of inspection.**

5. Basement Sump Pump: Submerged - **Inoperative at time of inspection. Pump was not plugged in and pump pit was dry. The sump pump did not have a visible back flow device in place at the time of inspection.**

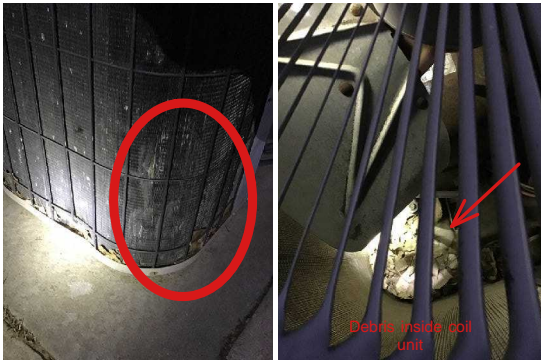
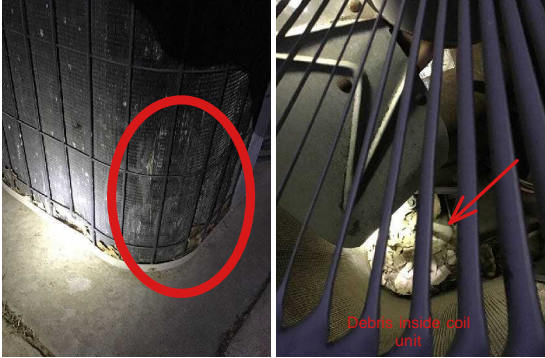
1. A/C System Operation: Not inspected - Did not operate a full cycle due to low temperatures as it was unsafe to do so.
2. Condensate Removal: PVC
3. Exterior Unit: Pad mounted
4. Manufacturer:
5. Area Served: Whole building Approximate Age:
6. Fuel Type: 220 VAC Temperature Differential:
7. Type: Central A/C Capacity:
8. Visible Coil: Copper core with aluminum fins - Fins damaged, A qualified air conditioning contractor is recommended to evaluate and estimate repairs.

7. Main AC System Visible Coil: Copper core with aluminum fins - Fins damaged, A qualified air conditioning contractor is recommended to evaluate and estimate repairs.

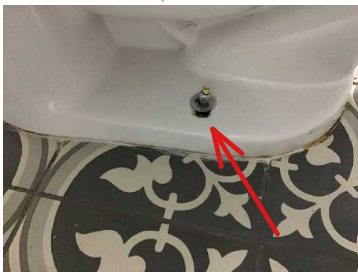
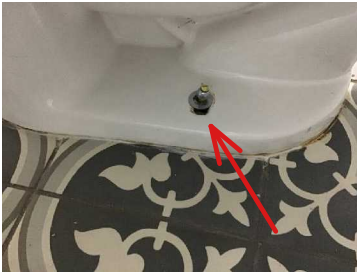
1. Ceiling: Paint
2. Walls: Paint
3. Floor: Ceramic tile
4. Doors: Hollow wood
5. Electrical: 110 VAC - Non-GFCI circuit -recommend GFCI circuit be installed
6. Counter/Cabinet: Granite
7. Sink/Basin: Porcelain
8. Tub/Surround: Fiberglass tub and fiberglass surround
9. Toilets: 1 1/2 Gallon Tank - **Both sides of the toilet need to be properly fastened to prevent possible leakage and water damage. Ths toilet was secured on one side but repair needed for the loose attachment point.**

8. 1st floor main Bathroom Toilets: 1 1/2 Gallon Tank - Both sides of the toilet need to be properly fastened to prevent possible leakage and water damage. This toilet was secured on one side but repair needed for the loose attachment point.

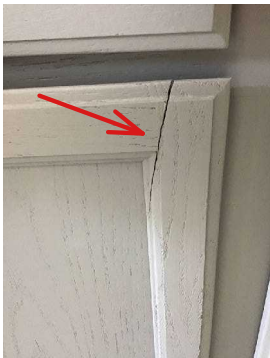
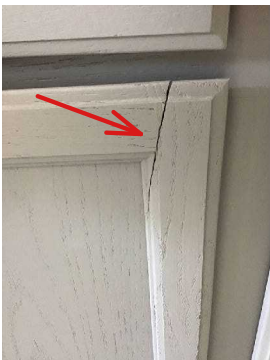
12. Ceiling: Texture paint
13. Walls: Paint
14. Floor: Tile
15. Doors: Hollow wood
16. Electrical: 110 VAC GFCI - **Faulty GFCI outlet-replace. Can not test or reset manually.**
17. Counter/Cabinet: Wood - **Second counter door cracked.**

9. Master Bathroom Counter/Cabinet: Wood - Second counter door cracked.

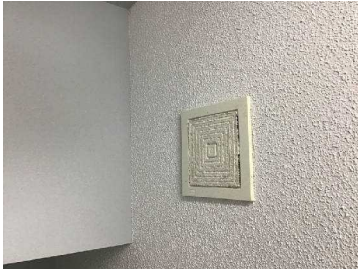
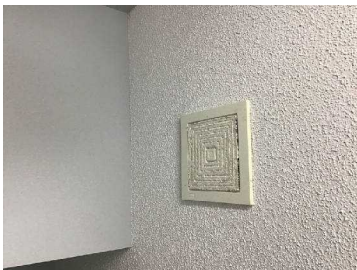
- 18. Sink/Basin: Porcelain
- 19. Tub/Surround: Fiberglass tub and fiberglass surround
- 20. Toilets: 1 1/2 Gallon Tank
- 21. HVAC Source: Heating system register
- 22. Ventilation: Electric ventilation fan - **Vent clogged during inspection. Recommend cleaning.**

10. Master Bathroom Ventilation: Electric ventilation fan - Vent clogged during inspection. Recommend cleaning.

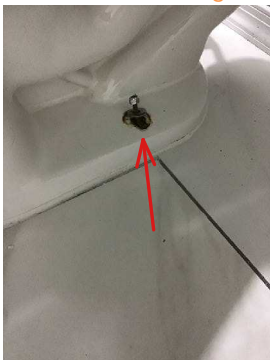
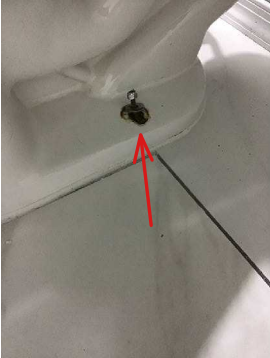
- 23. Ceiling: Texture paint
- 24. Walls: Paint
- 25. Floor: Tile
- 26. Doors: Hollow wood
- 27. Electrical: 110 VAC - Non-GFCI circuit. In addition outlets not working. Recommend further evaluation by a licensed electrician.
- 28. Counter/Cabinet: Wood
- 29. Sink/Basin: Porcelain
- 30. Tub/Surround: Fiberglass tub and fiberglass surround
- 31. Toilets: 1 1/2 Gallon Tank - **Both sides of the toilet need to be properly fastened to prevent leakage and water damage.**

11. Basement Bathroom Toilets: 1 1/2 Gallon Tank - Both sides of the toilet need to be properly fastened to prevent leakage and water damage.

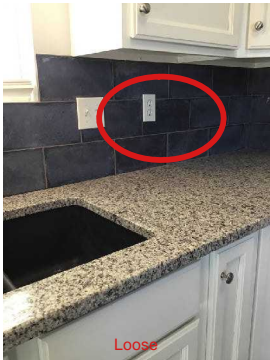
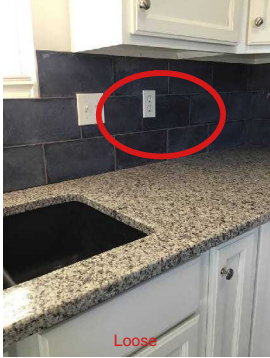
1. Cooking Appliances: Whirlpool - Electric
2. Ventilator: Broan
3. Disposal: **Does not function. The breaker assigned to this unit was tripped. A licensed plumber is recommended to evaluate.**
4. Dishwasher: Whirlpool - **Inoperative at time of inspection. Breaker in garage is switched to off position.**
5. Air Gap Present? Yes No
6. Refrigerator: Whirlpool
7. Microwave:
8. Electrical: 110 VAC GFCI - **Loose switch or outlet should be resecured**

10. 1st Floor Kitchen Electrical: 110 VAC GFCI - Loose switch or outlet should be resecured

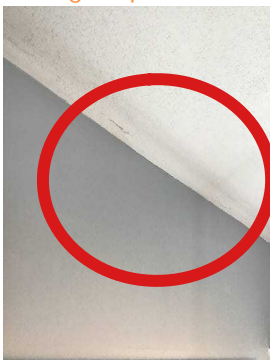
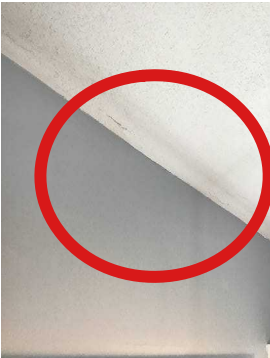
9. Counter Tops: Granite
10. Cabinets: Wood
11. Ceiling: Texture paint - **Loose or peeling paint, Water stains present. No active water leak noted during inspection.**

12. 1st Floor Kitchen Ceiling: Texture paint - Loose or peeling paint, Water stains present. No active water leak noted during inspection.

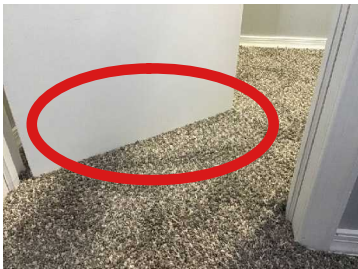
20. Closet: Walk In - Closet door was difficult to close due to dragging on carpet. Recommend repair.
