Testing of Impact-Resistant Asphalt Shingles

By Steven R. Smith, PE;
Timothy P. Marshall, PE;
and Jonathan S. Goode, PhD, PE

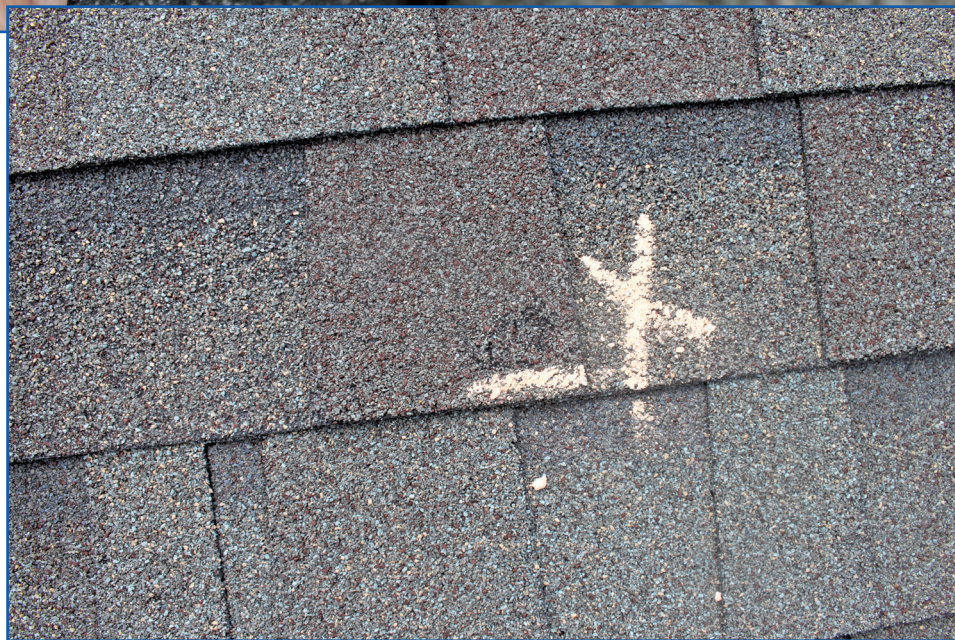
Figure 1 – Example of a hail-caused bruise looking down at the top of an asphalt shingle.

Hail damage to roofing is generally understood as a condition caused by hail that either reduces the water-shedding capability or the remaining service life of the roofing material.^{[4],[5],[6]} These criteria do not address cosmetic effects, which are beyond the scope of this paper. Regarding asphalt shingles, hail-caused damage is typically a rupture in the mat material (reinforcement). Hail-caused ruptures in asphalt shingles are often described using other terms, including fractures, tears, or bruises. These terms are synonymous when discussing hail-caused damage and should not be confused as separate conditions. The term “bruise” came about because once the reinforcement is compromised by a hail impact, a relatively soft spot (similar to a soft bruise in an apple) can be felt manually during a roof inspection. Bruises in shingles not only can be felt by tactile examination, but they can also be observed visually on the bottom sides of shingles. Even slight bruises can allow water seepage and, over time, can lead to premature weathering at the bruise. Consequently, hail-caused bruises in shingles are considered damage because they compromise the ability of the shingle to shed water. A hail-caused bruise viewed on the top of an asphalt shingle is depicted in *Figure 1* and the bottom of the same shingle at the bruise in *Figure 2*.

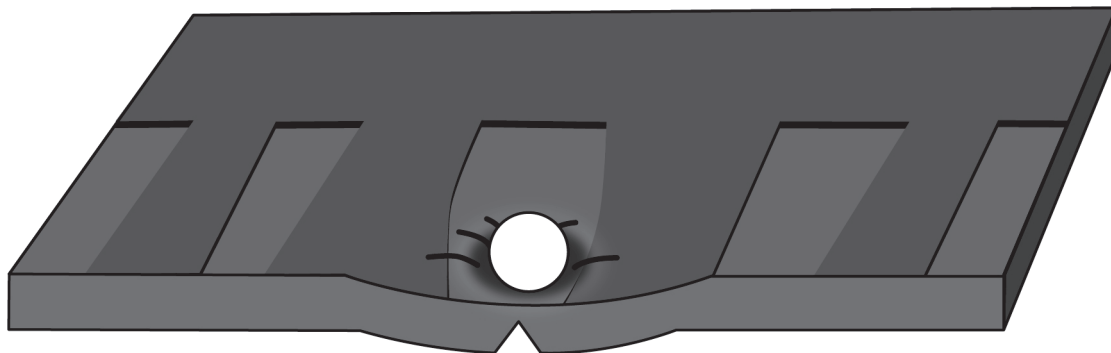
Figure 3 – Illustration depicting the formation of a hail-caused bruise/fracture in an asphalt shingle.

bottom sides of shingles because the shingles flex on impact. The flexure imparts a tensile stress on the bottom of the shingle, which can tear the reinforcement. Because most of the shingle strength is provided by the reinforcement, a bruise in a shingle means the reinforcement is fractured or substantially strained. *Figure 3* illustrates a hailstone impacting a shingle, causing a bruise/fracture.

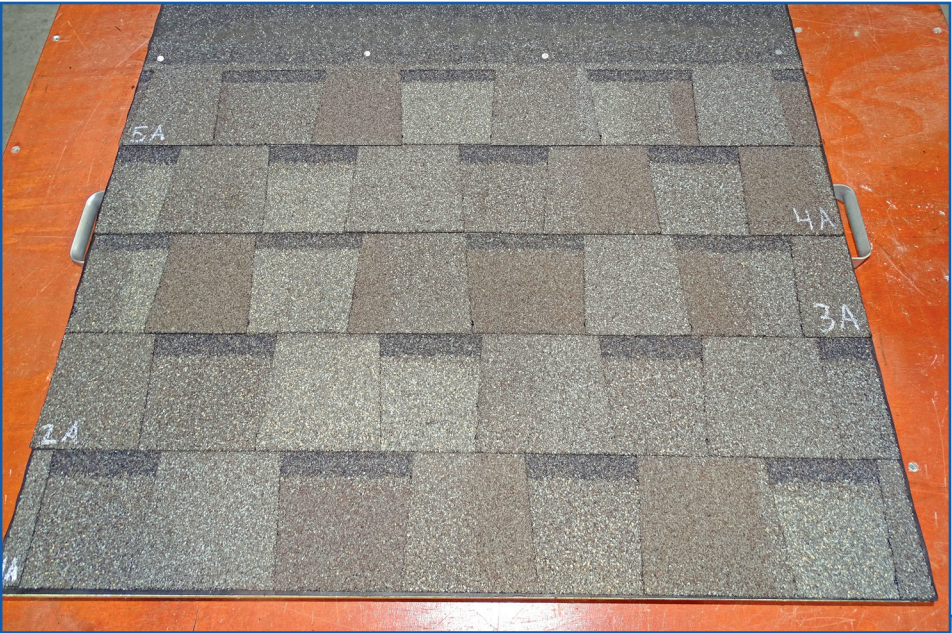
Figure 4 – Laminated shingle test panel.

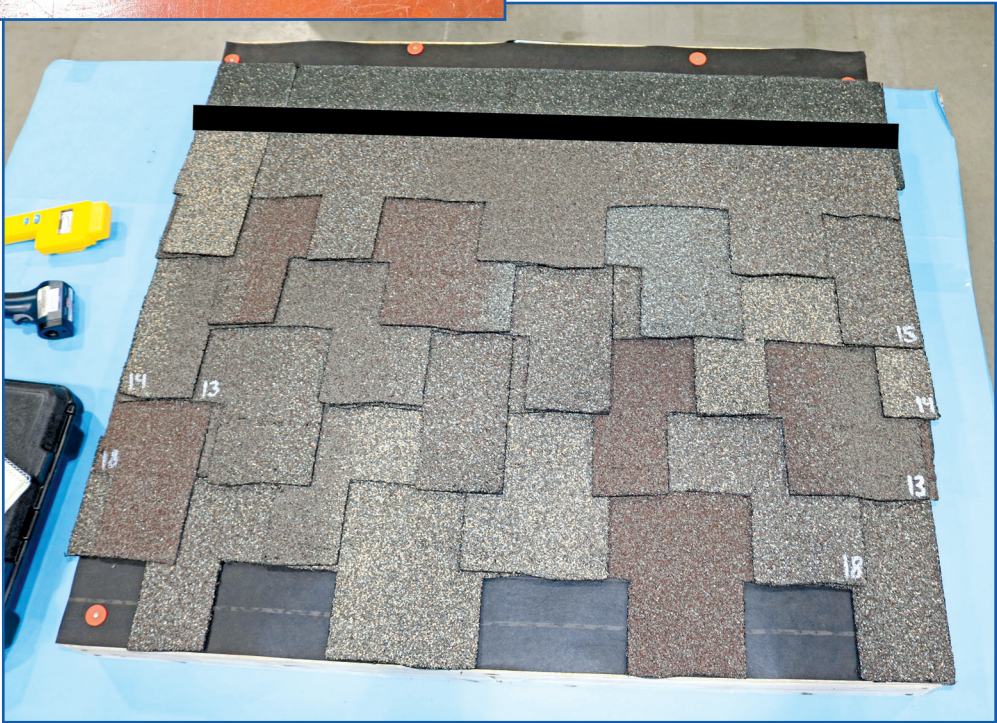
Figure 5 – High-profile shingle test panel.

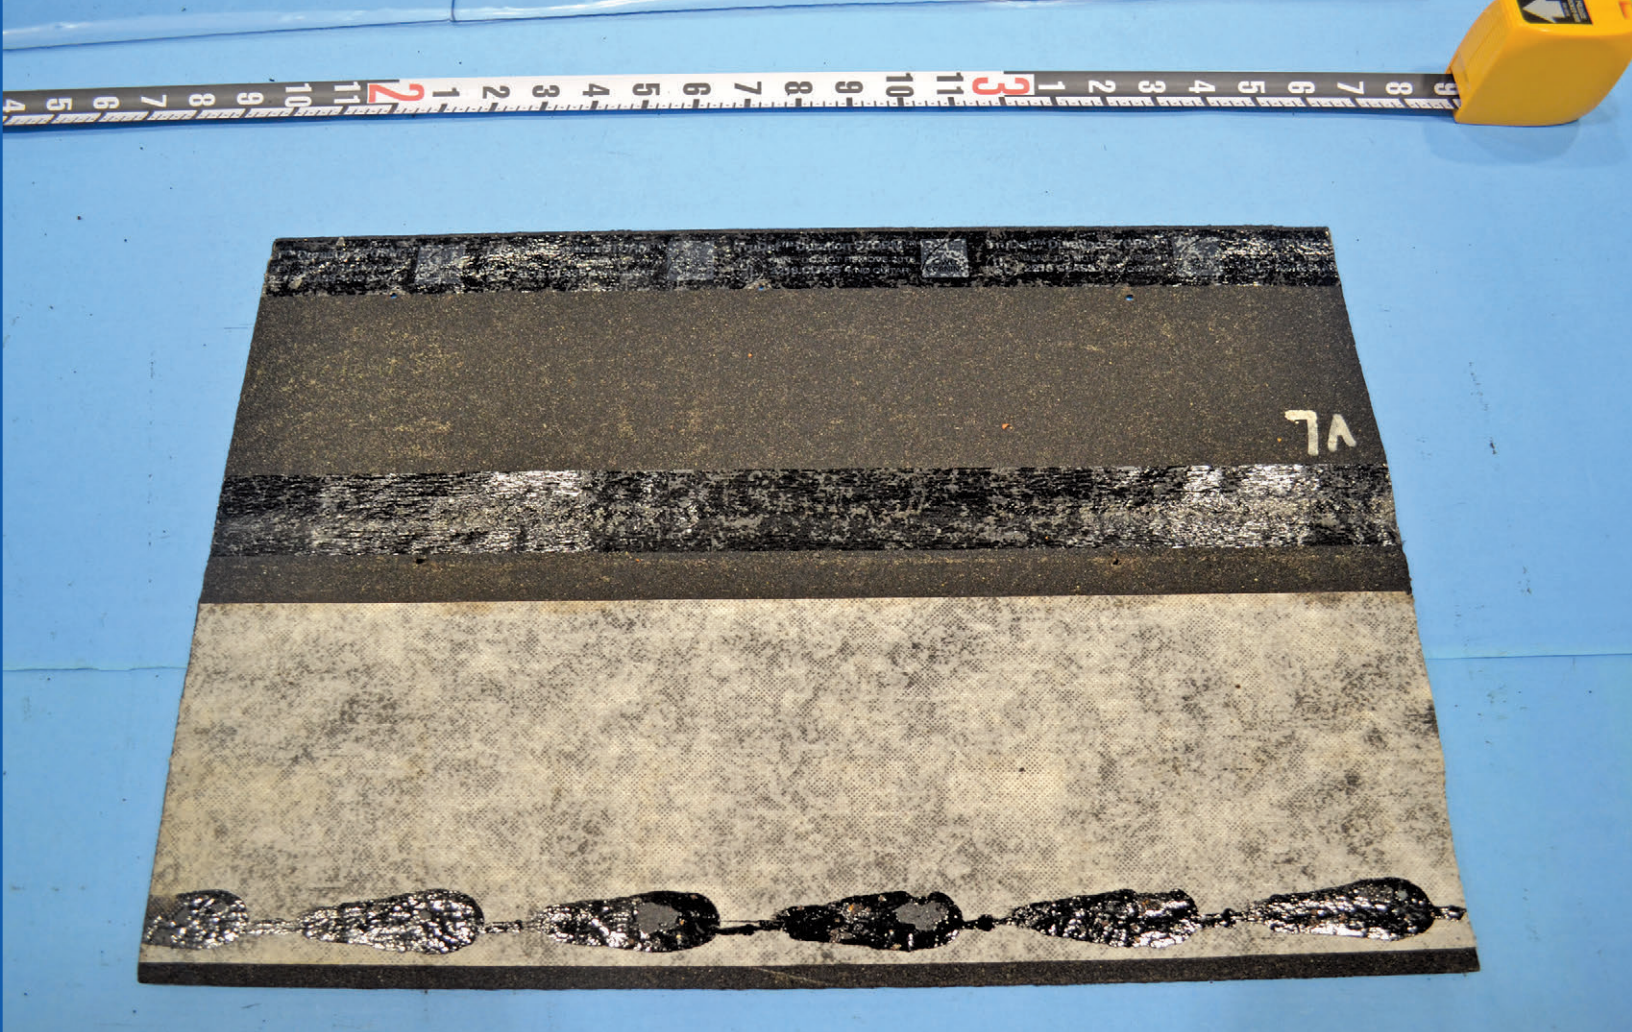
Figure 6 – Reinforced backing on an impact-resistant asphalt shingle.

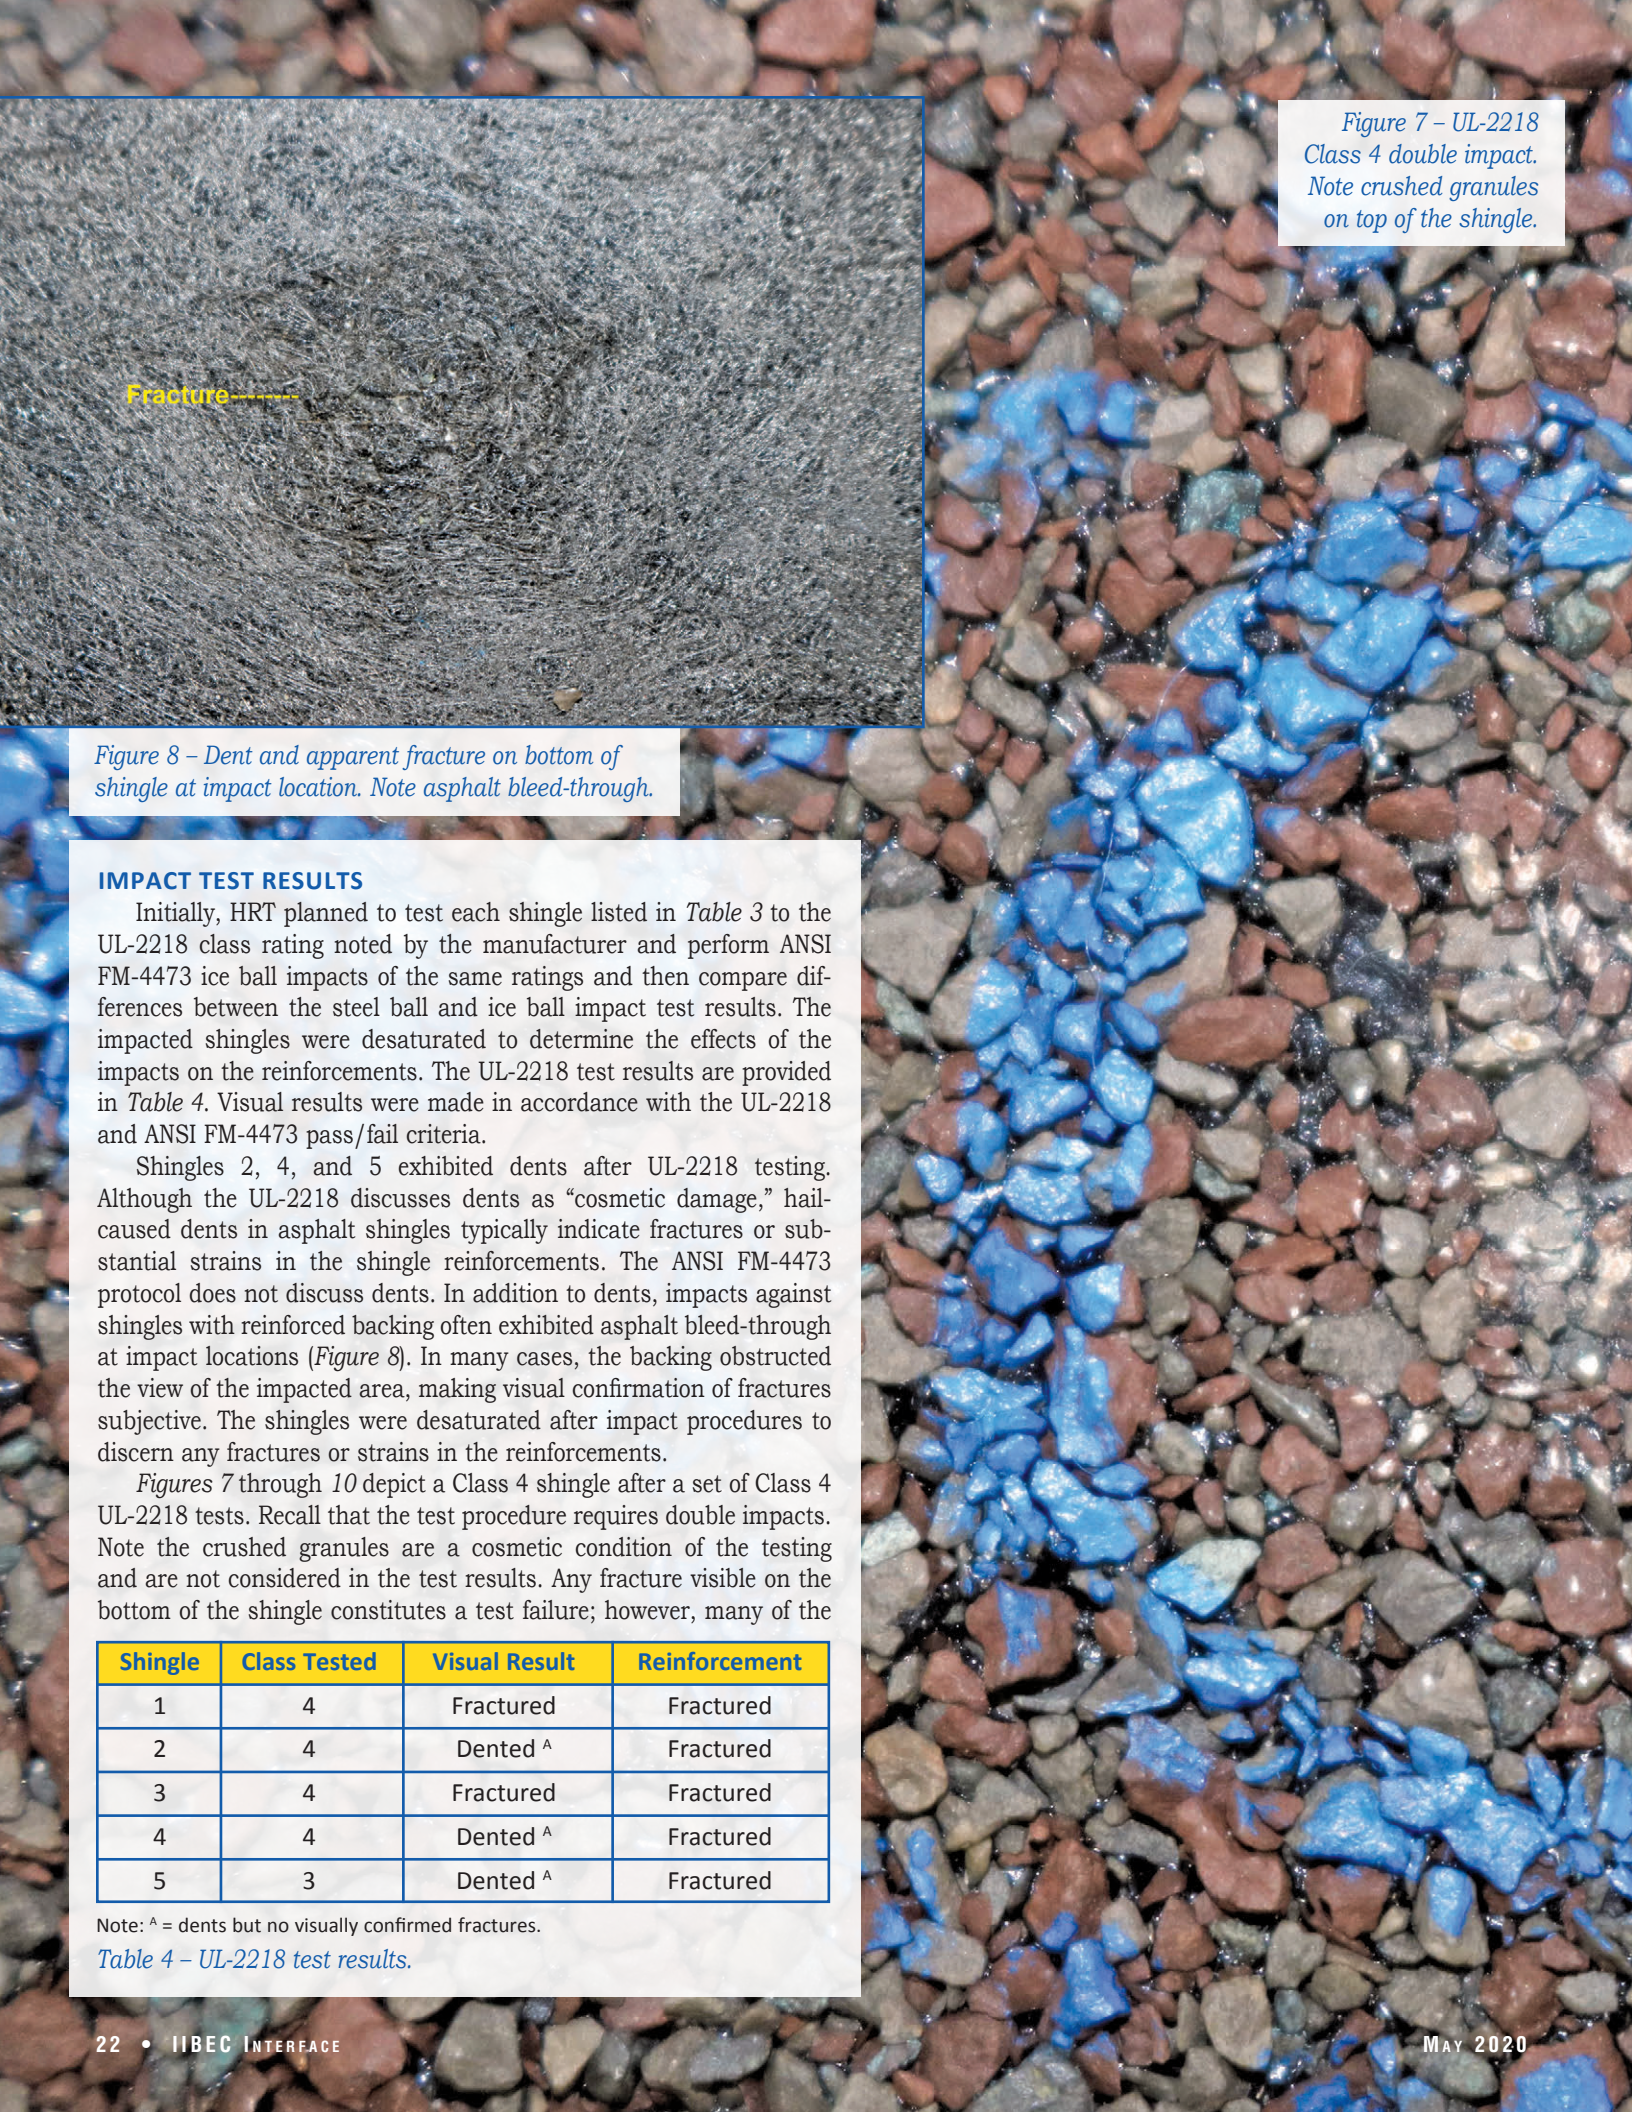
Figure 7 – UL-2218
Class 4 double impact.
Note crushed granules
on top of the shingle.

Figure 8 – Dent and apparent fracture on bottom of
shingle at impact location. Note asphalt bleed-through.

Figures 7 through 10 depict a Class 4 shingle after a set of Class 4 UL-2218 tests. Recall that the test procedure requires double impacts. Note the crushed granules are a cosmetic condition of the testing and are not considered in the test results. Any fracture visible on the bottom of the shingle constitutes a test failure; however, many of the

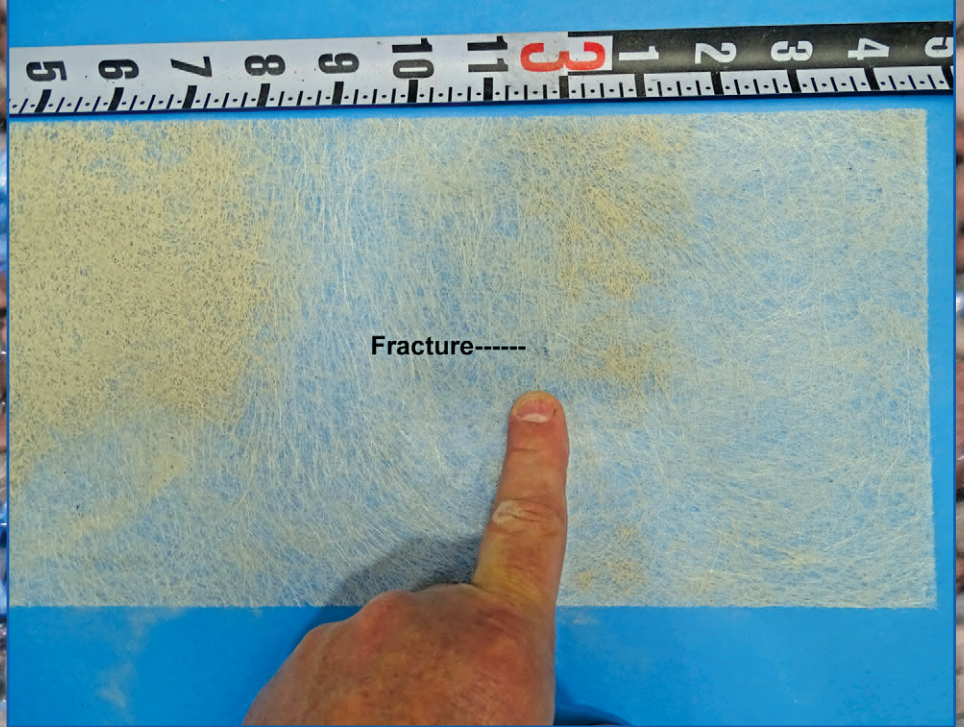
Figure 9 – Desaturated shingle pointing to the impact location.

shingles exhibited conditions that appeared to be fractures but could not be visually confirmed. Desaturation of the shingle revealed a fracture in the reinforcement, which would constitute hail damage in field inspection/evaluation.

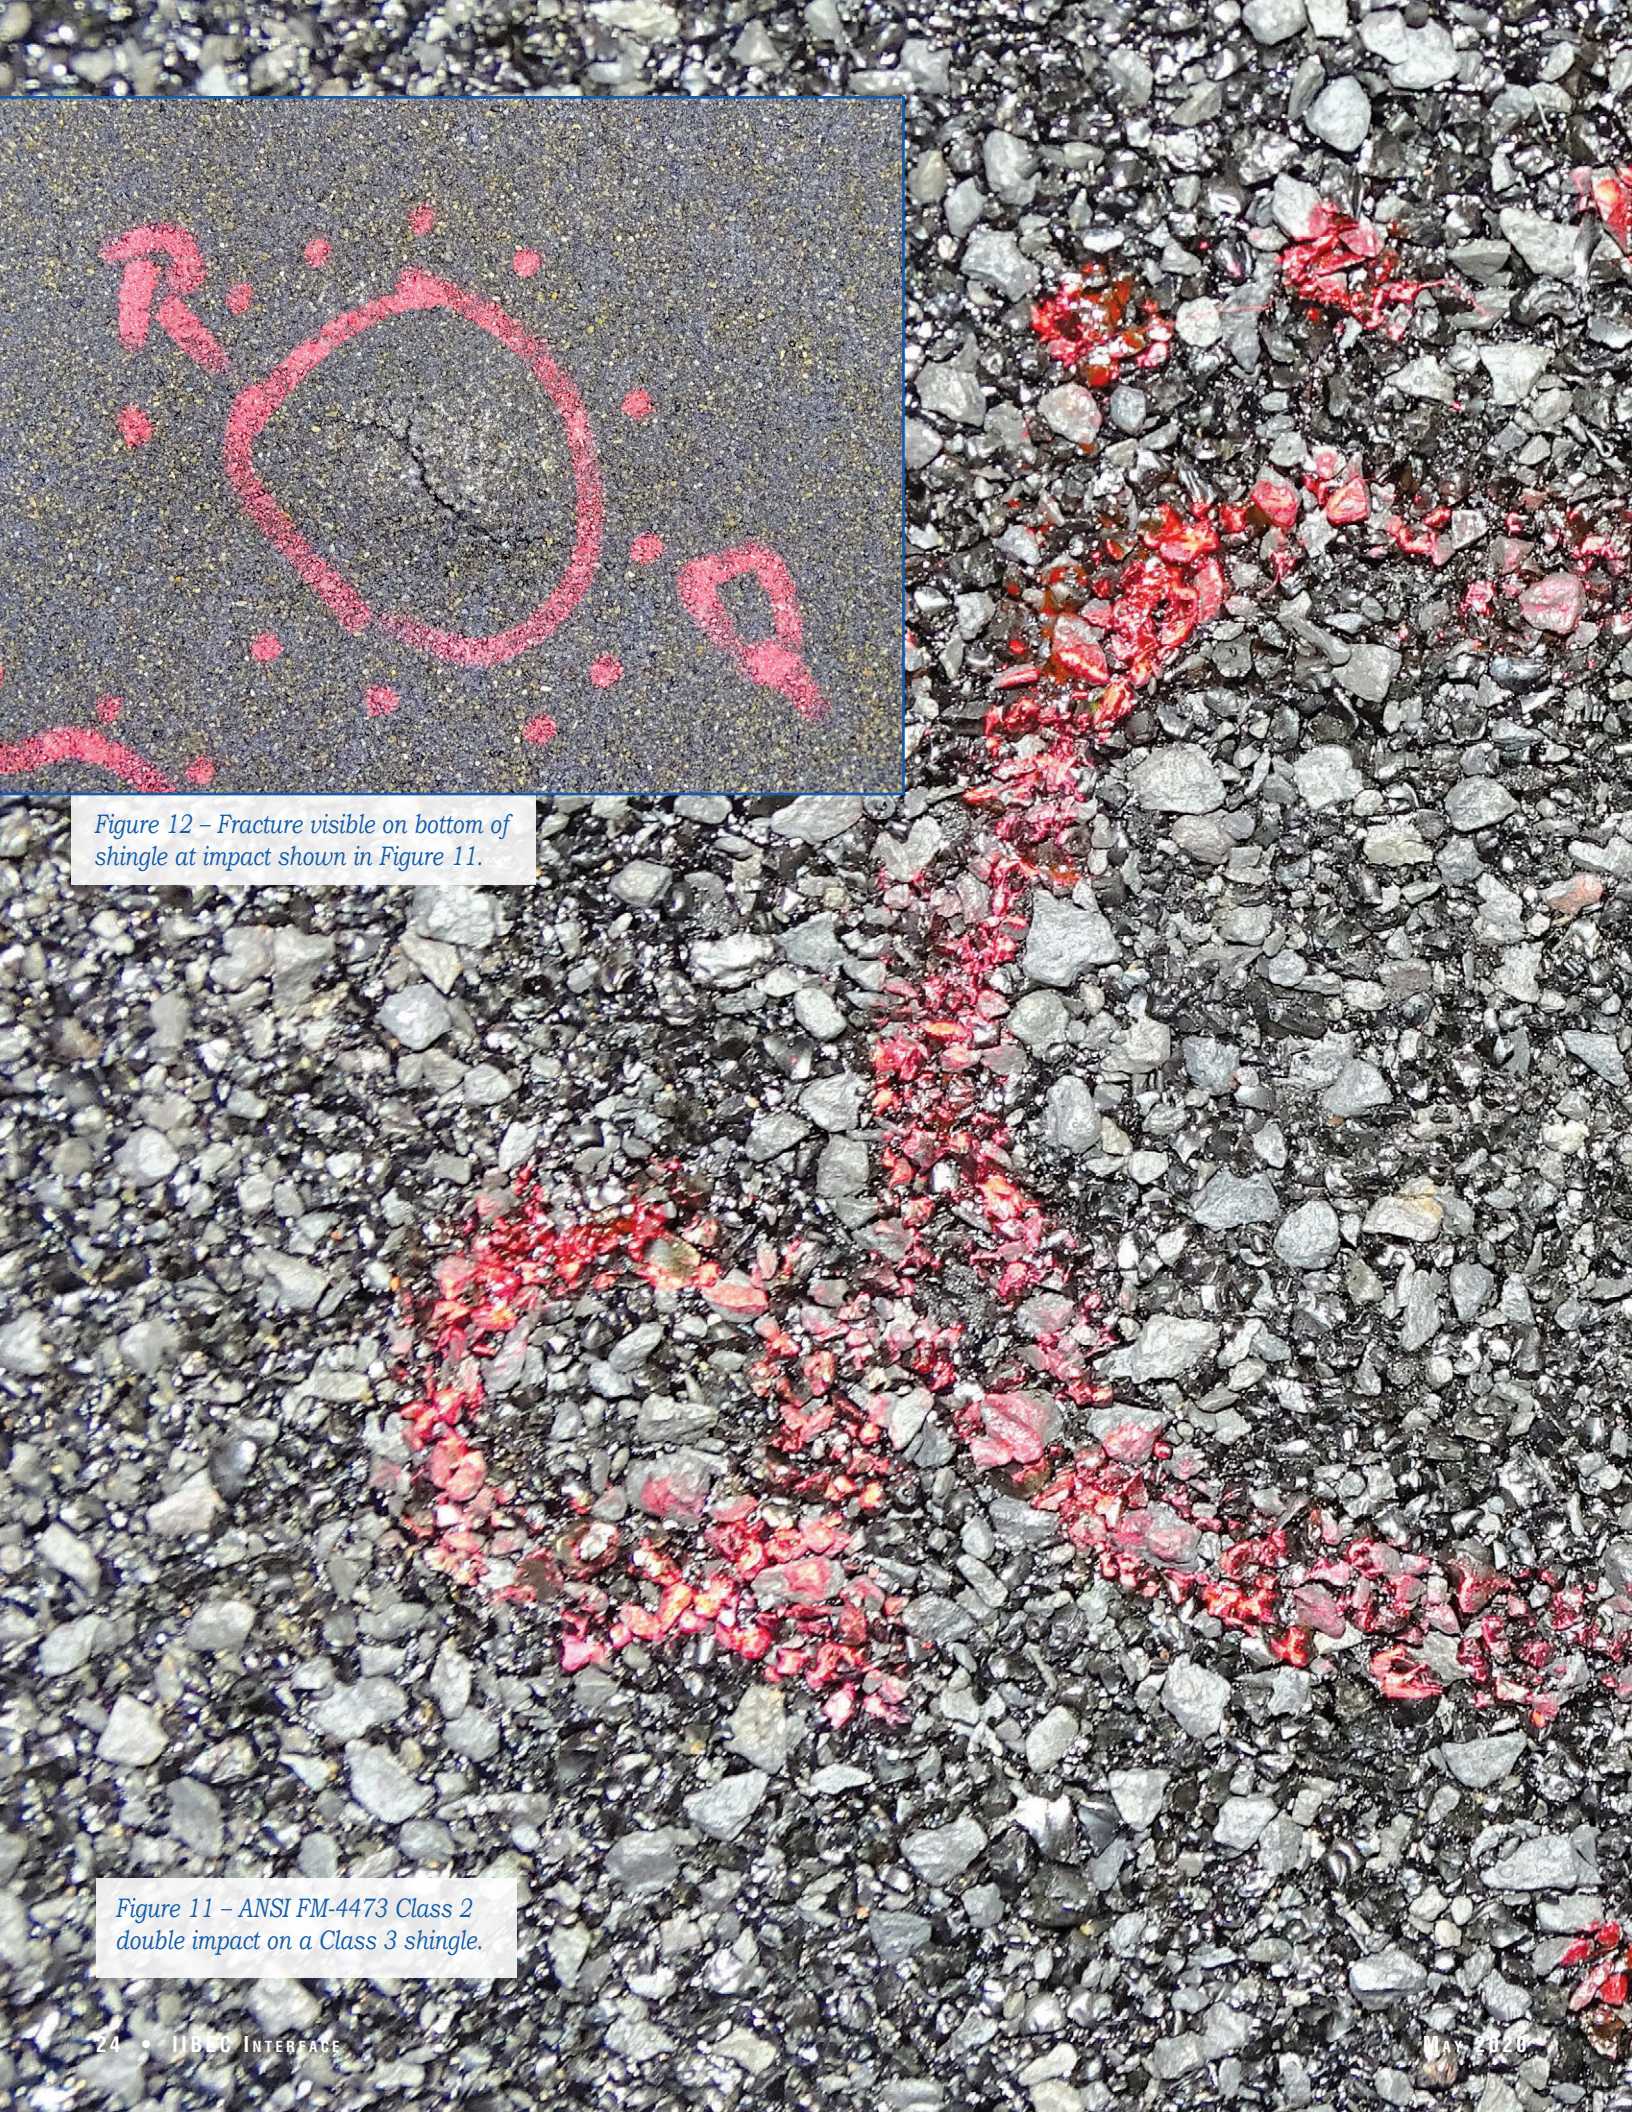
Figure 12 – Fracture visible on bottom of shingle at impact shown in Figure 11.

Figure 11 – ANSI FM-4473 Class 2 double impact on a Class 3 shingle.

Figures 11 through 14 depict the Class 3 shingle after a set of Class 2 double impacts per the ANSI FM-4473 standard. Note the granules did not crush, but a clear fracture was detected on the bottom side of the shingle. Desaturation of the shingle revealed a fracture in the reinforcement at the impact location.

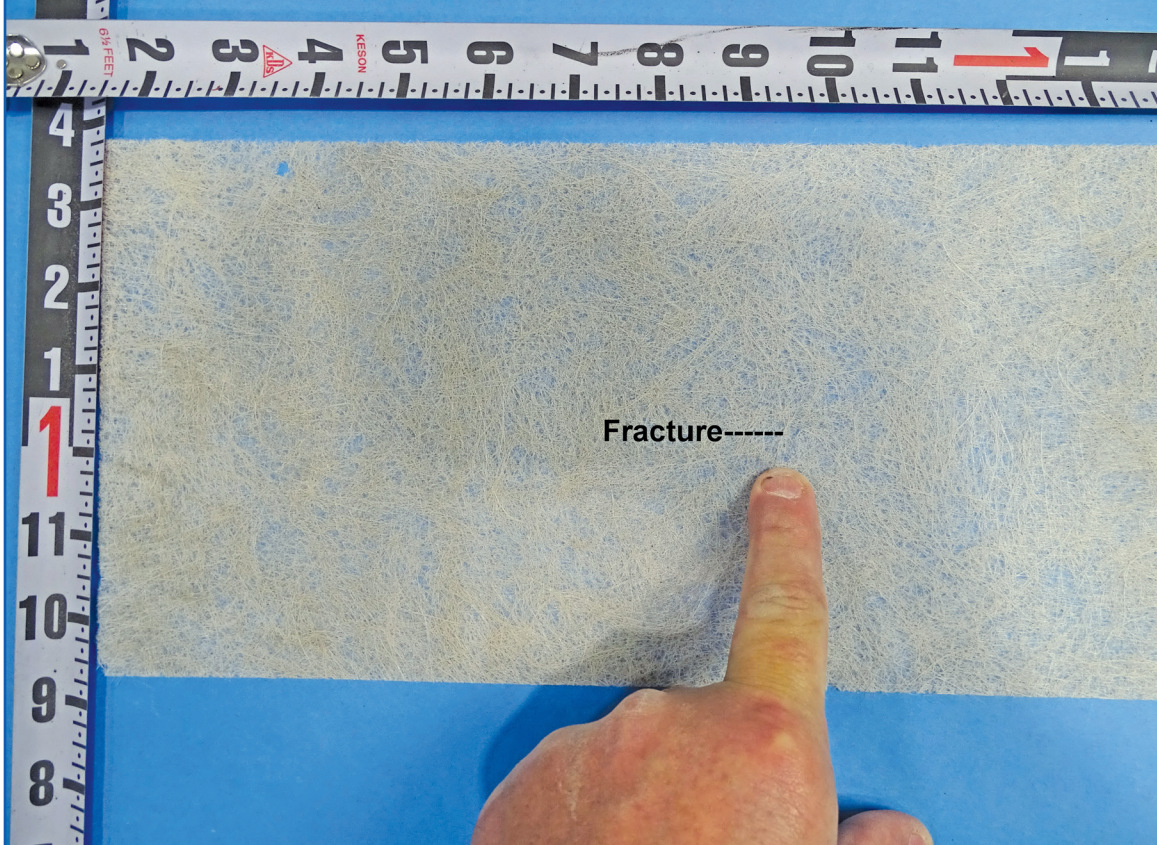
Figure 13 – Desaturated Class 3 shingle showing fractured reinforcement.

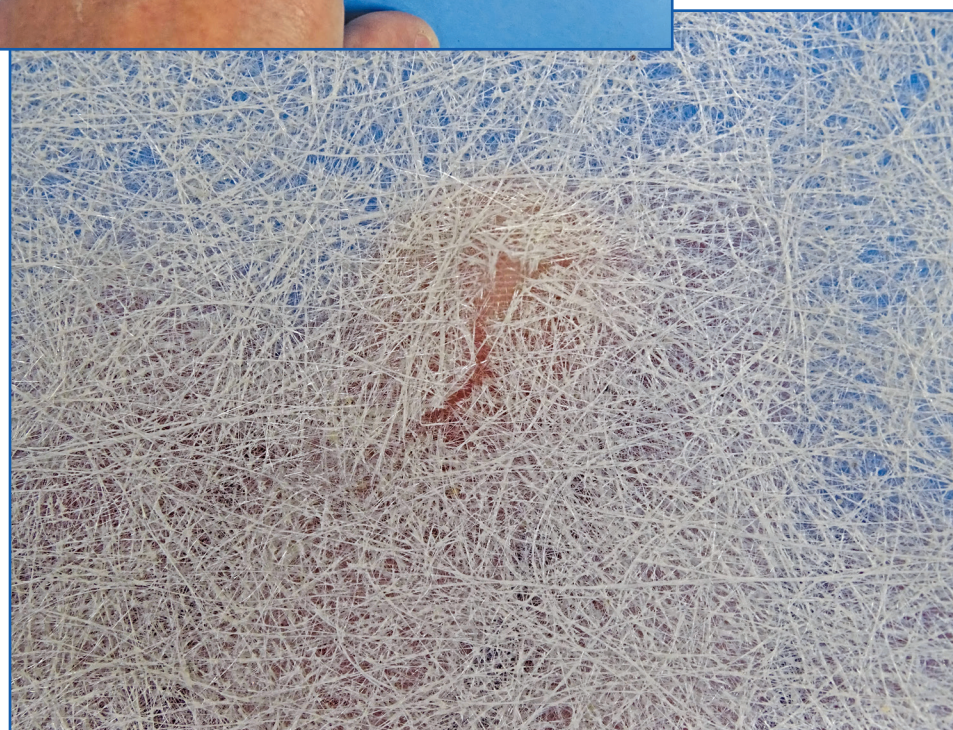
Figure 14 – Close-up of fracture in reinforcement shown in Figure 13.
