1981 48 Delta/LeClerq Combination Fishing
"FV: Mattea Marie"

Report of Marine Survey

Report of Condition/Valuation

"FV: Mattea Marie"

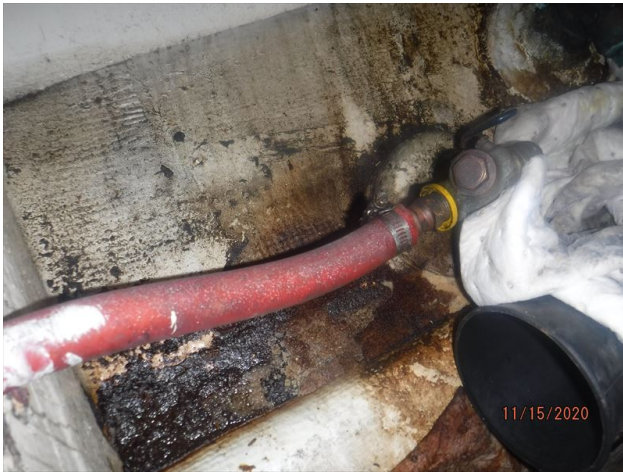
No significant water was observed collecting in the bilges. General cleaning of the bilges under the engine is recommended.

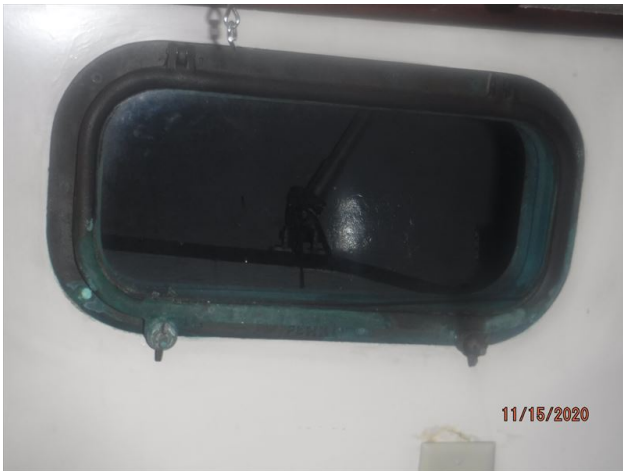
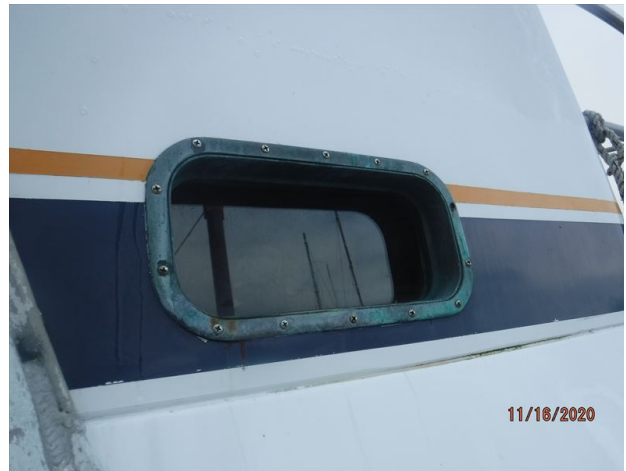
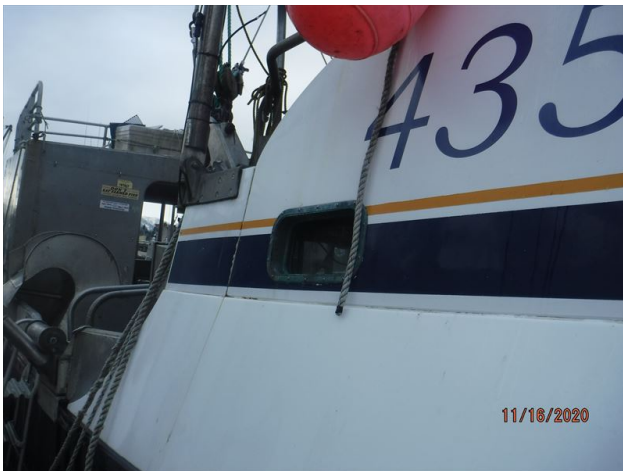
FINDING C-1

Opening bronze and tempered glass port lights Monitor frequently for signs of leakage.

Master stateroom port light is exhibiting signs of possible leakage

Investigate further, and service, repair or replace as necessary.

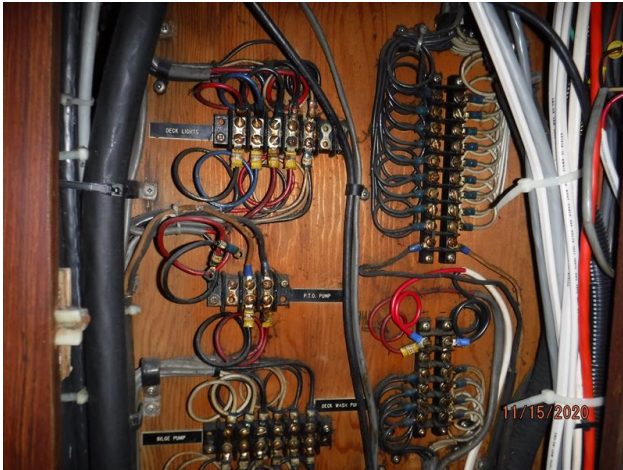
FINDING B-3

Appeared to be well supported and secured, where sighted some exceptions were observed (see Findings Appendix).

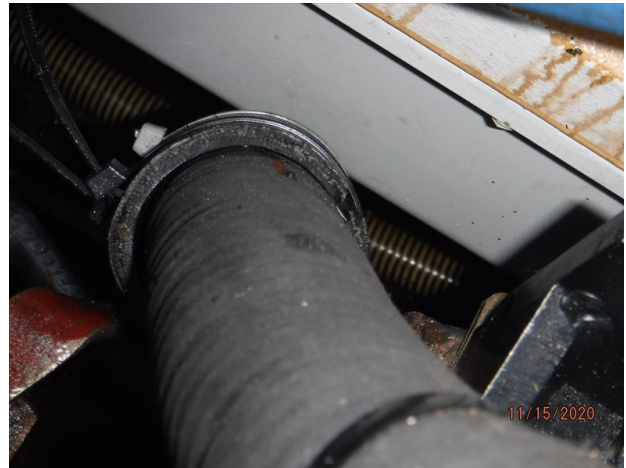
The cooling hoses were blistered, worn

Inspect all hoses and replace the hoses with appropriate type, as necessary.

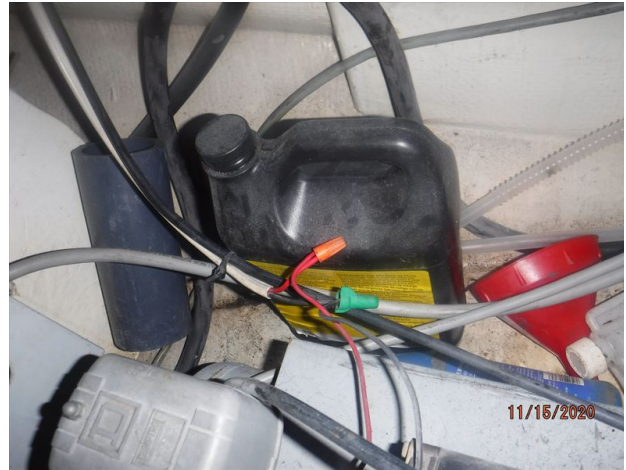
Appeared to be well supported and secured, where sighted some exceptions were observed (see Findings Appendix).

Replace wire nut connections with Marine Grade insulated butt connections (wire nuts are approved for solid household type wiring only).

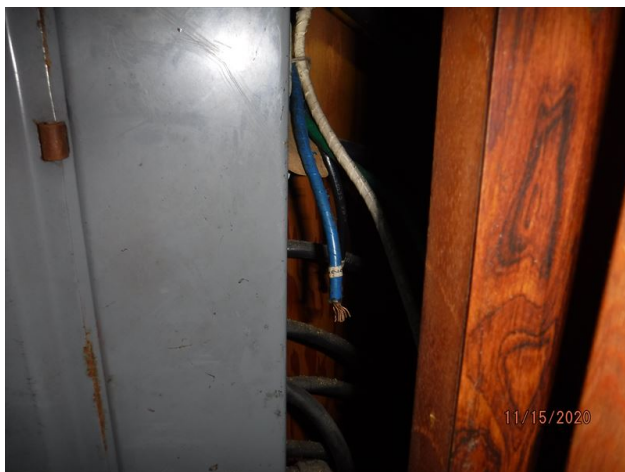
Appeared serviceable for intended use where sighted, except where noted.

Protect and insulate the bare wire ends
