### 1962 Southeast Alaska Limit Seiner "F/V: Karen Jean"

# **Report of Marine Survey**

**Report of Condition/Valuation**

**"F/V: Karen Jean"**

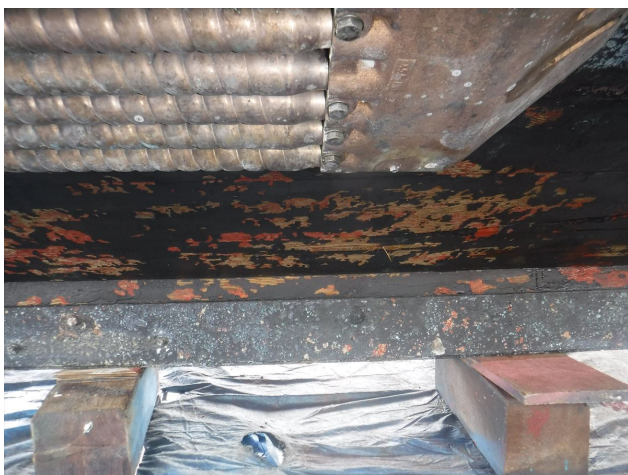
Unseen inside the boat except in the lazarette. Outside looking at the exterior there appeared to be some slight impact/scraping damage port side inboard of the keel cooler. Wood planks appear serviceable.

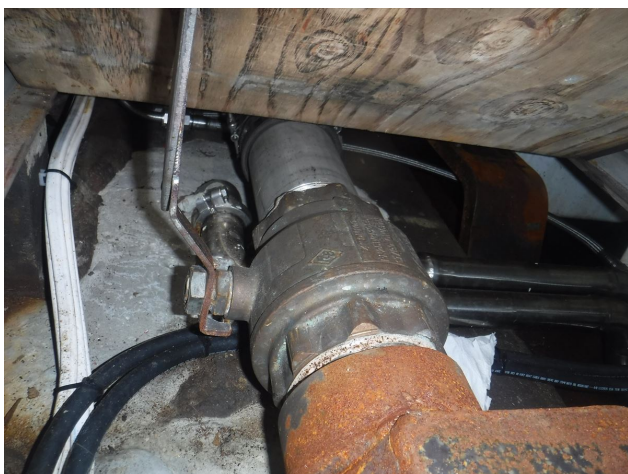
Seachest Raw water seacocks were bronze alloy ball valve type. Lubricate, exercise and monitor frequently. Recommend performing maintenance on all seacocks & sea-strainers annually (disassemble, inspect, clean and lubricate). It is also recommended that all below the waterline and near the waterline thru-hulls have a proper sized wooden plug attached to function as an emergency plugging device.

seacock valve shunting off the main sea chest that leads to the refer (stainless, yellow handle) appeared to be excessively stiff. When working the valve it loosened up considerably.

Service/lubricate or rebuild/replace the seacocks to ensure emergency operation, as necessary.

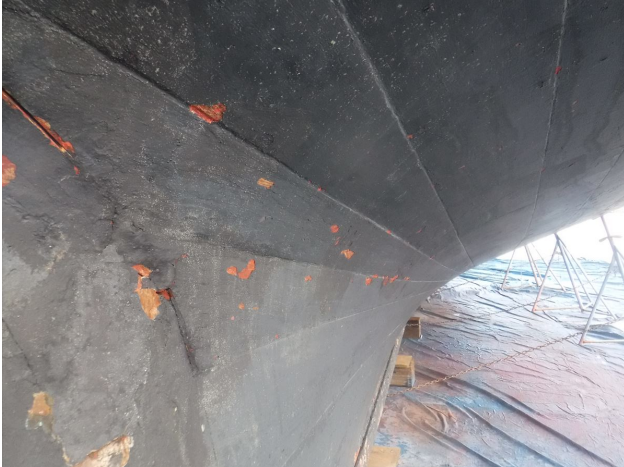
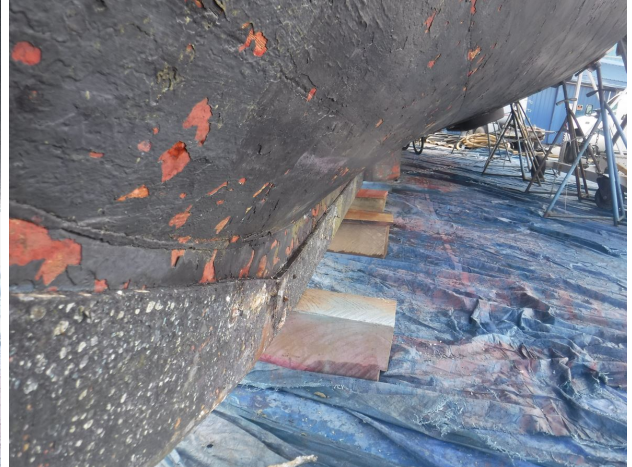
The antifouling bottom paint appeared to be nearing the end of its serviceable life and was flaking off/failing in several areas, with slight marine growth also observed along the hull's wetted surfaces.

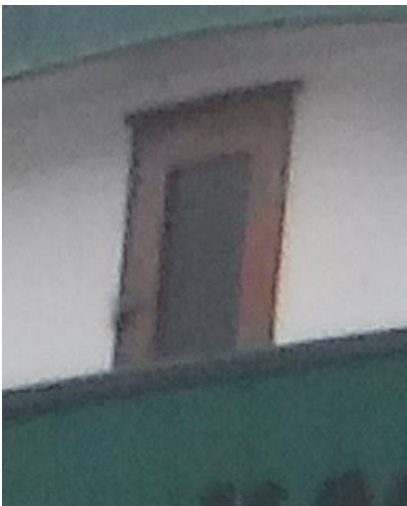
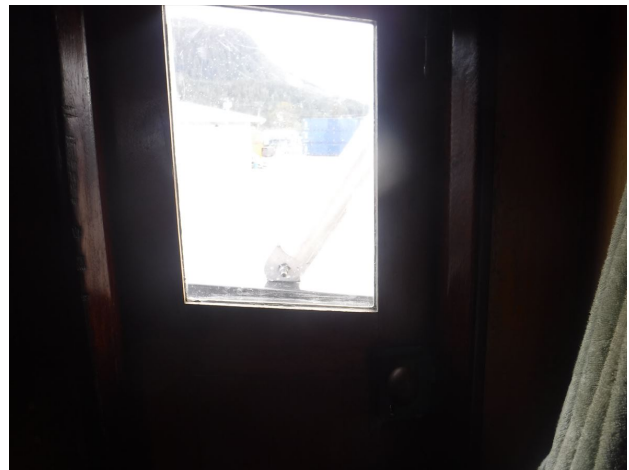
Stainless steel aft cabin door, 2 dogs, double Dutch made by Freeman, 3 wood (starboard of center aft cabin wood door is a store room access, port side wood door is head access, forward cabin starboard wood door is for front cabin access and part of the secondary means of egress vessel emergency plan), 1 aluminum two dog windowed aft tophouse weather deck access.

The door is working as intended and accessible. This note is a reminder. Please keep access clear

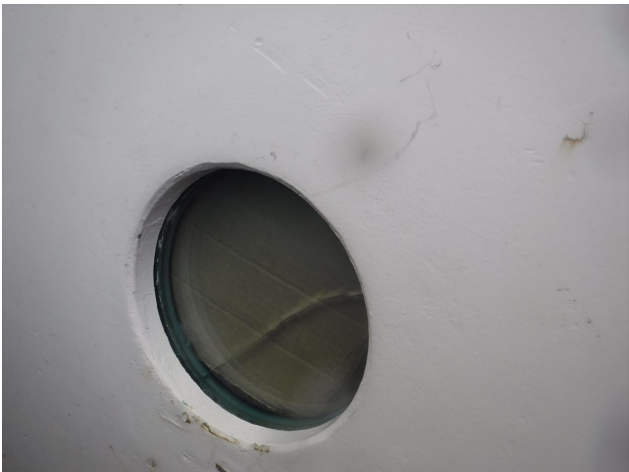
<b>FINDING C-1</b>
Lower cabin port light is cracked
<b>RECOMMENDATION</b>
Investigate further, and service, repair or replace as necessary.

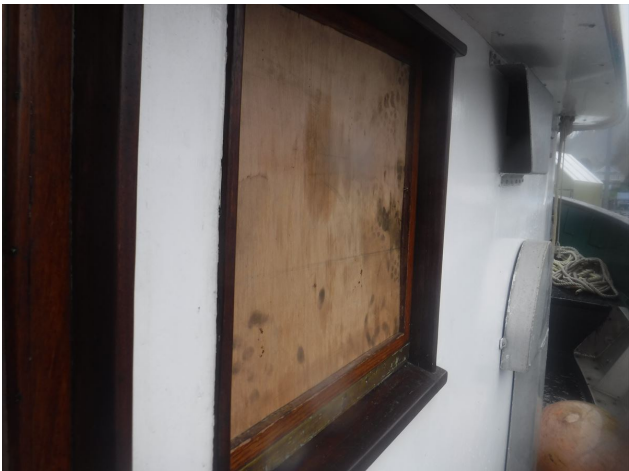
<b>FINDING C-2</b>
Galley window was found to be missing.
<b>RECOMMENDATION</b>
Replace the broken window glass, as necessary.
