1981 45' C&L Raised Pilothouse Trawler "SHENANDO"

Report of Marine Survey

Report of Condition/Valuation of the vessel

July 1, 2020

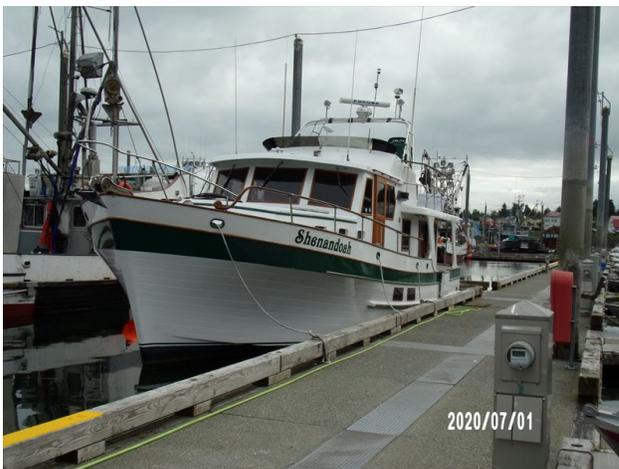
The exterior of the vessel appeared to be generally well kept. There is some staining on the aft salon bulkhead that should be removed.

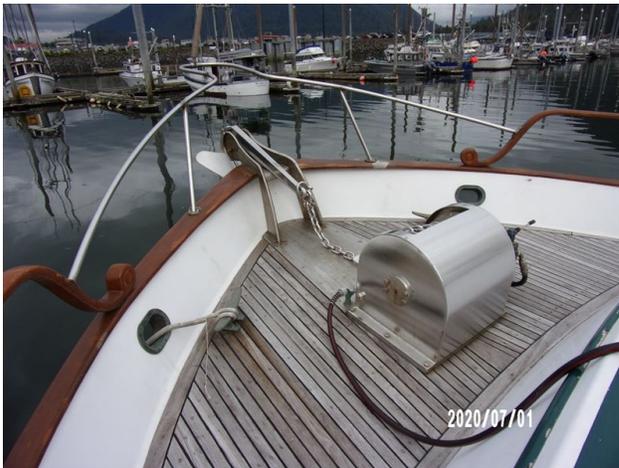
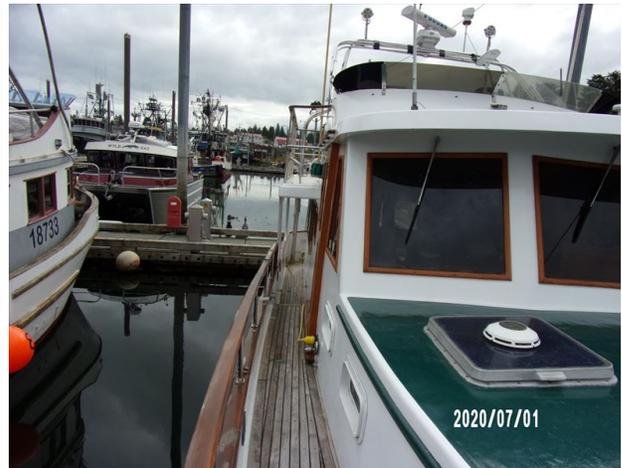
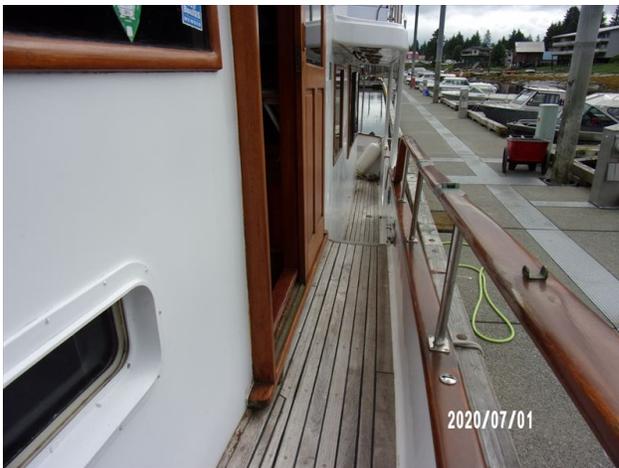
Teak aft deck, side decks and foredeck . The decking varnish is worn, weathered and due to be refinished.

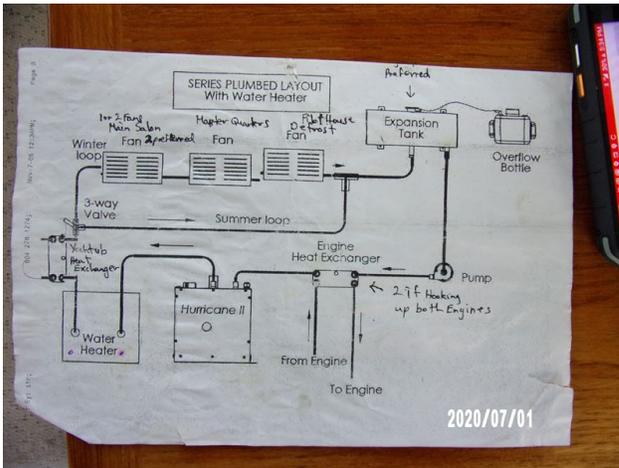
There were various portable space heaters aboard. The Hurricane furnace heating system has been diagrammed, The document is kept onboard
