## Scott Heitman Marine Survey

**1977 60' Steel, Combination Fishing Vessel, Rigged for Summer Salmon Tendering.**

**"f/v: Demo Man's Fish Boat"**

**Report of Condition/Valuation**

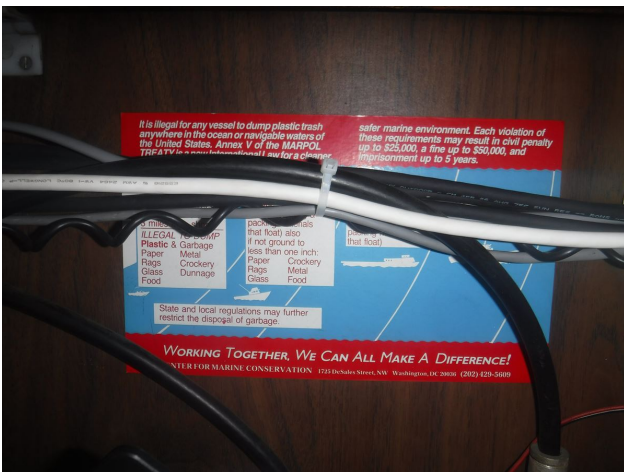
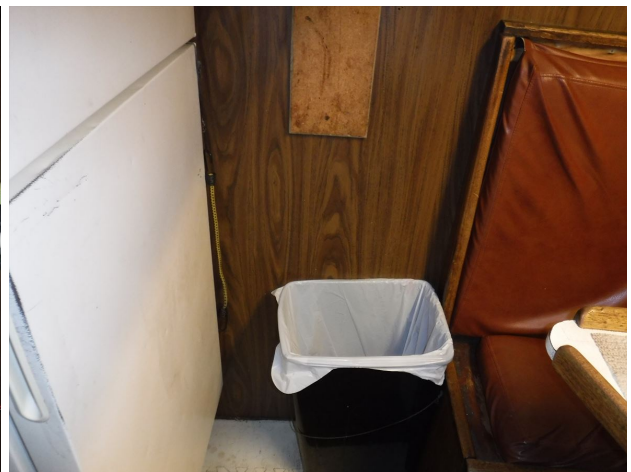
### FINDING C-2

Observed on board, but may be not properly displayed. Properly display if necessary.

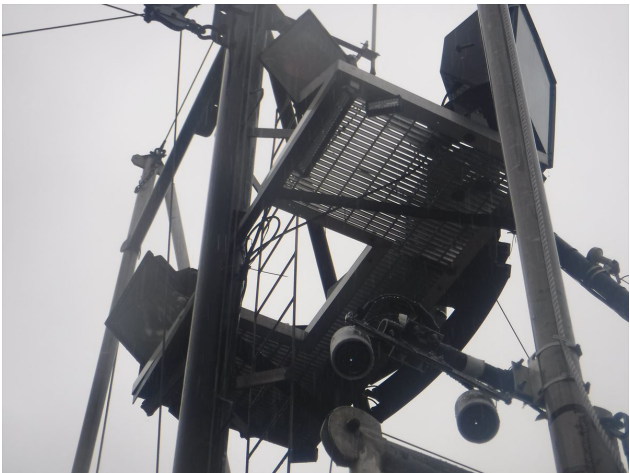
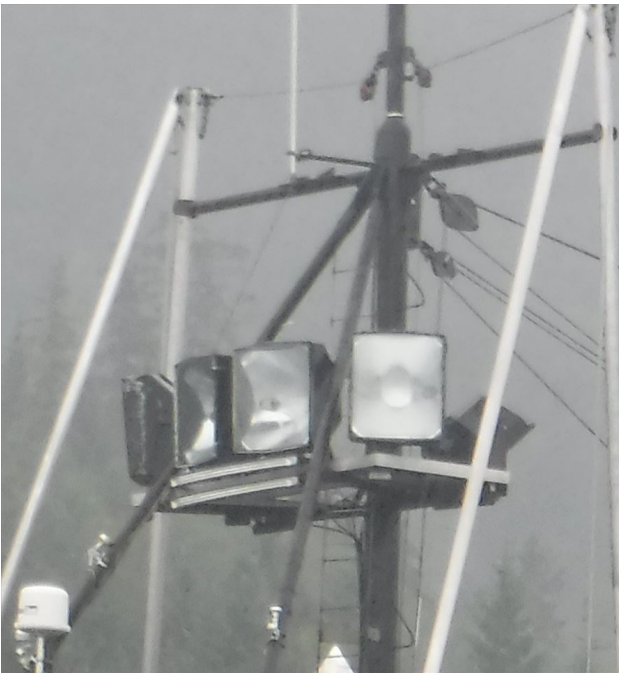
<b>FINDING B-1</b>
No protective railings around the mast work platform
<b>RECOMMENDATION</b>
fabricate and mount safety rails around the platform

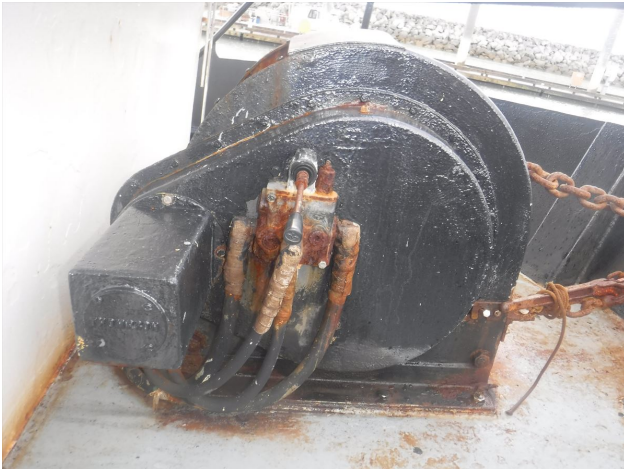
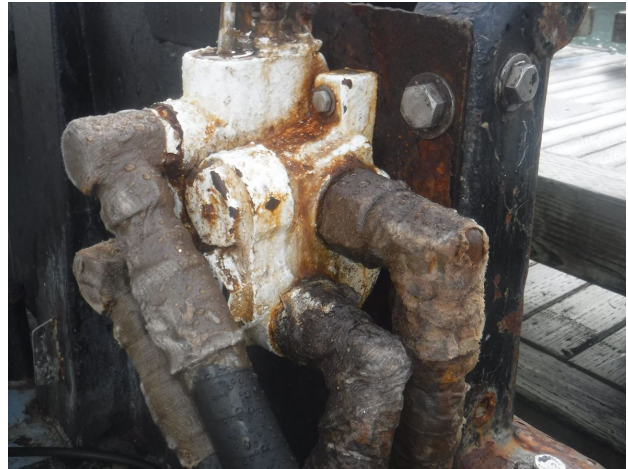
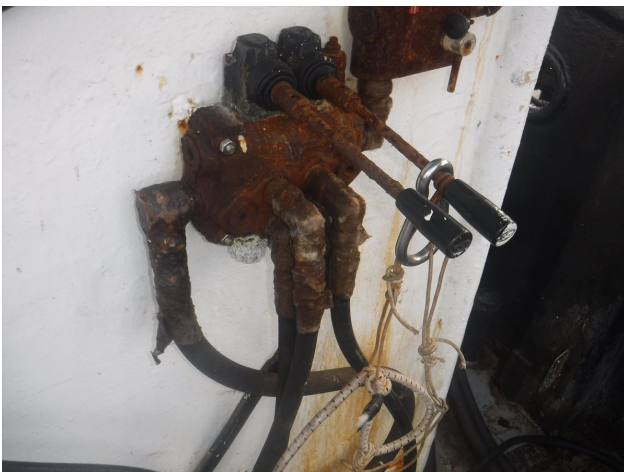
The tape appears worn and dry. The fittings are due for retaping.

rewrap fittings and valves or replace and wrap as needed

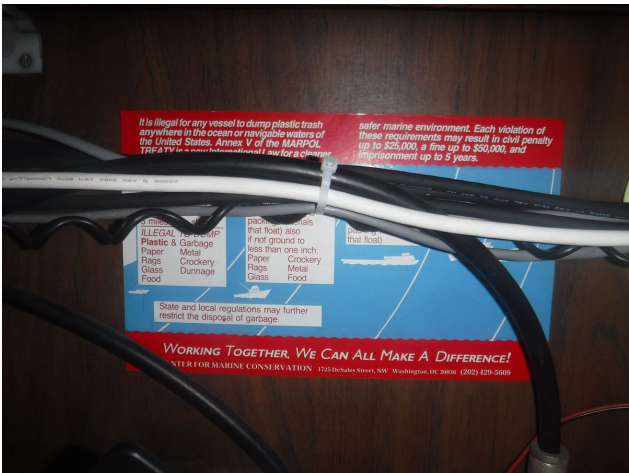
Observed on board, but may be not properly displayed. Properly display if necessary.

<b>FINDING C-2</b>
A "Garbage Disposal Rules" Placard was observed onboard. Displayed on the bridge
<b>RECOMMENDATION</b>
Display approved Pollution Placard to comply with USCG regulations for Trash dumping and plan (33 CFR 151.59). Required on vessels over 26' in length. Investigate further

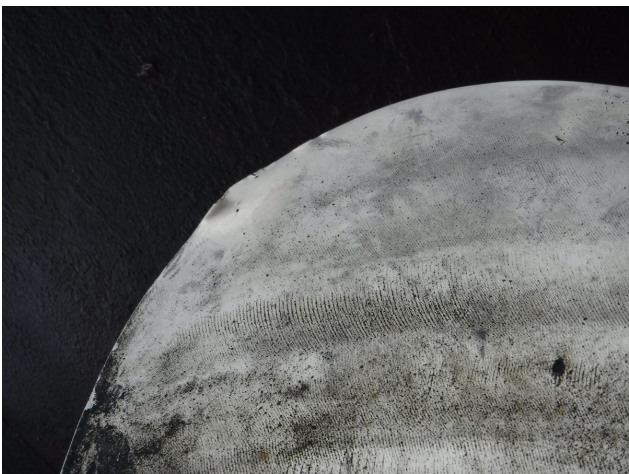
Bronze, right hand 3-blade, 42 pitch note some slight impact damage.

<b>FINDING C-3</b>
The port propeller blade had an impact ding.
<b>RECOMMENDATION</b>
Investigate further, and recondition the propeller as necessary.

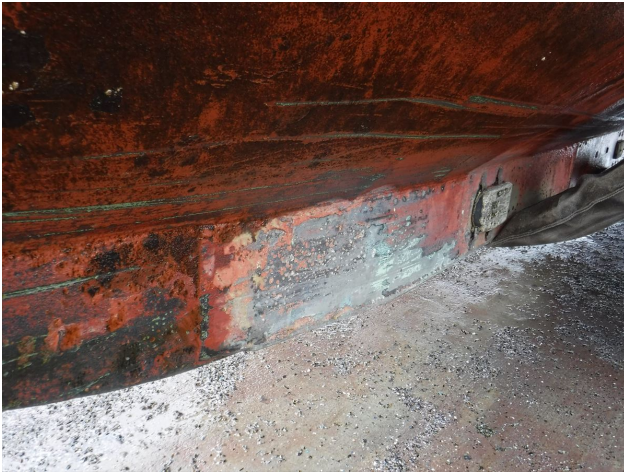
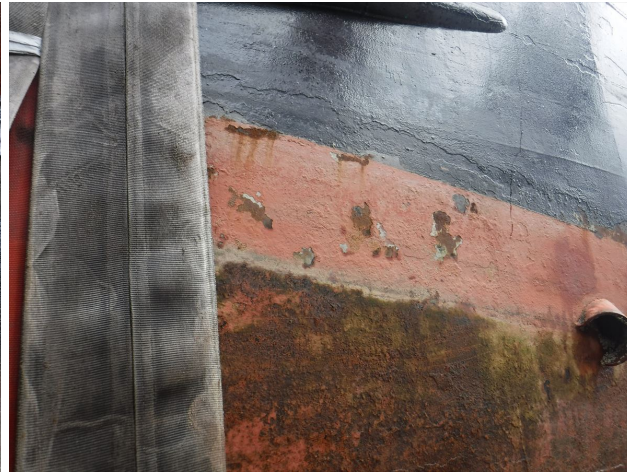
The antifouling bottom paint appeared to be nearing the end of its serviceable life and was flaking off/failing in several areas, with slight marine growth also observed along the hull's wetted surfaces.

Clean, prepare and repaint, as necessary.
