1982 58' Delta Limit Seiner, Combination Fishing
"F/V: Artaios"

Report of Marine Survey

Report of Condition/Valuation of the Fishing Vessel

Inspected on November 21-22, 2020

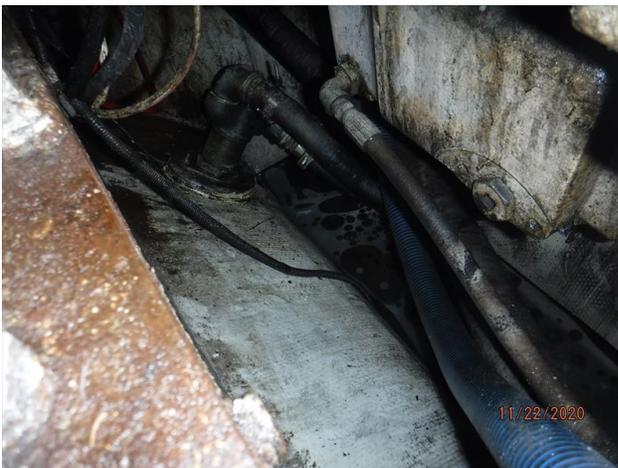
No significant water was observed collecting in the bilges. General cleaning of the bilges under the engine is recommended.

Each vessel must comply with the oil pollution prevention requirements of 33 CFR parts 151 and 155.350. In order that stray oil in the bilges will not migrate to the bilge pumps the vessels bilges should be cleaned or wiped down with sorbents. I also recommend placing sorbent logs in the bilges either side of the pumps.

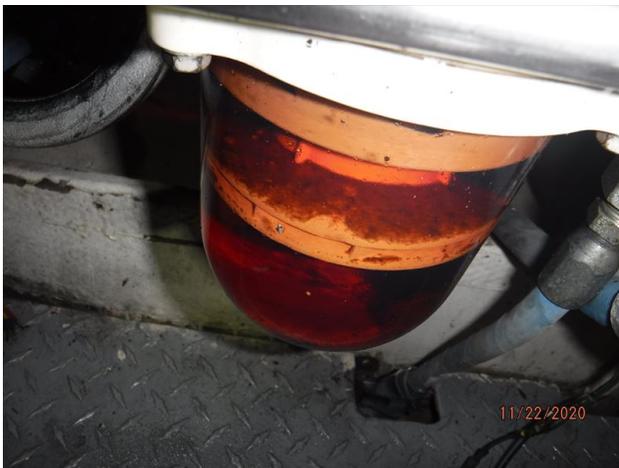
Slight sediment was observed in the generator Primary fuel filter's sight bowl and on its diffuser. Monitor and service often.

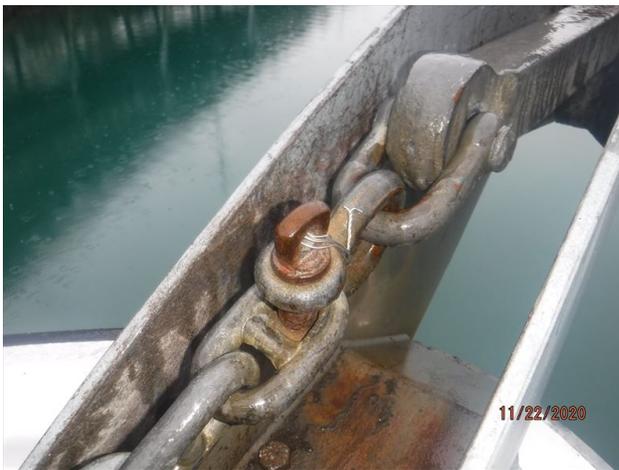
Appeared serviceable, galvanized, seized with stainless steel wire, except where noted

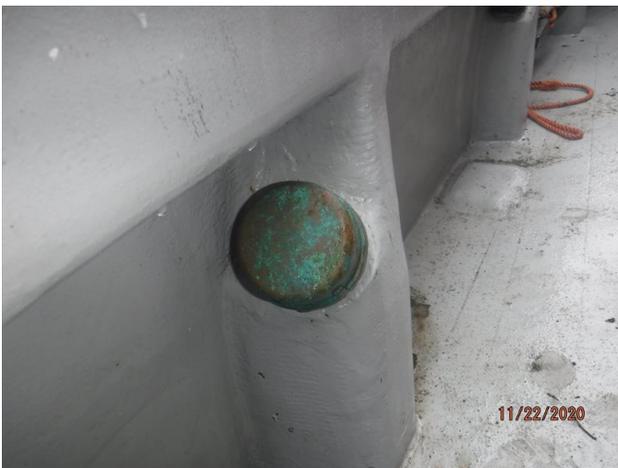
The fuel fill fittings were NOT clearly marked as to fuel type.

Label fuel fills to identify as fuel fill.

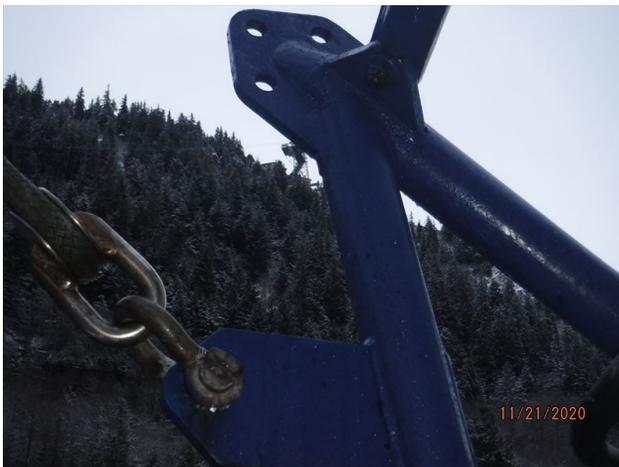
Some of the clevises are unprotected from unintentional loosening at the standing rigging. chapter 3-2 SHIP'S GEAR AND RIGGING PROCEDURES, part d safety and inspection sub part 4 mousing

Seize the pins closed with stainless steel wire

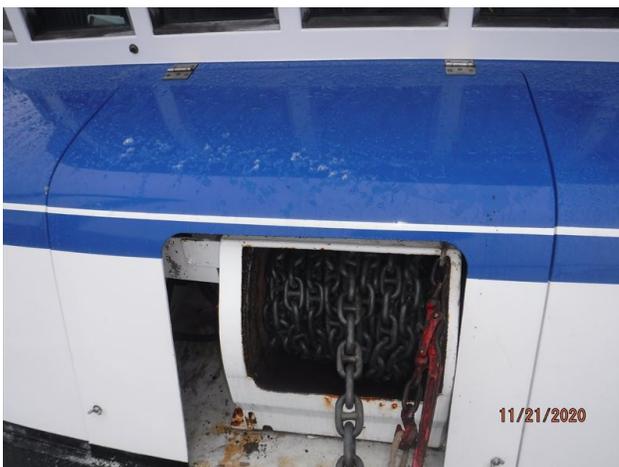
Missing stainless steel flat washer at the anchor cowl toggle bolt port side

Replace the washer to protect the fiberglass cowl from damage
