Inspection Report

4567 Avenida Bolivar Sierra Vista AZ 12345

Date: 11/8/2018	Time: 11:00 AM	Report ID: 20181108-4567-Avenida-Bolivar
Property: 4567 Avenida Bolivar Sierra Vista AZ 12345	Customer: Mr. John McDougal	Real Estate Professional:

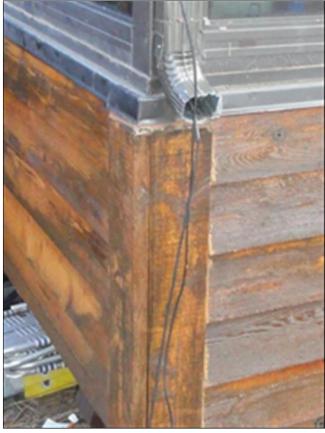
E. Item 1(Picture)

E. Heat tape was installed along the gutter and downspout at the sunroom eave. This should be checked periodically for operation during the winter months.

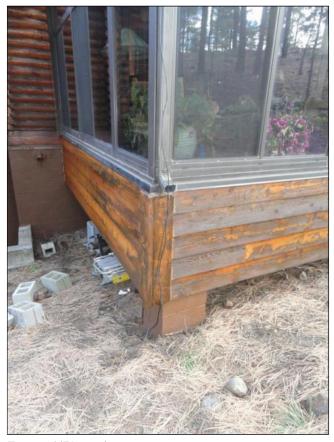
F. Item 1(Picture)

The downspout on the sun room should be directed so the water does not infiltrate the earth near a footing.

▲ F. The downspout on the sun room should be directed so the water does not infiltrate the earth near a footing.

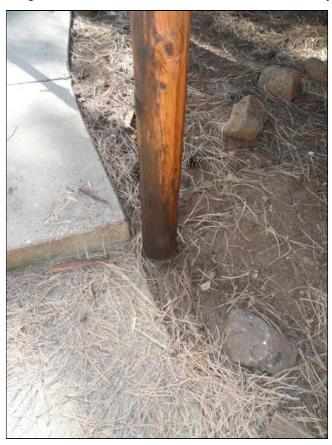
H. Item 1(Picture)

H. There are a couple locations where the earth and pine needles should be pulled away from some wood framing and shingle members. This should be done at least once a year.

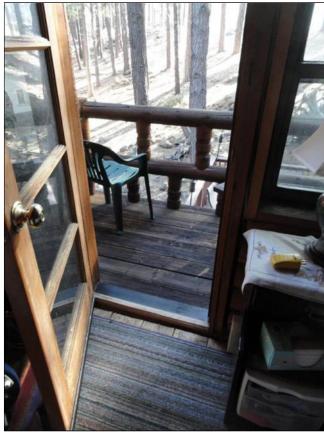
J. Item 1(Picture)

- **J.** Although the balcony guardrails may have complied with the building safety standards in effect at the time of original construction and were built with the log cabin aesthetic, they do not meet generally-accepted current standards and may be hazardous to small children. Current standards include the following:
 - 1. A 4 inch sphere may not pass through the guardrail at any point
 - 2. The guardrail should not be climbable (especially by children).
 - 3. Minimum guardrail height is 36 inches
 - 4. Any walking surface 30 inches or more above grade should have a guardrail.

The deck failed to meet safety standard number 1 and 2. A qualified contractor could be contacted for options and costs for updating this condition.

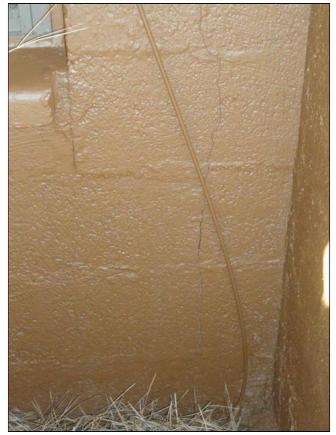
A. Item 1(Picture)

A. There is a couple locations where the CMU wall has cracked at some time in the past. This house is 40 years old and the cracks appear to be stable.

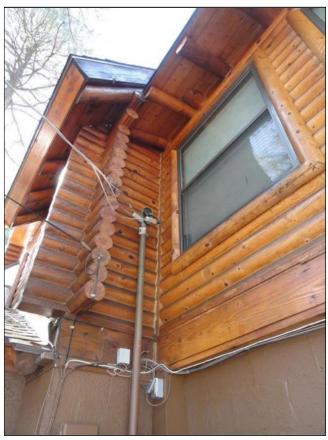
D. Item 1(Picture)

4567 Avenida Bolivar Page 17 of 36 **D.** Current electrical code requires a 3 foot setback for the weatherhead to the windows.

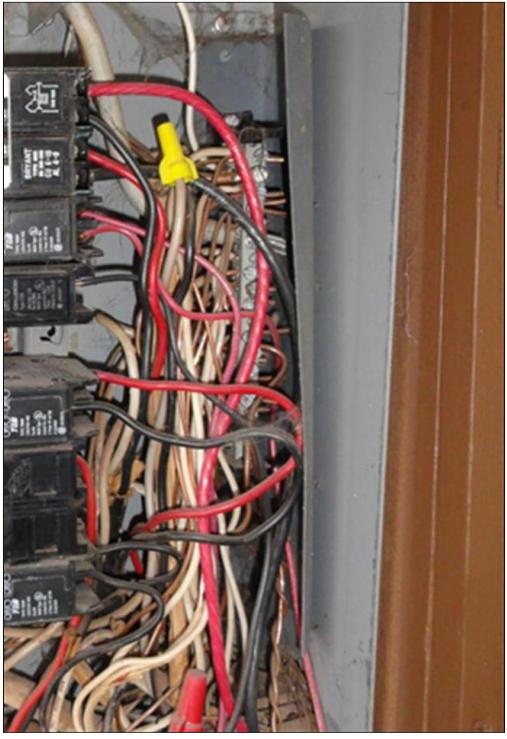
J. Item 1(Picture)

J. (1) Ground and Neutral wires run to same bus. Have a qualified electrician evaluate power panel.

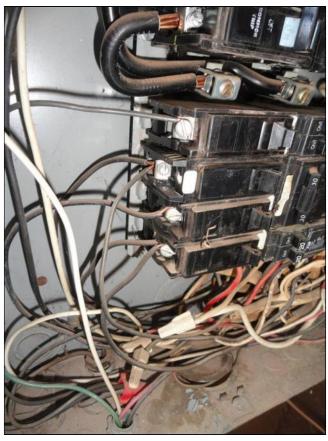
J. Item 2(Picture)

(2) In the service panel, two conductors were installed in a lug designed for only one. This condition may be improper. The inspector recommends an inspection by a qualified electrical contractor.

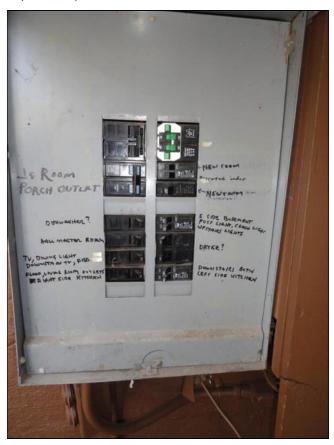
J. Item 4(Picture)

(4) This panel requires 7 switch throws to turn all the power off where 6 maximum is standard. Have a qualified electrician inspect this panel.

⚠ (4) This panel requires 7 switch throws to turn all the power off where 6 maximum is standard. Have a qualified electrician inspect this panel.

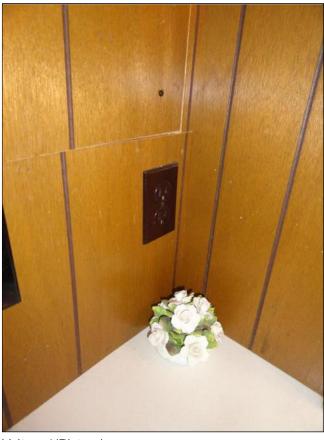
V. Item 1(Picture)

(1) No ground fault circuit interrupter (GFCI) protection of the basement or third floor bathrooms were provided in the home at the time of inspection. Although GFCI protection may not have been required at the time the home was built, for safety reasons, the Inspector recommends that electrical receptacles located in basements, crawlspaces, garages, the home exterior, and interior receptacles located within 6 feet of a plumbing fixture be provided with ground fault circuit interrupter (GFCI) protection in good working order to avoid potential electric shock or electrocution hazards. This can be achieved relatively inexpensively by: 1. Replacing an individual standard receptacle with a GFCI receptacle. 2. Replacing the electrical circuit receptacle located closest to the overcurrent protection device (usually a breaker) with a GFCI receptacle. 3. Replacing the breaker currently protecting the electrical circuit that contains the receptacles of concern with a GFCI breaker.

4567 Avenida Bolivar Page 22 of 36 ▲ V. (1) No ground fault circuit interrupter (GFCI) protection of the basement or third floor bathrooms were provided in the home at the time of inspection. Although GFCI protection may not have been required at the time the home was built, for safety reasons, the Inspector recommends that electrical receptacles located in basements, crawlspaces, garages, the home exterior, and interior receptacles located within 6 feet of a plumbing fixture be provided with ground fault circuit interrupter (GFCI) protection in good working order to avoid potential electric shock or electrocution hazards. This can be achieved relatively inexpensively by: 1. Replacing an individual standard receptacle with a GFCI receptacle. 2. Replacing the electrical circuit receptacle located closest to the overcurrent protection device (usually a breaker) with a GFCI receptacle. 3. Replacing the breaker currently protecting the electrical circuit that contains the receptacles of concern with a GFCI breaker.

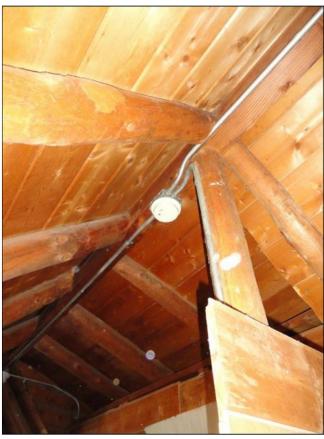
E. Item 1(Picture)

E. There was a permanent, hard-wired smoke detector at the third floor ceiling. Since the third floor has no bedroom doors, this may work well. The master bedroom had a battery powered smoke and CO detector which was battery powered. Smoke detector placements appeared to be adequate except: a smoke/CO detector should be installed near the water heater and boiler locations. Smoke detectors are not tested as part of a general home inspection. The Inspector recommends that all detectors be checked to confirm that they don't need battery replacement.

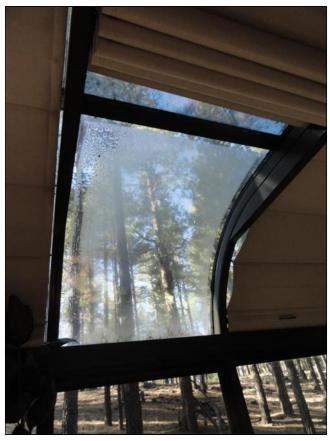
G. Item 1(Picture)

🛕 11 All the windows that were checked appeared to be operational and in good order. The exception is a curved, insulated window unit in the sunroom which had moisture between the glass.

⚠ **G.** All the windows that were checked appeared to be operational and in good order. The exception is a curved, insulated window unit in the sunroom which had moisture between the glass.

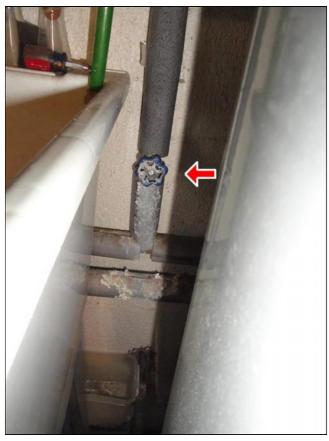
C. Item 1(Picture)

C. There is a shut off valve next to the water heater that cuts off water to the exterior hose bibbs. This should be closed prior to freezing weather so the pipes don't burst.

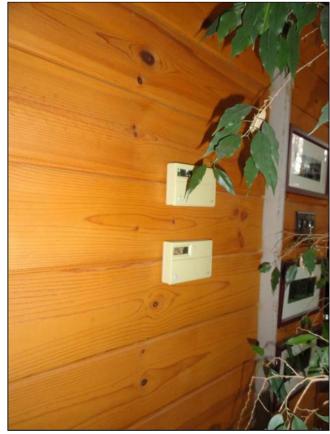
A. Item 2(Picture) Sunroom has 2 heating zones, floor and box radiators.

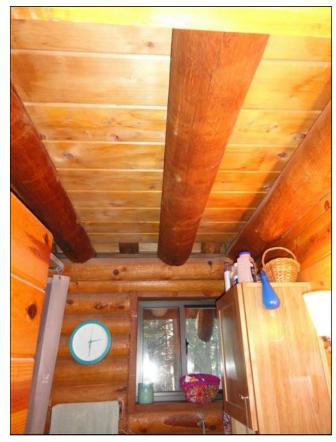
I. Item 1(Picture)

I. There is no bathroom fan in any of the 3 bathrooms in the home. The 2 full bathrooms have openings at the top of the walls to allow the moisture to move out of the bathrooms. There doesn't appear to be any damage from excess moisture due to this issue in the bathrooms.

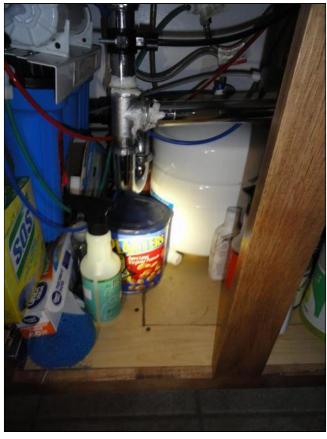
K. Item 1(Picture)

4567 Avenida Bolivar Page 34 of 36 K. As with most homes, there is some minor water damage under the kitchen sink which doesn't effect any functionality. There was no current leak at the time of inspection.
