Inspection Report

100 Main Drive
Sedona AZ 86336

"Almost Home" Inspection Services LLC

Date: 11/30/2020	Time: 09:00 AM	Report ID: Example Report
Property: 100 Main Drive Sedona AZ 86336	Customer:	Real Estate Professional:

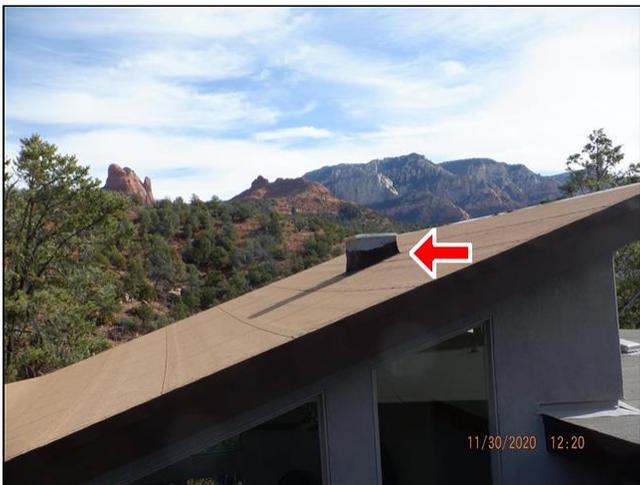
C. Item 1(Picture)

C. This roof penetration occurs over the main home's living room. The Buyer can ask the Seller about it's purpose/history.

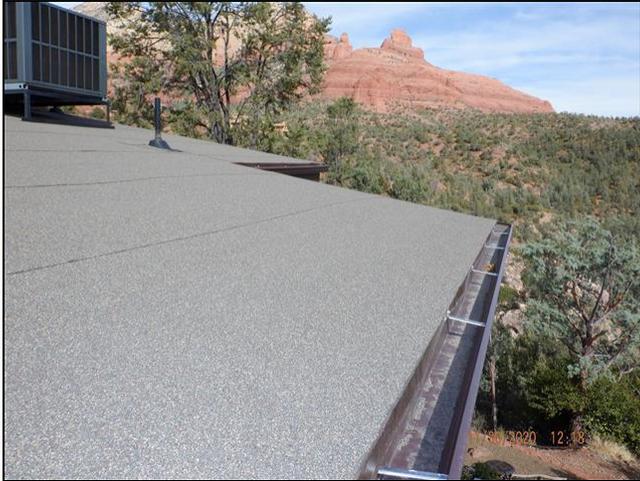
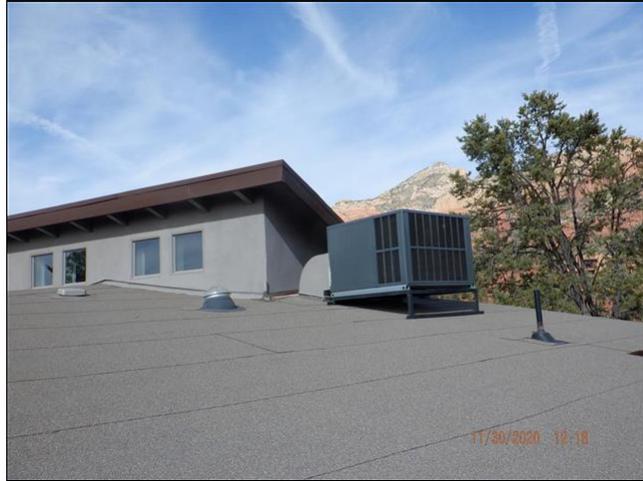
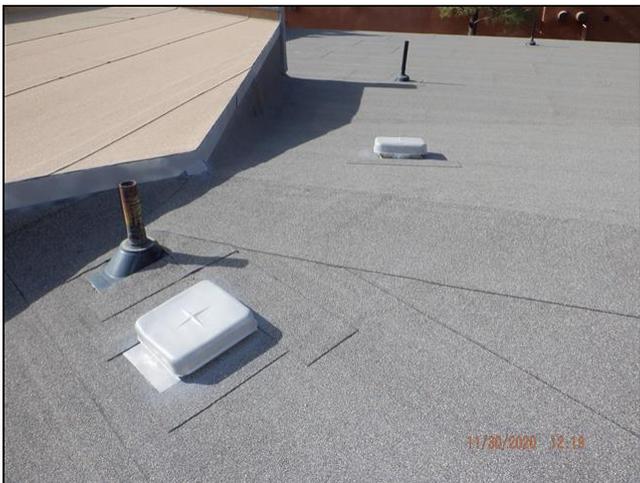
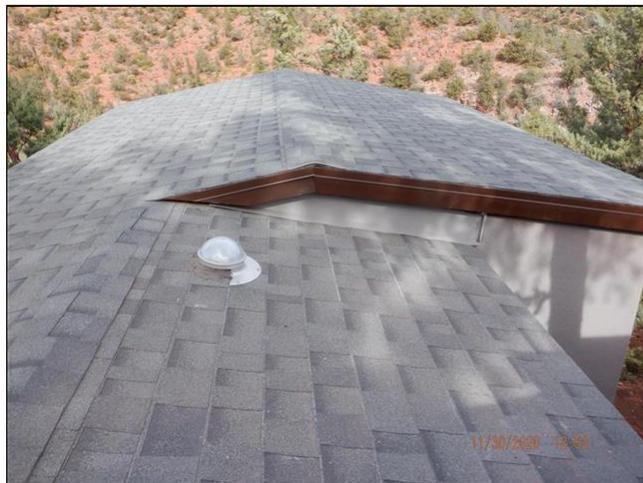
R. (1) The roof had rolled roofing that appeared to be in good or like new condition. The shingles on the guest house appeared to be fairly new as well.

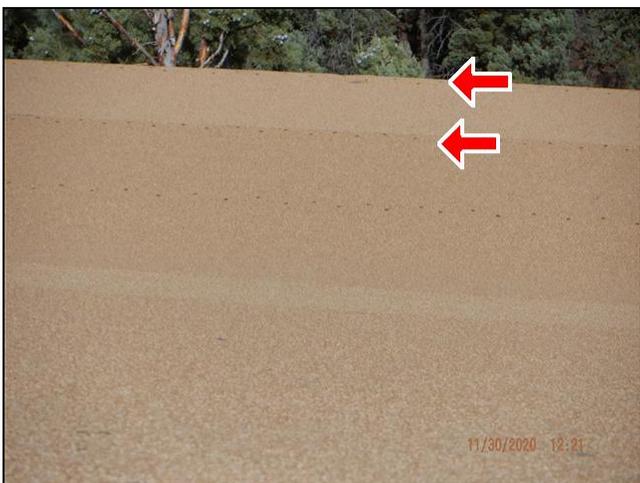
R. Item 5(Picture)

(2) There are a couple rows of roofing nails along the low eave area of the livingroom roof. These nails penetrate the roofing material which can lead to leaks down the road. The Buyer should ask the Seller about this.

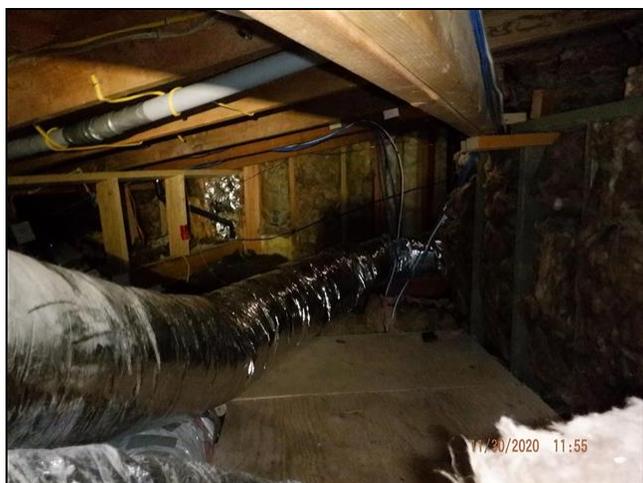
A. Item 2(Picture)

(2) The attic space lacked adequate headroom for safe entry. As a result, inspection of the attic space lies beyond the scope of the General Home Inspection and it was not inspected. Attics may contain potential fire or health hazards, other safety issues, damage, or defects that have the potential to cause damage to the home.

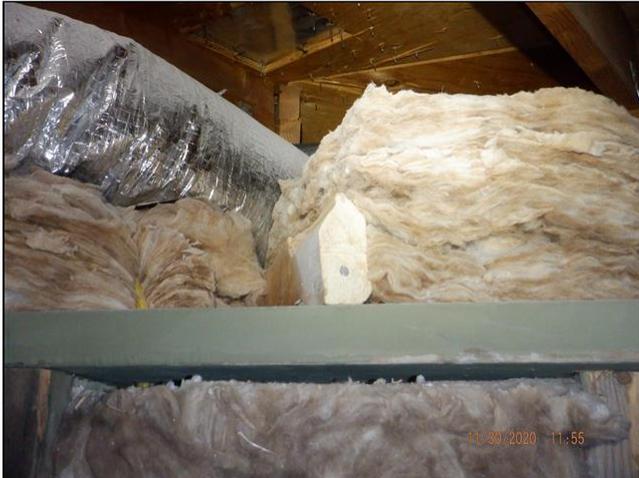
I. Item 1(Picture)

I. The attic floor insulation depth averaged approximately 8 to 10 inches. The Inspector always recommends the consideration of installing additional insulation.

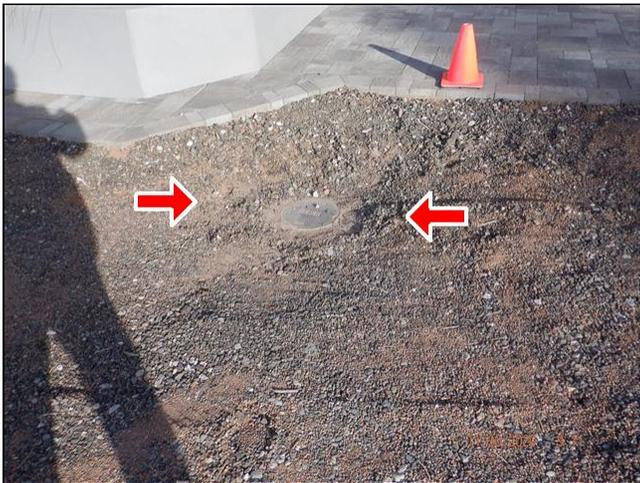
B. Item 1(Picture)

B. This low sewer access pipe in front of the new driveway will may lead to damage to the driveway edge and cause cars to jump when driven over. The Inspector suggests having this sewer appurtenance raised to grade to protect these items. This work would probably involve the City of Sedona.

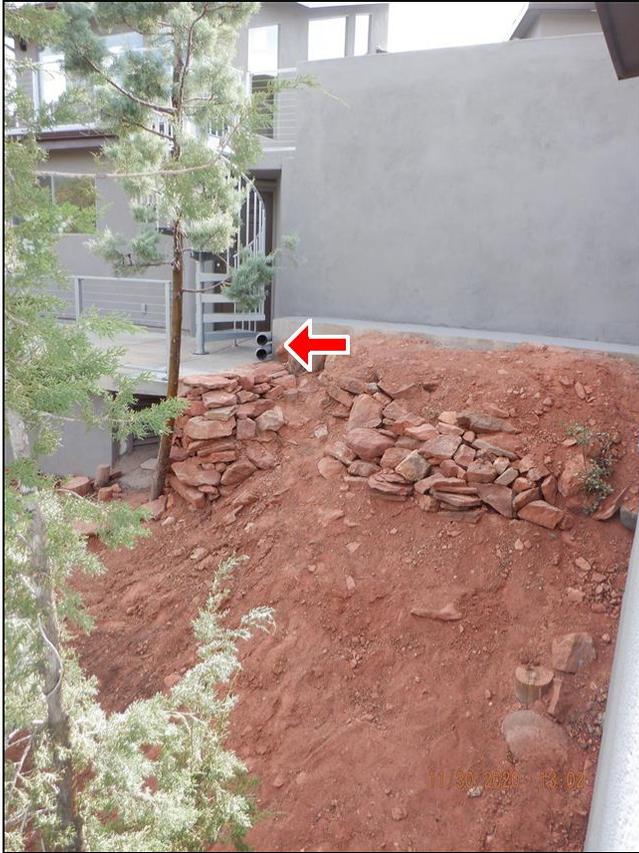
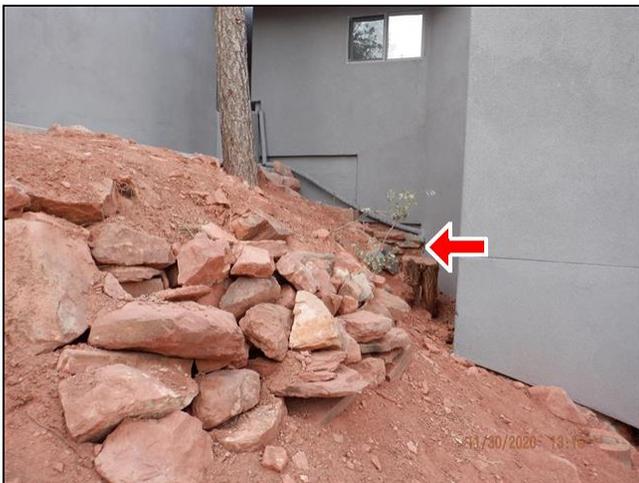
E. (1) These drain pipes behind the main house dump onto a slope that is partially protected by rocks. The Buyer should keep an eye on this and other areas as erosion may occur. A competent landscaper can help with this if a problem develops.

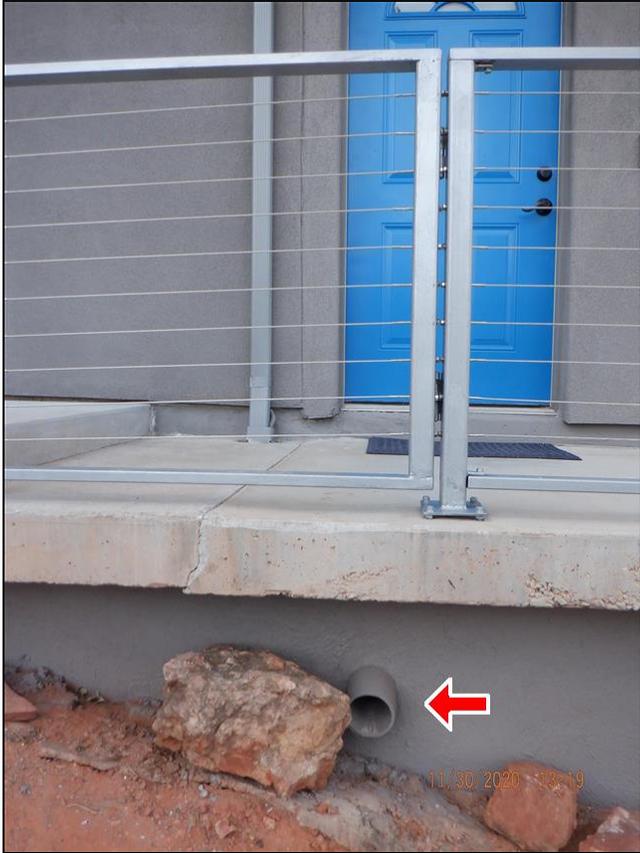
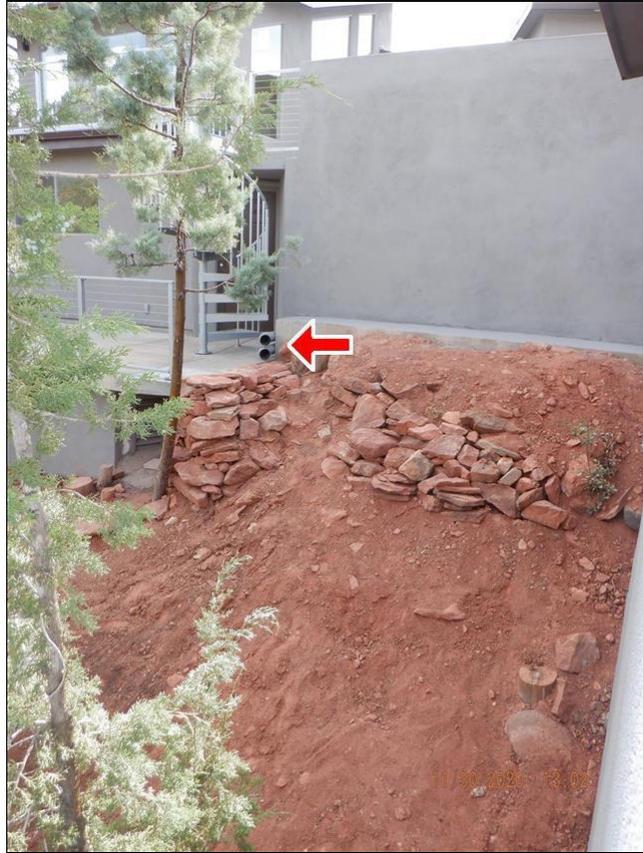
(2) There are lots of water drainage pipes on the property. The Buyer should review these systems with the Seller prior to closing. A video of this type of "walk about" will save information for later review."

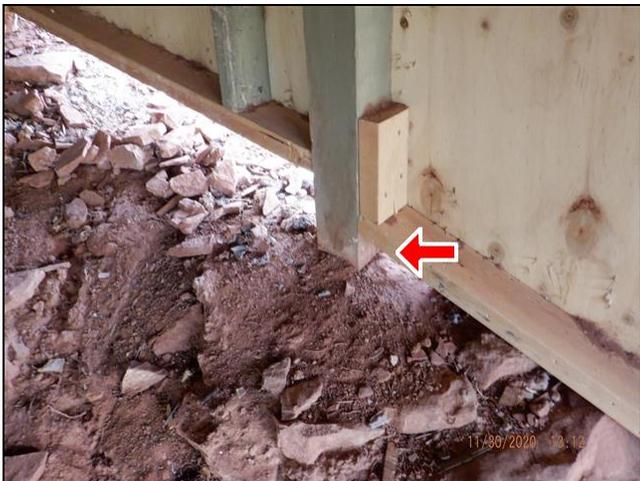
H. Item 1(Picture)

H. There are a couple of posts around the guest house that are in contact with dirt and concrete. This contact can lead to wood rot. A competent carpenter can address this item.

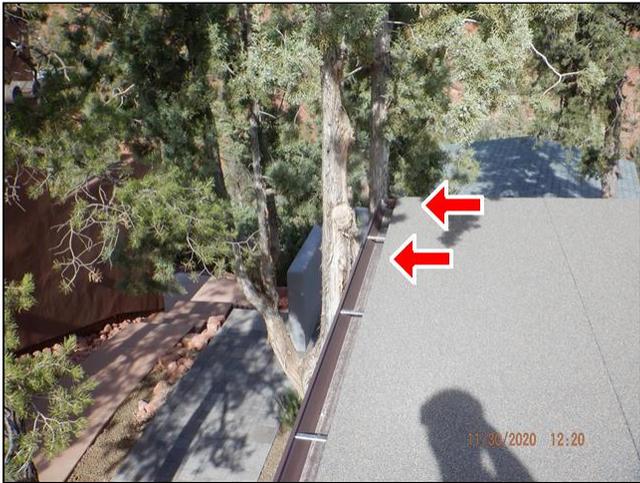
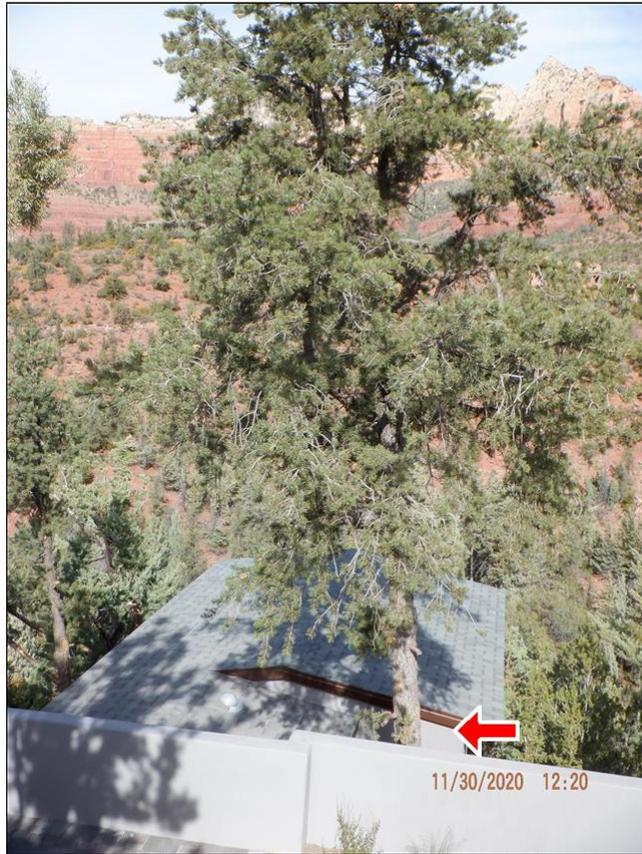
N. There are a couple of trees at the NW corner of the home that are very close to the home. The buyer should review related requirements with their insurance company. Closely located trees encourage fire and wood damaging insects to transfer to the home as well as storm damage concerns.

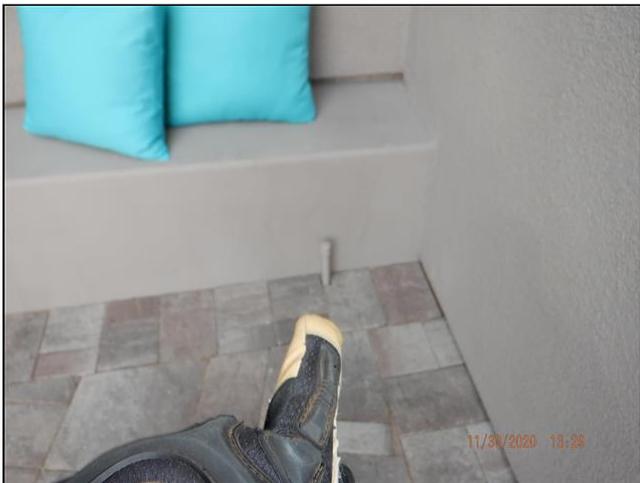
R. Item 1(Picture)

R. Irrigation is not included in a general home inspection. The Inspector suggests reviewing the irrigation system with the Seller. This capped off pipe in in the back patio area.

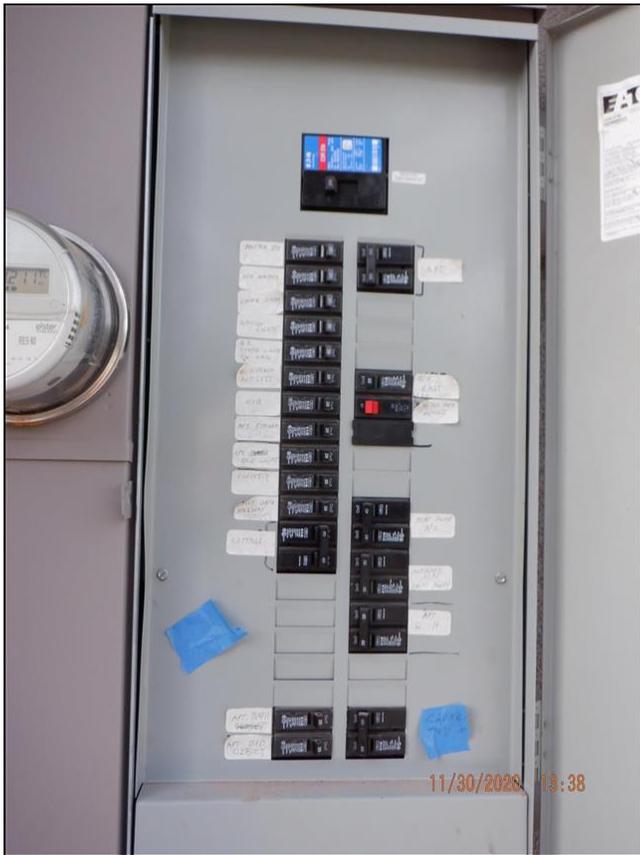
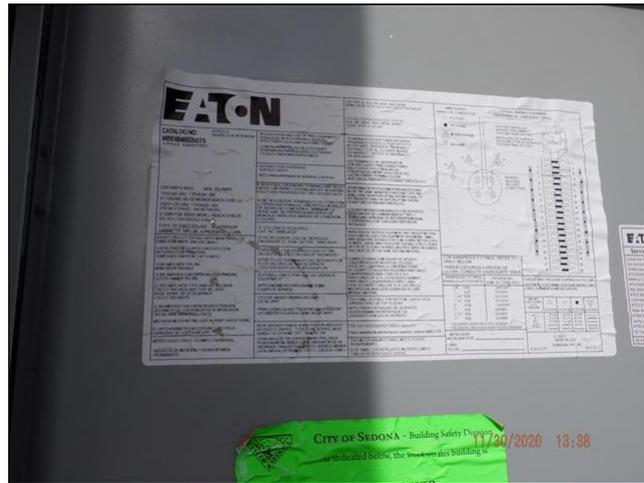
⚠️ I. The Inspector suggests that a competent electrician inspect/review the electrical distribution system on the property with the aid of the Seller, and more clearly label the circuits in the service and sub-panels as a safety effort. There is currently a branch circuit with a 125 amp breaker labeled "garage stub up" as an example which is probably the main electrical shut off for the garage hallway sub-panel, but it should be clearly marked as such. With a home that has undergone several additions and remodels, this is always a good idea.

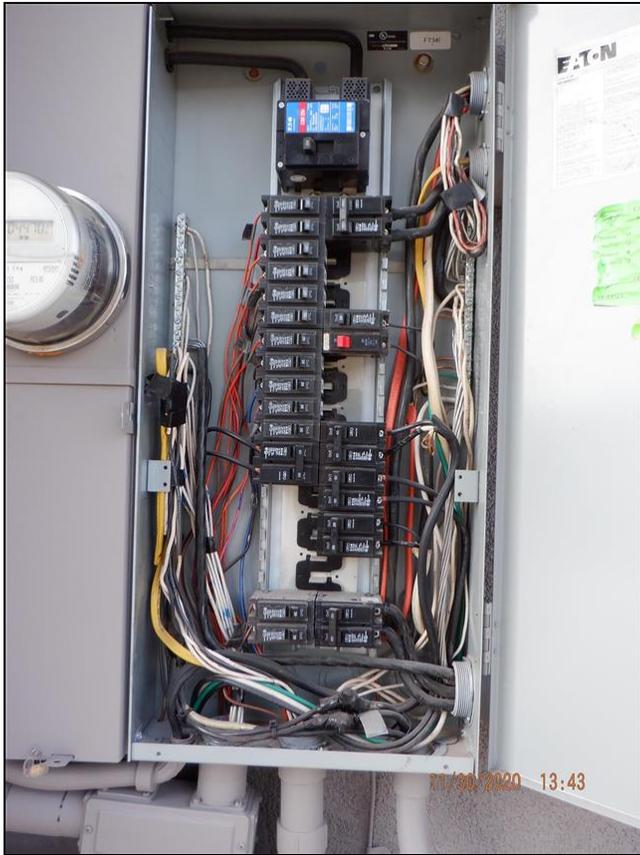
J. Item 1(Picture)

J. The wiring in the main service panel appeared to be correct, but the nature of the wiring methods made it hard to inspect. A inspection by a competent electrician would be a prudent activity to ensure safe use/operation by the Buyer.

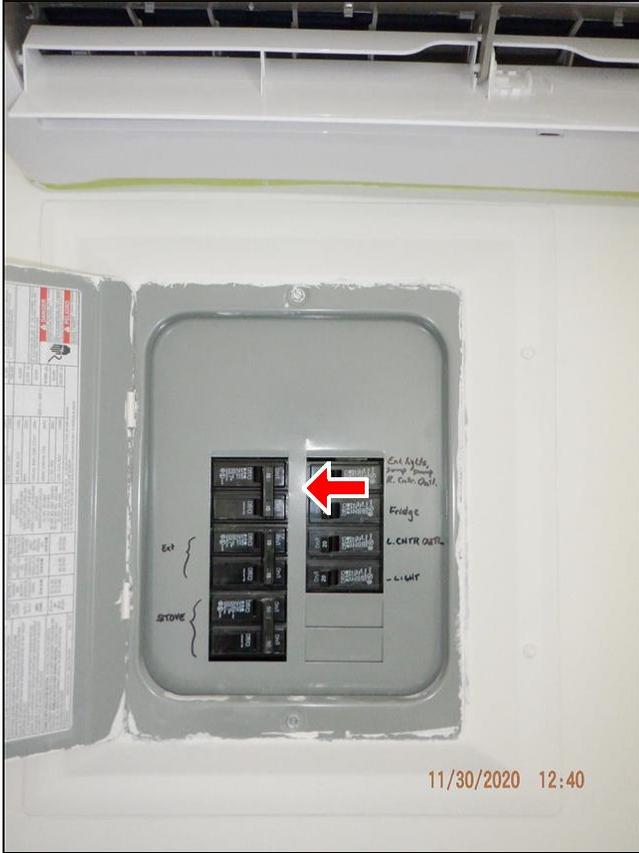
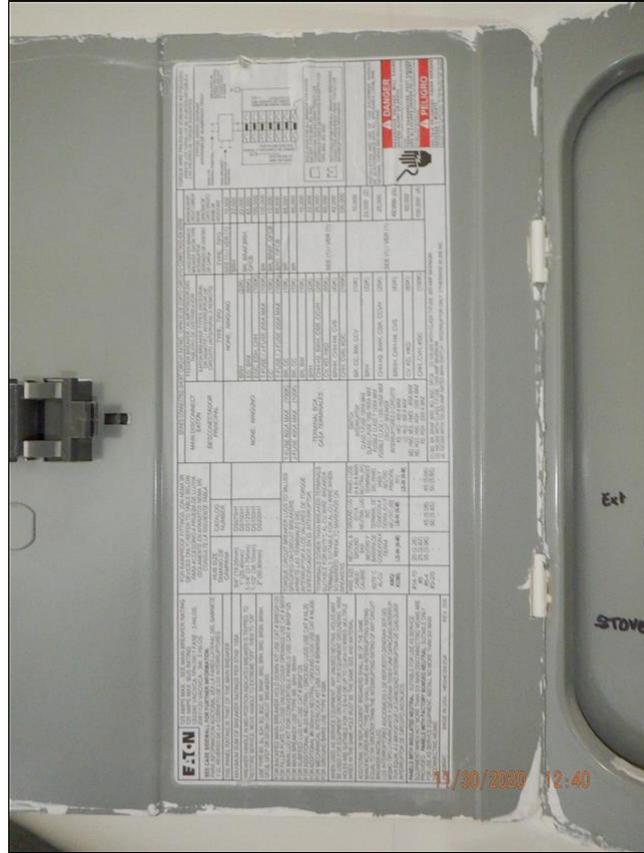
⚠️ (2) A 15 amp, 240 volt circuit is unlabeled in the basement suite sub-panel. This circuit should be properly labeled for safety reasons. A competent electrician or Seller can help with this.

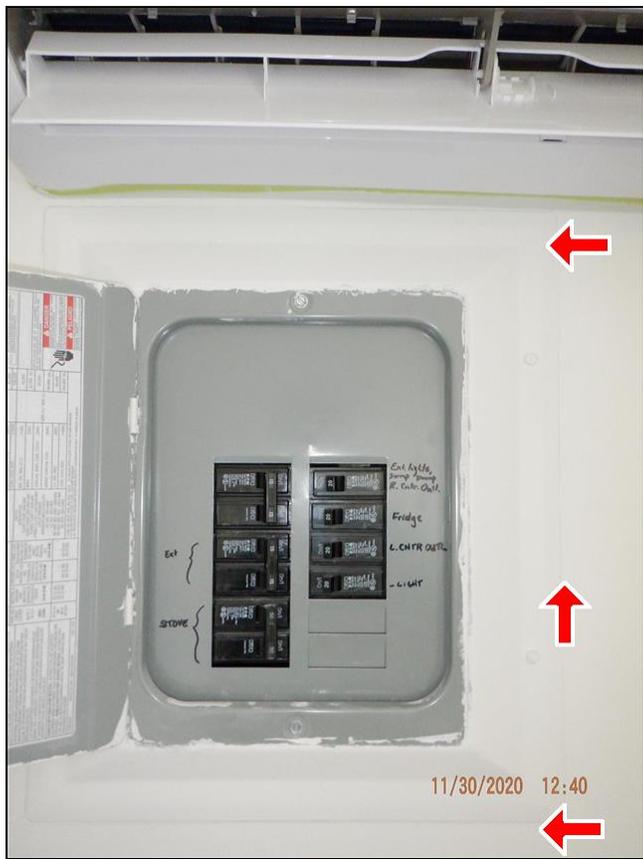
S. Item 2(Picture)

(2) The basement suite sub-panel faceplate was "painted in". The Inspector could not inspect the wiring because removing the cover would damage the finish on the wall.

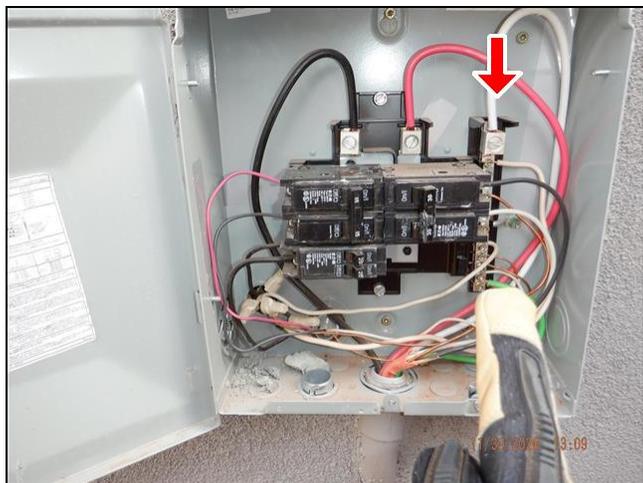
S. Item 3(Picture)

⚠ (3) The guest house service panel appeared to be wired incorrectly. A sub-panel should have it's grounding system separated from the neutral system as a safety standard. A competent electrician can address this item.

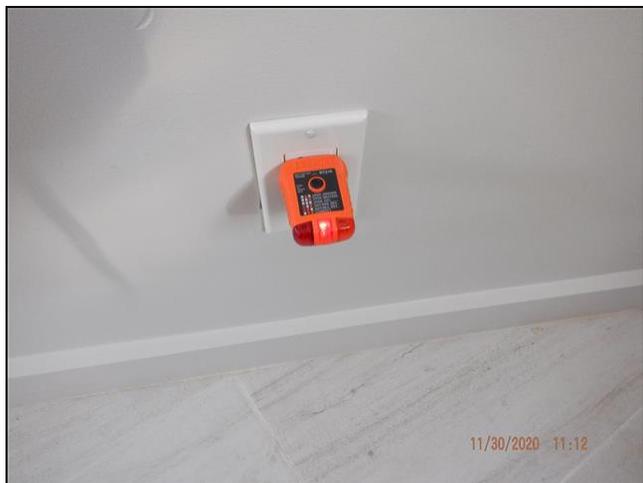
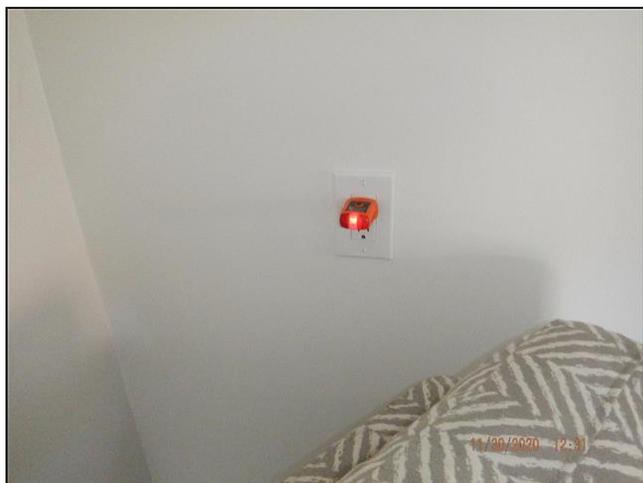
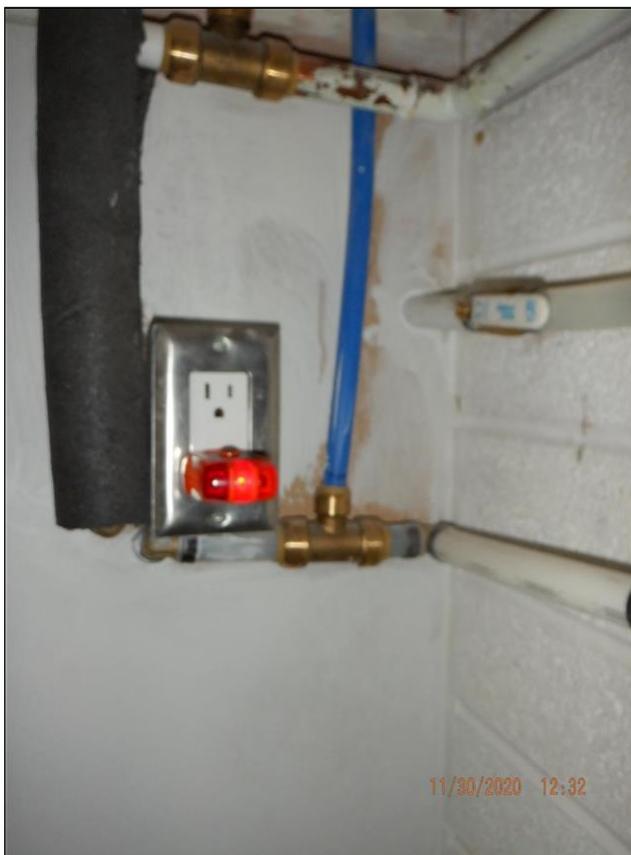
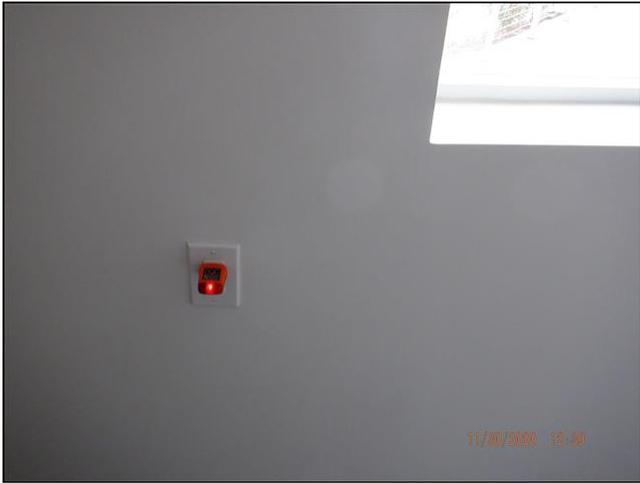
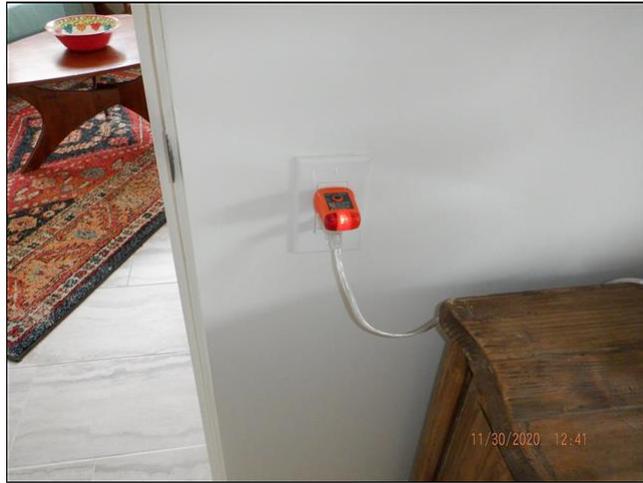
⚠ U. Several electrical outlets where missing a ground. Receptacle grounding is a current standard safety feature and the Inspector suggests bringing these outlets up to current standards. A competent electrician can address this item.

U. Item 1(Picture) guest bedroom

U. Item 3(Picture) main house basement suite

U. Item 4(Picture) main house basement suite water heater closet

U. Item 5(Picture) basement suite bedroom

U. Item 6(Picture) basement suite bedroom

- ⚠ 5 Several electrical outlets were missing a ground. Receptacle grounding is a current standard safety feature and the Inspector suggests bringing these outlets up to current standards. A competent electrician can address this item.

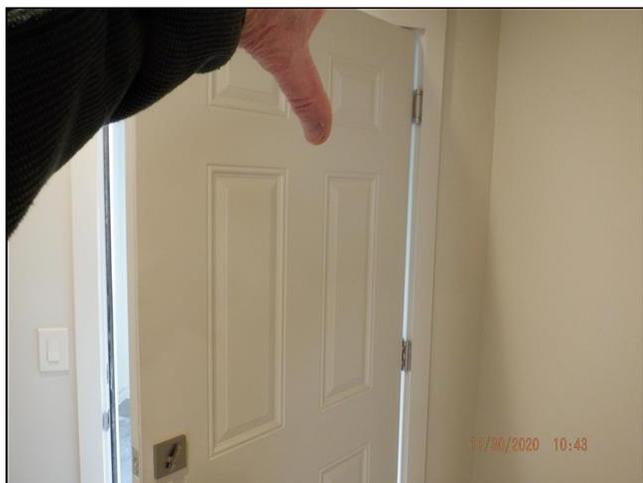
F. Item 1(Picture)

⚠ F. The door between the garage and the living space needs to be self-closing per current standards. This keeps fire and fumes from entering the living space. A competent carpenter or handyman can repair/adjust or replace a hinge on this door to address this item.

- ⚠ 6 The door between the garage and the living space needs to be self-closing per current standards. This keeps fire and fumes from entering the living space. A competent carpenter or handyman can repair/adjust or replace a hinge on this door to address this item.

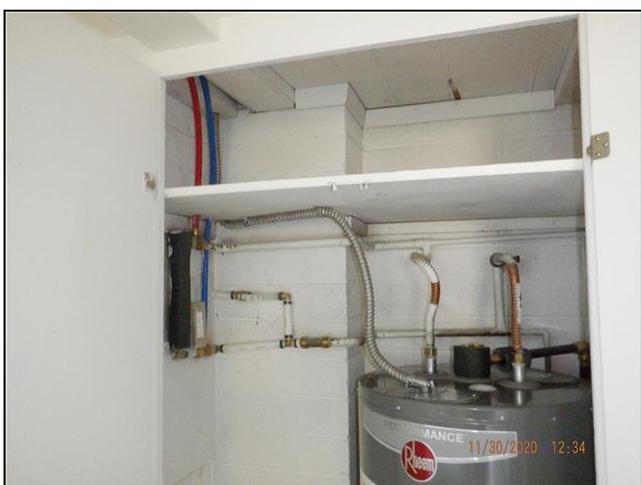
C. Item 5(Picture)

(3) There is some plumbing piping with zone valves at the water heater location in the basement suite. The Buyer should review the plumbing system operation with the Seller prior to closing.

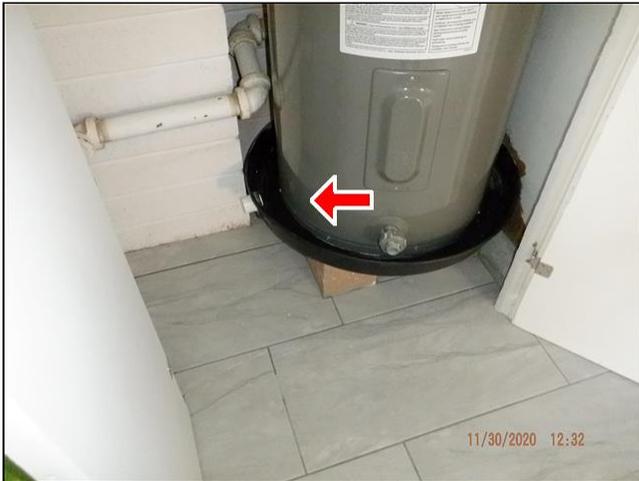
M. Item 6(Picture)

(5) The water heater in the basement suite does not have a drain pipe for the drip pan. Additionally, the P&V relief valve may dump into the drain pan. Any water draining from this pan can damage adjacent finishes. A competent plumber can address this item if desired.

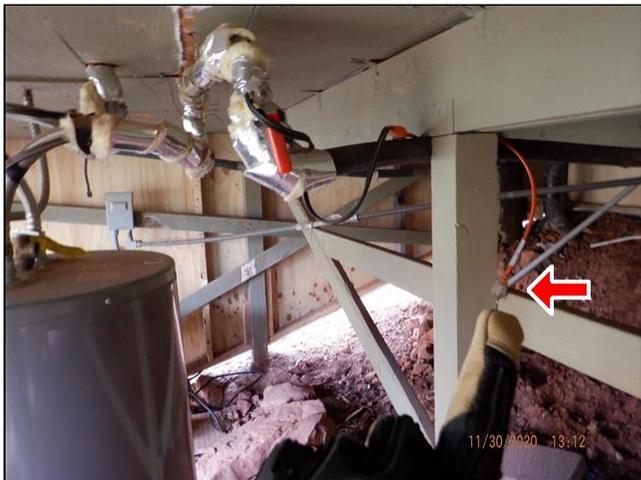
M. Item 8(Picture)

(7) There are some water pipes under the guest house that have insulation and heat tape aimed at keeping these pipes from freezing. The heat tape was not plugged in at the time of inspection even though the winter months are upon us. The Seller should review this system with the Buyer and demonstrate that the heat tape is operational.

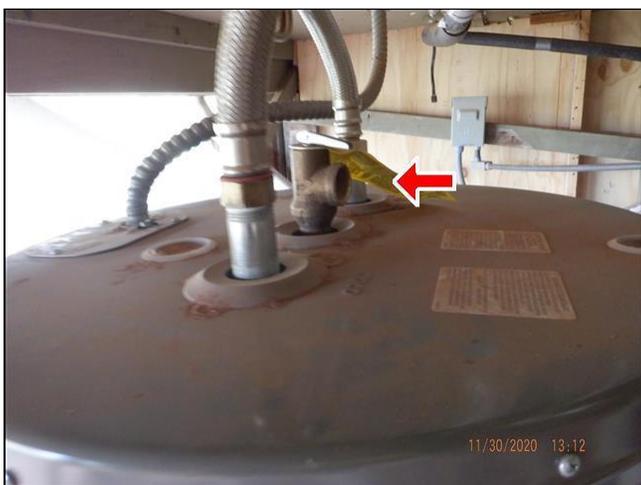
M. Item 9(Picture)

⚠️ (8) The water heater under the guest house does not have a drain pipe servicing the T&P relief valve. A hot water release from this valve could burn someone and damage adjacent electrical items and the crawlspace grade. A competent handyman or plumber can address this item.

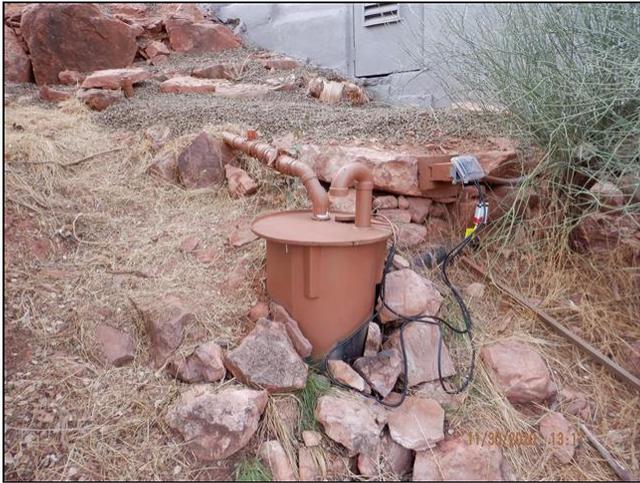
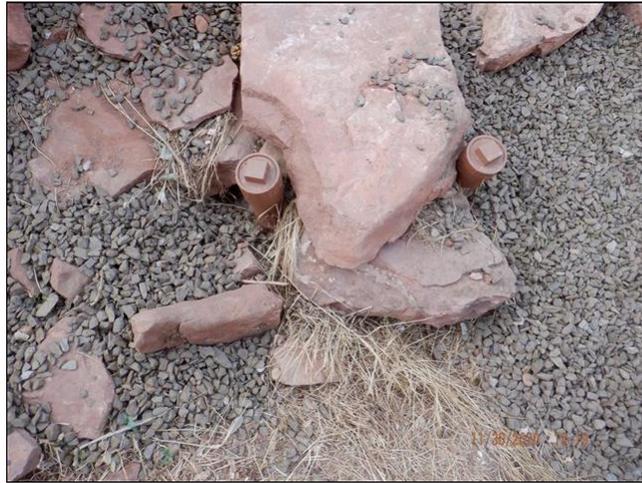
P. This sump is located at the NE corner of the main house. The Seller should demonstrate it's operation to the Buyer. The Inspector believes that it is a sewage ejector pump. There didn't appear to be a emergency alarm installed. The Buyer should have this system inspected by a competent ejector pump contractor. A sewage pump is not part of a general home inspection. There didn't appear to be any leaks/overflow during the inspection: the system appears to be operational. An item of note is that this system was referred to as a sump pump in the electrical panel.

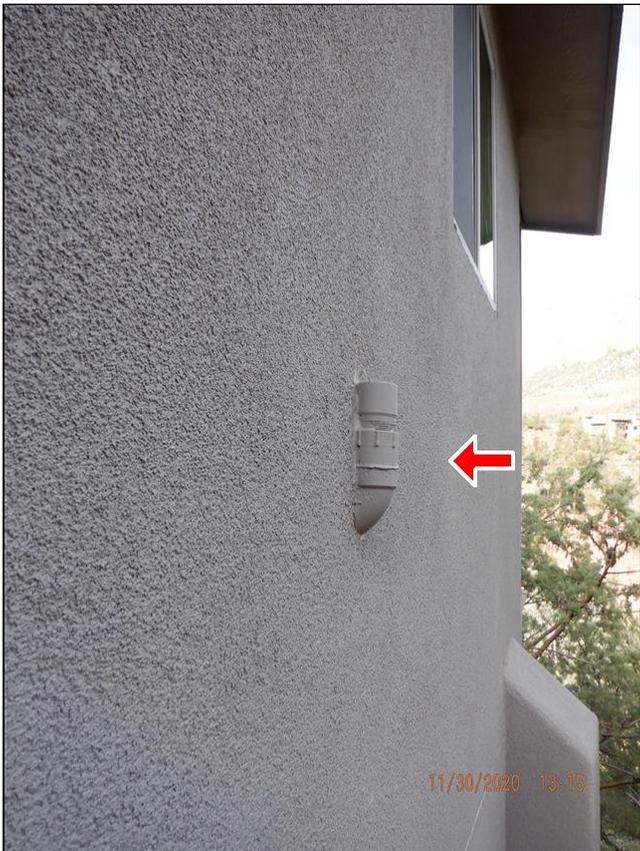
S. Item 1(Picture)

S. This air admittance valve at the guest house was not moved away from the wall prior to stuccoing. This may make it tougher to replace and may provide a place for water to get into the wall. The Buyer should keep an eye on this detail for future repair.

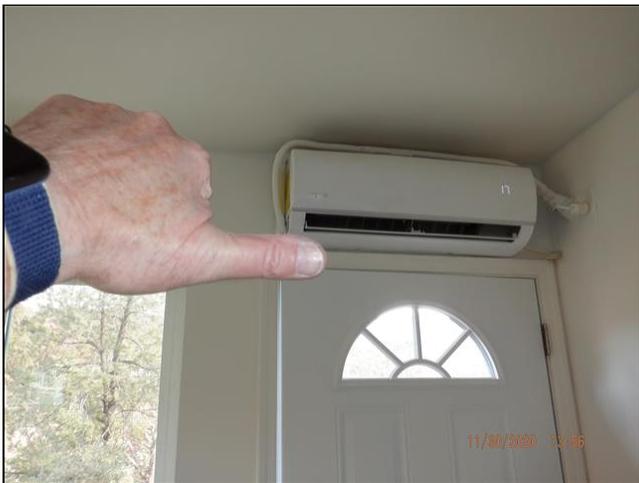
A. Item 7(Picture)

(3) The Seller should demonstrate the operation of the basement suite's two mini-split air conditioning units. It appeared to the Inspector that the unit in the bedroom started right up while the kitchen unit appeared to start up slower or possibly start up after the bedroom unit was stopped.

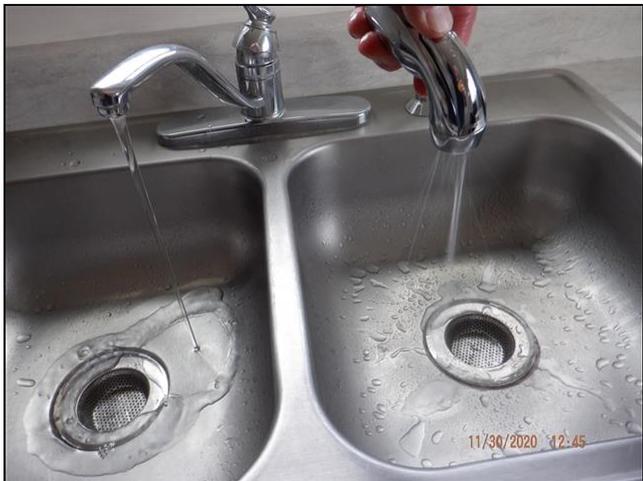
K. Item 1(Picture)

⚠️ **K.** The basement suite kitchen faucet sprayer did not function properly. A competent handyman or plumber can address this item.

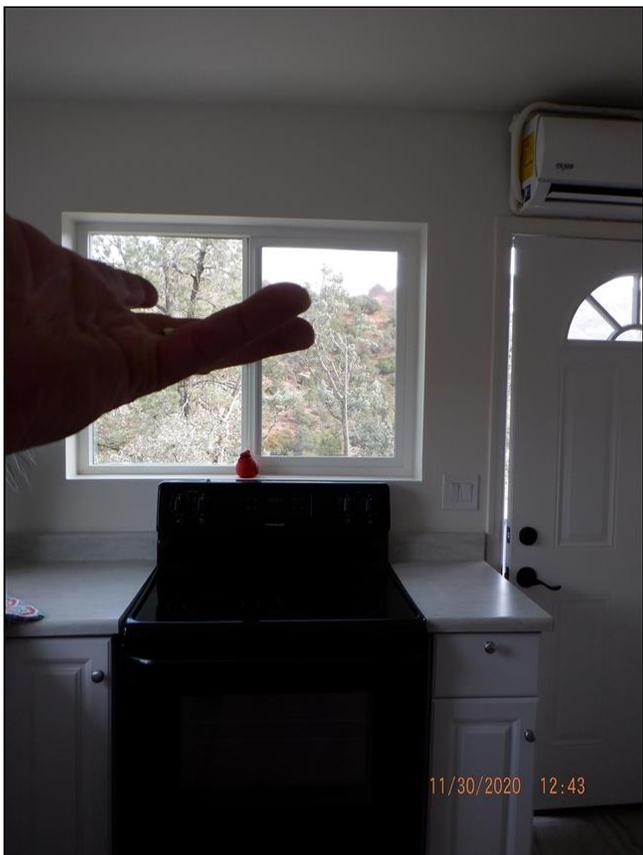
N. Item 1(Picture)

N. The basement suite range had no hood to remove the cooking vapors/moisture. During temperate weather, the adjacent window can be opened to help with this. A hood can probably be added. Without a hood, grease can settle on adjacent surfaces more readily.
