Report # / I.D : 3404
Inspection Date : February 19 2018 **Time :** 2:00 pm
Client Name : Donna Poole
Property Address : 107 Congressional Drive Stevensville, MD 21666

Type Of Inspection: Pre-Purchase Inspection

Home Type / Style: Single Family Home

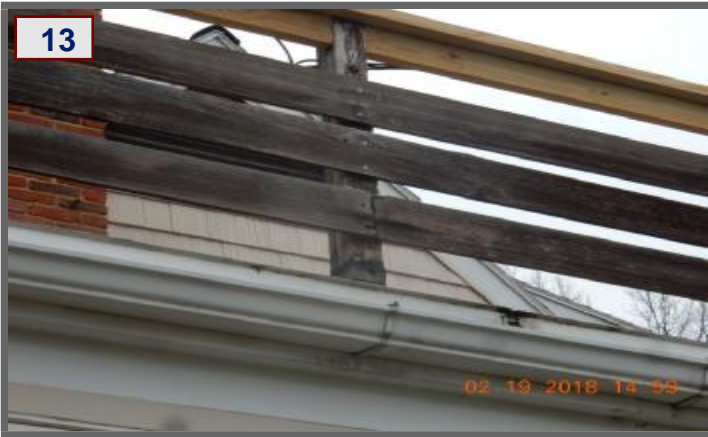
13

The upper deck rails are climbable and the attachment is not secure. (2)(4)(5)

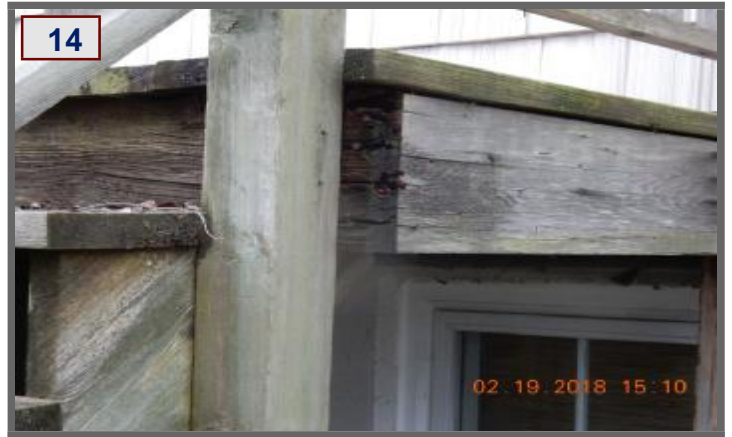
Rot noted on ledger board at the deck stairs. (2)(4) See Photo # 14

Rot noted on ledger board at the deck stairs. (2)(4)

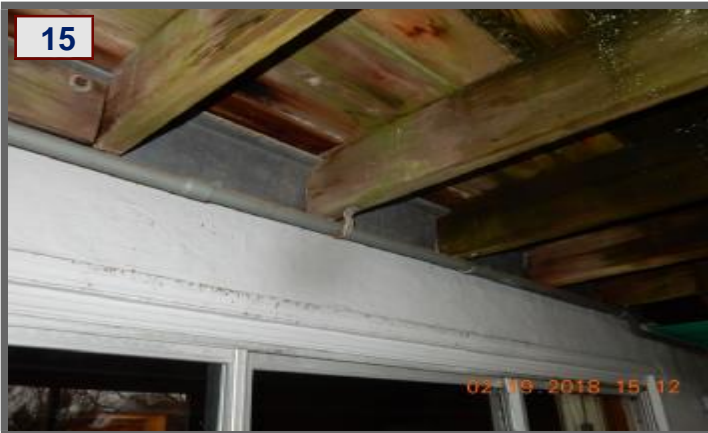
Deck lacks proper attachment to house / unsecured and unsafe. (2)(4) Additional support post and beam is recommended for deck. Decks higher than 3 steps should be free standing. (2)(4)(5) See Photo # 15

Deck lacks proper attachment to house / unsecured and unsafe. (2)(4) Additional support post and beam is recommended for deck. Decks higher than 3 steps should be free standing. (2)(4)(5)

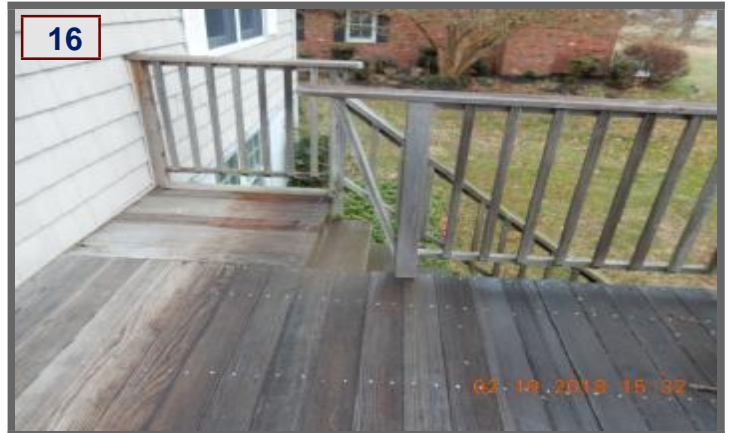
16

The railing openings are loose and the openings are too wide. Railing spacing exceeds 4 inch maximum required. Recommend upgrading to provide enhanced safety for children / pets. (2)(4)(5) See Photo # 16-18

The railing openings are loose and the openings are too wide. (2)(4)

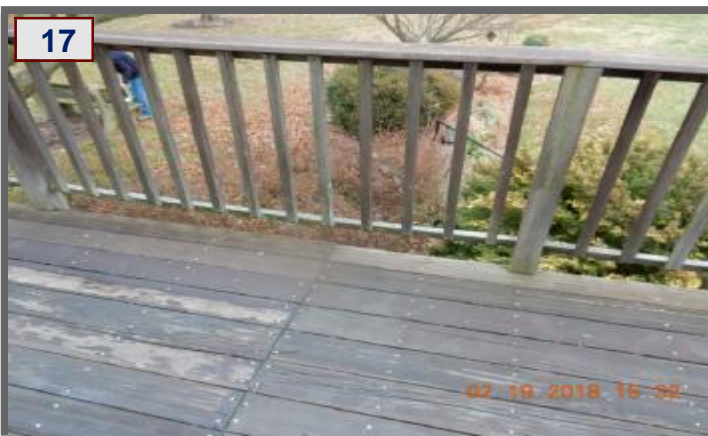
17

The railing openings are loose and the openings are too wide. (2)(4)

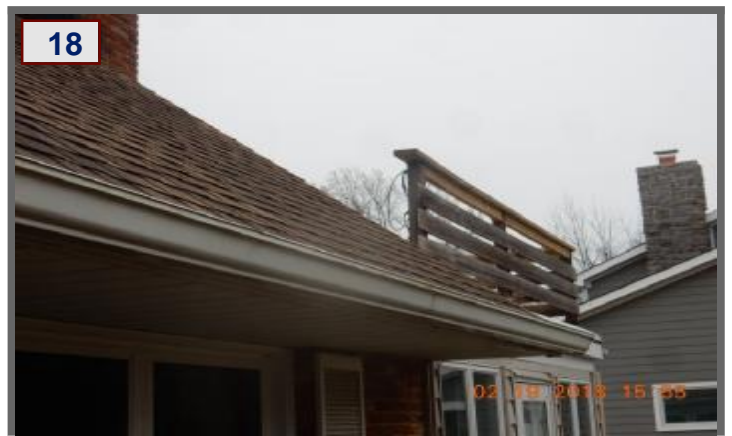
18

The railing openings are loose and the openings are too wide. (2)(4)

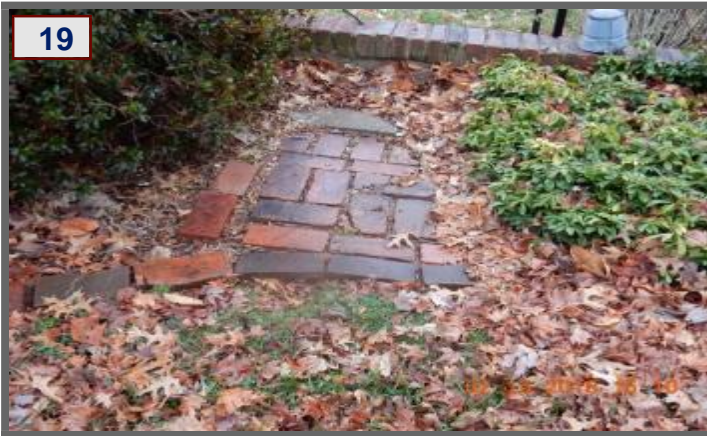
Pavers for sidewalks are a trip hazard. (2)(4) See Photo # 19

Pavers for sidewalks are a trip hazard. (2)(4)

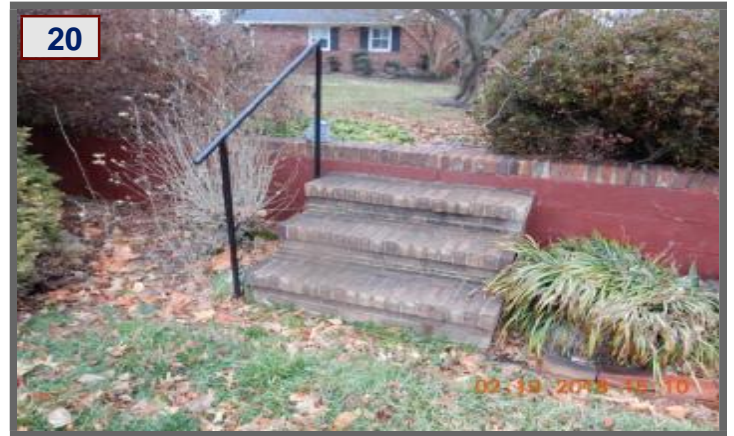
The rear steps have uneven rise and the railings are incorrect. (2)
(4)

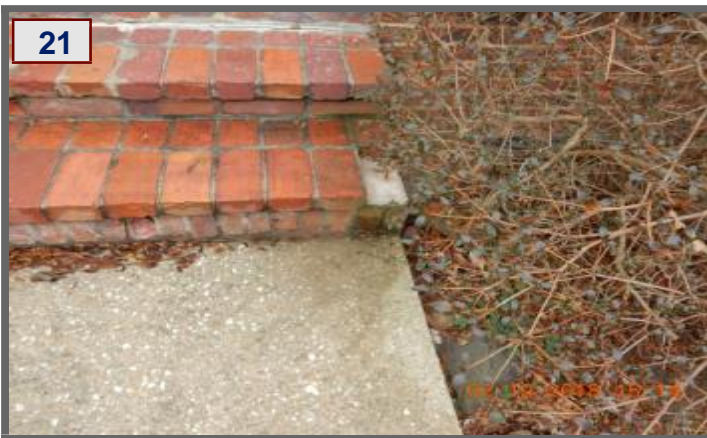
Missing bricks noted at the front entry steps. (2)(4) See Photo # 21

Missing bricks noted at the front entry steps. (2)(4) See

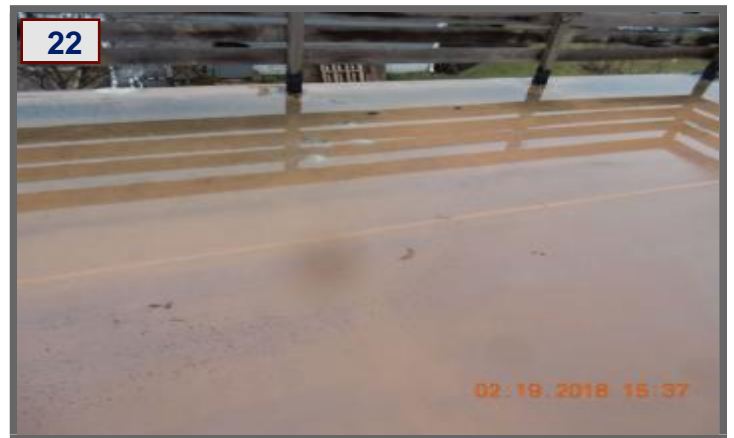
Pooling water noted on the low slope roof. (2) See Photo # 22

Pooling water noted on the low slope roof. (2)

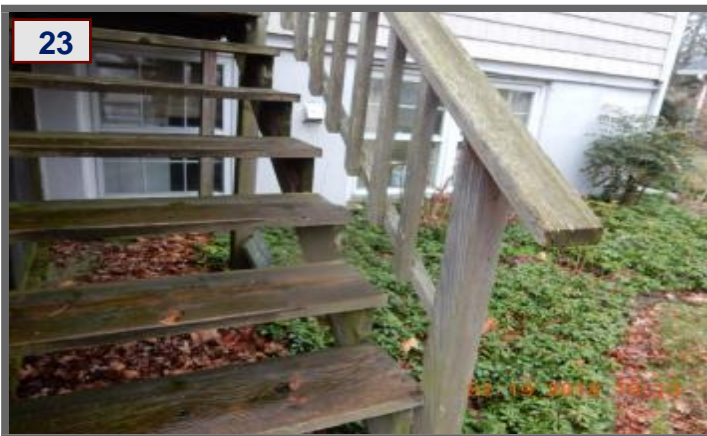
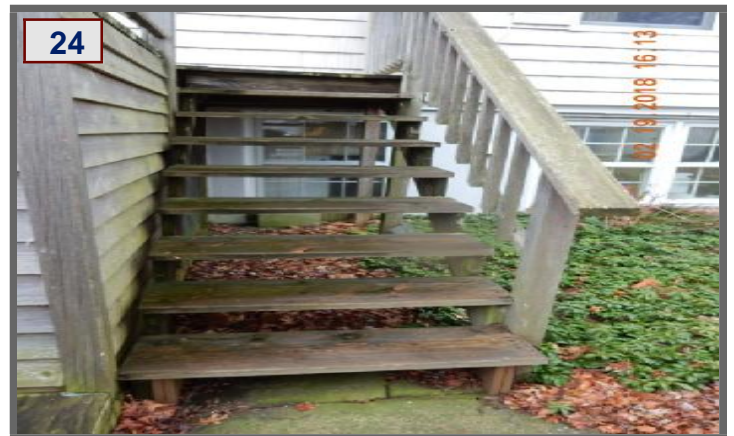
The rear deck steps are loose, the railings are too wide and rot was noted. (2)(4) See Photo # 23-24

The rear deck steps are loose, the railings are too wide and rot was noted. (2)(4)

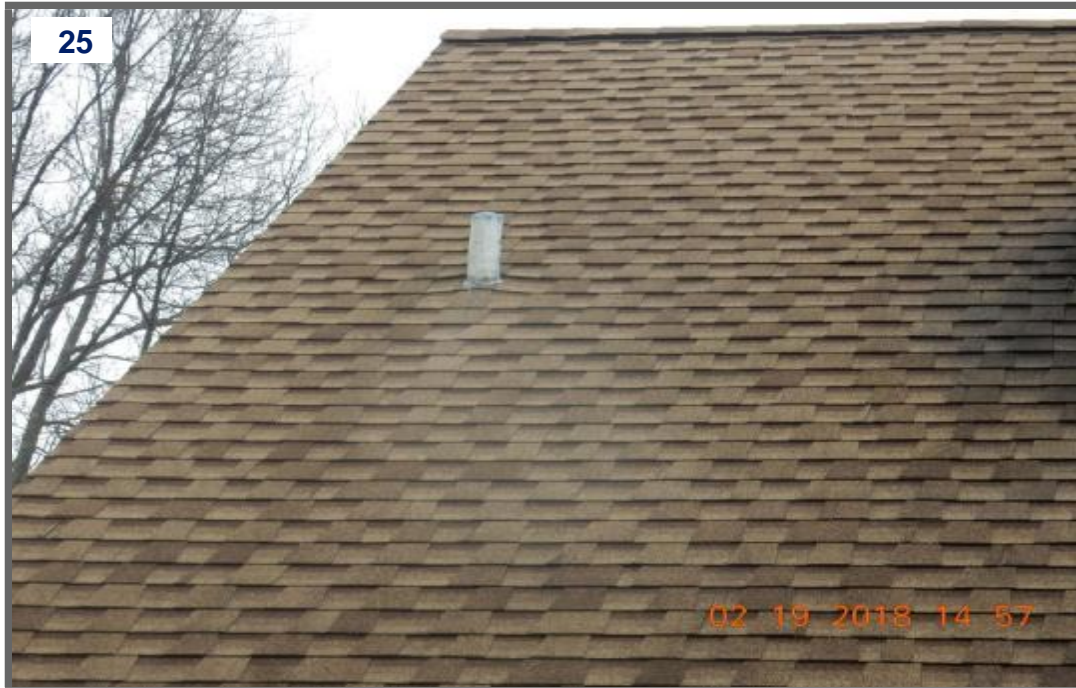
The flashing for the drain waste vent is incorrect. (2)

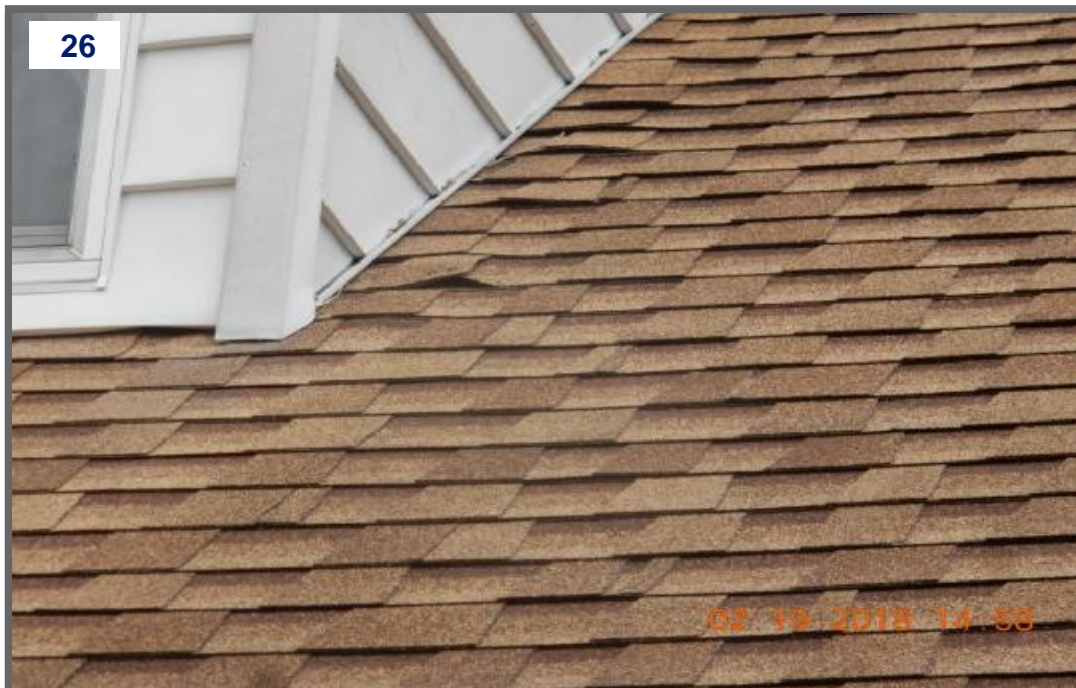
Appears to be some nail heads starting to pop up on roof, which is causing to raise at some locations. This is in the very early stages. Recommend addressing this in the near future. (2) See Photo # 26

Appears to be some nail heads starting to pop up on roof, which is causing to raise at some locations. This is in the very early stages. Recommend addressing this in the near future. (2)

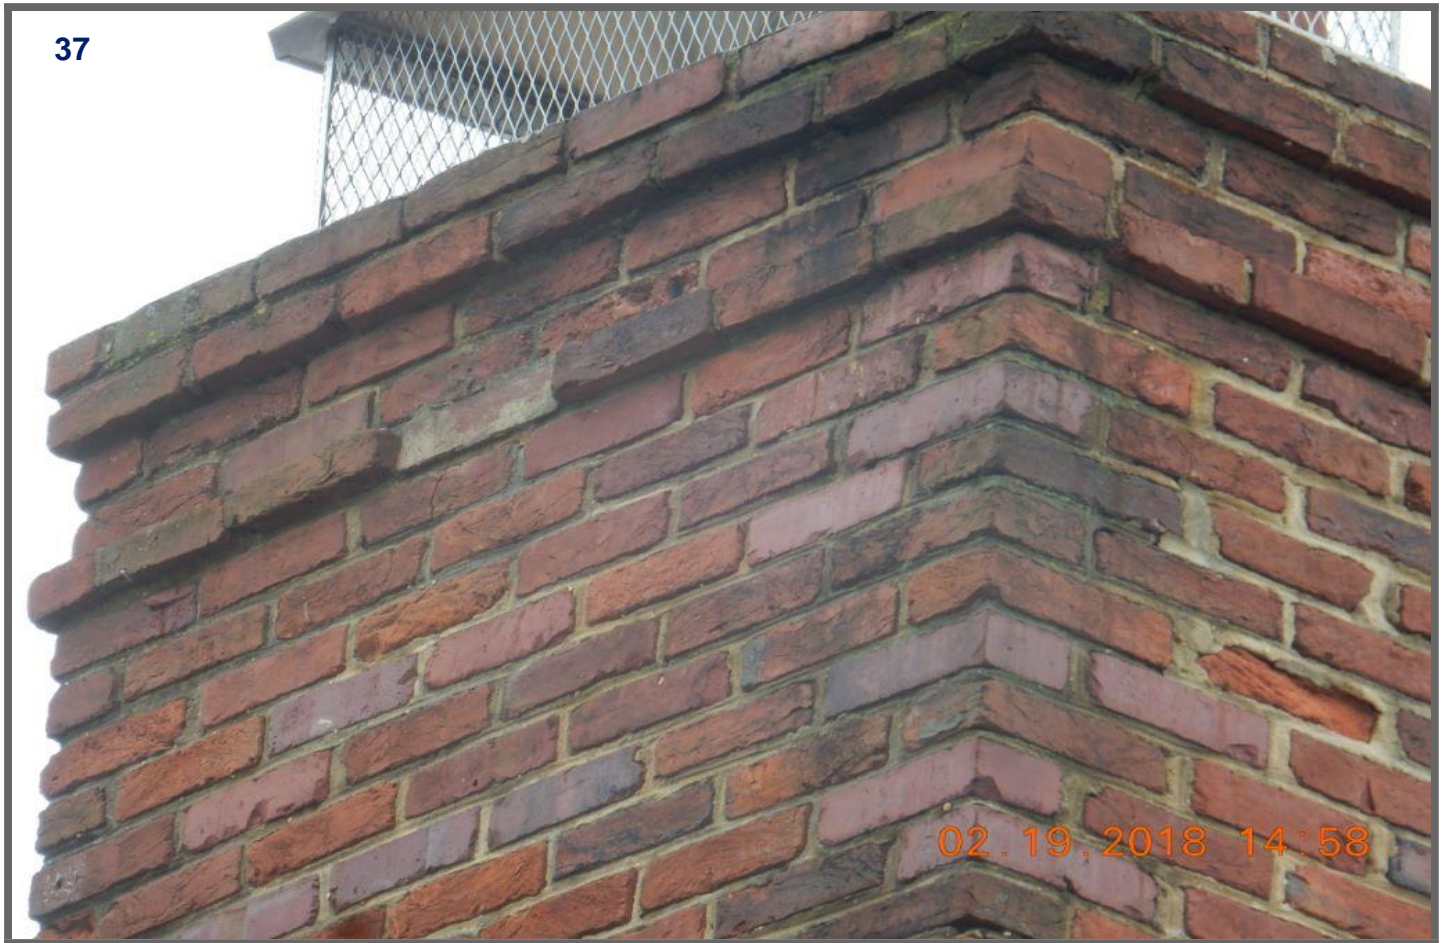
Spalling bricks noted on the chimney. (2) See Photo # 37

Spalling bricks noted on the chimney. (2)

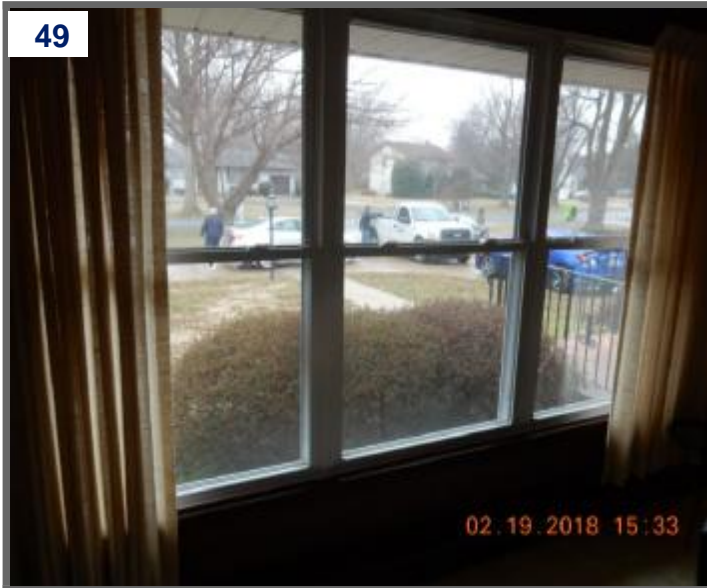
The front living room windows do not lock. (2)

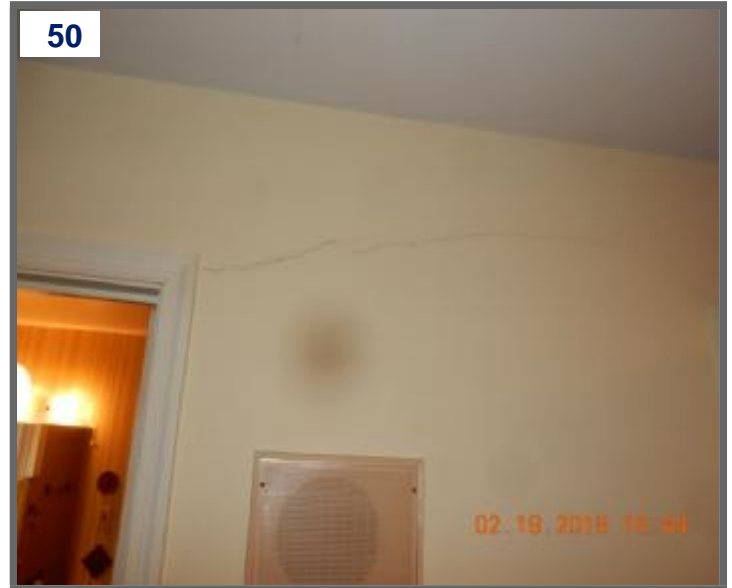
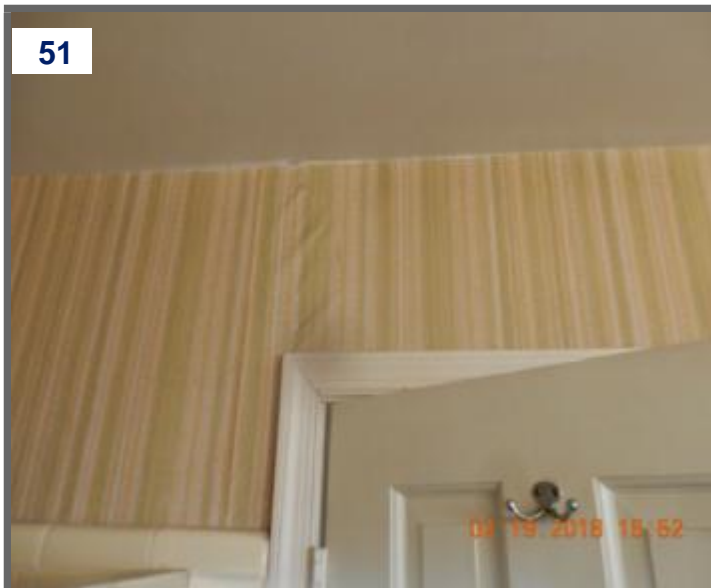
Unusual cracks noted around the doors at the jack and jill bathroom. (2) See Photo # 50-51

Unusual cracks noted around the doors at the jack and jill bathroom. (2)

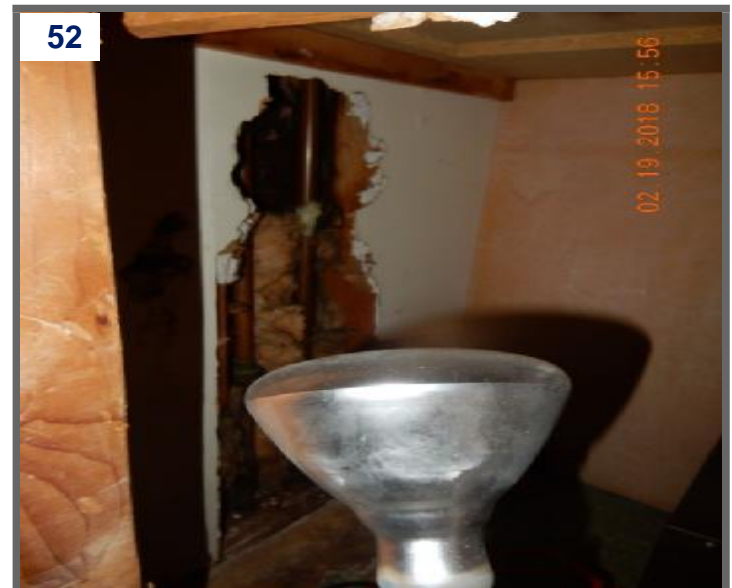
Evidence of freezing pipes noted at the lower level master bedroom closet. (2) See Photo # 52

Evidence of freezing pipes noted at the lower level master bedroom closet. (2)

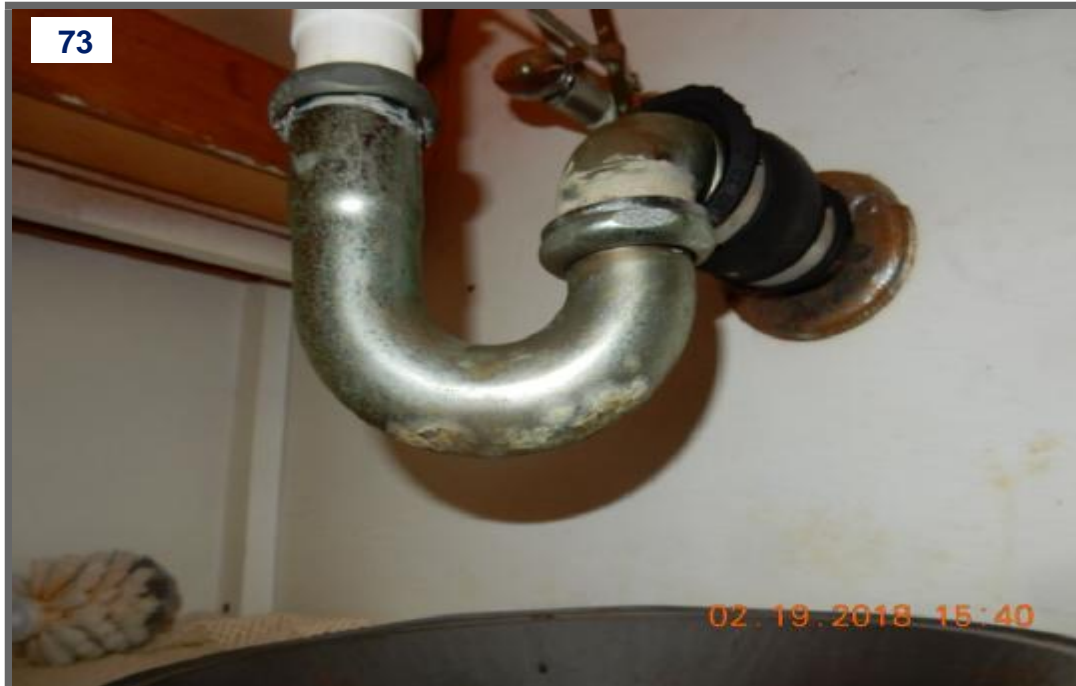
Lower Bathroom: Corroded drain trap noted. (2) See Photo # 73

Lower Bathroom: Corroded drain trap noted. (2)

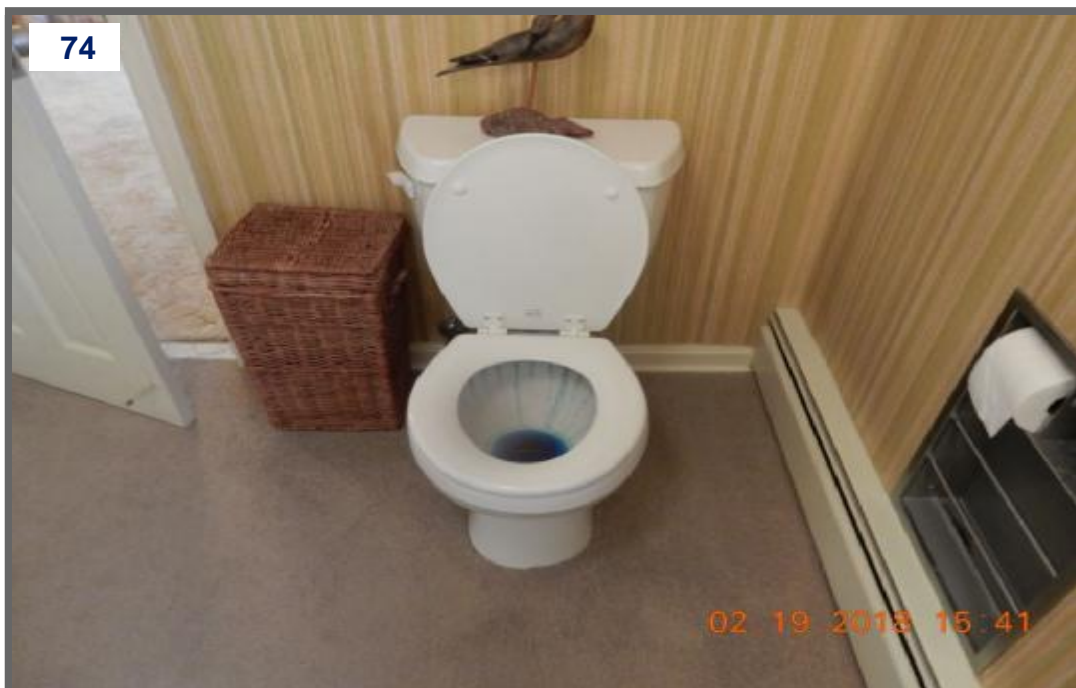
Master Bathroom is not functional. (2)

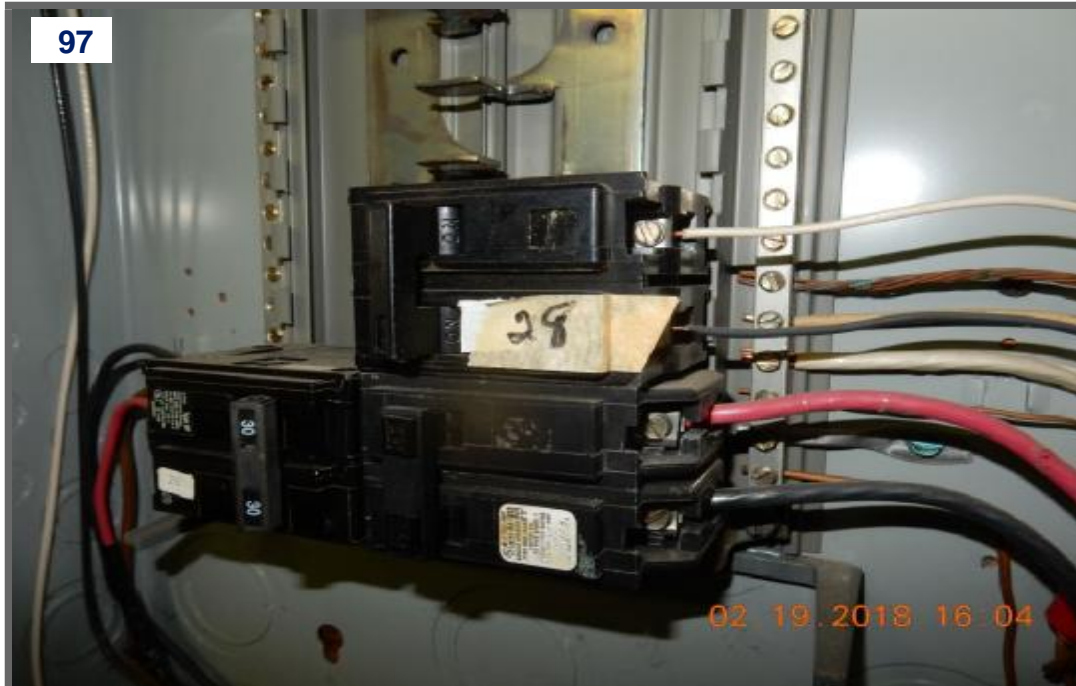
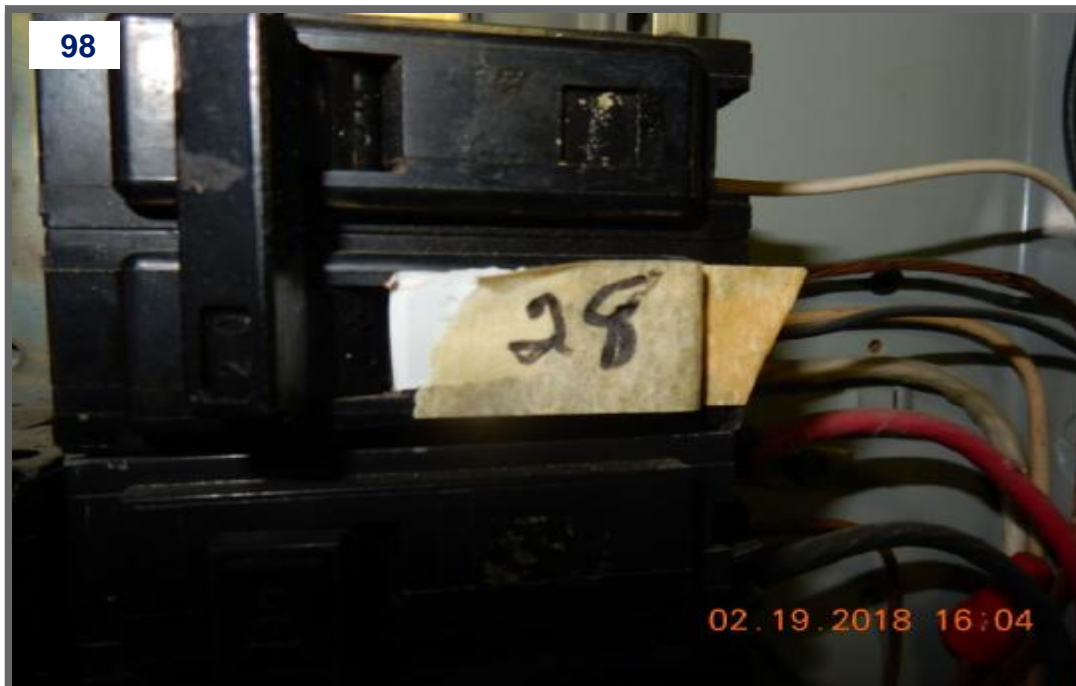
Over fusing, breaker size too large for wire at main electrical panel. (2) (4)

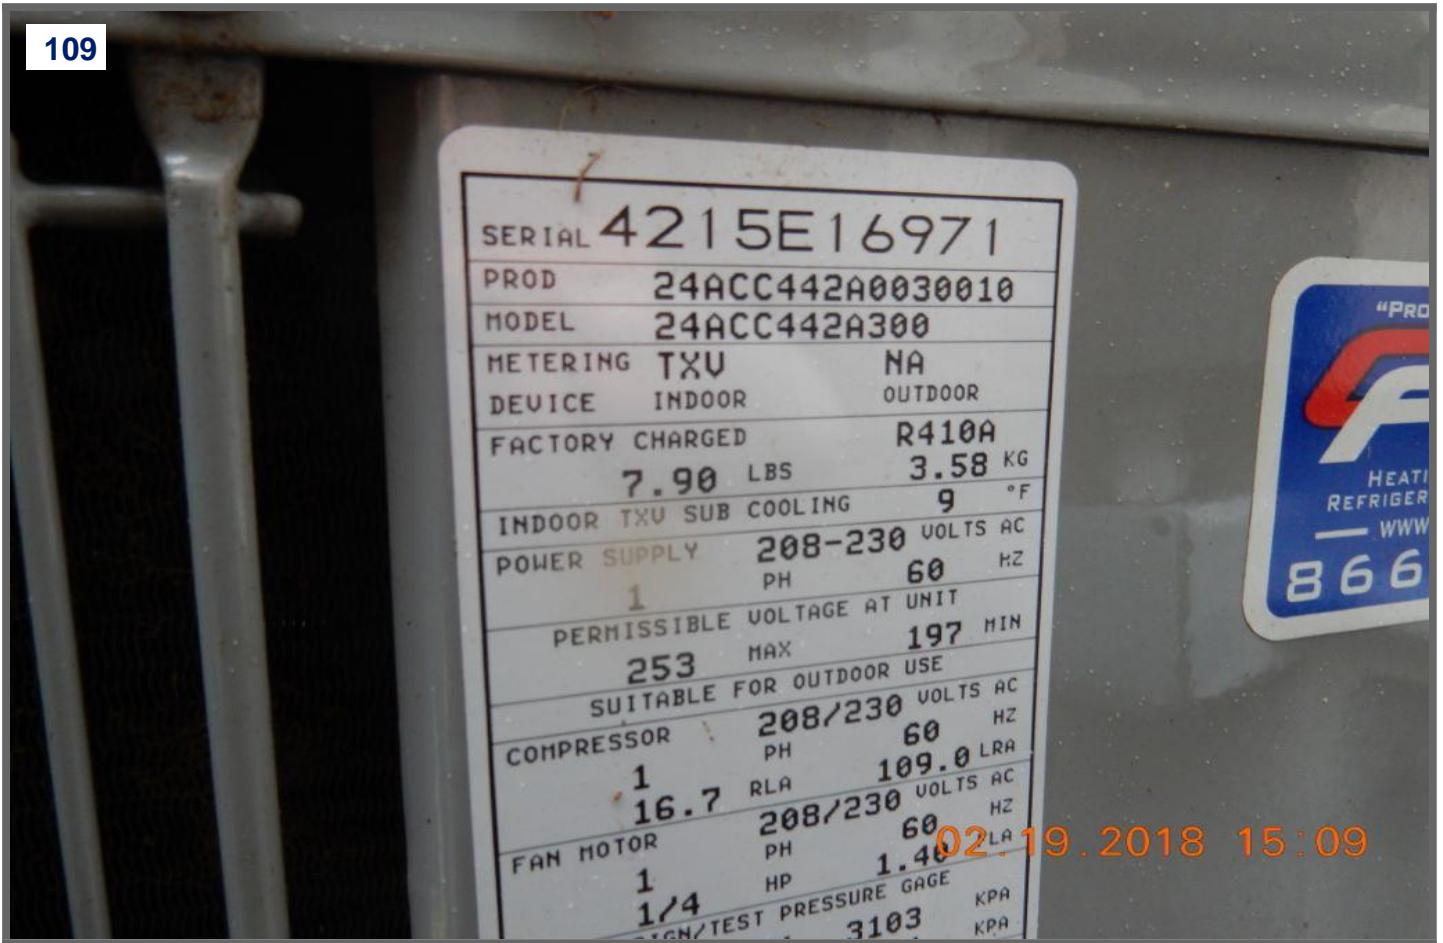
The age of the AC compressor appears to be a 2015.
