Joseph D. Hiller Engineering, LLC

Subject Property: XXXXXX

Re: Structural Engineering Assessment – XXXXXXX

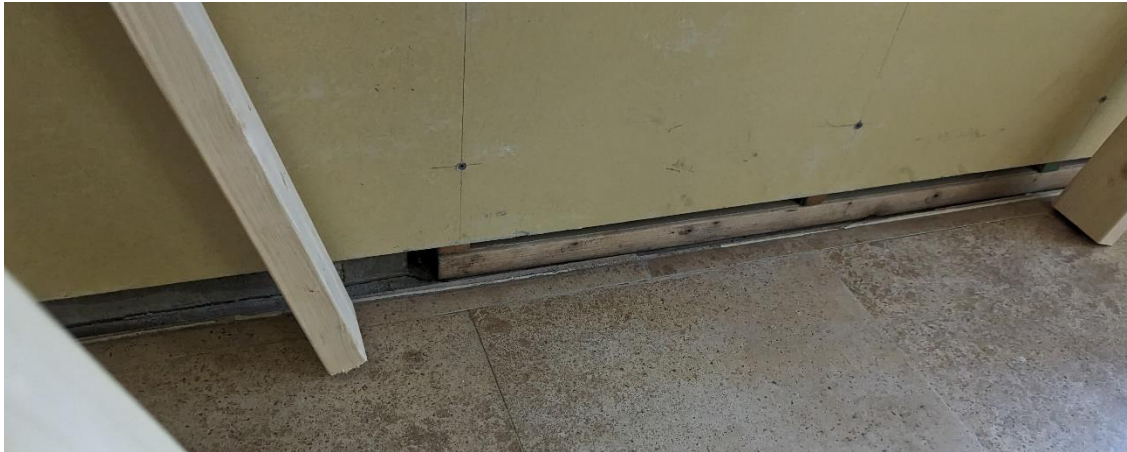
The foundation slab, where visible, is severely cracked at wall-floor joint.

During the inspection, structural deficiencies were observed and the foundation of the home appears to be in poor condition. After inspecting the subject property, it is my professional opinion that this house should not be lifted.
