Confidential Inspection Report 528 Locust Avenue Manteca, California 95337

**Prepared for: Irma Conteras**

# **GENERAL INFORMATION**

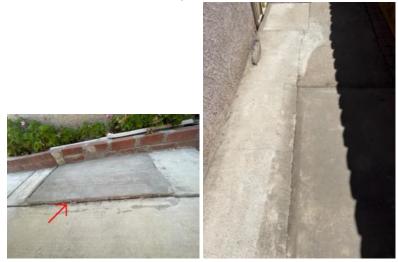
- Sidewalk type: Concrete, Surface raised/settled, Tripping hazards.
- □ ☑ □ Sidewalk type: Concrete, Cracks noted are typical, Cracks noted are major.

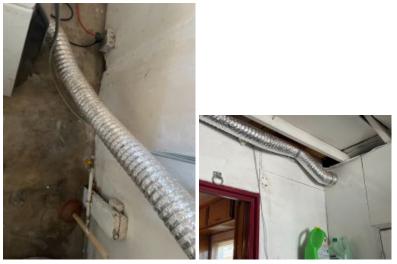
### Dryer Vent:

A dryer vent is provided, and in good visual condition. No tears were noted.
