**Inspection reference: 541**

**Confidential Inspection Report**  
**1781 Thomas Dehaven Lane**  
**Tracy, California 95376**

**August 19,2024**

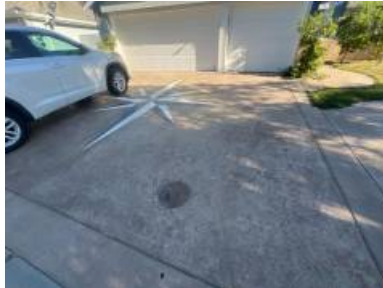
Driveway Type: Concrete, Cracks noted are typical.

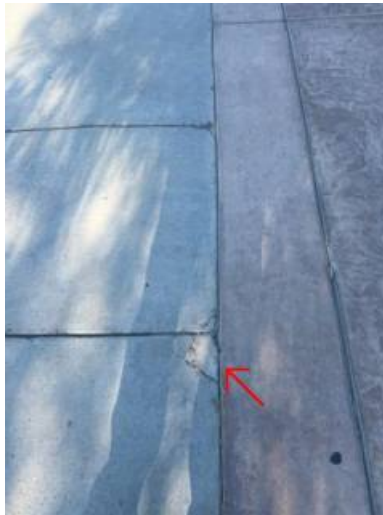
Sidewalk type: Concrete, Portions missing.

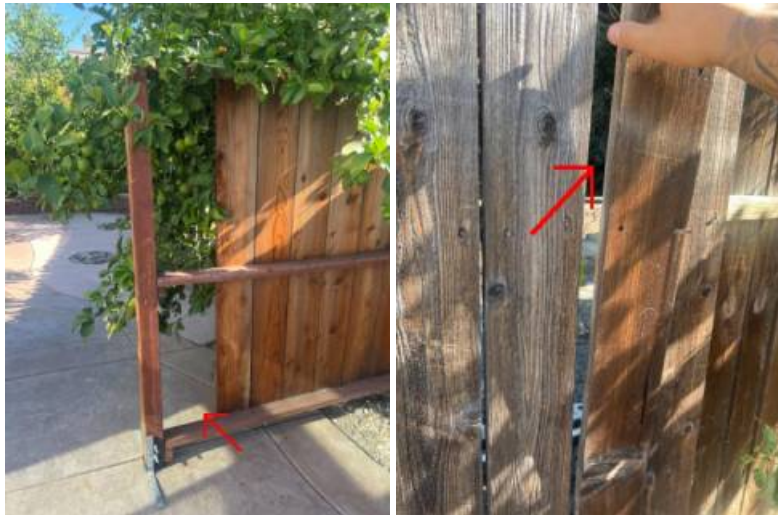
Type: Wood, **Broken/missing boards.**  
   **Loose /missing boards.**

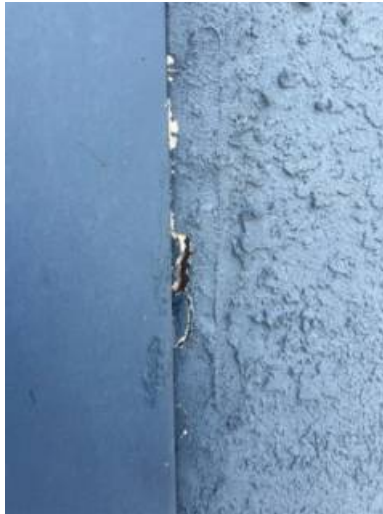
Walls are constructed with Stucco. **Small hairline cracks/chips which are closed and without gaps can best be hidden by application of sealer prior to repainting. This can be done the next time the house needs repainting.**

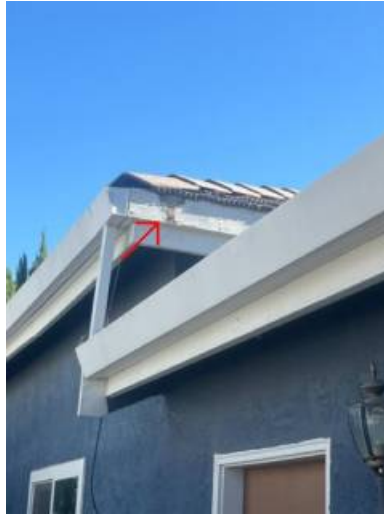
Wood materials. **Paint/finish is needed,**

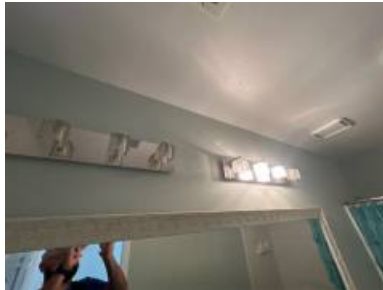
*Hall Bath:*

Lights inoperable.

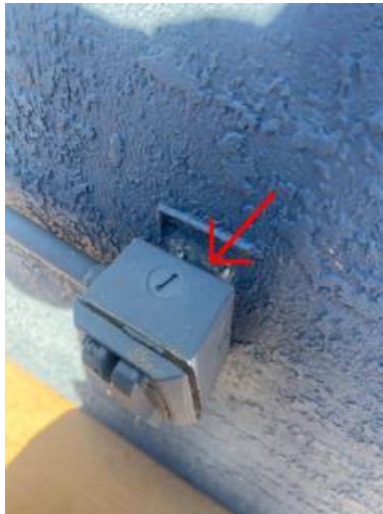
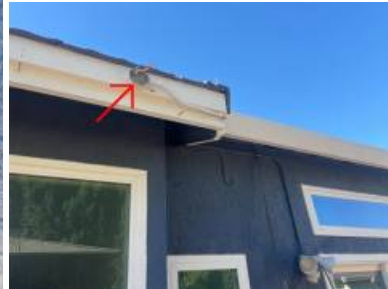
A representative sampling of outlets was tested. As a whole, outlets throughout the house are in serviceable condition. **Junction box cover(s) are missing.**

**Loose/Damaged outlets are seen.**

**Exposed wires noted.**

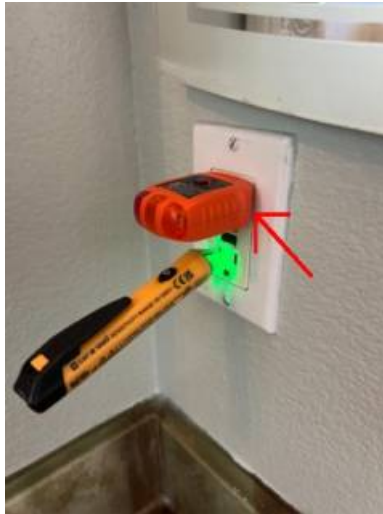
*Master Bath:*

**Some outlets did not function.**

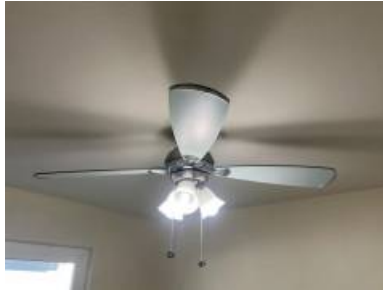
*Bedroom #3:*

The ceiling fan installed in this room did not function using normal controls. Due to the fan hanging I did not attempt to run the fan blades.

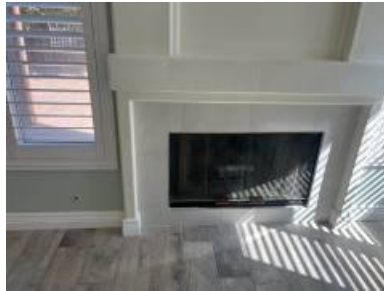
*Family Room:*

Wood Stove, Gas valve is found in the fire box- Valve should be removed! There is a set of glass doors installed. Used correctly, these will help minimize heat loss when the fireplace is not in use. They also eliminate burning embers from flying into the room during a fire and reduce the volume of room air sucked up the chimney. There is a mantle installed, and it meets the 12" minimum clearance above the firebox.

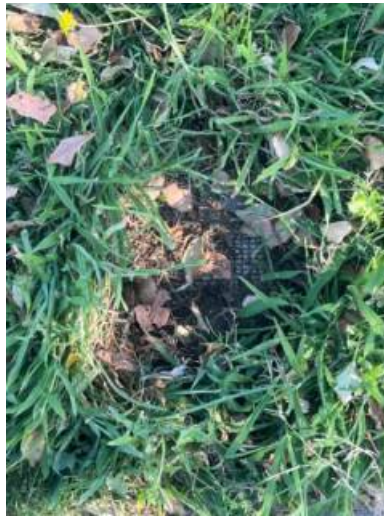
Trim away at shut off valve. Unable to open at the time of inspection.

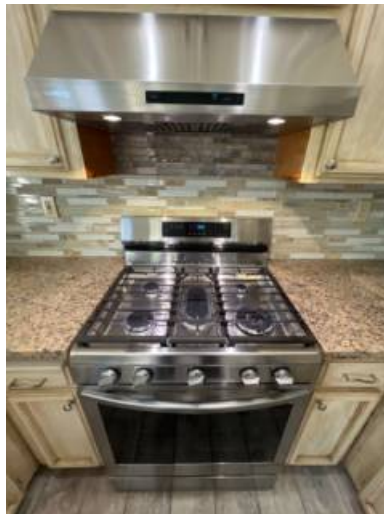
Gas, Stove has not been secured as required by manufacturer's installation instructions. A tip-over hazard exists for small children. Stove should be properly secured right-away.

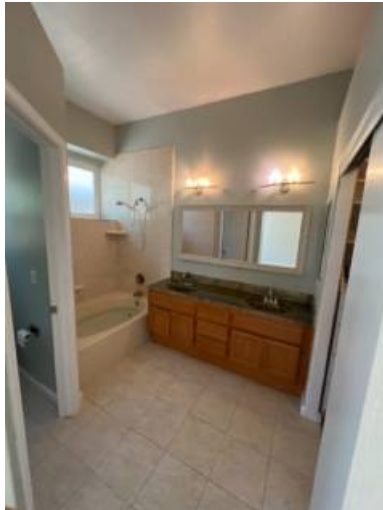
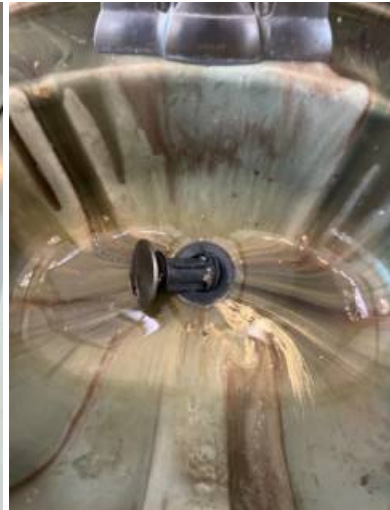
Counters/cabinets appear serviceable, **The following problems were noted at the drain: Stopper did not operate properly.**

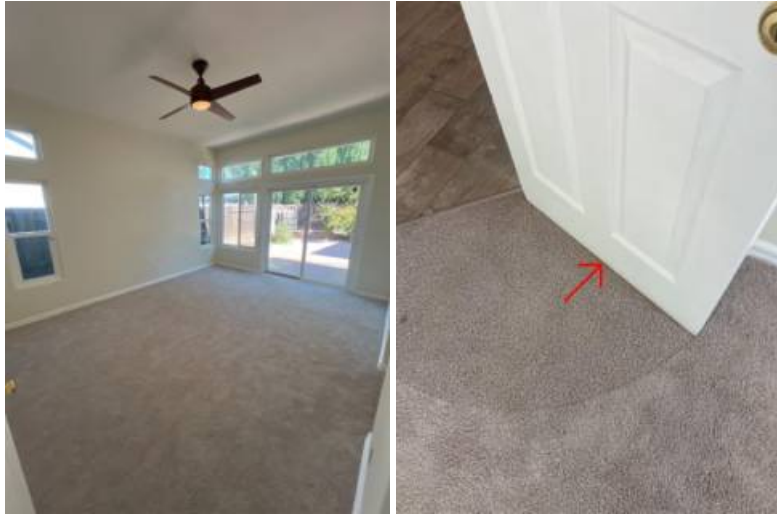
*Master Bedroom:*

**Door drags on carpet, recommend removing door and trimming bottom of door.**

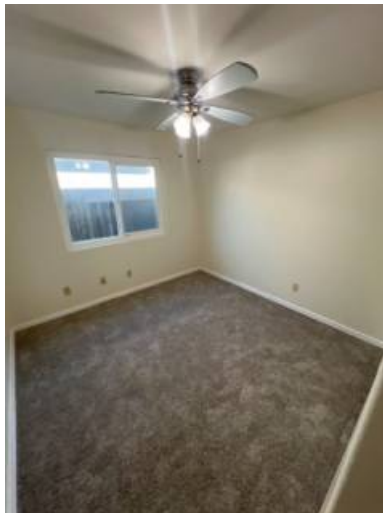
*Bedroom #2:*

Hardware operational, Door drags on carpet, recommend removing door and trimming bottom of door.

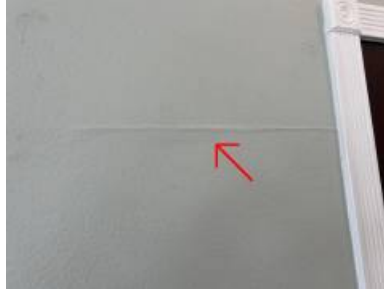
*Living Room:*

There is some minor bubbling in the sheetrock. Most likely this is due to slight settlement or shrinkage.

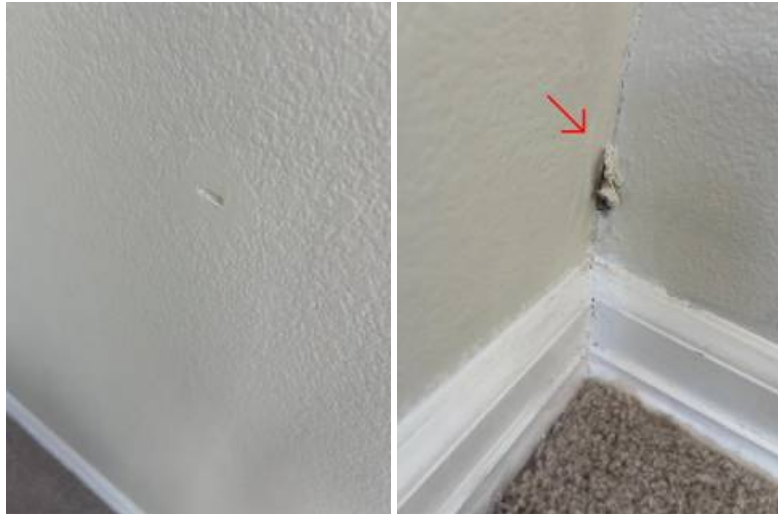
poor patch work noted.

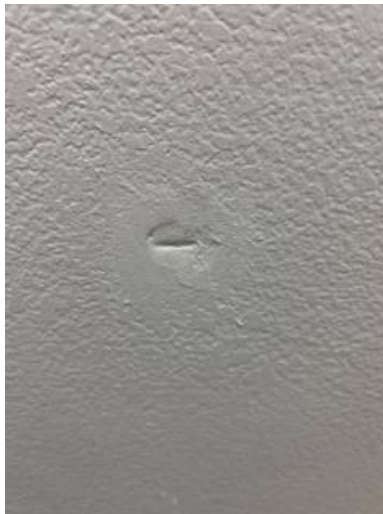
No signs of damages at the time of inspection.  
**Damage noted.**

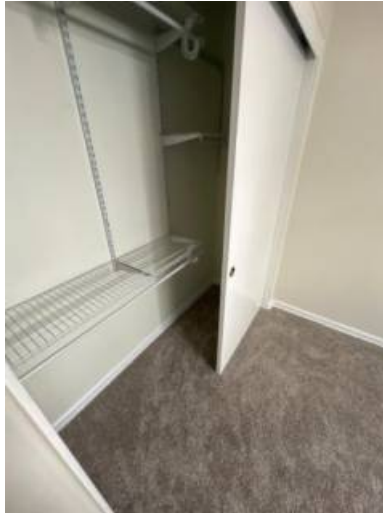
Bedroom #3:

Some portion of the closet door or interior fixtures needs repair or replacement. It is not functional as is. Slides or sliding hardware. Door missing. 1 or more of the closet doors are missing or damaged.

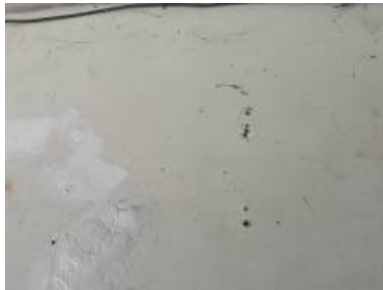
Drywall **Multiple mounting holes noted.**

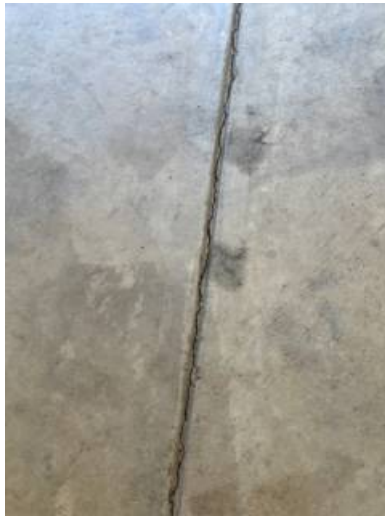
Typical cracks noted. Salt damage is noted.
