# RV Inspection Report

**Prepared for: John Doe**

**Sep 17, 2024-2017/Thor Palazzo 33-2**

Sunflower RV Inspections

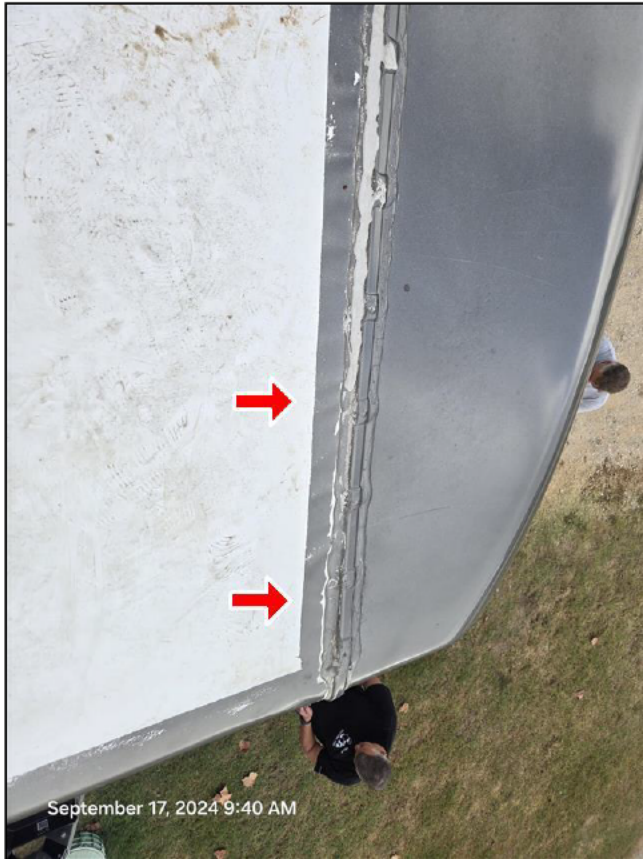
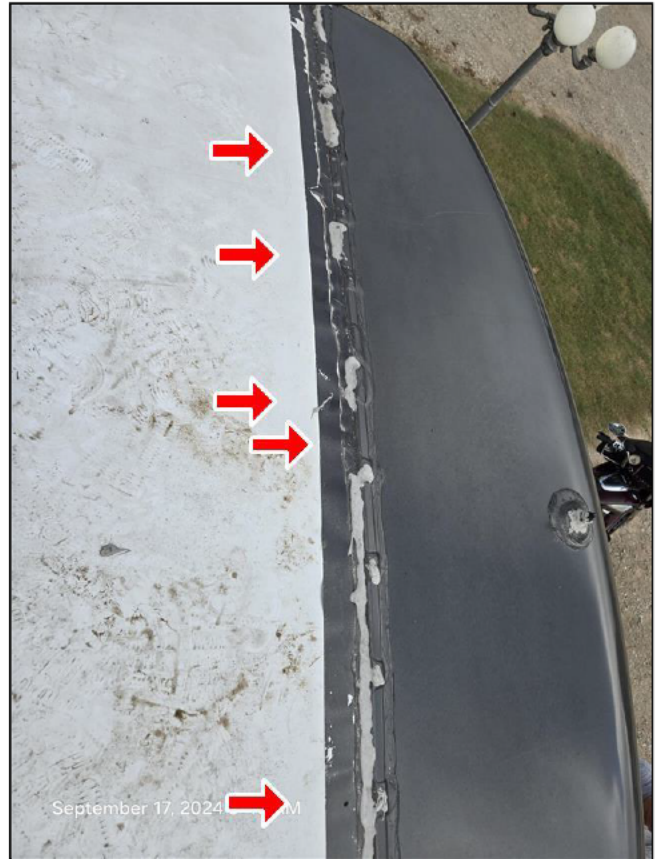
Front Cap Seal

## 3.1 Front Cap, Joints and Seals - Condition

Poor

The lap sealant front cap has multiple holes. This could allow water intrusion. It is recommended that this be further evaluated by a qualified RV technician.

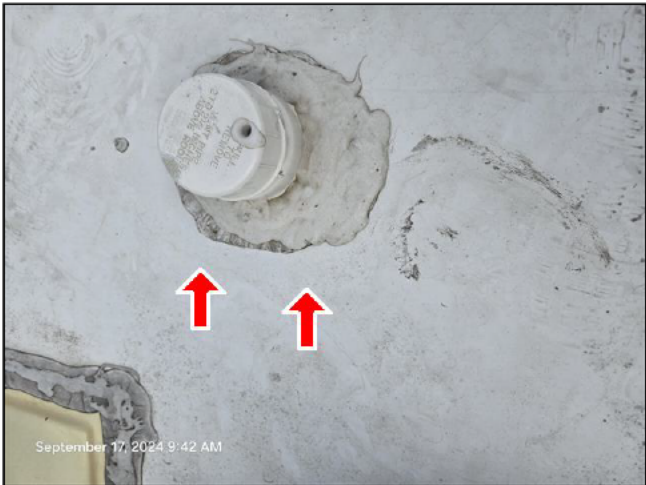
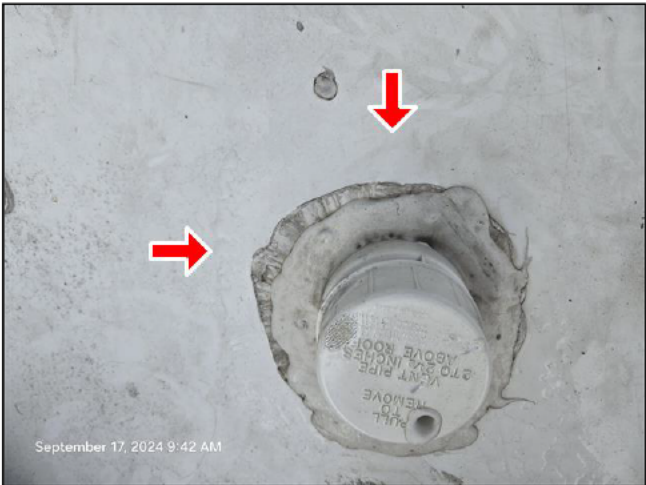
Vent Cover

## 3.7 Exterior Vent Covers - Condition

Poor

The lap sealant around the external vent is cracked and peeling. This could allow water intrusion. It is recommended that this be further evaluated by a qualified RV technician.

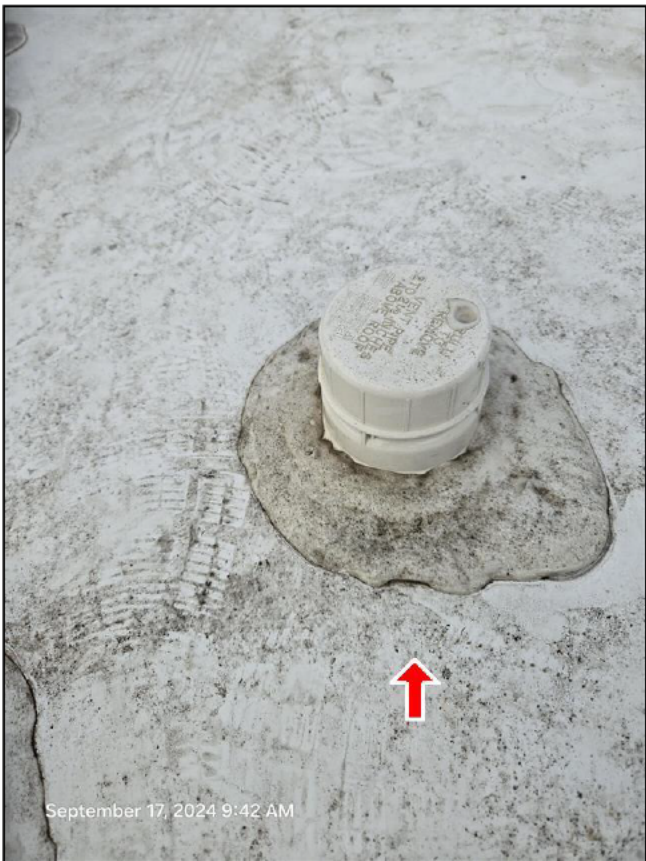
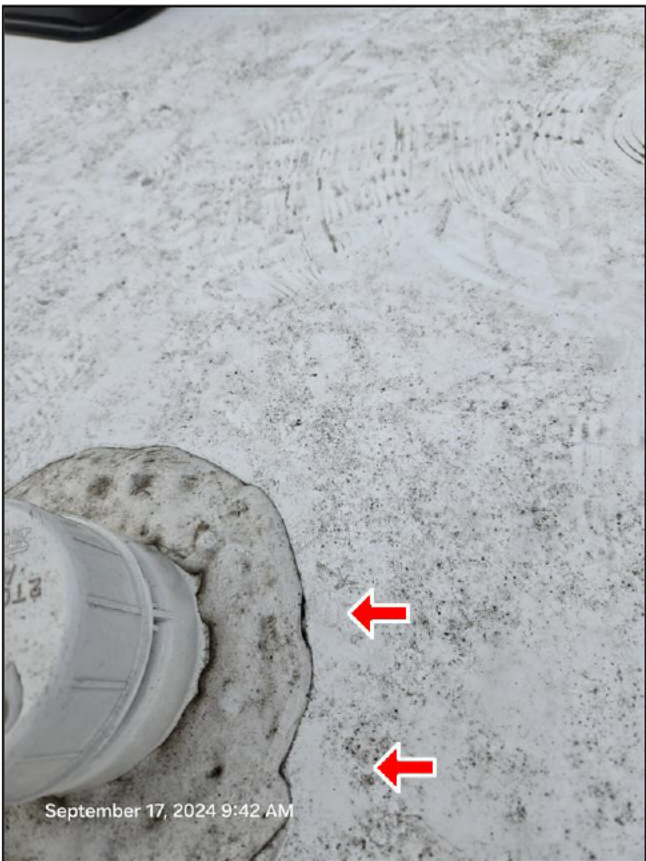
Plumbing Vent Cover

3.8 Plumbing Vent Covers - Condition

Poor

The lap sealant plumbing vent at center has come loose from the roof. This could allow water intrusion. It is recommended that this be further evaluated by a qualified RV technician.

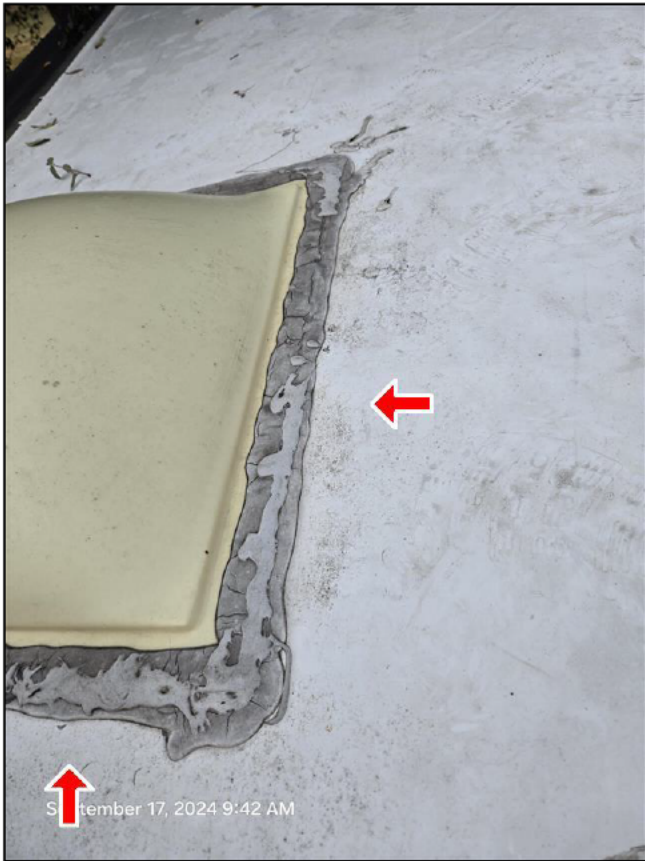
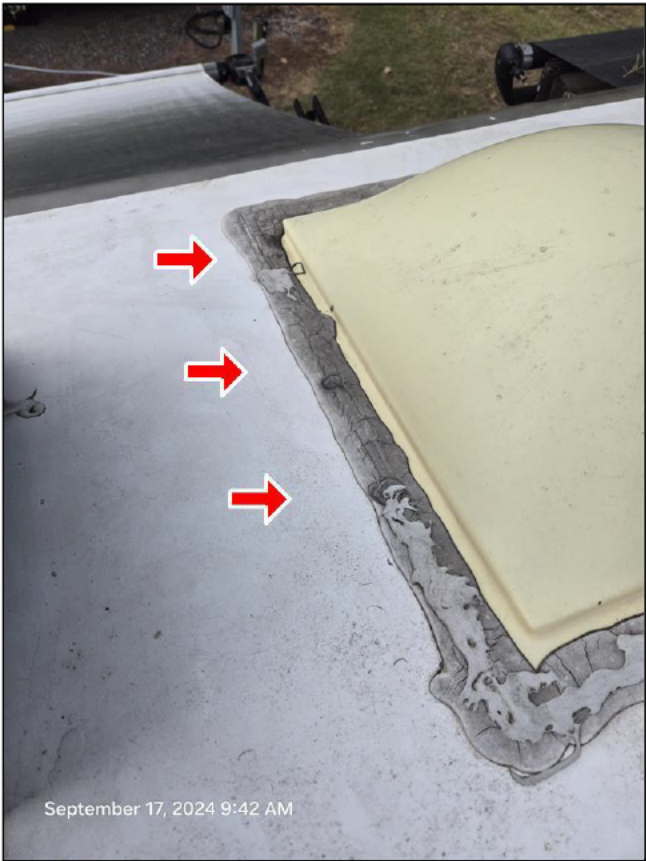
Skylight

3.10 Skylights - Condition

The lap sealant skylight is cracked in multiple places. This could allow water intrusion. It is recommended

that this be further evaluated by a qualified RV technician.

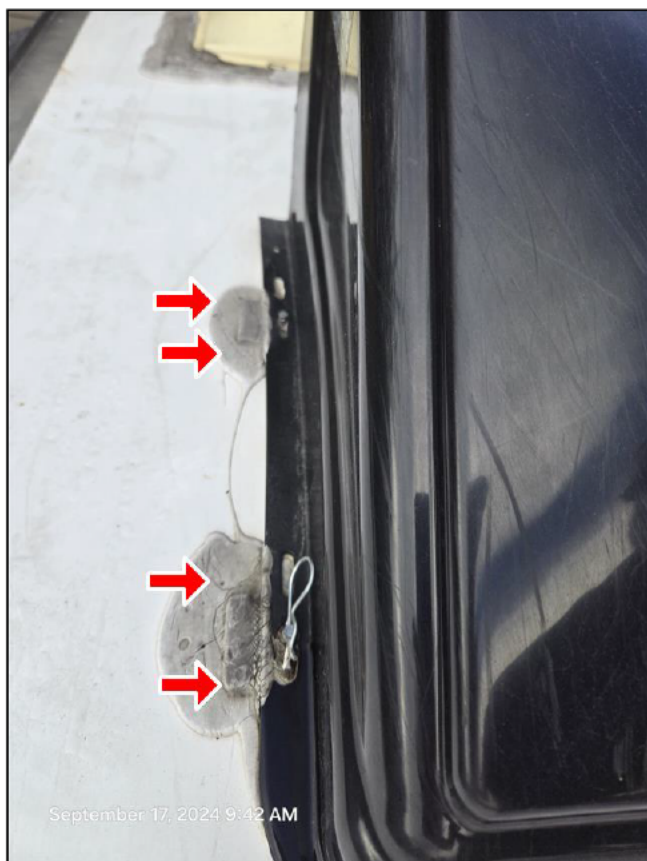
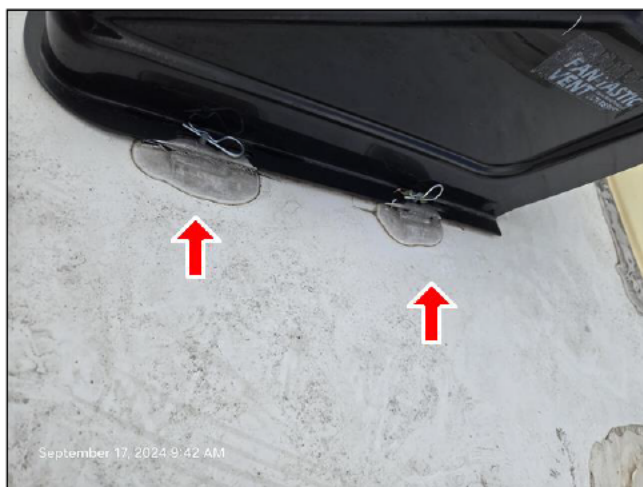
Front Air Conditioner Shroud

3.11 Front Air Conditioner - Cover (Shroud) - Condition  
Poor

The lap sealant at front air conditioner shroud is cracked. This could allow water intrusion. It is recommended that this be further evaluated by a qualified RV technician.

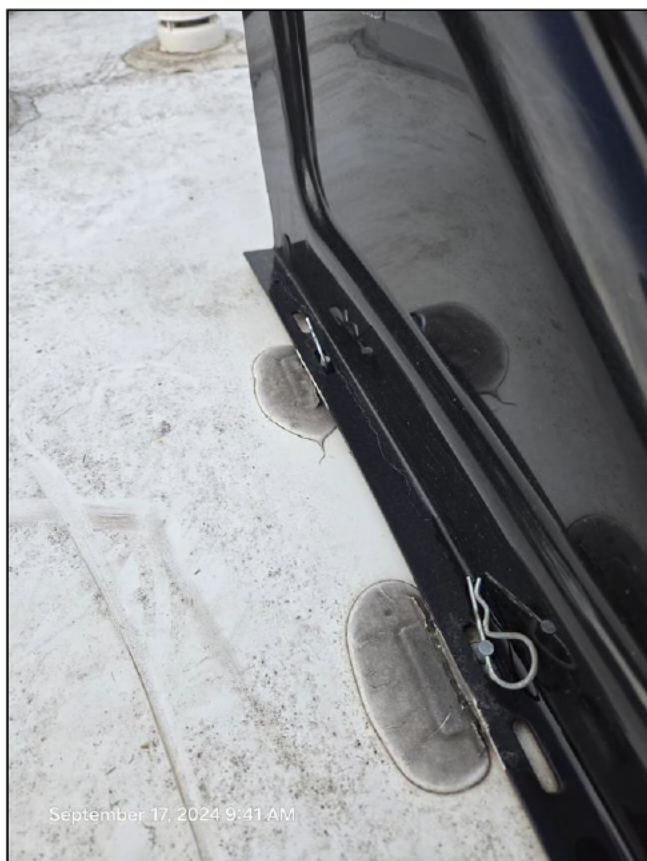
### 3.13 Rear Air Conditioner - Cover (Shroud) - Condition

Poor

The rear air conditioner lap sealant around the shroud is cracked and dried out. This could allow water intrusion. It is recommended that this be further evaluated by a qualified RV technician.

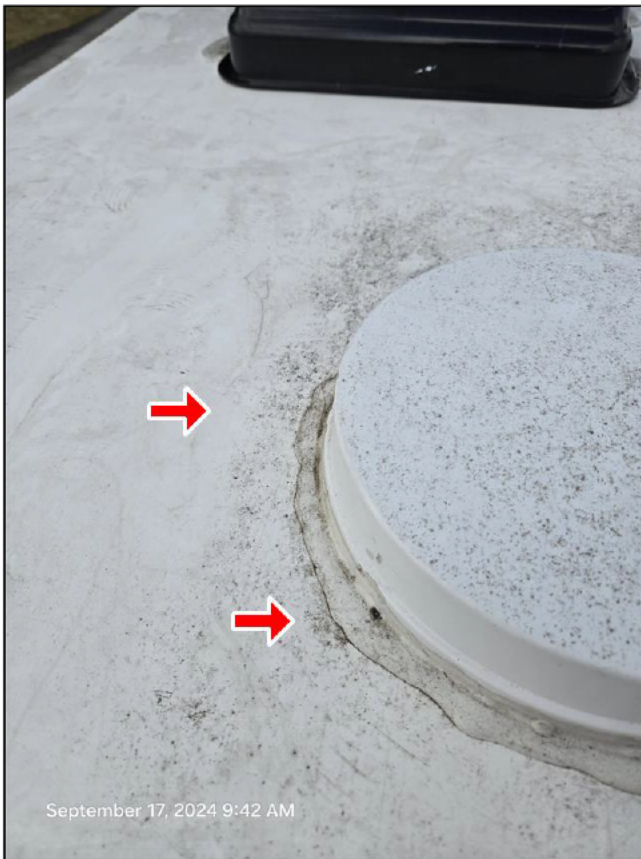
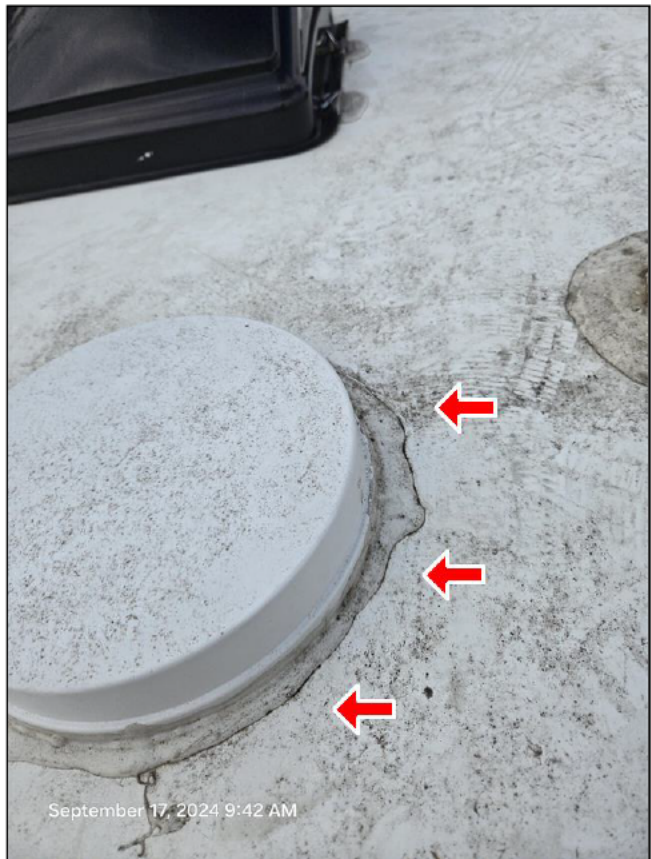
TV Radio Satellite Receiver

### 3.15 TV Antenna - Exterior Roof Unit - Condition

Poor

The lap sealant around the satellite antenna has holes. This could allow water intrusion. It is recommended that this be further evaluated by a qualified RV technician.

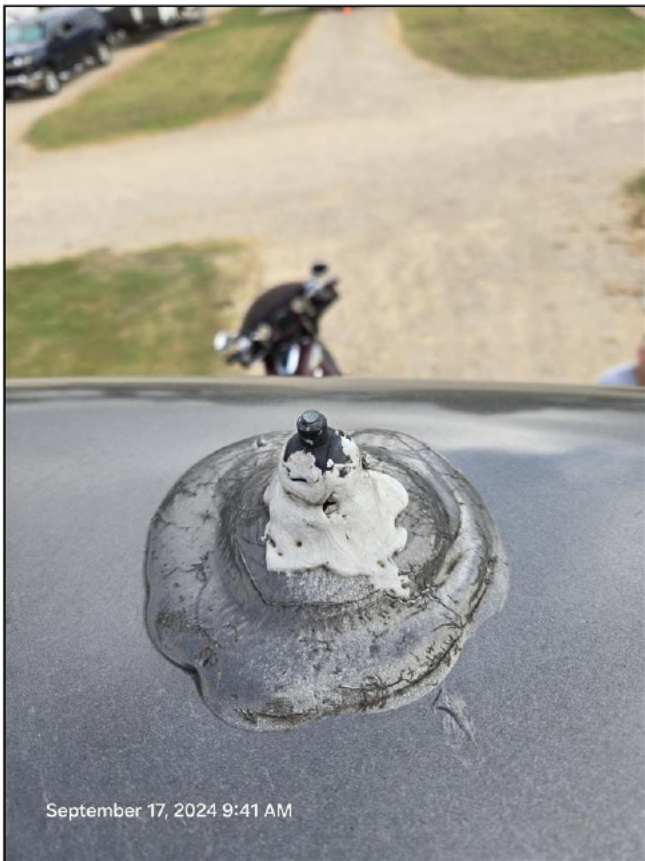
Roof Antennae

**3.18 Radio Antenna - Condition**

Poor

The lap sealant around radio antenna front has holes. This could allow water intrusion. It is recommended that this be further evaluated by a qualified RV technician.

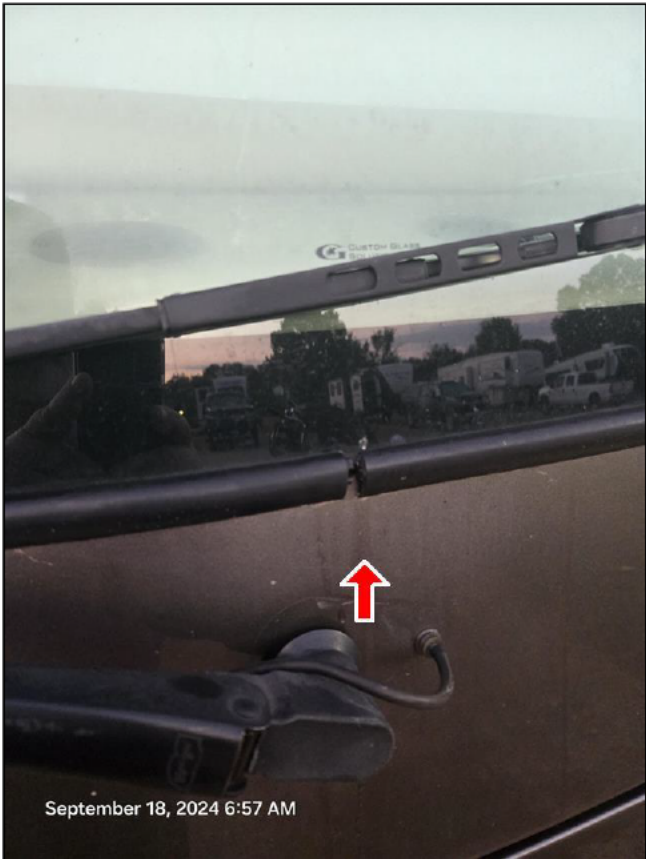
4.0 Windshield - Condition  
Fair

There is a gap in the sealant of the windshield. The sealant front bottom is missing. This could allow water intrusion. It is recommended that this be further evaluated by a qualified glass technician.

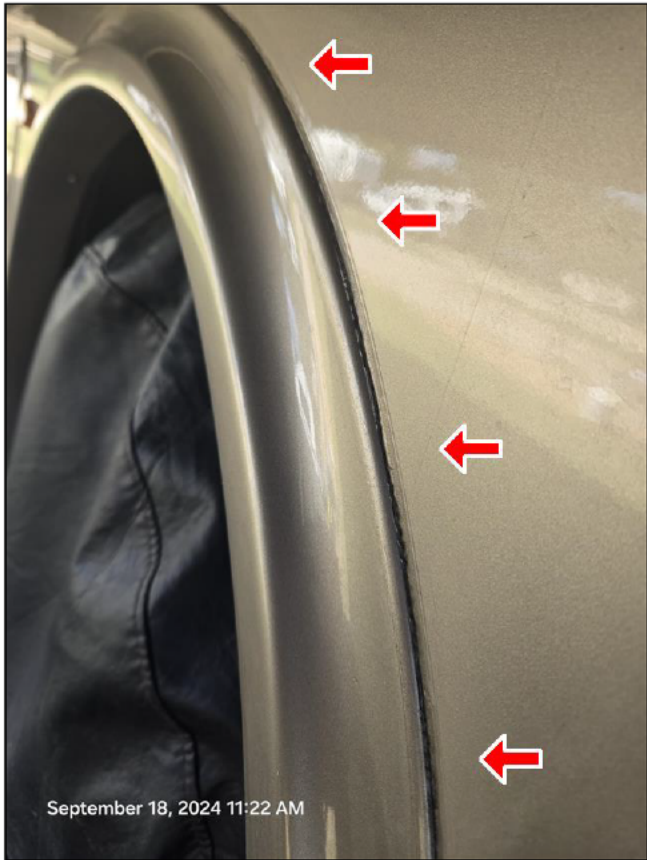
Curbside Front Wheel Trim

- 5.0.B Sidewall - Condition
- Acceptable
- (1) The sealant around the curbside front wheel trim is cracked. This could allow water intrusion. It is recommended that this be further evaluated by a qualified RV technician.

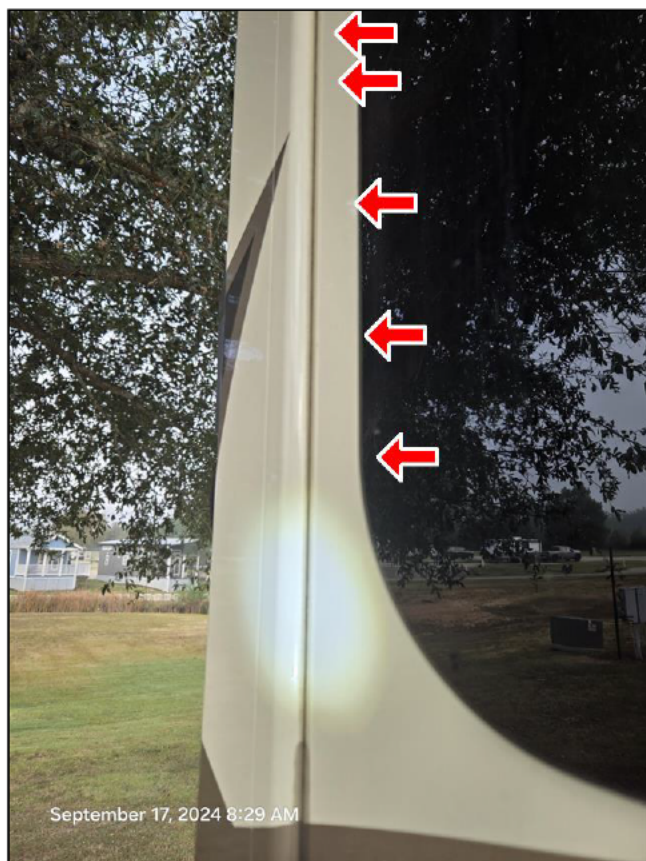
Rear Seal

(2) The seal where the sidewall meets the rear cap is missing sealant. This could allow water intrusion. It is recommended that this be further evaluated by a qualified RV technician.

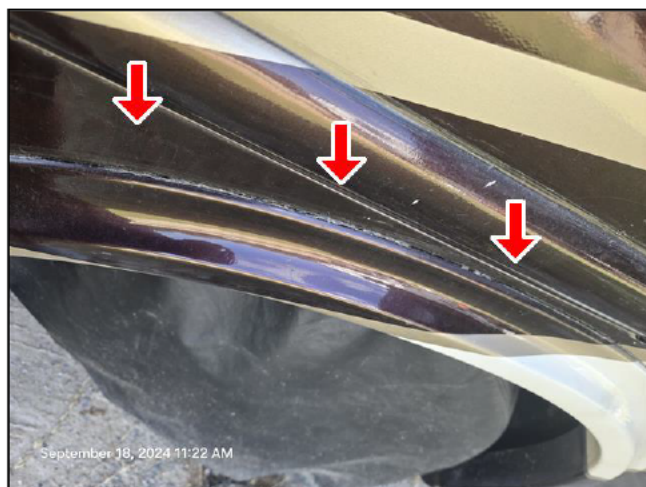
Curbside Rear Wheel Trim

(3) The sealant around the curbside rear wheel trim is cracked. This could allow water intrusion. It is recommended that this be further evaluated by a qualified RV technician.

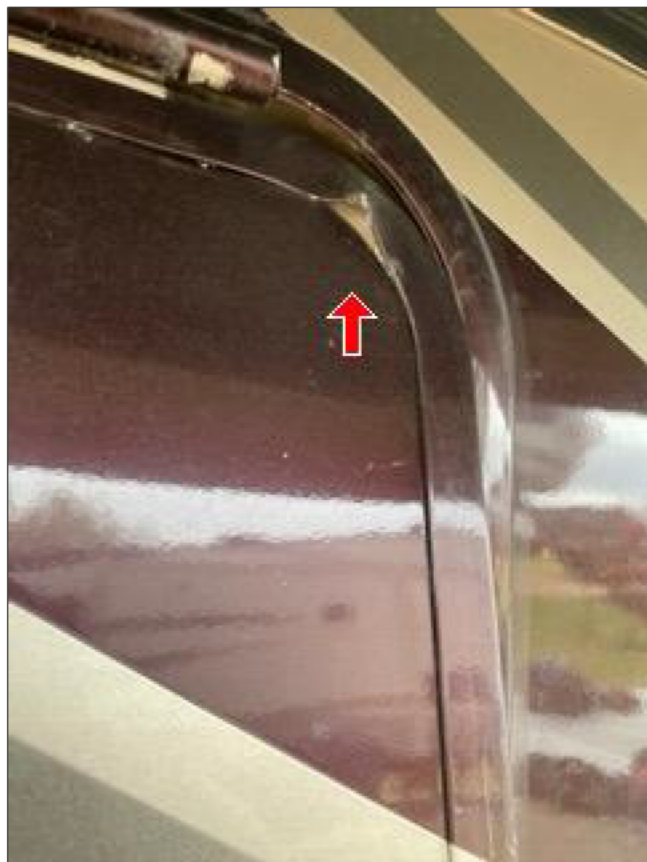
Middle Cargo Door

(4) The trim on the middle cargo door is cut and split

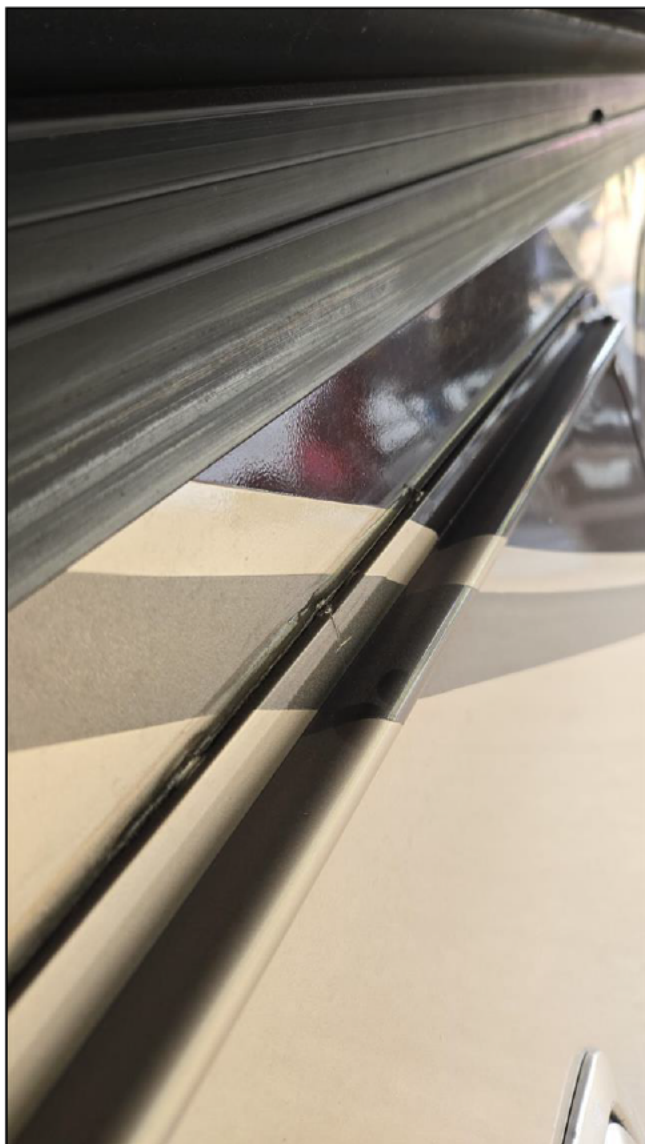
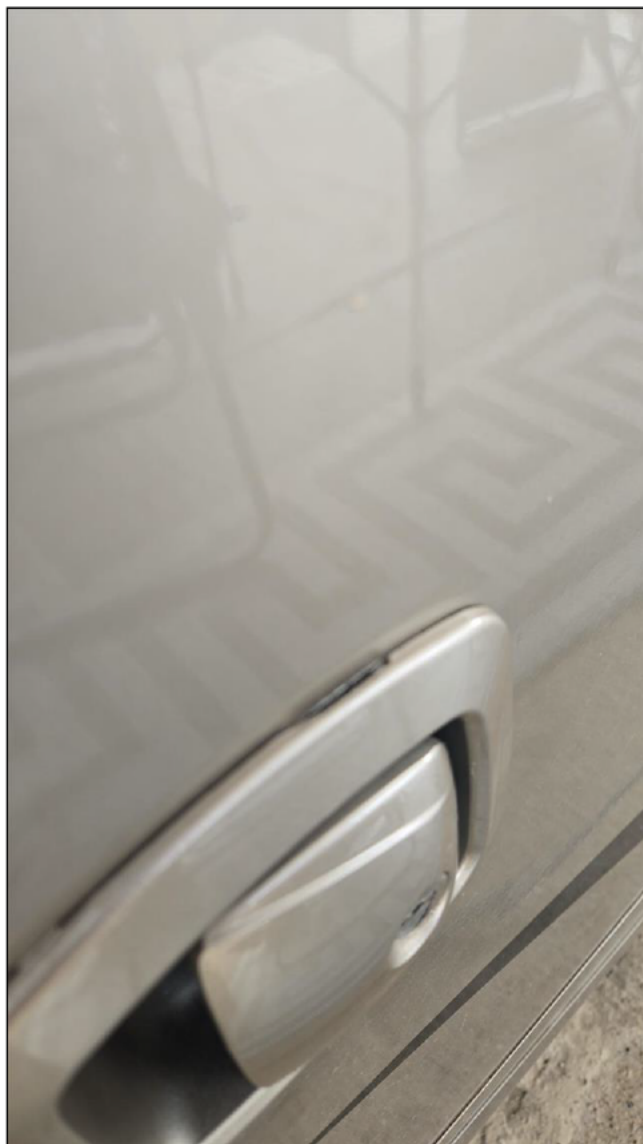
(1) The sealant on the cargo door handle top is cracked curbside. This could allow water intrusion. It is recommended that this be further evaluated by a qualified RV technician.

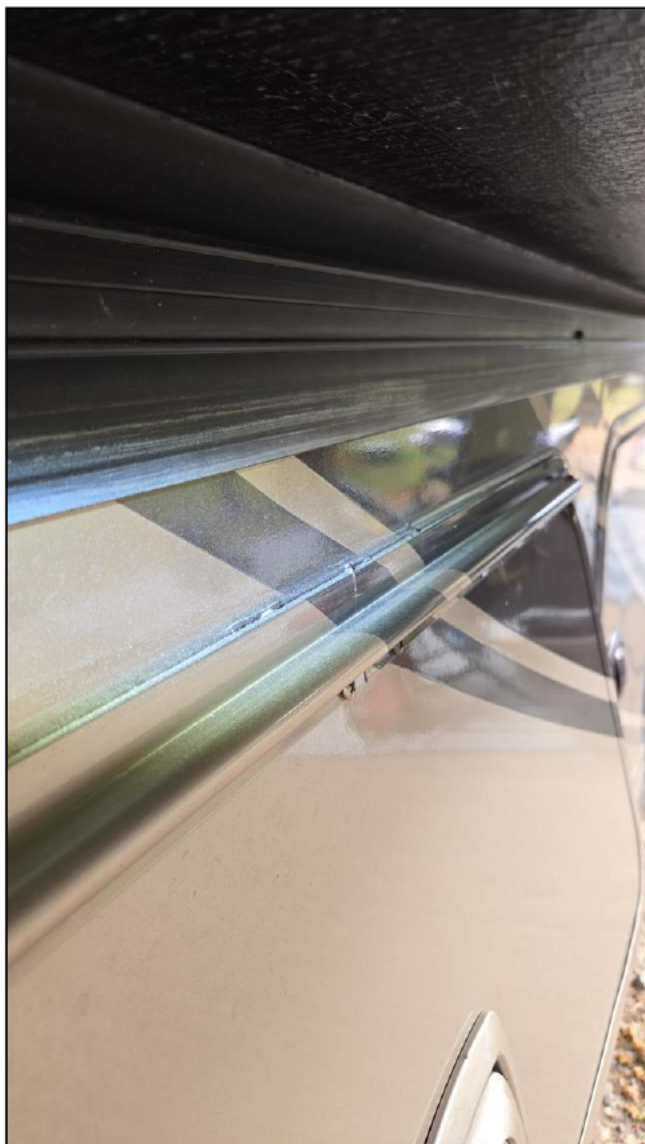
Curbside Cargo Door

(2) The sealant on the curbside rear cargo door is cracked on the top. This could allow water intrusion. It is recommended that this be further evaluated by a qualified RV technician.

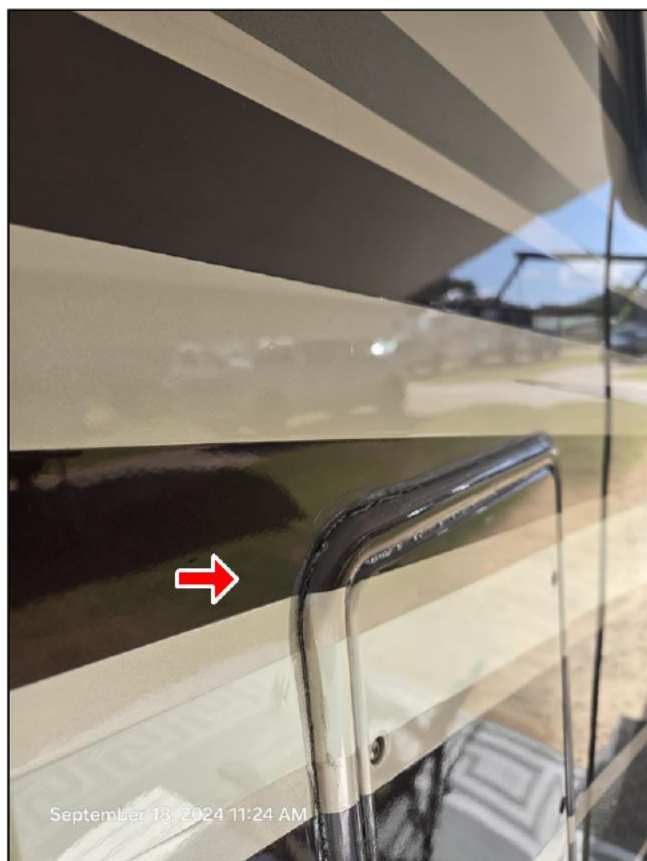
Battery Access Door

#### **5.4.B Cargo / Access Doors - Condition**

Poor

The sealant at the curbside battery access door is cracked. This could allow water intrusion. It is recommended that this be further evaluated by a qualified RV technician.

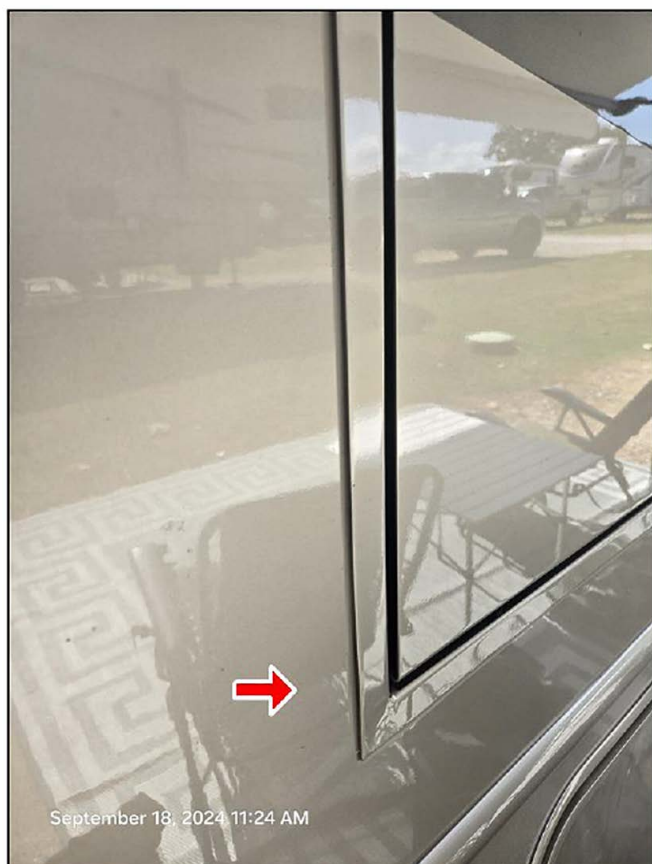
Outside TV Cover

#### **5.5.B Cargo / Access Doors - Condition**

Poor

The sealant at the TV access door is cracked. This could allow water intrusion. It is recommended that this be further evaluated by a qualified RV technician.

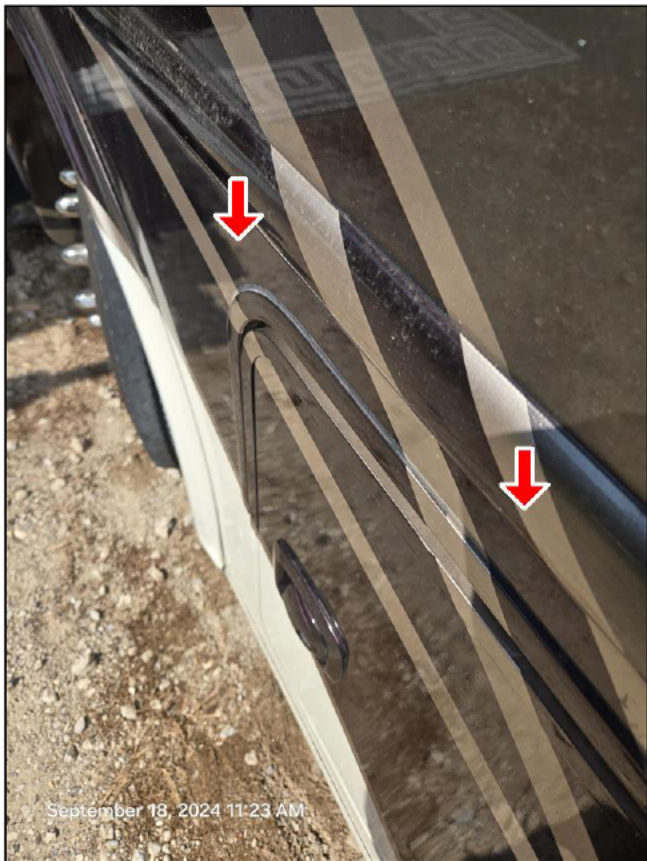
Middle Cargo Door

#### **5.6.B Cargo / Access Doors - Condition**

Poor

The sealant at the cargo door curbside is cracked. This could allow water intrusion. It is recommended that this be further evaluated by a qualified RV technician.

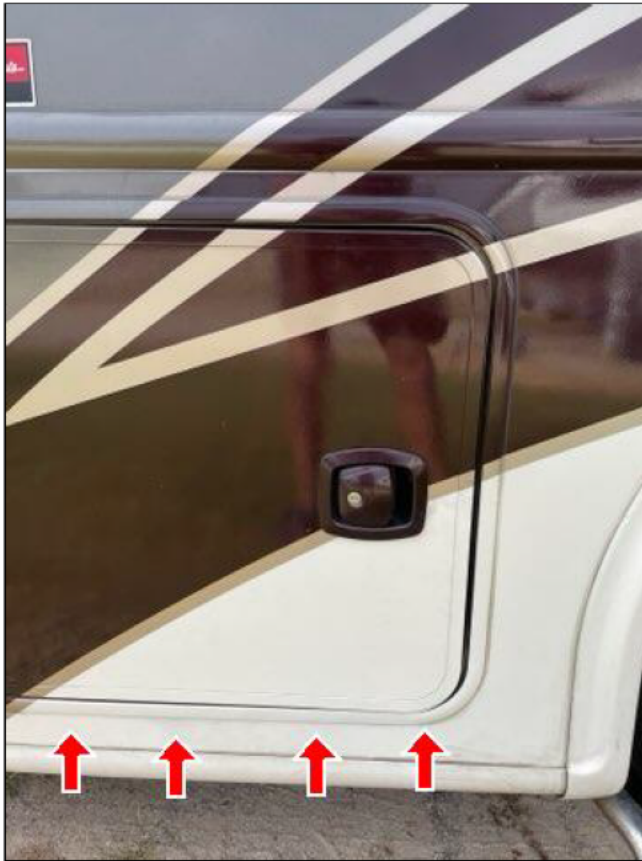
Front Cargo Door

(2) The front cargo door is not aligned correctly

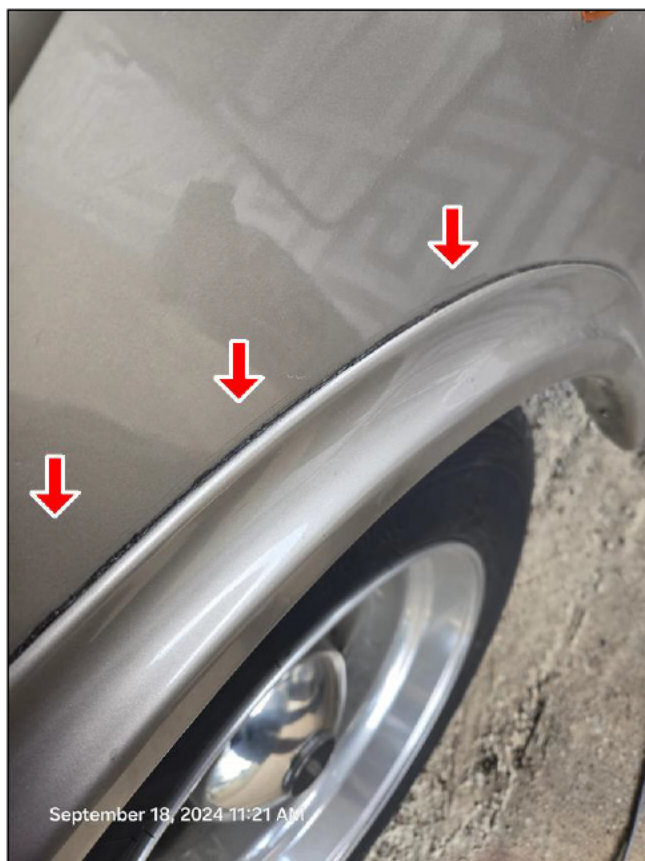
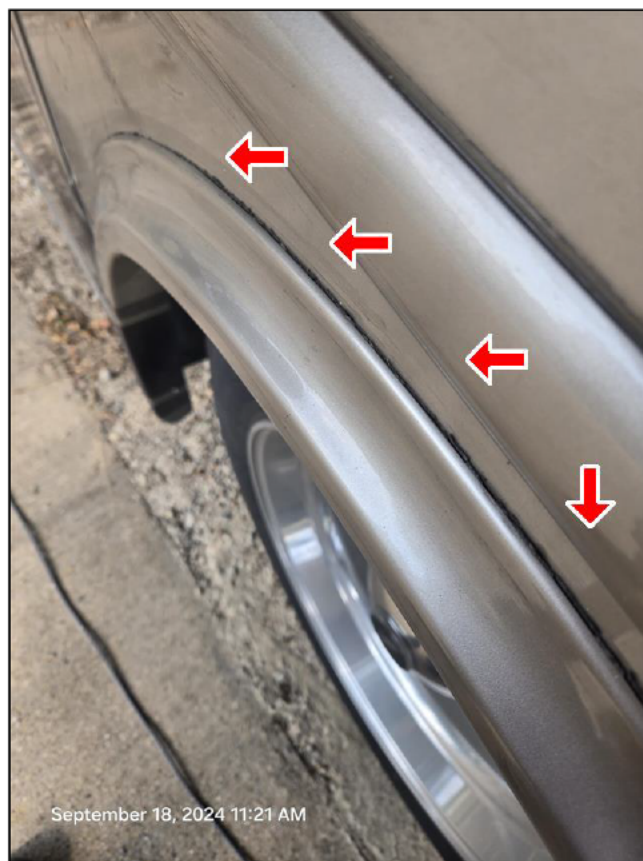
(3) .The sealant around the curbside front wheel trim is cracked. This could allow water intrusion. It is recommended that this be further evaluated by a qualified RV technician

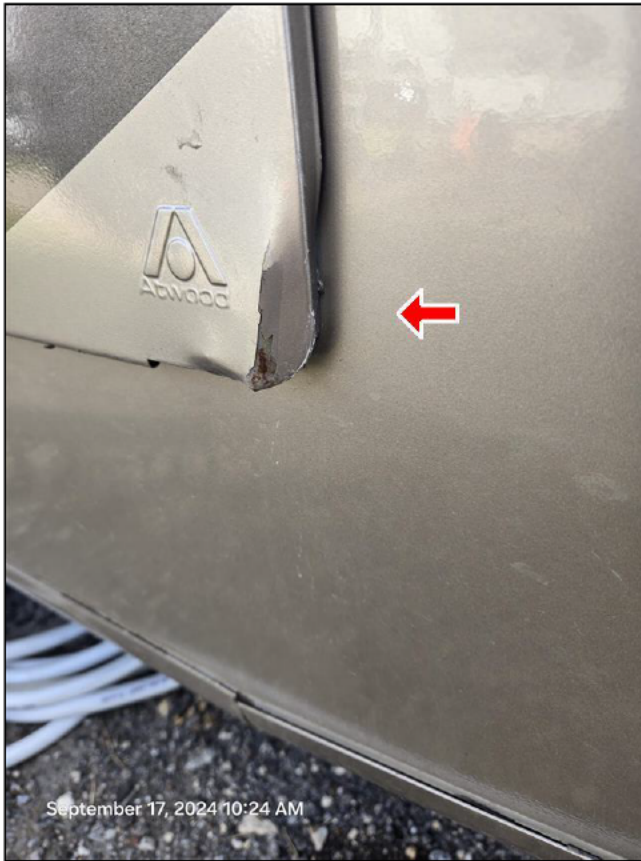
Water Heater Access Door

(1) The water heater access door lower right corner is bent.

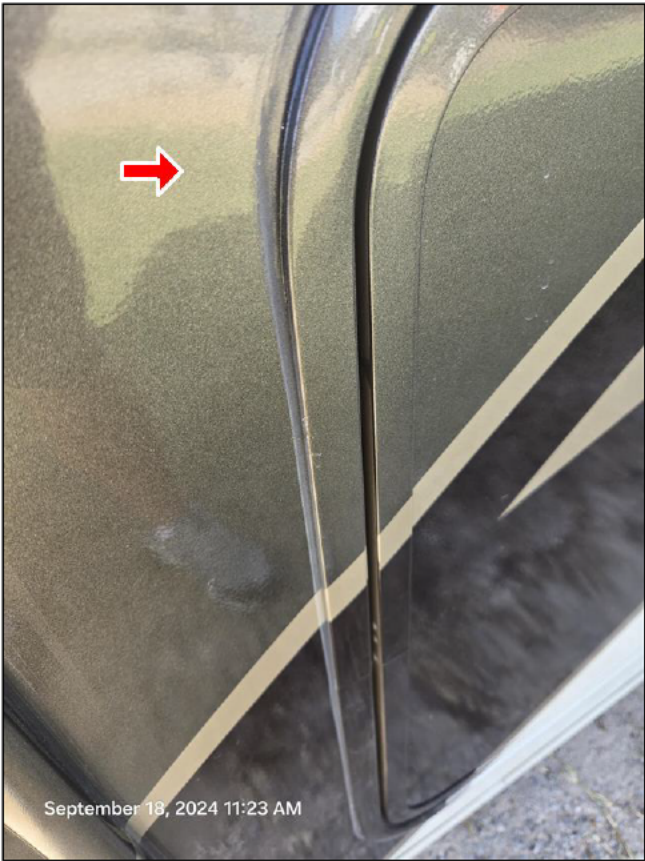
Middle Cargo Door

(2) The sealant around the middle cargo door is cracked. This could allow water intrusion. It is recommended that this be further evaluated by a qualified RV technician.

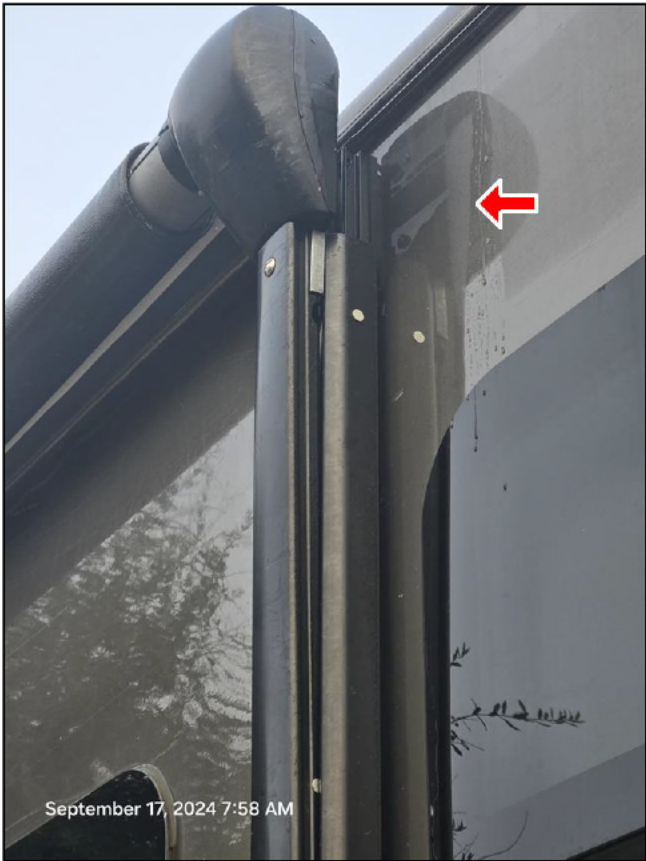
Awning Mechanism

The front awning arm does not fully retract.

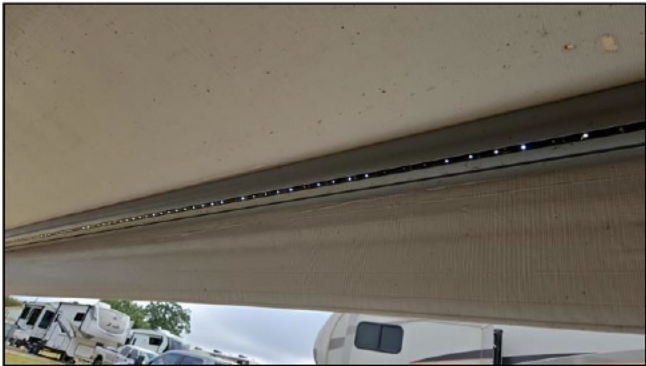
Awning Lights

There are burnt-out LED lights under the curbside awning. Not all are working It is recommended that this be further evaluated by a qualified RV Technician.

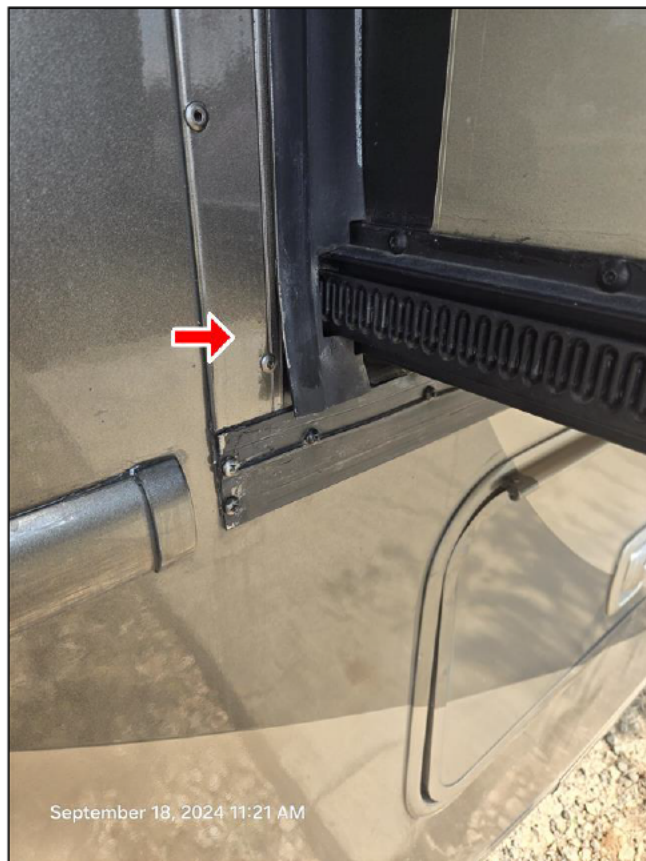
Rear Slideout Gasket

(1) The rear gasket on the slideout is warped. This could allow water intrusion. It is recommended that this be further evaluated by a qualified RV technician.

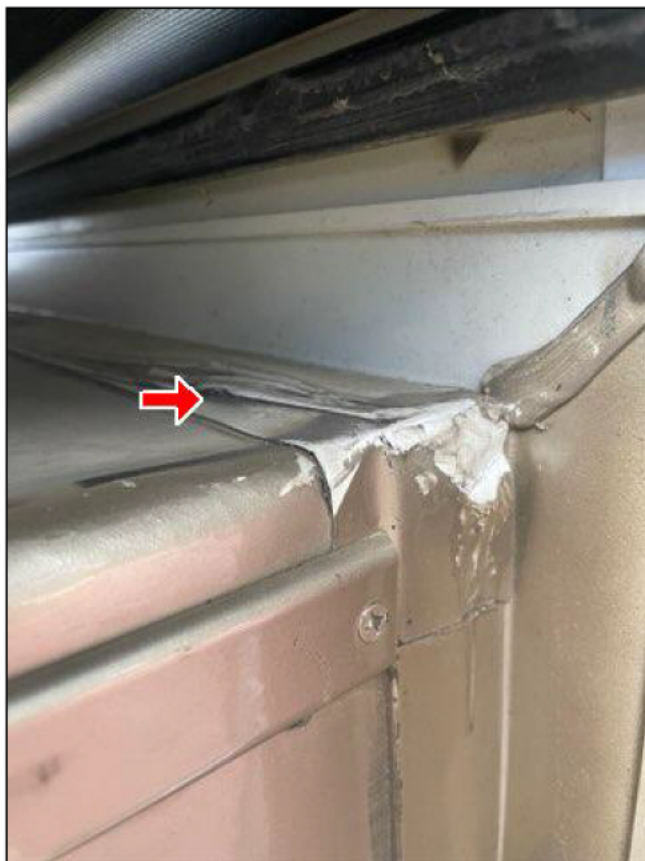
Curbside Slideout

(2) The tape that covers the joint where the T-molding attaches to the roof is lifting. It is recommended that this be further evaluated by a qualified RV technician.
