Jodi Patrich
Balboa Island Resident
RE: Tree assessment walk - Marine Ave.
10/04/18

Rick Harlow
ISA Board-Certified Master Arborist WC3880
Orange Coast College
Department Head, Horticulture

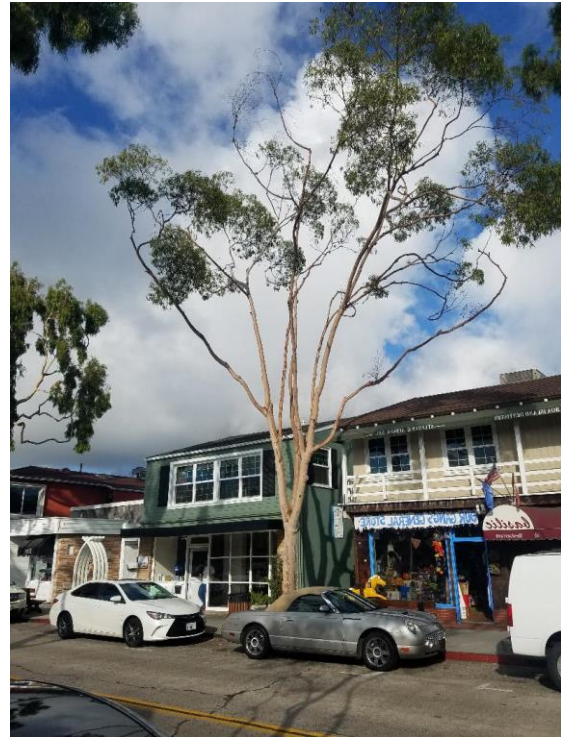
Most of the *Eucalyptus* were in fair to good condition with evidence of some branch tip dieback on several the *E. citriodora* species. The estimated age was between 70 and 80 years for most of the larger *Eucalyptus* having grown into their surroundings over that time. There were 4 planting holes vacant. There was also an artificial turf covering over the planting squares covering the soil and wrapping up to the root crown area (trunk flair). I only observed what appeared to be lerp psyllid on one of the *E. maculata*, but the tree didn't seem to be damaged from the psyllid infestation and was in full leaf. The trees seemed to have been pruned regularly and were not showing any signs of needing structural pruning or maintenance thinning. Evidence of hard root pruning was evident on one tree (see picture) due to proximity to the curb.

Opinions: Branch tip dieback is generally associated with root issues. The trees having grown into their spaces over many decades receive their water mostly when it rains as water percolates through the streets, sidewalks and planter openings. Having 7 of the last 10 years being droughty years with less than normal rainfall, and covering being placed over the planting holes in the last few years, my first guess would be lack of water to the roots as well as the benefits of rainfall leaching any excessive accumulated salts down away from the root systems. There was smaller than expected evidence of heaving and lifting from tree roots on the sidewalks and in the streets.

The worst of the branch observed

The trees showing tip dieback should be regularly monitored allowing for proactive decisions to both help the trees and maintain public safety.

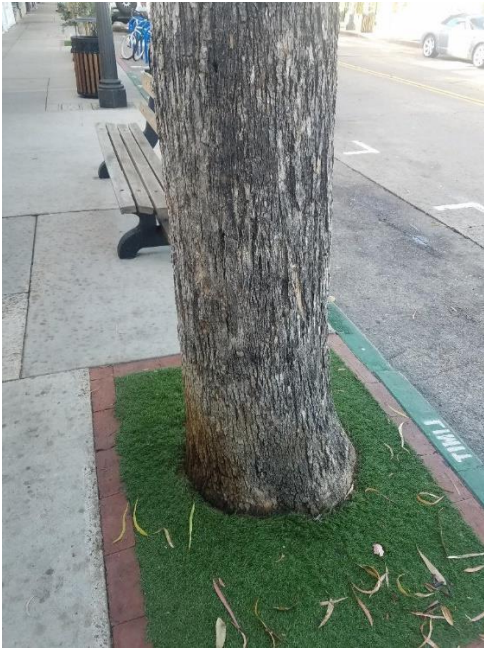
Astro turf covering root crown

I feel that the "Astro turf" should be addressed and possibly removed. Tree root crowns need to be exposed to the air and kept dry and injury free and this addition cannot be doing the trees any good and might be contributing to issues mentioned previously.

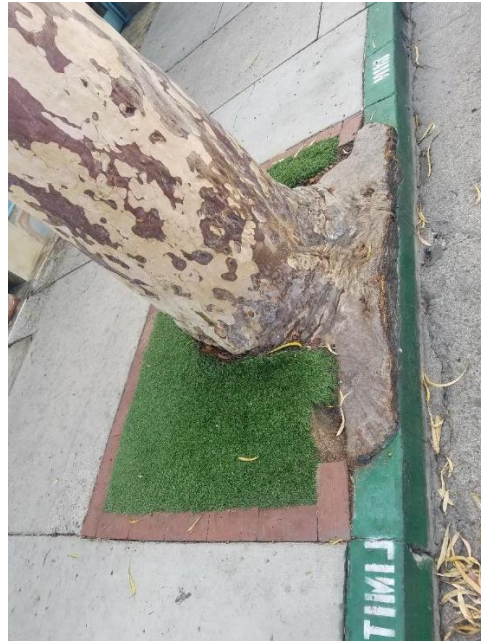
Root Pruning
