**Appendix I:**  
**50 North Broadway Conditions Report**

June 20, 2022  
06252.0008

Re: Structural Investigation  
50 North Broadway  
Yonkers, NY

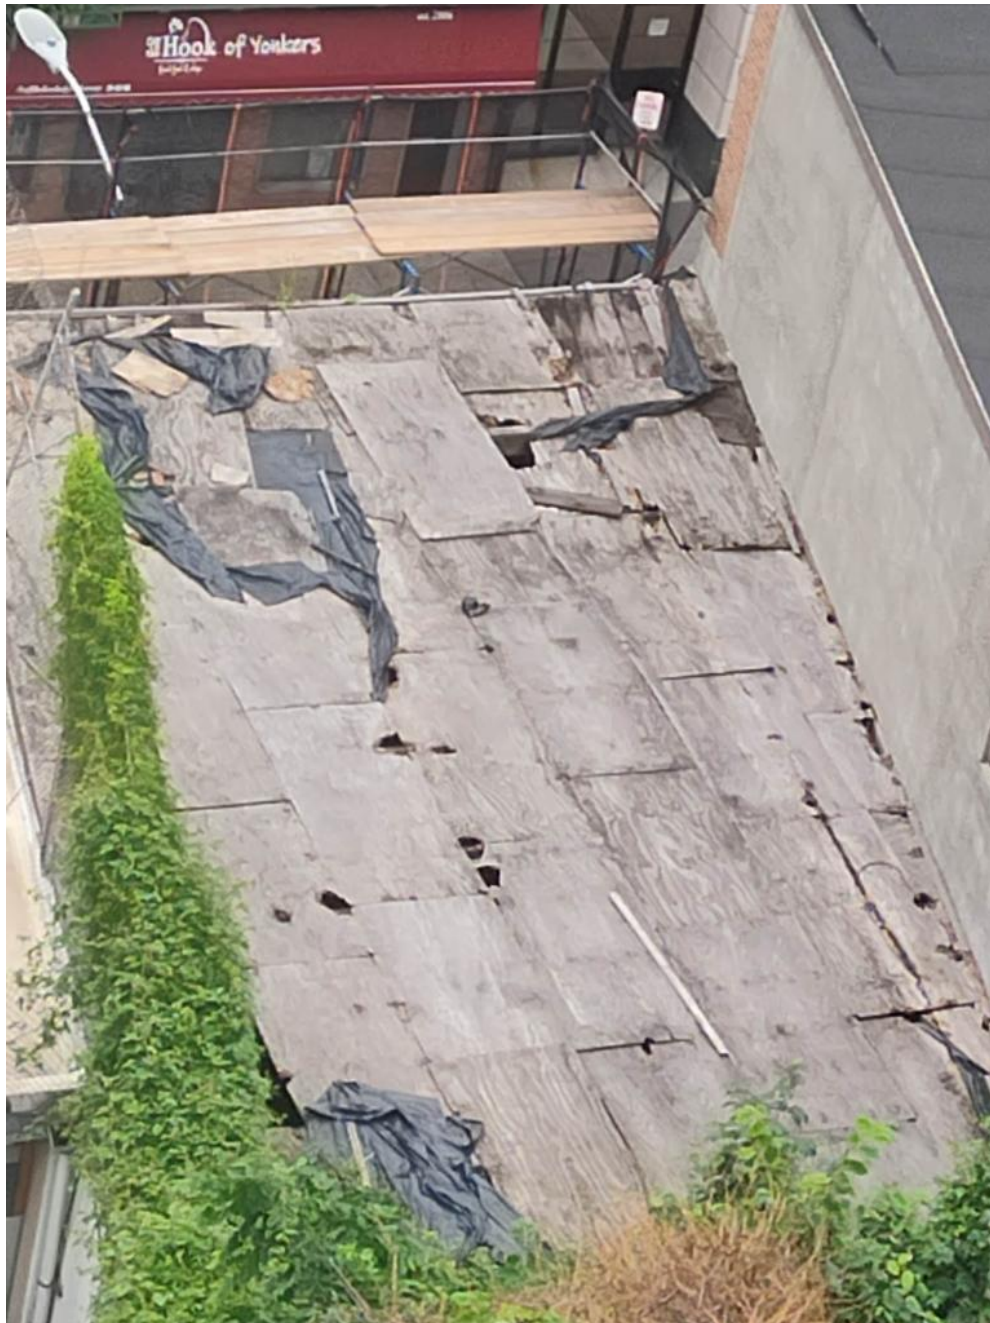
While it is unknown if any of the repair work ordered by the City or proposed in the building permits was completed, no public records exist indicating any repair work has been performed and it is unlikely due to the present condition of the site. The most recent Building Permit was for a complete reconstruction of the building. In the 8 years since that Building Permit was filed, the structural condition of the building has certainly deteriorated even further.

Photo 1: View of existing roof from above. No signs of any repair or shoring work can be seen.

Due to the discovered public records and visual inspection of the building, it is PS&S's recommendation that the entire building be demolished. To preserve and reuse any existing structural members or repair the front façade is practically and economically unfeasible, in our opinion. The single party walls on each side of the structure appear to be integral with the adjacent buildings, so care should be taken during demolition to avoid damage. A demolition permit including demolition and shoring drawings prepared by a Professional Engineer should be submitted to the City of Yonkers as soon as practical prior to any construction activity.

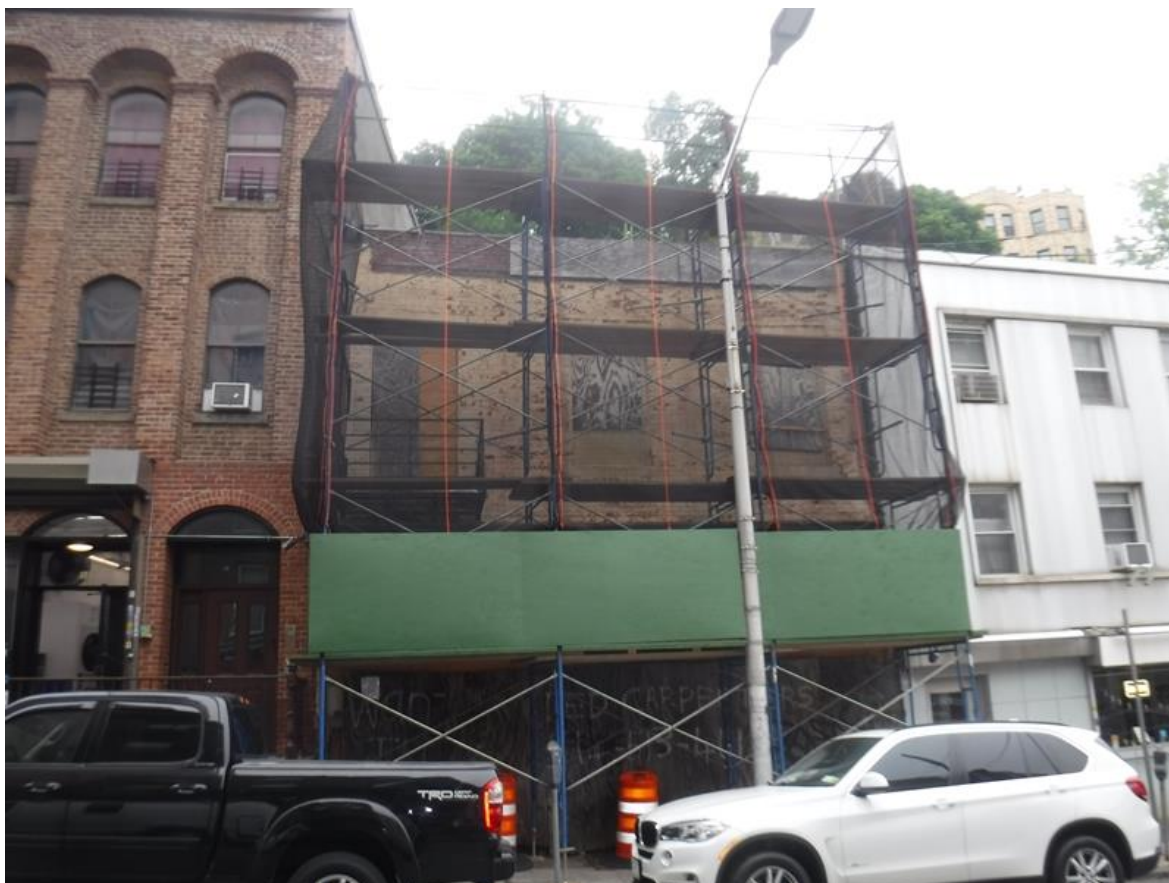
On March 15, 2022, a Notice of Violation was issued by the Department of Housing and Buildings pertaining to the loose bricks and plywood at the street side of the building. See existing photos in Appendix A, attached.

PS&S concurs with the March 15, 2022, Notice of Violation that the façade and plywood at the front to the building poses an immediate threat to pedestrians below, and the sidewalk should be protected until it is removed or repaired.

Photo 2: View of front face of building, showing plywood covering façade to prevent bricks from falling.

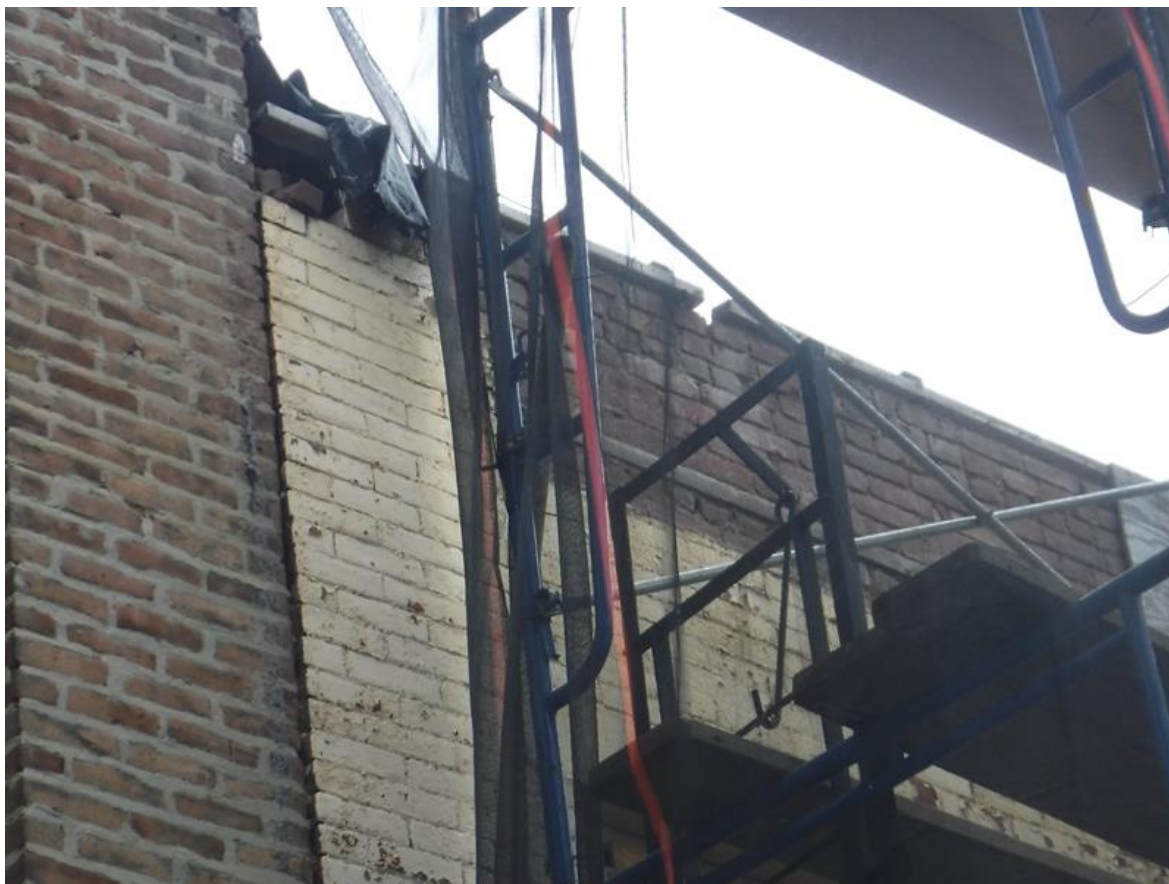
The building is a two-story brick building with a basement, with brick party walls on two sides. The floors and roof consist of wooden beams spanning between the party walls and a single line of lally-column supported wood beams. There are no windows or doors remaining on the building, with all exterior openings partially covered with plywood. The brick façade was in fair condition at the first floor but several loose and missing bricks were observed at the parapet, indicating that bricks are highly prone to falling onto the sidewalk below.

Photo 3: View of brick façade, showing missing bricks and mortar.
