MKhomeinspections
PO BOX 11492
Olympia, Wa 98508-1149
360-338-8171

Property Condition Report

1234 Unit A & B Duplex

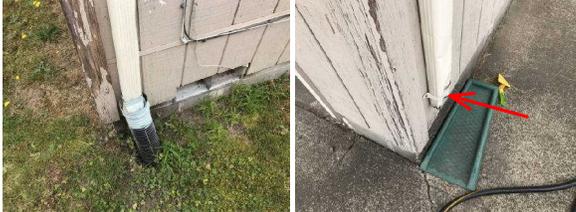
- 8. Marginal Exterior Surface Drain: Surface drain - Evidence of poor drainage at the down spouts. the down spouts are discharging next the foundation which can lead to foundation settling issues along with introducing moisture into the crawl space. I recommend adding extensions to help divert water away from the foundation.

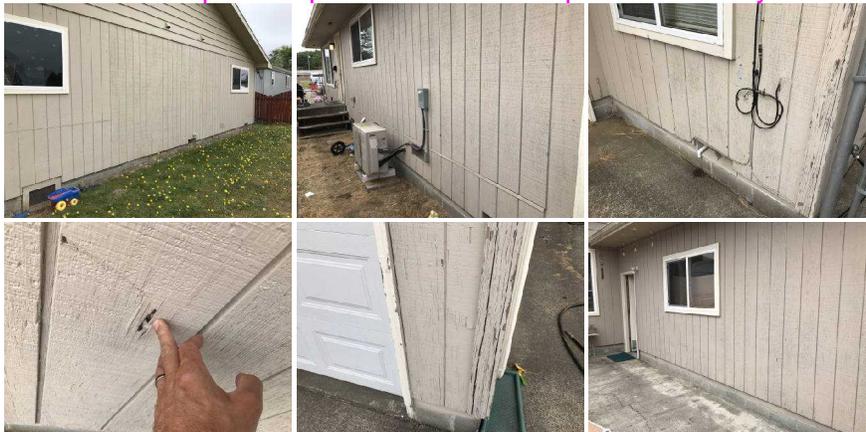
- 1. Marginal, Defective Type: Wood - I noticed the siding is showing signs of wear and deterioration. Chipped and peeling paint was found in multiple areas along with some moisture damages. I recommend a qualified persons make all repairs necessary and to paint the exterior

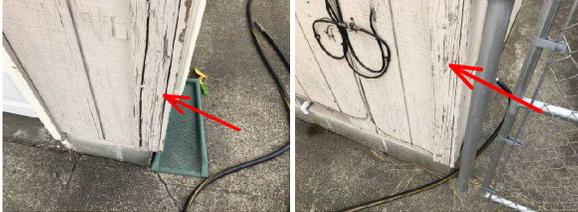
2. Defective Trim: Wood - Damaged trim was present in a few locations. repairs recommended

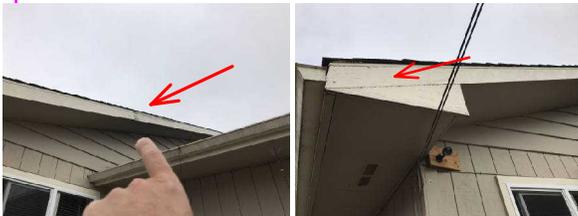
3. Defective Fascia: Wood - I noticed some wood rot conditions on the upper fascia boards. When the roof is replaced these damaged fascia boards should be replaced. Repairs are recommend from a qualified contractor.

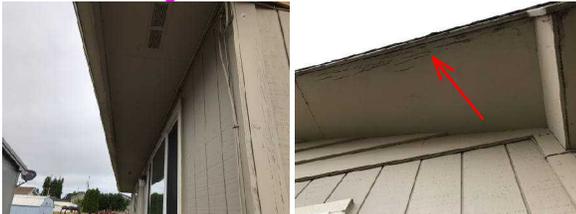
4. Marginal, Defective Soffits: Plywood - Evidence of moisture damages at the back of the house soffit. Repairs to this damaged soffit area is recommended

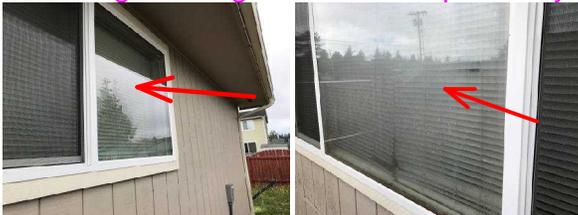
6. Defective Windows: Vinyl slider - I noticed on unit 614 multiple failing windows. The south facing windows had broken seals this has allowed moisture to enter in between the layers of glass. I recommend all damaged failing windows be replaced by a qualified contractor

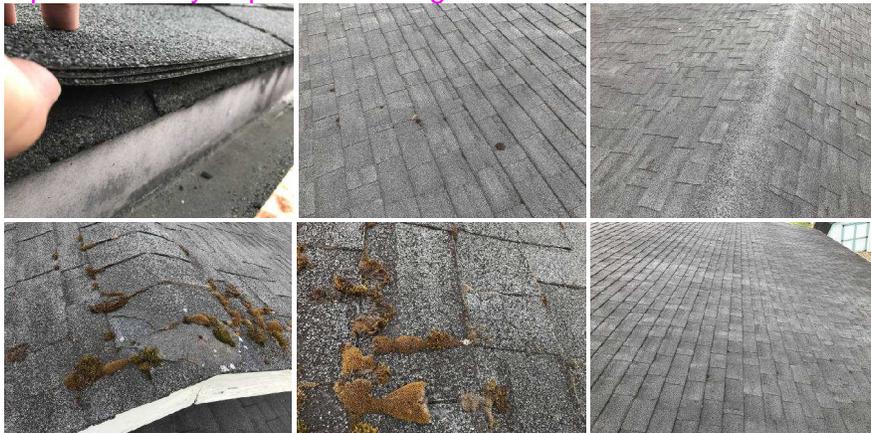
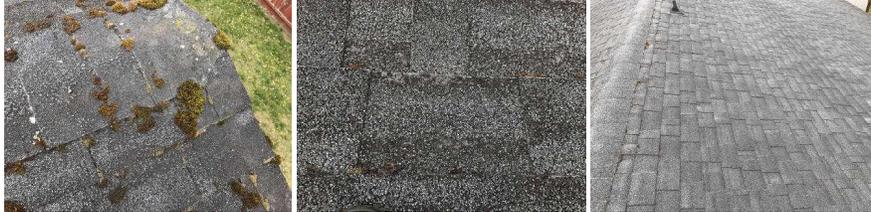
- 1. Method of Inspection: On roof
- 2. Acceptable Unable to Inspect: 10%
- 3. Marginal, Defective Material: Asphalt shingle - Loose or damaged shingles, Signs of cracking, Roof shows signs of deterioration, Roof is near or at the end of it's useful life. Heavy granular loss is present along with cupping and the fibers are showing on the materials. I noticed no roof vents present! This will also contributing to faster deterioration of the roofing materials. I recommend proper and adequate ventilation be install on this roof by a roof contractor. I also noticed two layers of roofing materials are present. That means when it comes time to replace the roof both layers will require removal. This is an added expense. The roof is need of replacement within the next year. I would get estimates sooner than later for replacement by a qualified roofing contractor.

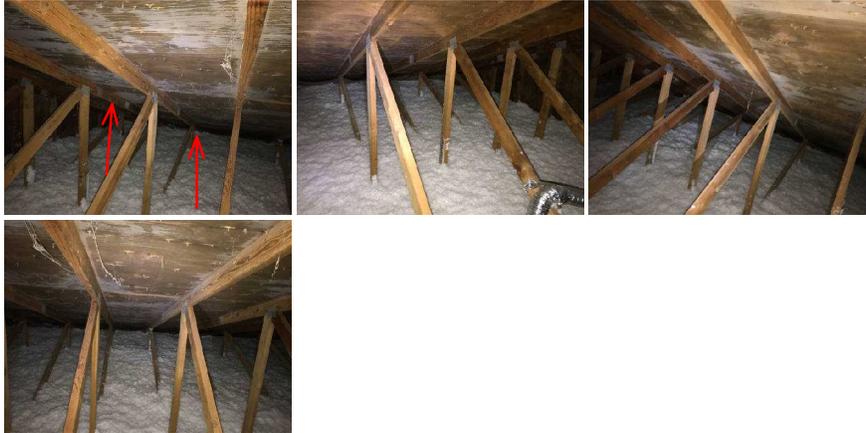
4. Marginal, Defective Sheathing: Plywood - The attic had areas of discoloration that appeared to be microbial growth, possibly mold. Confirming the presence of mold would require laboratory analysis. To avoid potential damage to home materials or the development of unhealthy conditions related to mold, the Inspector recommends that the source of moisture be identified and the condition corrected by a licensed Environmental Contractor.

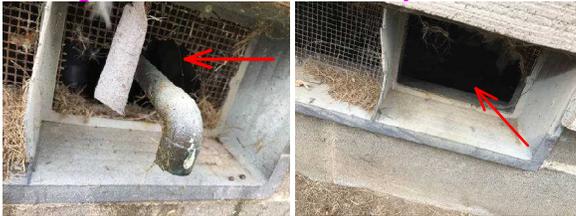
- 1. Method of Inspection: In the crawl space
- 2. Acceptable Unable to Inspect: 15%
- 3. Acceptable Access: Small
- 4. Acceptable Moisture Penetration: Was dry at time of inspection
- 5. Moisture Location: Was dry at time of inspection
- 6. Defective Ventilation: Vents - I noticed one or more of the crawl space vents was torn or had a big enough hole in it that rodents could enter the crawl space. I recommend a qualified person repair all damaged screens as necessary.

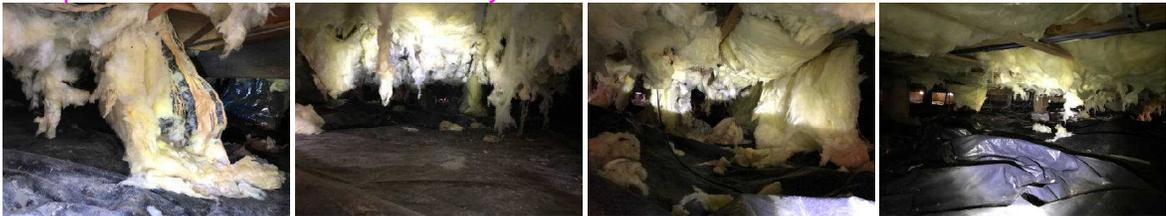
- 7. Defective Insulation: Fiberglass - Evidence of Rodents or Mice have been found. This can pose a Safety concern Rodents such as Mice and Rats can spread harmful diseases. Not to mention can destroy insulation and get into your heating ducts which can be costly to remedy. It is important to seal off any entry points where they may be able to enter the house. It is recommend that you contact a pest control company to further evaluate and eliminate pest activity. The floor insulation in multiple areas of the crawl space has fallen down. This may result in increased Heating or Cooling costs due to decreased energy efficiency. A qualified person needs to repair or replace the insulation as necessary.

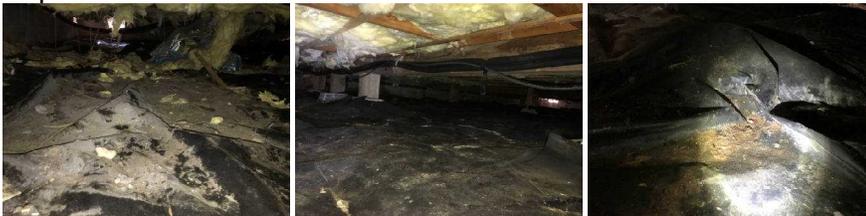
- 8. Marginal Vapor Barrier: Under entire home

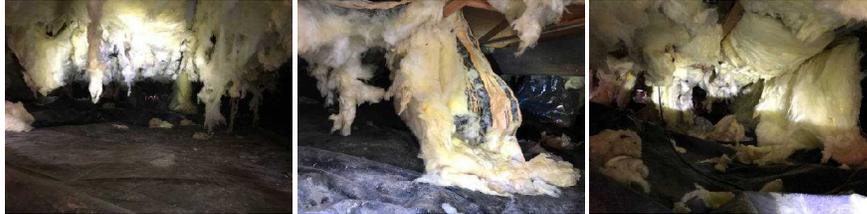
- 9. Acceptable Electrical: 110 VAC
- 10. Defective, Safety Issue Vermin There appears to be evidence of rodent activity in the Crawl space. Sings of rodent droppings urine stains nesting was noted. I recommend that a professional exterminator block any points of entry for rodents into Crawl space space and eliminate any remaining rodents. Insulation vapor barrier that is damaged should be replaced. Rodents in the northwest some have been known to carry Hantavirus Pulmonary Syndrome HPS. A rare disease with high mortality rate. I highly recommend that you do not expose yourself to their urine or droppings and have a professional clean up if necessary.

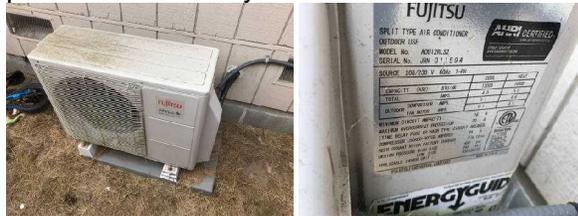
1. Acceptable, Marginal Heating System Operation: Adequate - The last service date of this system appeared to be more than one year ago, or the inspector was unable to determine the last service date. The client should ask the property owner when it was last serviced. If unable to determine the last service date, of if this system was serviced more than one year ago, a qualified heating and cooling contractor should inspect, clean, and servicing should be performed annually in the future.

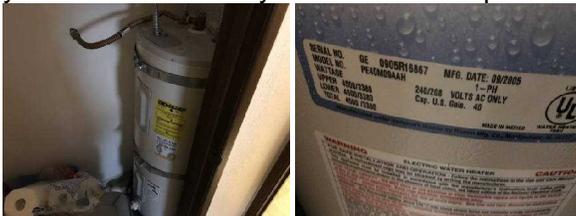
- 7. Marginal Water Heater Operation: Functional at time of inspection - The water heater is now 12 years old, Water heaters typically have an expected life span of 12-15 years or so. I recommend that you monitor carefully for leaks and replace the water heater as needed.

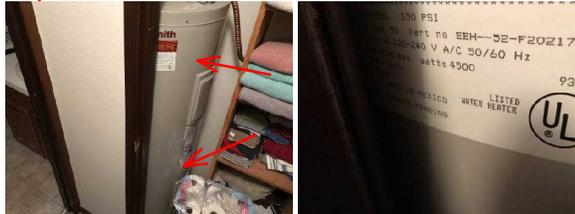
- 8. Marginal, Defective, Safety Issue Water Heater Operation: Functional at time of inspection - **Securing water heaters is mandatory in the state of Washington when buying or selling a home. It is also Washington state law the water heaters be secured with state architect approved restraining devises. Water heaters must be secured with two straps-one near the top and another near the base. They must be firmly anchored to studs or masonry. Bracing kits are widely available at most home improvement stores.**

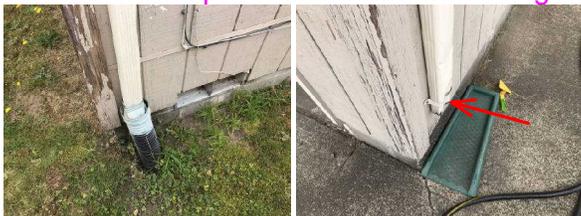
6. Exterior Surface Drain: Surface drain - Evidence of poor drainage at the down spouts. the down spouts are discharging next the foundation which can lead to foundation settling issues along with introducing moisture into the crawl space. I recommend adding extensions to help divert water away from the foundation.

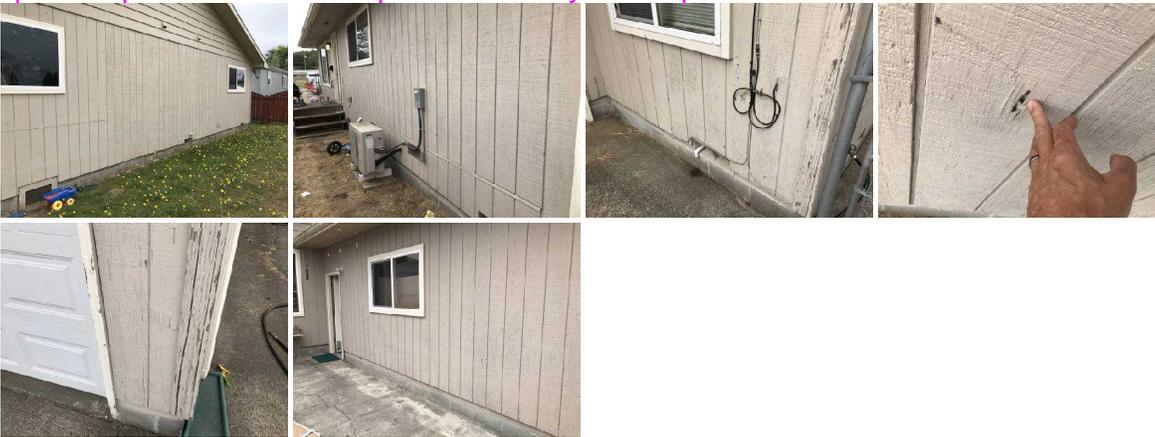
8. 1st Floor Exterior Surface Type: Wood - I noticed the siding is showing signs of wear and deterioration. Chipped and peeling paint was found in multiple areas along with some moisture damages. I recommend a qualified persons make all repairs necessary and to paint the exterior

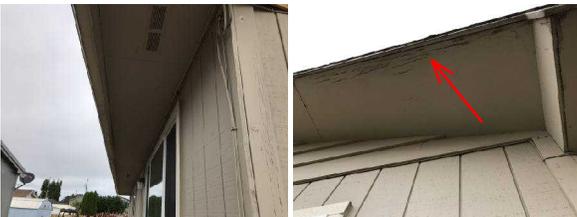
9. Soffits: Plywood - Evidence of moisture damages at the back of the house soffit. Repairs to this damaged soffit area is recommended

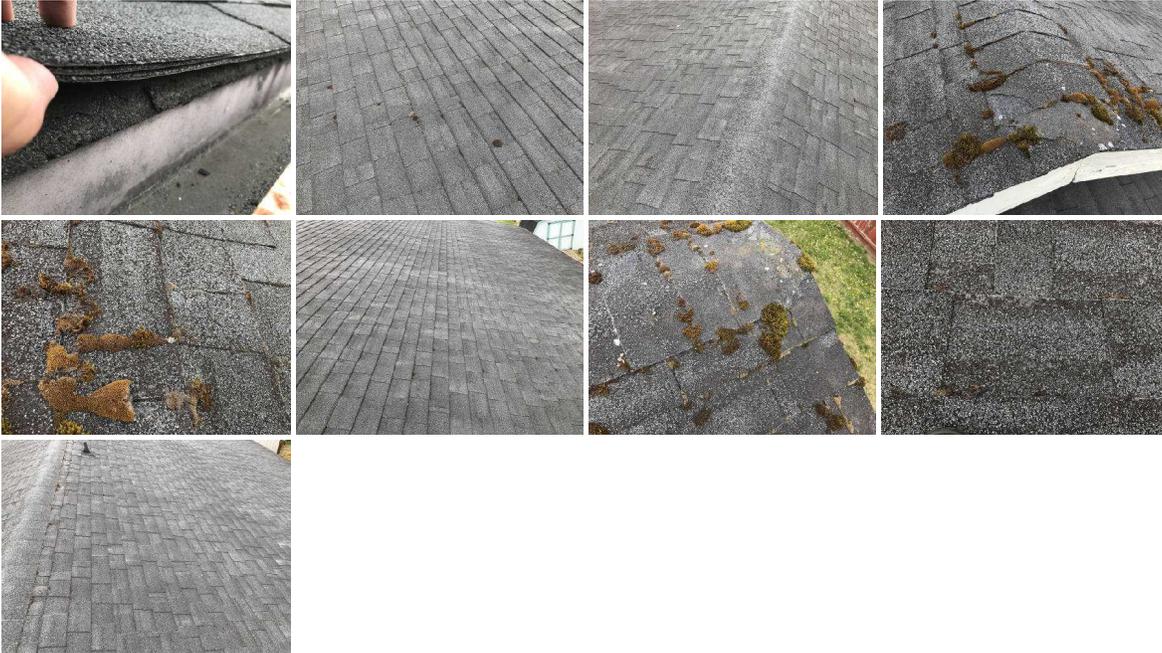
12. Gable Roof Surface Material: Asphalt shingle - Loose or damaged shingles, Signs of cracking, Roof shows signs of deterioration, Roof is near or at the end of it's useful life. Heavy granular loss is present along with cupping and the fibers are showing on the materials. I noticed no roof vents present! This will also contributing to faster deterioration of the roofing materials. I recommend proper and adequate ventilation be install on this roof by a roof contractor. I also noticed two layers of roofing materials are present. That means when it comes time to replace the roof both layers will require removal. This is an added expense. The roof is need of replacement within the next year. I would get estimates sooner than later for replacement by a qualified roofing contractor.

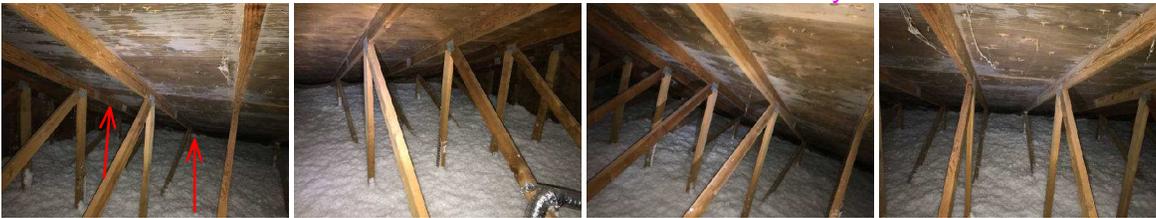
22. Main Attic Sheathing: Plywood - The attic had areas of discoloration that appeared to be microbial growth, possibly mold. Confirming the presence of mold would require laboratory analysis. To avoid potential damage to home materials or the development of unhealthy conditions related to mold, the Inspector recommends that the source of moisture be identified and the condition corrected by a licensed Environmental Contractor.

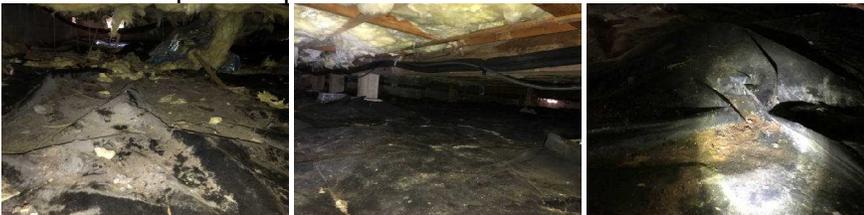
23. Main Crawl Space Vapor Barrier: Under entire home

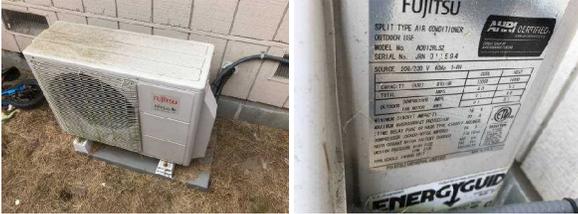
Heating System Operation: (continued)
servicing should be performed annually in the future.

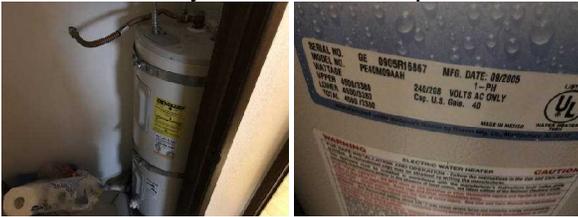
25. Closet Water Heater Water Heater Operation: Functional at time of inspection - The water heater is now 12 years old, Water heaters typically have an expected life span of 12-15 years or so. I recommend that you monitor carefully for leaks and replace the water heater as needed.

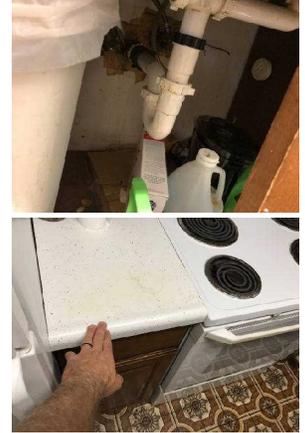
- 30. 1st Floor Kitchen Ventilator: Nutone - Missing light bulb at the hood vent
- 31. 1st Floor Kitchen Plumbing/Fixtures: PVC - Appears old leaks were present under the sink this should be monitored

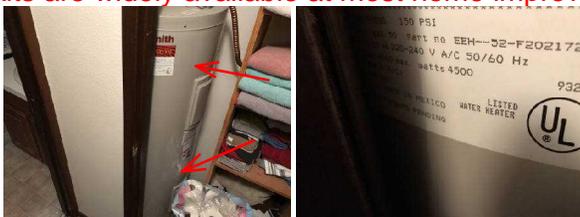
- 47. Closet Water Heater Water Heater Operation: Functional at time of inspection - **Securing water heaters is mandatory in the state of Washington when buying or selling a home. It is also Washington state law the water heaters be secured with state architect approved restraining devises. Water heaters must be secured with two straps-one near the top and another near the base. They must be firmly anchored to studs or masonry. Bracing kits are widely available at most home improvement stores.**

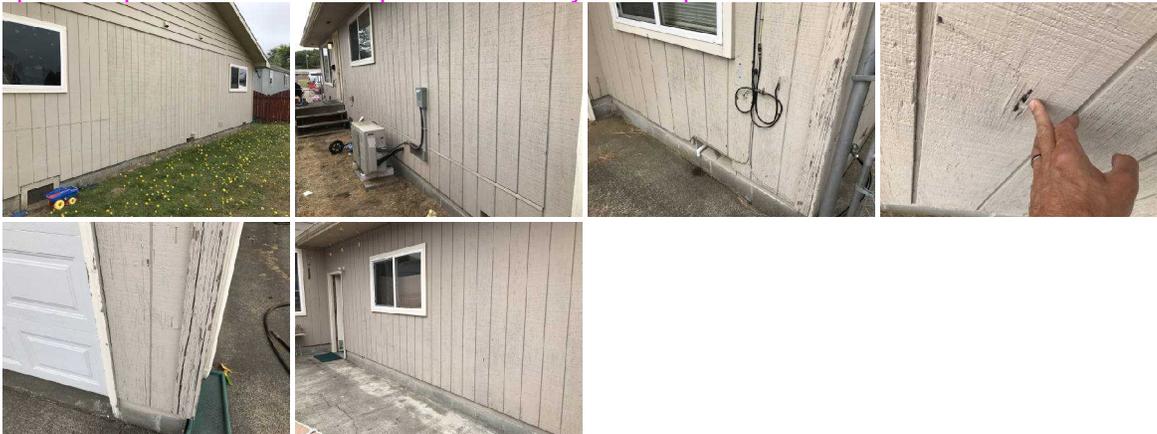
2. 1st Floor Exterior Surface Type: Wood - I noticed the siding is showing signs of wear and deterioration. Chipped and peeling paint was found in multiple areas along with some moisture damages. I recommend a qualified persons make all repairs necessary and to paint the exterior

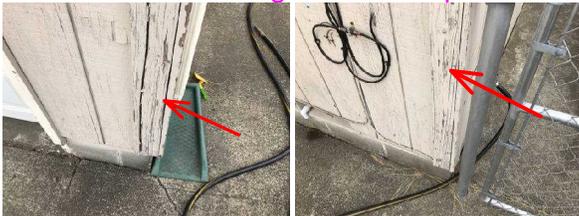
3. Trim: Wood - Damaged trim was present in a few locations. repairs recommended

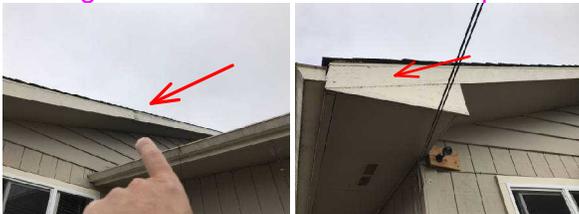
4. Fascia: Wood - I noticed some wood rot conditions on the upper fascia boards. When the roof is replaced these damaged fascia boards should be replaced. Repairs are recommend from a qualified contractor.

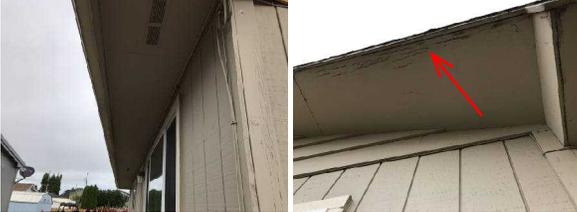
5. Soffits: Plywood - Evidence of moisture damages at the back of the house soffit. Repairs to this damaged soffit area is recommended

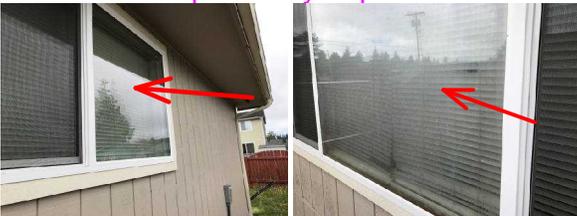
6. Windows: Vinyl slider - I noticed on unit 614 multiple failing windows. The south facing windows had broken seals this has allowed moisture to enter in between the layers of glass. I recommend all damaged failing windows be replaced by a qualified contractor

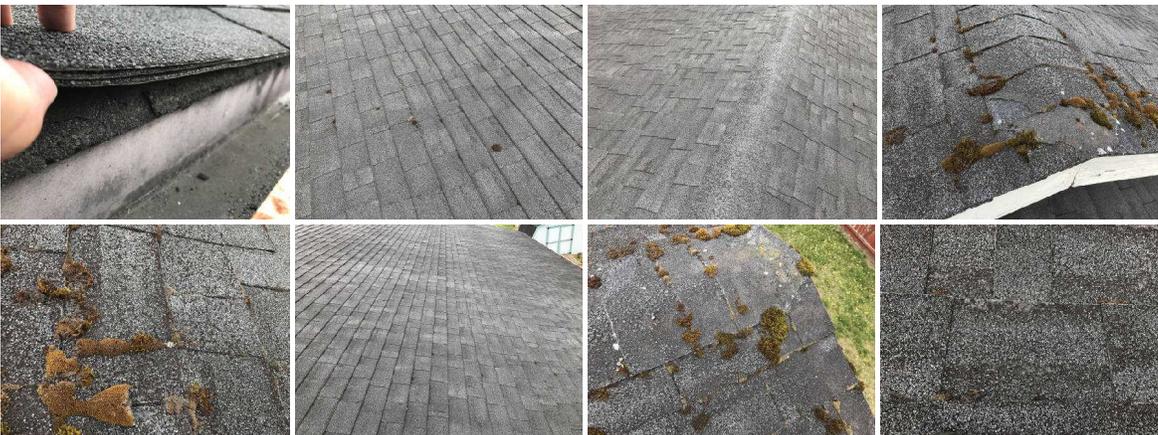
8. Gable Roof Surface Material: Asphalt shingle - Loose or damaged shingles, Signs of cracking, Roof shows signs of deterioration, Roof is near or at the end of it's useful life. Heavy granular loss is present along with cupping and the fibers are showing on the materials. I noticed no roof vents present! This will also contributing to faster deterioration of the roofing materials. I recommend proper and adequate ventilation be install on this roof by a roof contractor. I also noticed two layers of roofing materials are present. That means when it comes time to replace the roof both layers will require removal. This is an added expense. The roof is need of replacement within the next year. I would get estimates sooner than later for replacement by a qualified roofing contractor.

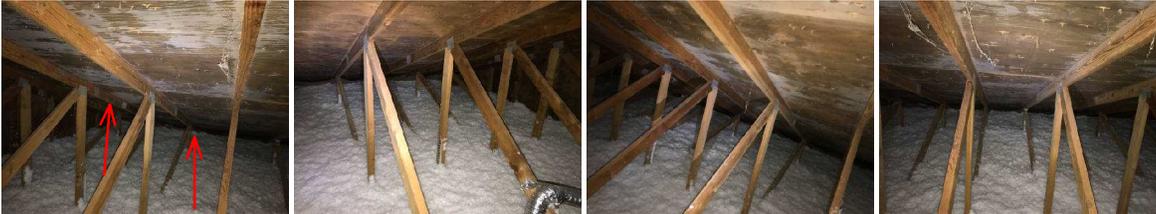
- 12. Main Attic Sheathing: Plywood - The attic had areas of discoloration that appeared to be microbial growth, possibly mold. Confirming the presence of mold would require laboratory analysis. To avoid potential damage to home materials or the development of unhealthy conditions related to mold, the Inspector recommends that the source of moisture be identified and the condition corrected by a licensed Environmental Contractor.

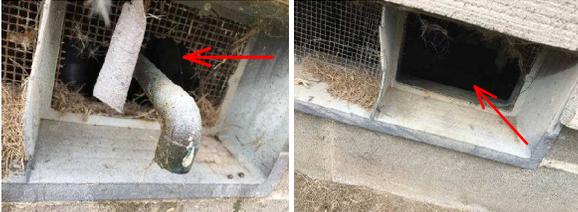
- 14. Main Crawl Space Ventilation: Vents - I noticed one or more of the crawl space vents was torn or had a big enough hole in it that rodents could enter the crawl space. I recommend a qualified person repair all damaged screens as necessary.

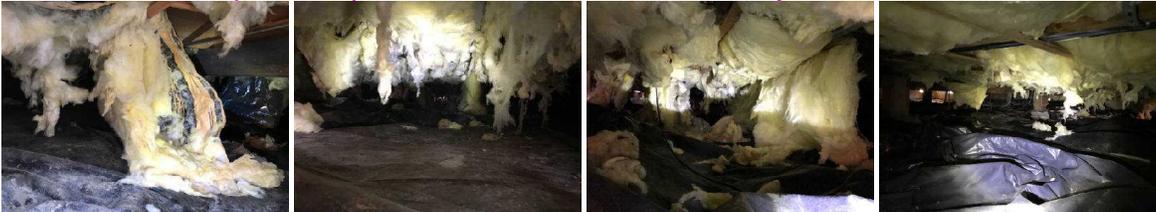
- 15. Main Crawl Space Insulation: Fiberglass - Evidence of Rodents or Mice have been found. This can pose a Safety concern Rodents such as Mice and Rats can spread harmful diseases. Not to mention can destroy insulation and get into your heating ducts which can be costly to remedy. It is important to seal off any entry points where they may be able to enter the house. It is recommend that you contact a pest control company to further evaluate and eliminate pest activity. The floor insulation in multiple areas of the crawl space has fallen down. This may result in increased Heating or Cooling costs due to decreased energy efficiency. A qualified person needs to repair or replace the insulation as necessary.

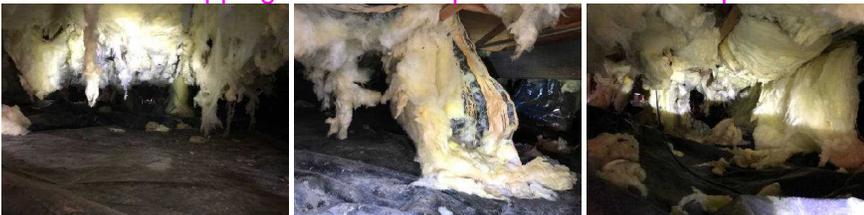
- 16. Main Crawl Space Vermin There appears to be evidence of rodent activity in the Crawl space. Signs of rodent droppings urine stains nesting was noted. I recommend that a professional exterminator block any points of entry for rodents into Crawl space space and eliminate any remaining rodents. Insulation vapor barrier that is damaged should be replaced. Rodents in the northwest some have been known to carry Hantavirus Pulmonary Syndrome HPS. A rare disease with high mortality rate. I highly recommend that you do not expose yourself to their urine or droppings and have a professional clean up if necessary.

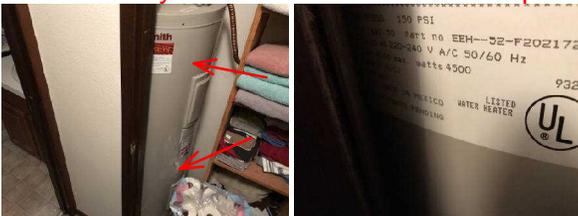
24. Closet Water Heater Water Heater Operation: Functional at time of inspection - Securing water heaters is mandatory in the state of Washington when buying or selling a home. It is also Washington state law the water heaters be secured with state architect approved restraining devises. Water heaters must be secured with two straps-one near the top and another near the base. They must be firmly anchored to studs or masonry. Bracing kits are widely available at most home improvement stores.

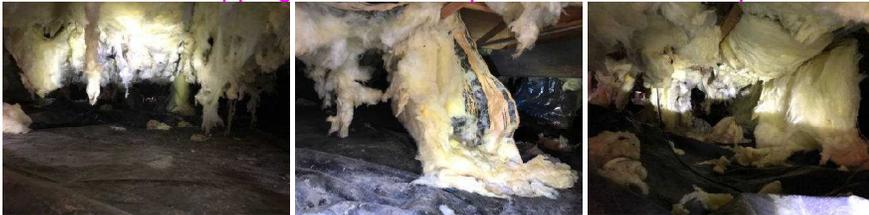
3. Main Crawl Space Vermin There appears to be evidence of rodent activity in the Crawl space. Sings of rodent droppings urine stains nesting was noted. I recommend that a professional exterminator block any points of entry for rodents into Crawl space space and eliminate any remaining rodents. Insulation vapor barrier that is damaged should be replaced. Rodents in the northwest some have been known to carry Hantavirus Pulmonary Syndrome HPS. A rare disease with high mortality rate. I highly recommend that you do not expose yourself to their urine or droppings and have a professional clean up if necessary.

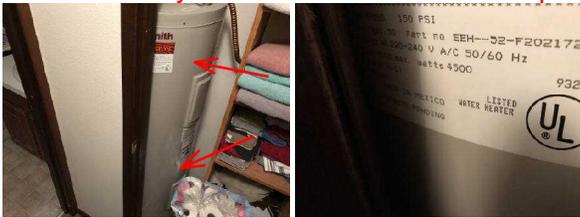
7. Closet Water Heater Water Heater Operation: Functional at time of inspection - Securing water heaters is mandatory in the state of Washington when buying or selling a home. It is also Washington state law the water heaters be secured with state architect approved restraining devices. Water heaters must be secured with two straps-one near the top and another near the base. They must be firmly anchored to studs or masonry. Bracing kits are widely available at most home improvement stores.
