Property Condition Report

1234 Newer Home

Property Address: 1234 Newer Home
City State Zip: Lacey, Wa

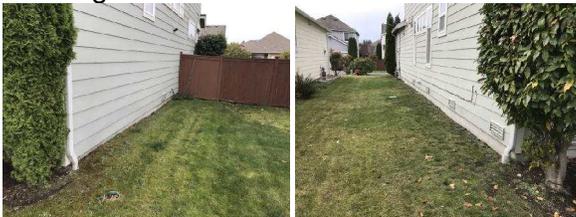
- 5. Acceptable Patio: Concrete
- 6. Acceptable Grading: Flat

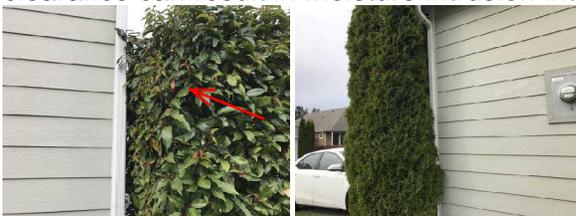
- 7. Acceptable Swale: Adequate slope and depth for drainage
- 8. Marginal Vegetation: Shrubs - Recommend that all ground vegetation be trimmed at a minimum of 12inches away from contact with siding to promote air circulation failure to maintain adequate clearance can result in moisture intrusion into siding and associate damage/wood rot.

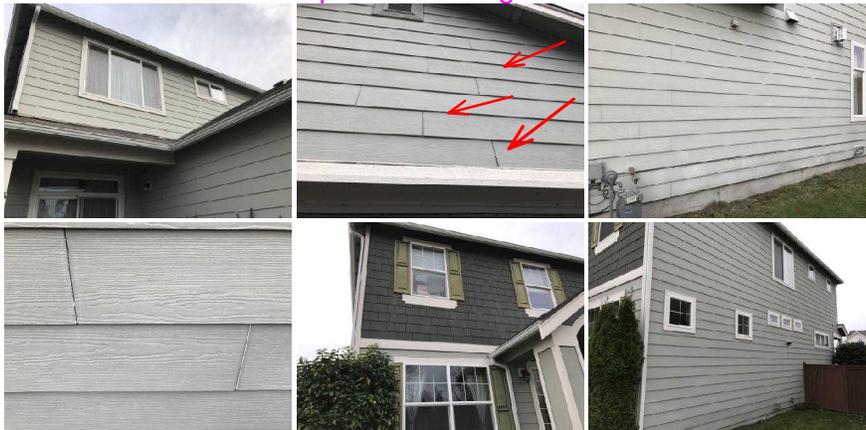
1. Marginal, Defective Type: Hardie board - Gaps not properly sealed at several locations. Special attention to the south and west facing sides of the house. This is at the butt joints and exterior trim on the lap siding. These gaps could allow for moisture intrusions behind the siding. New harder plank installations require a membrane flashing behind these joints. This house was built before that manufacturing require for install. Therefore Caulking is needed: I recommend that exterior of structure be (re)caulked as needed to prevent moisture intrusion and that this practice be preformed yearly as part of an annual maintenance program. Popper maintenance involves detailed caulking of any joint, seam or penetration (windows, doors, pipes, wires, nail heads etc.) of the siding. The paint is also a contractor grade paint is fading. The house will most likely need to be paint within the next few years. The exterior is need of maintenance to prevent damages.

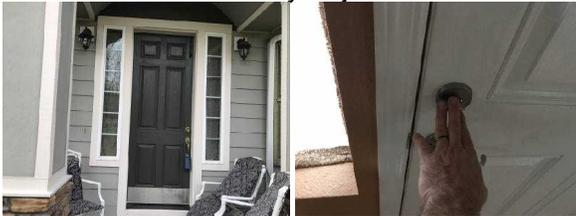
6. Marginal Entry Doors: Fiberglass - The dead bolt is a sticky and should be adjusted to properly lock the front door. I would maybe just install a new dead bolt at the front door.

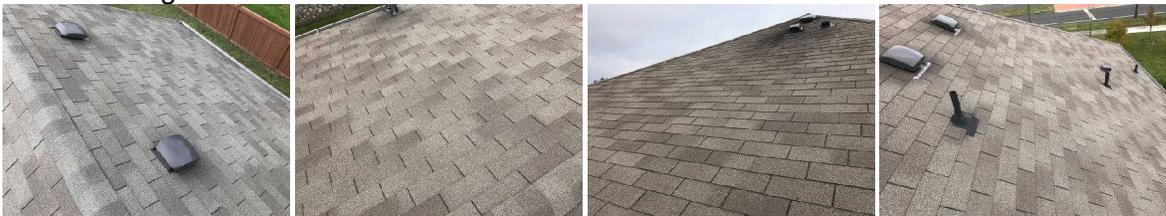
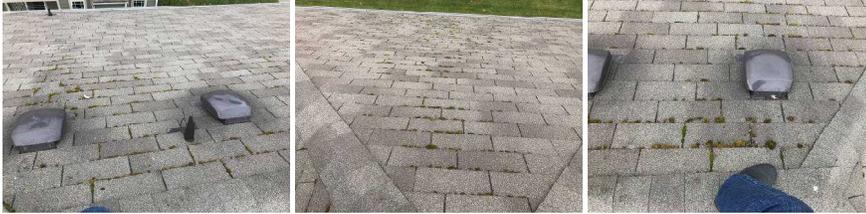
3. Marginal Material: Asphalt shingle - This is a contractor grade three tab roofing shingle. The roof was in fare shape and was exhibiting normal wear for a 12 years old roof. Typical three tab roofing material last around 15-20 years.

I noticed heavy amounts of , Moss was growing on the roof. As a result, shingles may lift or be damaged. Leaks may result and or the roof surface may fail prematurely. The is a conducive condition for wood destroying organisms and insects. Efforts should be taking to kill moss during its growing season (wet months). Recommend treatment is necessary to prevent continued or future damage to roof surface.

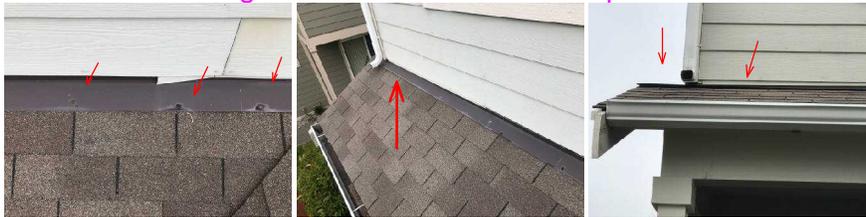
6. Marginal, Defective Flashing: Aluminum - I noticed above the back porch the wall to roof flashing is loose. The nails were also pulling up and loose. A qualified persons is recommended to properly secure this flashing and seal the nail heads to prevent moisture intrusions.

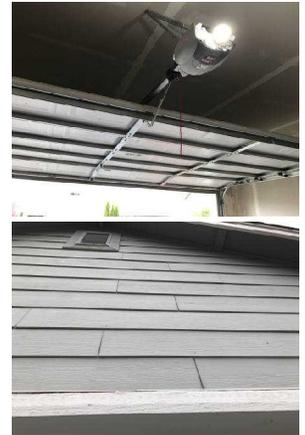
- 5. Marginal Exterior Surface: Hardie board - Caulking is needed: I recommend that exterior of structure be (re)caulked as needed to prevent moisture intrusion and that this practice be performed yearly as part of an annual maintenance program. Proper maintenance involves detailed caulking of any joint, seam or penetration (windows, doors, pipes, wires, nail heads etc.) of the siding.

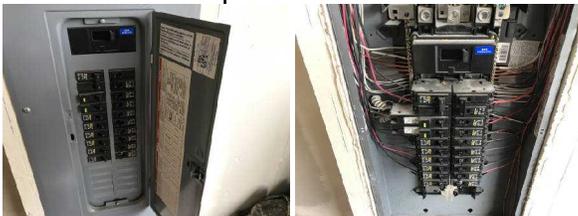
Garage Electric Panel

9. Acceptable Manufacturer: Square D

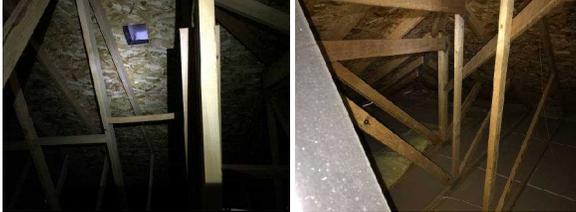
5. Marginal Ventilation: Roof and soffit vents - I noticed some of the baffles have fallen down in the attic space. These help prevent the insulation from blocking the eve vents. When these fall down they can pinch off airflow leading to conditions conducive to fungal growth. I recommend all baffles that have fallen down be reattached tot he rafters. A qualified persons is recommended to make all repairs necessary.
I also noticed in the SE corner a birds nest was found and one or more of the soffit vents might be damaged allow birds to enter the attic space. Further evaluation and repairs recommended by a qualified persons.

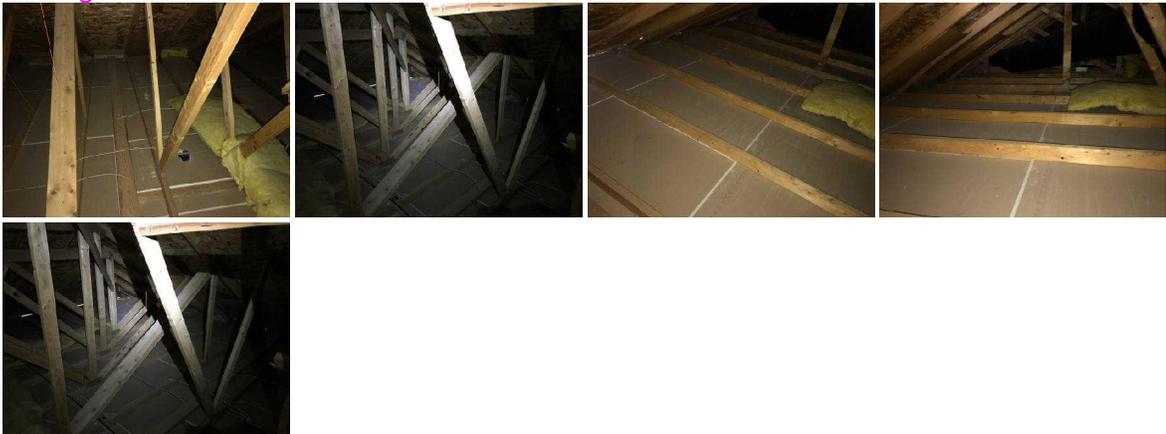
6. Defective Insulation: None - This attic has never been insulated!, Inadequate insulation levels- QC Thermal insulation was not installed to limit heat gain and loss in the living space did not appear to meet widely-accepted modern standards. To reduce energy consumption and heating/cooling costs, the inspector recommends that thermal insulation be installed to meet modern standards. This should be 18-20 inches of insulation and we have zero in this attic. I honestly feel bad for the tenants who have been paying astronomical energy bills because this attic was never insulated. A qualified insulation contractor needs to install insulation in the attic space prior to closing.

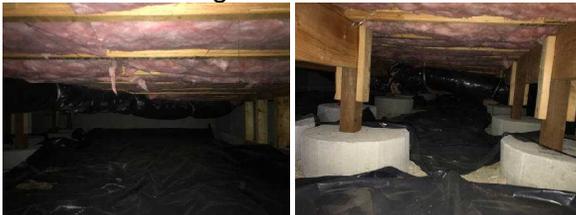
- 1. Method of Inspection: In the crawl space
- 2. Acceptable Unable to Inspect: 10%
- 3. Acceptable Access: Wood door
- 4. Acceptable, Marginal Moisture Penetration: Appears previous moisture intrusions
- 5. Moisture Location: Was dry at time of inspection
- 6. Acceptable Ventilation: Vents
- 7. Acceptable Insulation: Fiberglass

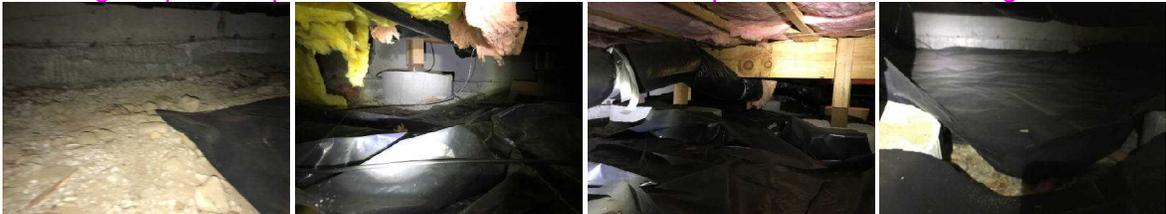
Vapor Barrier: Under entire home - The crawl space vapor barrier had areas of bare ground showing. A qualified persons should redistribute the vapor barrier so no bare ground is showing.

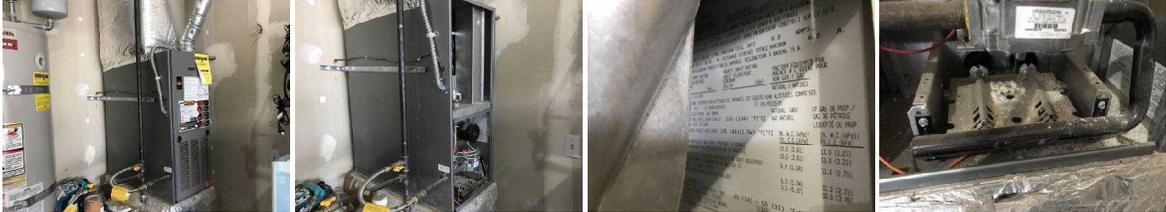
1. Defective Heating System Operation: Appears functional - **Furnace is now 12 years old, It appears it has never been serviced and was extremely dirty. After inspecting the attic space i noticed the attic had never been insulated. This furnace has been working ten times harder to heat this non insulated house. This furnace which is a mid efficiency furnace could be nearing the end of its designed life span sooner than normal due to the extra wear and tear of having to work harder to heat the house. Its appears it has never been serviced. The last service date of this system appeared to be more than decade ago, or the inspector was unable to determine the last service date. The client should ask the property owner when it was last serviced. If unable to determine the last service date, of if this system was serviced more than one year ago, a qualified heating and cooling contractor should inspect, clean, and servicing should be performed annually in the future.**

Dirt and/or dust were visible in one or more sections of supply and/or return ducts. This can be a health hazard, especially for those with allergies or respiratory problems. The Environmental protection association (EPA) recommends considering having ducts professionally cleaned when "ducts are clogged with excessive amounts of dust and debris and /or particles are actually released into the home from your supply registers". Recommend having a qualified contractor clean the ducts.

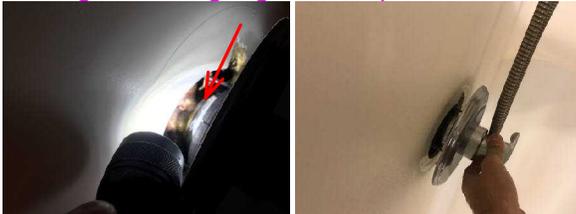
- 3. Defective Water Lines: PEX - The master bathroom shower is actively leaking behind the wall from what appears to be from the mixing valve. The valve was completely loose and pulling out of the shower wall. Depending on how long this has been going possible damages in the inside of the wall cavity could be present. A complete evaluation and All repairs are highly recommended from a1licensed plumbing contractor. A general contractor is needed to further evaluate to insure no damages or fungal growth is present inside the wall cavities prior to closing.

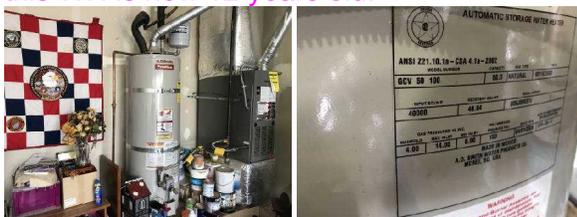
- 8. Marginal, Defective Water Heater Operation: Functional at time of inspection - Water heater is nearing the end of it's design life. Water heaters typically have an expected life span of 12-15 years or so. I recommend that you monitor carefully for leaks and replace the water heater as needed. this WH is now 12 years old.

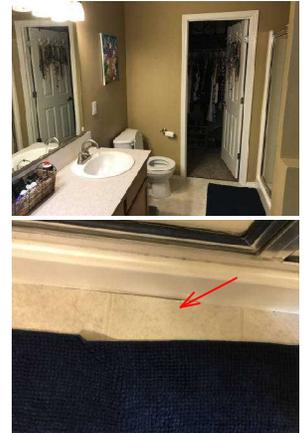
17. Marginal Floor: Linoleum - The flooring is peeling up by the shower. Repairs recommended

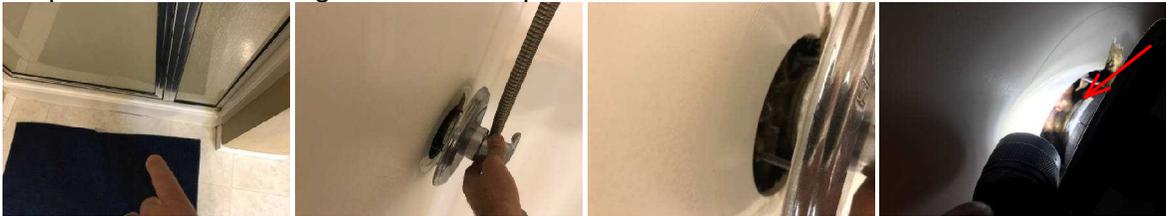
18. Acceptable Doors: Hollow wood
19. Acceptable Windows: Vinyl slider
20. Acceptable Electrical: 110 VAC GFCI
21. Acceptable Counter/Cabinet: Composite and wood
22. Acceptable Sink/Basin: Molded single bowl
23. Acceptable Faucets/Traps: Delta fixtures with a PVC trap
24. Acceptable Tub/Surround: Fiberglass tub and ceramic tile surround
25. Defective Shower/Surround: Fiberglass pan and fiberglass surround - The shower valve is completely loose and not attached. This could lead to moisture intrusions into the wall cavity. It also appears to be actively leaking either from the valve or a plumbing connection in the wall. A licensed plumbing contractor is recommended to evaluate and make all repairs necessary.
Replace the old caulking at the shower pan.

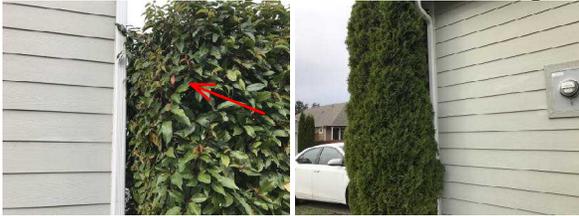
2. Vegetation: Shrubs - Recommend that all ground vegetation be trimmed at a minimum of 12 inches away from contact with siding to promote air circulation failure to maintain adequate clearance can result in moisture intrusion into siding and associate damage/wood rot.

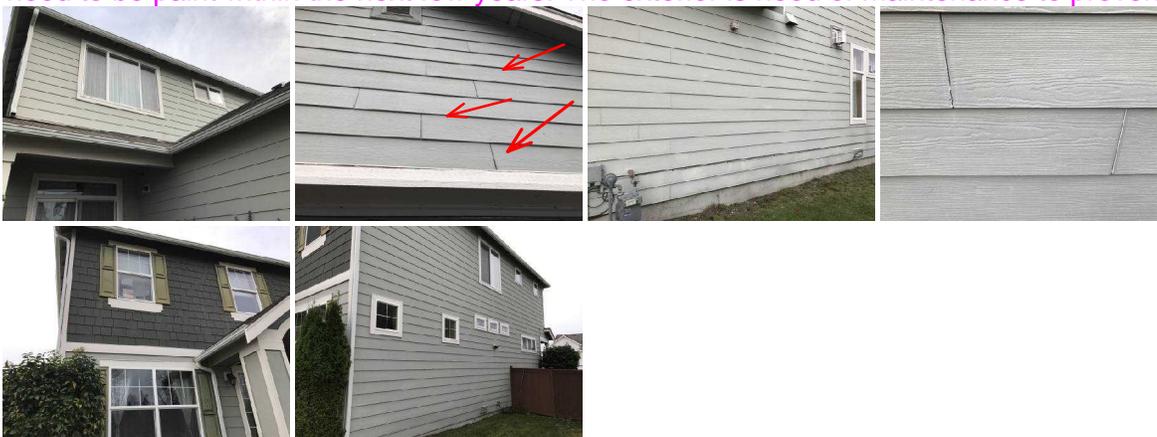
3. 1st & 2nd Floor Exterior Surface Type: Hardie board - Gaps not properly sealed at several locations. Special attention to the south and west facing sides of the house. This is at the butt joints and exterior trim on the lap siding. These gaps could allow for moisture intrusions behind the siding. New harder plank installations require a membrane flashing behind these joints. This house was built before that manufacturing require for install. Therefore Caulking is needed: I recommend that exterior of structure be (re)caulked as needed to prevent moisture intrusion and that this practice be preformed yearly as part of an annual maintenance program. Popper maintenance involves detailed caulking of any joint, seam or penetration (windows, doors, pipes, wires, nail heads etc.) of the siding. The paint is also a contractor grade paint is fading. The house will most likely need to be paint within the next few years. The exterior is need of maintenance to prevent damages.

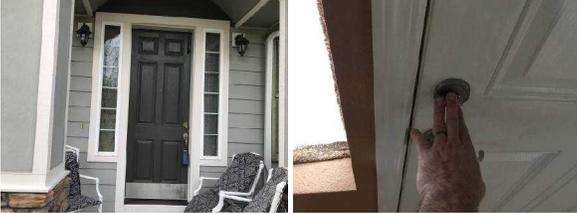
4. Entry Doors: Fiberglass - The dead bolt is a sticky and should be adjusted to properly lock the front door. I would maybe just install a new dead bolt at the front door.

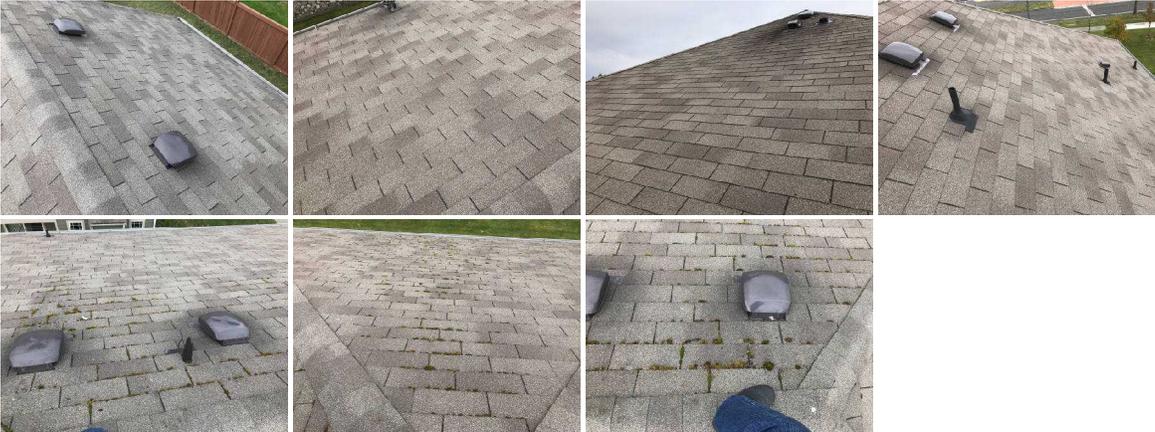
7. HIP Roof Surface Material: Asphalt shingle - This is a contractor grade three tab roofing shingle. The roof was in fare shape and was exhibiting normal wear for a 12 years old roof. Typical three tab roofing material last around 15-20 years.

I noticed heavy amounts of Moss was growing on the roof. As a result, shingles may lift or be damaged. Leaks may result and or the roof surface may fail prematurely. The is a conducive condition for wood destroying organisms and insects. Efforts should be taking to kill moss during its growing season (wet months). Recommend treatment is necessary to prevent continued or future damage to roof surface.

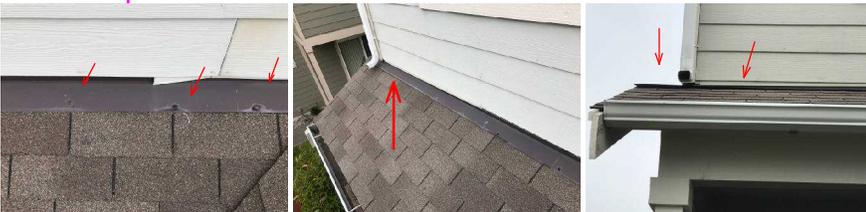
8. Flashing: Aluminum - **I noticed above the back porch the wall to roof flashing is loose. The nails were also pulling up and loose. A qualified persons is recommended to properly secure this flashing and seal the nail heads to prevent moisture intrusions.**

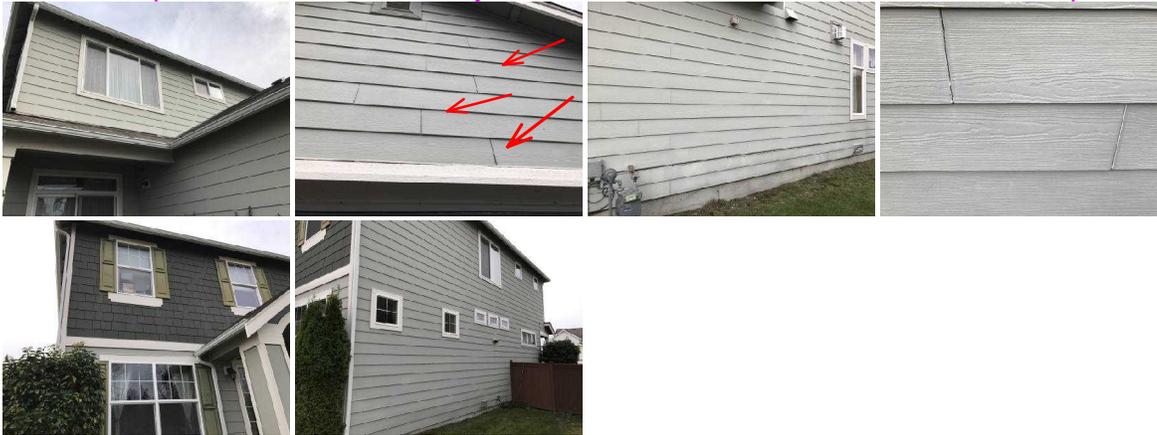
1. 1st & 2nd Floor Exterior Surface Type: Hardie board - Gaps not properly sealed at several locations. Special attention to the south and west facing sides of the house. This is at the butt joints and exterior trim on the lap siding. These gaps could allow for moisture intrusions behind the siding. New harder plank installations require a membrane flashing behind these joints. This house was built before that manufacturing require for install. Therefore Caulking is needed: I recommend that exterior of structure be (re)caulked as needed to prevent moisture intrusion and that this practice be preformed yearly as part of an annual maintenance program. Popper maintenance involves detailed caulking of any joint, seam or penetration (windows, doors, pipes, wires, nail heads etc.) of the siding. The paint is also a contractor grade paint is fading. The house will most likely need to be paint within the next few years. The exterior is need of maintenance to prevent damages.

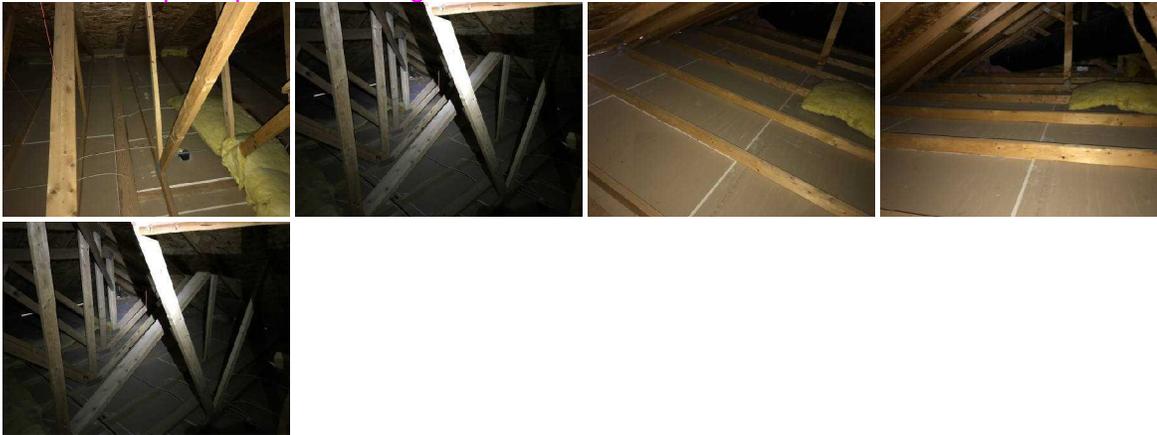
6. Main Attic Insulation: None - This attic has never been insulated!, Inadequate insulation levels- QC
Thermal insulation was not installed to limit heat gain and loss in the living space did not appear to meet widely-accepted modern standards. To reduce energy consumption and heating/cooling costs, the inspector recommends that thermal insulation be installed to meet modern standards. This should be 18-20 inches of insulation and we have zero in this attic. I honestly feel bad for the tenants who have been paying astronomical energy bills because this attic was never insulated. A qualified insulation contractor needs to install insulation in the attic space prior to closing.

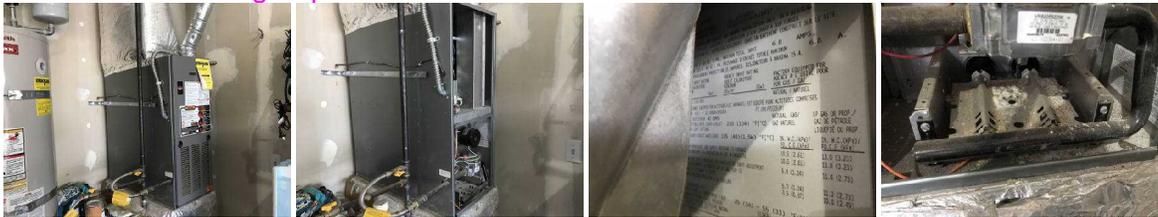
the extra wear and tear of having to work harder to heat the house. Its appears it has never been serviced. The last service date of this system appeared to be more than decade ago, or the inspector was unable to determine the last service date. The client should ask the property owner when it was last serviced. If unable to determine the last service date, of if this system was serviced more than one year ago, a qualified heating and cooling contractor should inspect, clean, and servicing should be performed annually in the future.

Dirt and/or dust were visible in one or more sections of supply and/or return ducts. This can be a health hazard, especially for those with allergies or respiratory problems. The Environmental protection association (EPA) recommends considering having ducts professionally cleaned when "ducts are clogged with excessive amounts of dust and debris and /or particles are actually released into the home from your supply registers". Recommend having a qualified contractor clean the ducts.

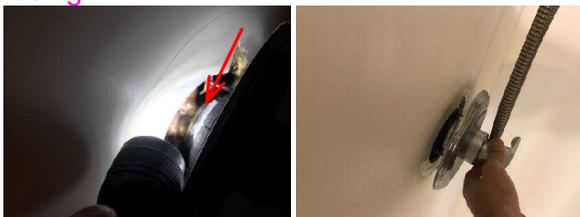
12. Water Lines: PEX - The master bathroom shower is actively leaking behind the wall from what appears to be from the mixing valve. The valve was completely loose and pulling out of the shower wall. Depending on how long this has been going possible damages in the inside of the wall cavity could be present. A complete evaluation and All repairs are highly recommended from a licensed plumbing contractor. A general contractor is needed to further evaluate to insure no damages or fungal growth is present inside the wall cavities prior to closing.

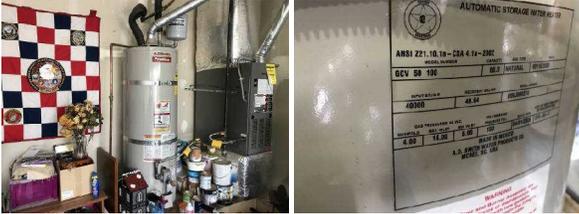
13. Garage Water Heater Water Heater Operation: Functional at time of inspection - Water heater is nearing the end of it's design life. Water heaters typically have an expected life span of 12-15 years or so. I recommend that you monitor carefully for leaks and replace the water heater as needed. this WH is now 12 years old.

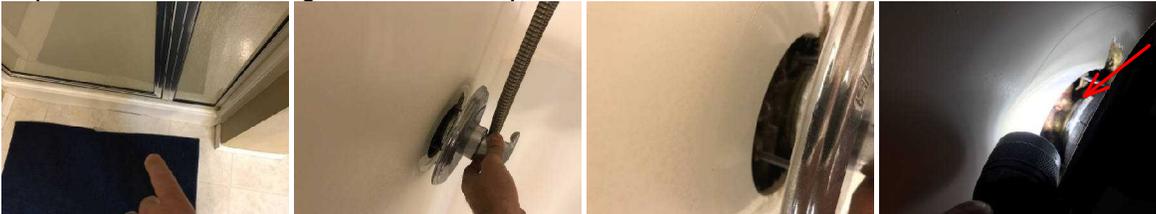
15. 2nd floor main Bathroom HVAC Source: none - No heat source found in the bathroom?? A contractor is recommended to make all repairs necessary.
16. Master Bathroom Shower/Surround: Fiberglass pan and fiberglass surround - The shower valve is completely loose and not attached. This could lead to moisture intrusions into the wall cavity. It also appears to be actively leaking either from the valve or a plumbing connection in the wall. A licensed plumbing contractor is recommended to evaluate and make all repairs necessary.
Replace the old caulking at the shower pan.
