MKhomeinspections
PO BOX 11492
Olympia, Wa 98508-1149
360-338-8171

Property Condition Report

1234 Older Home Dr

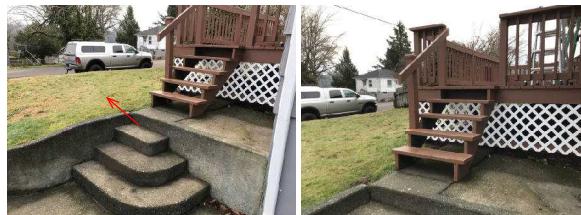
3. Defective, Safety Issue Steps/Stoops: Concrete - The front stairs were missing grab bars/handrails on the lower set of stairs. The upper step towards the front porch had an open handrail on one side and no barrier on the other side. This could lead to potential falls or slips. A qualified contractor is recommended to evaluate and install handrails in this location for safety.

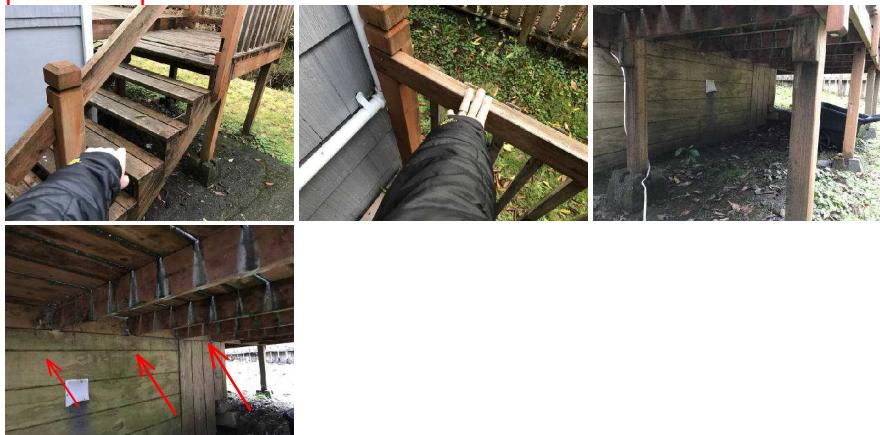
5. Marginal, Defective, Safety Issue Deck: Stained wood - When inspecting the deck i noticed the handrails were wobbly and the stairs had an open handrail. This is a fall hazard for children. I also noticed the back shed had a deck around it and the handrails were missing from that deck. Handrail need to be install around that deck or blocked off to prevent any falls. That is concerning and is a big drop off. A qualified contractor is recommended to install handrails at that location. The front deck had a few boards that were starting to rot out and should also be replace at that time. Ledger- nails only- QC
The deck ledger board was attached to the home with nails only. While no failure was seen at the time of the inspection and this was standard practice for many years, the modern standard fastener schedule for attachment of the deck to the home structure is one 1/2-inch lag screw installed every two feet, staggered up and down.

All mildew should be cleaned and removed from the back deck to help prevent slips and falls.

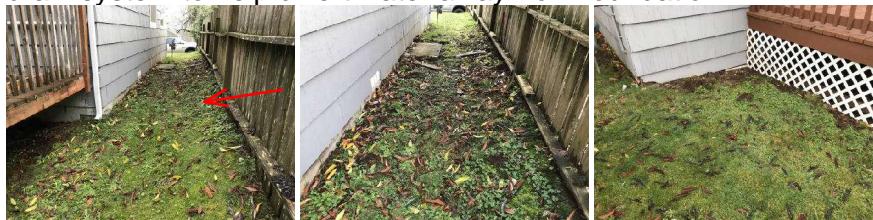
6. Marginal Grading: Minor slope - The Grading has a flat negative slope and water can pooling against the foundation. Under heavy rain conditions water may accumulate around this area cause water to pool up against the foundation. Efforts should be made to improve grade and or add a French drain system to help divert water away from foundation

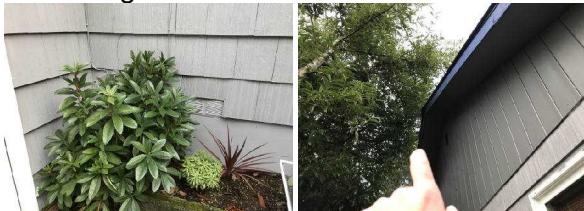
Vegetation: Shrubs - Recommend that all ground vegetation be trimmed at a minimum of 12inches away from contact with siding to promote air circulation failure to maintain adequate clearance can result in moisture intrusion into siding and associate damage/wood rot. Tree limbs over hang the roof should also be cut back.

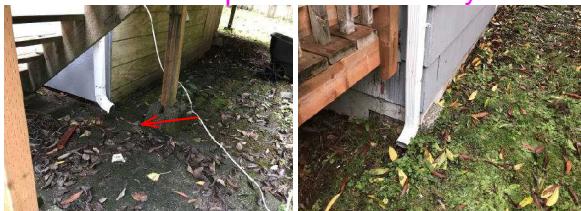
10. Marginal, Defective Exterior Surface Drain: Surface drain - Evidence of poor drainage at the down spouts. the down spouts are discharging next the foundation which can lead to foundation settling issues along with introducing moisture into the crawl space. I recommend adding extensions to help divert water away from the foundation.

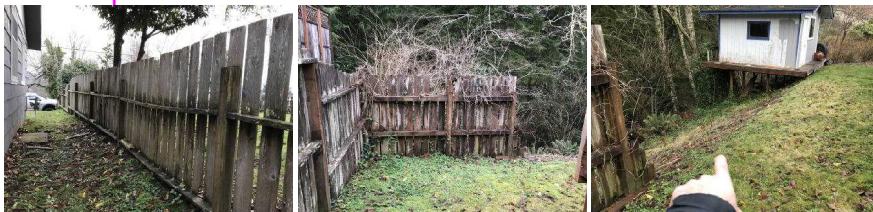
11. Marginal, Defective Fences: Wood - I noticed a few of the fence boards were damaged and should be repaired missing sections along the backside of the fence and the steep embankment could pose a fall safety issue and recommend that a barrier be put back in this location to prevent any falls. A qualified contractor is recommended to evaluate and make all repairs necessary.

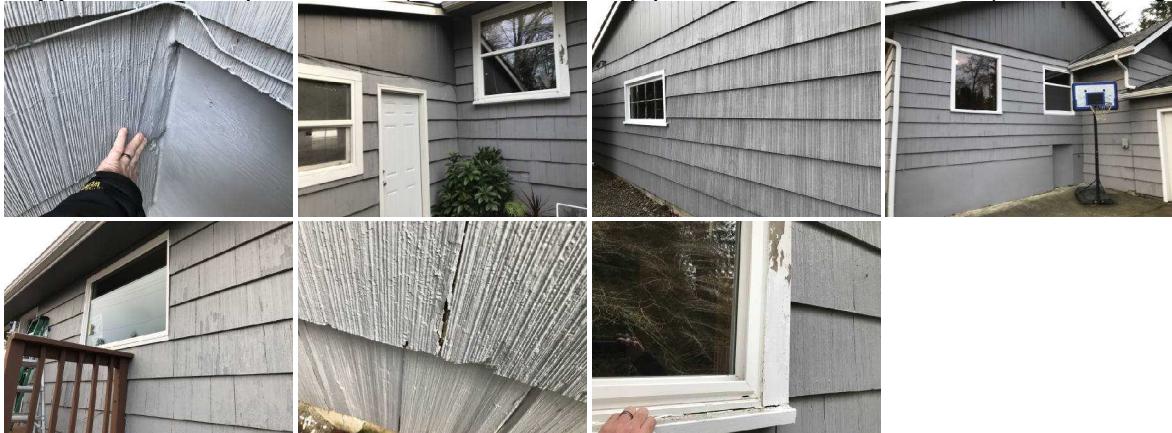
Type: Cedar - Appears to be the original siding. I noticed a few areas where it was patch in and other areas where caulking or other fillers were used. The skirting along the side of that house that are in contact with the ground. This is a conducive conditions for wood destroying organisms. Wood products that are in contact with the ground also tend to rot out over time. Future repairs can be expected. Caulking is needed: I recommend that exterior of structure be (re)caulked as needed to prevent moisture intrusion and that this practice be performed yearly as part of an annual maintenance program. Proper maintenance involves detailed caulking of any joint, seam or penetration (windows, doors, pipes, wires, nail heads etc.) of the siding.

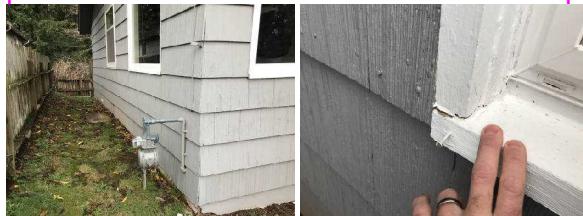
2. Marginal, Defective Trim: Wood - Noted at the back of the house peeling paint around some of the window trim and this should be repainted and caulked to prevent wood damages. A qualified person is recommended to make these repairs.

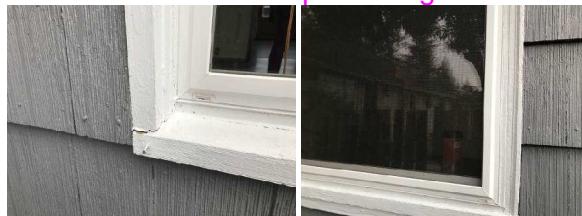
5. Not Present Door Bell:
6. Acceptable Entry Doors: Metal
7. Marginal Patio Door: Vinyl sliding - I recommend caulking around the back sliding glass door.
8. Marginal, Defective Windows: Vinyl slider wood casement - Some of the windows appear to be updated some appear to be possibly the original. The older single pane windows should be updated in the future. This will help with energy savings.

All exterior seams should be (re)caulked as needed to prevent moisture intrusion. Particular attention should be given to penetrations (doors ,windows, light fixtures pipes, wires etc.) I recommend using a high quality, paintable exterior caulk. This should be done on an annual basis as part of a general home maintenance procedure.

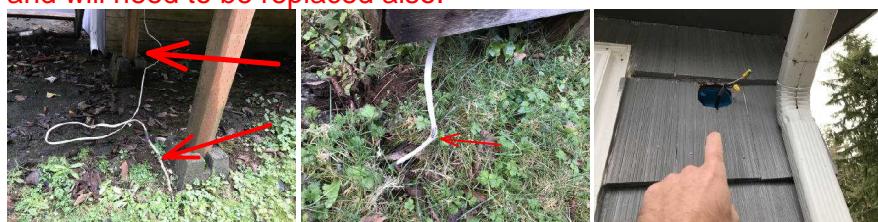
11. Defective, Safety Issue Exterior Electric Outlets: 110 VAC - When inspecting the backside of the house i noticed an exposed electrical wiring it appears it is going to the back shop but was not in a proper weatherproof conduit and was broken in several places this poses a major safety electrocution risk and recommend a qualified electrical contractor evaluate and route the electrical into a conduit. This wiring was severely damaged in multiple places and will need to be replaced also.

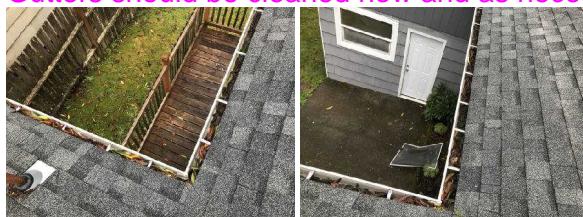
10. Marginal, Defective Gutters: Aluminum - Debris had accumulated in one or more gutters. This is a conducive condition for wood destroying insects since gutters may overflow and cause water to come in contact with the building exterior or make water accumulate around the foundation. Gutters should be cleaned now and as necessary in the future.

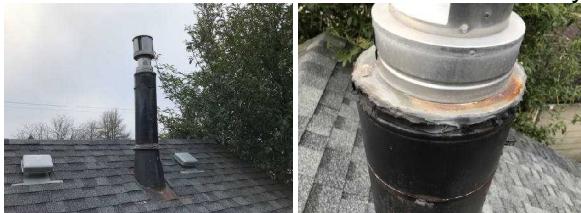
13. Marginal Chimney: Metal pipe - The metal chimney pipe is rusting in areas and should be painted. Being this house is in the harbor this will eventually need to be replaced at some point in the future.

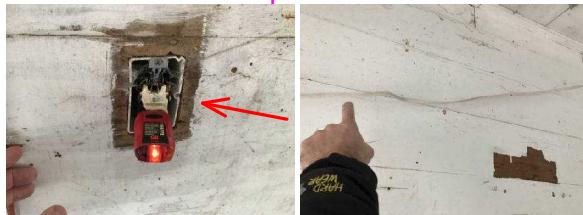
13. Defective Electrical: 110 VAC - The exposed electrical wiring should be properly attached is loose in a few areas recommend a qualified persons attach the wiring so it is not loose. I also noticed a broken damaged outlet that should be replaced along with the wiring repairs. Open or missing grounds were noticed at all three plug outlet this poses a safety issue this gives the fall sense that the outlet is grounded when it is not properly grounded. The evaluation and all repairs is recommended from a licensed electrician

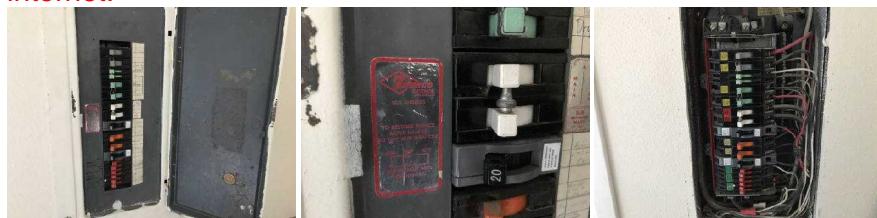
8. Defective, Safety Issue Manufacturer: Zinsco - Zinsco

The service panel brand was Zinsco. Zinsco panels are reputed to have a high rate of circuit breaker failure which can result in a fire or shock/electrocution. The Inspector recommends that before the expiration of your Inspection Objection Deadline, you consult with a qualified electrical contractor concerning the necessity for replacing this service panel. Information about defective Zinsco panels is widely available on the internet.

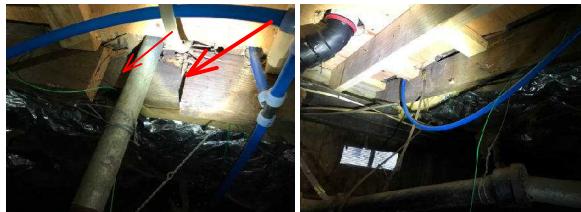
4. Acceptable Bearing Walls: Frame
5. Marginal, Defective Joists/Trusses: 2x8 - Joists have been modified and will require evaluation. It appears under the bathroom area Joist have been modified cut or added on to and where one of the Joist is sister onto it should be further looked at by a contractor and repaired.

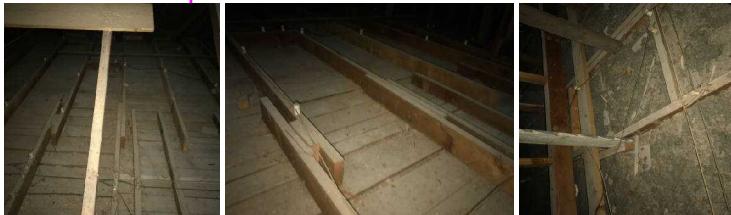
6. Defective Insulation: Fiberglass - Large areas of missing insulation over the bedrooms and living room areas of the attic space. the other locations were maybe 2 inches of insulation. Inadequate insulation levels- QC
Thermal insulation installed to limit heat gain and loss in the living space did not appear to meet widely-accepted modern standards. To reduce energy consumption and heating/cooling costs, the inspector recommends that additional thermal insulation be added to meet modern standards. A qualified insulation contractor should be able to advise you capably.

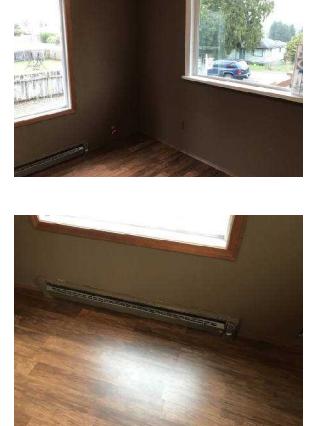
23. Marginal, Defective Windows: Non-opening - **non operable windows both were fixed.**
