**Adaptive Reuse Feasibility Study**  
**November 2019**

**BLACK BEAR INN (24SAxxx )  
THOMPSON FALLS, MONTANA  
ADAPTIVE REUSE FEASIBILITY STUDY**

Black Bear Inn  
101 Fulton Street  
Thompson Falls, MT 59873

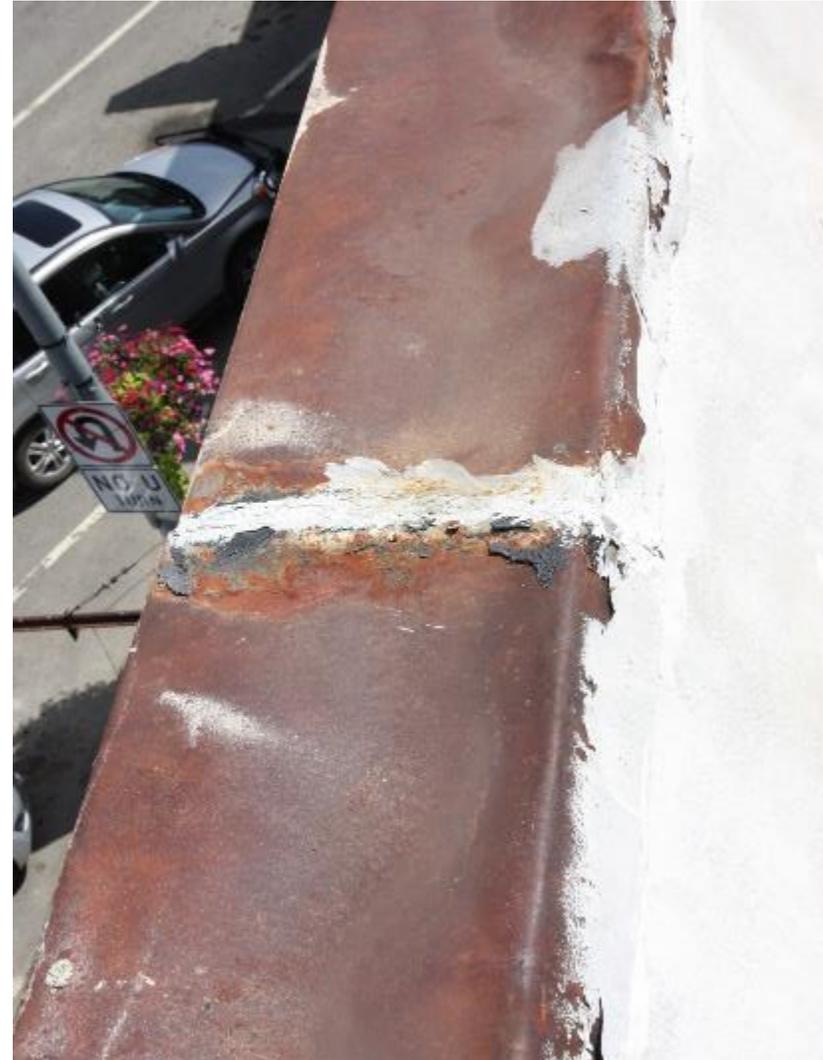
Figure 37: Black Bear Inn. Looking down at the rusted sheet metal coping of the front parapet. The sealant covering the joints has dried and cracked.

The sheet metal coping of the front parapet is rusting and in poor condition, holes have formed, and the joints between coping units (approximately two feet long) are loosening. The sealant used to cover these joints is dried and cracked with aging. The sheet metal coping of the side parapets is generally in fair condition and not

- c. Replace the sheet metal of the front coping, lapping over the roofing membrane. Resecure coping units at the joints. Coordinate this work with replacement of the parging (with sheet metal flashing) over the brick below the front edge of the coping.

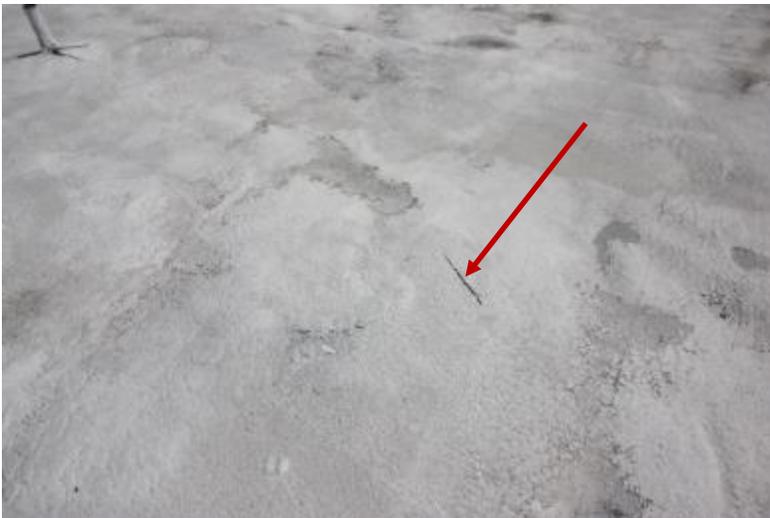
*Figure 37: Black Bear Inn. The crack at the arrow tip is a typical condition of the roofing membrane.*

1. Roofing:
  - a. Replace the roofing down to the sheathing.
  - b. Replace the hung gutter with a 5"-wide gutter. Reinstall the two existing downspouts.

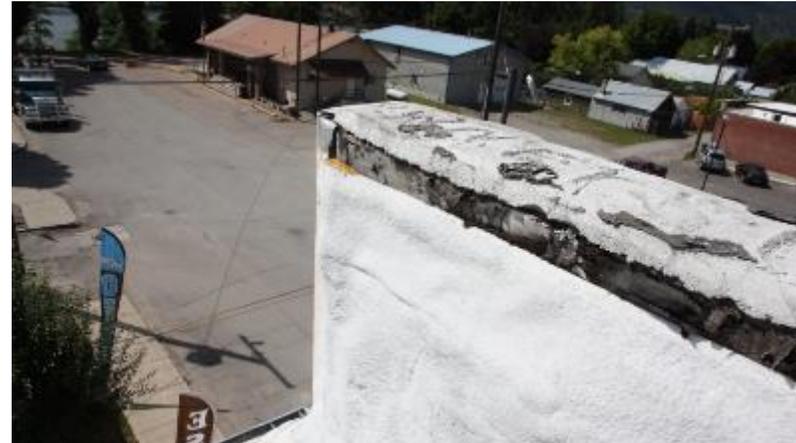
rusting, however the lapped joints are opening up. Wood sheathing and framing is exposed at the furthest south end of the west parapet, where the roofing membrane protective cover is deteriorated.

*Figure 38: Black Bear Inn. Looking southwest at the exposed parapet wall's wooden sheathing.*

- d. Provide sheet metal coping over southernmost end of west parapet wall.
  - e. Mechanical Penetrations and Chimney Flashing – Severe: Replace within two years, in conjunction with the roofing replacement.

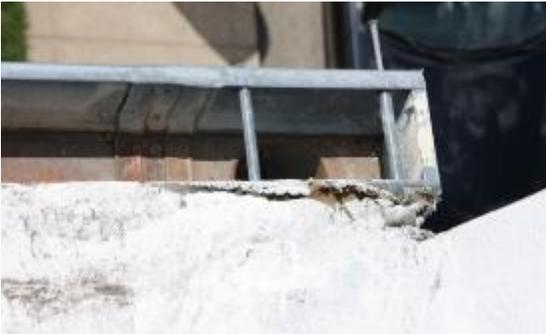
Per the Sheet Metal and Air Conditioning Contractors National Association, Inc. (SMACNA), this size of flat roof in Montana (Helena used for worst case scenario) requires a 5"-wide gutter with two downspouts of 2½" x 3½". Thus the downspouts are sized appropriately, but the gutter is too small.<sup>15</sup> This inadequacy of size could result in overflow down onto the wall below.

Figure39: Black Bear Inn. Looking down at the west end of the gutter. The bottom surface is rusting. The gutter is fastened to the wood fascia with a spike and ferrule system.

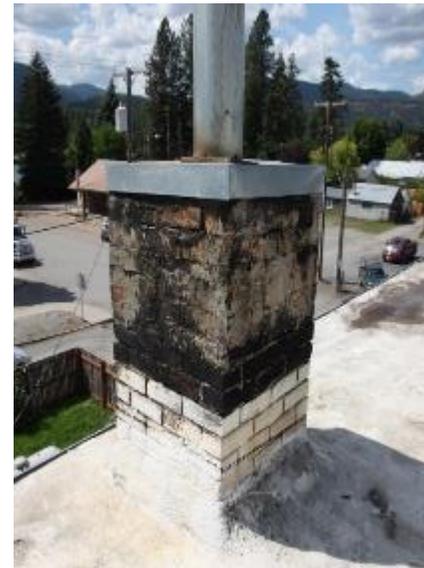
Figure 41: Black Bear Inn. The chimney is not properly flashed and the mortar joints have eroded.

1. Chimney: Repoint the mortar joints.
2. Repoint the joints in the stepped cracks above windows.
3. Prepare and fill skyward joints in the concrete windowsills.

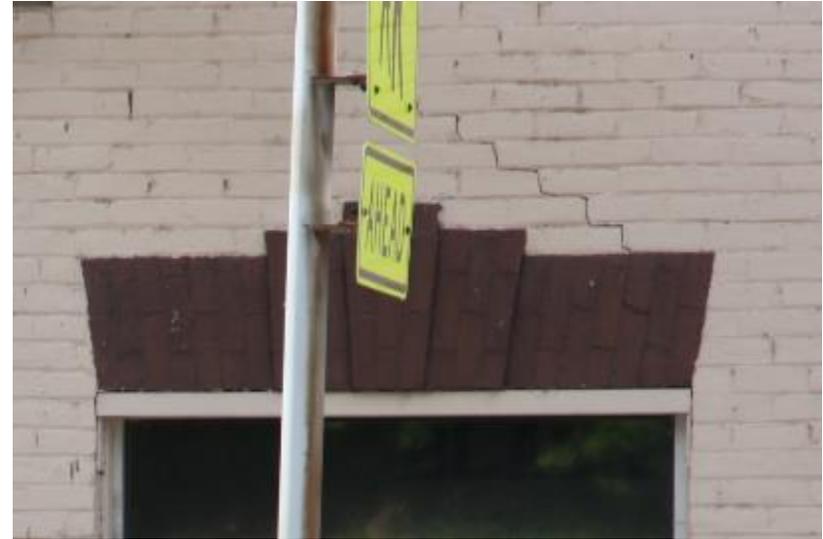
Figure 42: Black Bear Inn, north facade, showing a minor stepped crack above the jack arch of a first floor door.

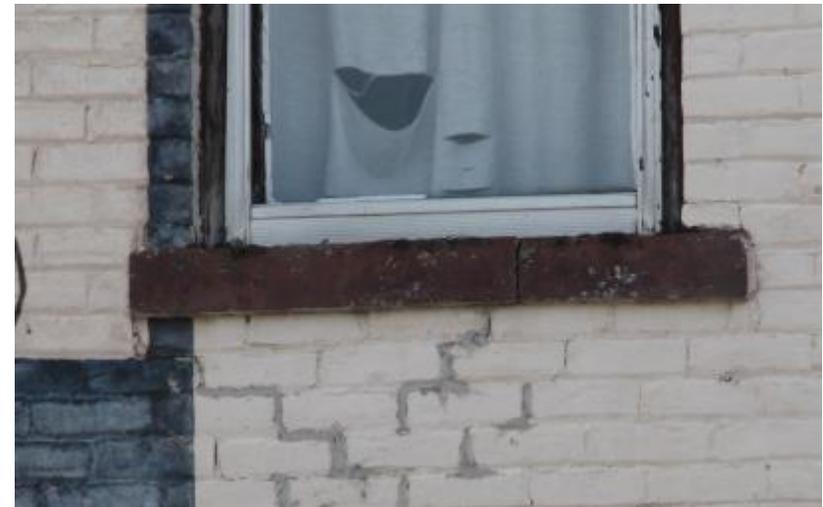
Figure 43: Black Bear Inn. The concrete sill of this second floor west facade window is cracked above the stepped crack in the brick below.

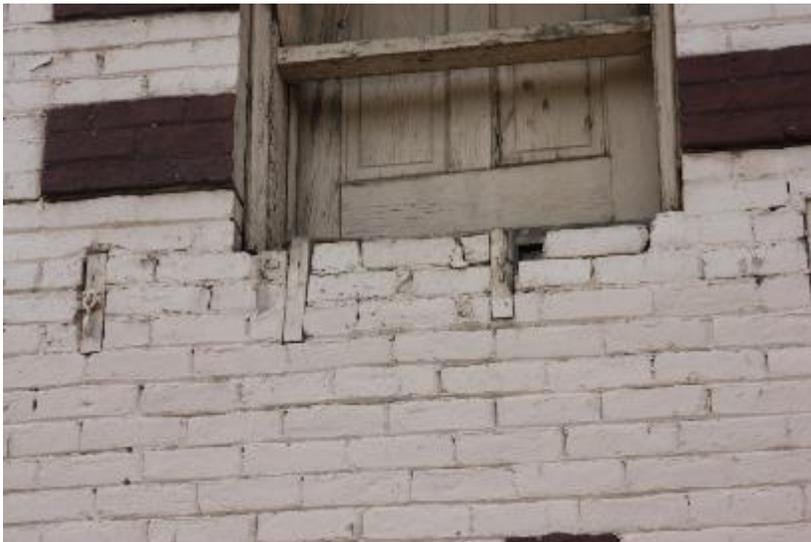
Figure44: Black Bear Inn. The door threshold at the second floor, north facade, does not appear to cover the brick veneer sufficiently.

- f. Resecure the concrete windowsills to remove or lessen the gap at the sheathing. Flash as required to keep moisture from penetrating the wall below.
- g. Provide flashing at second floor door sill of north façade.

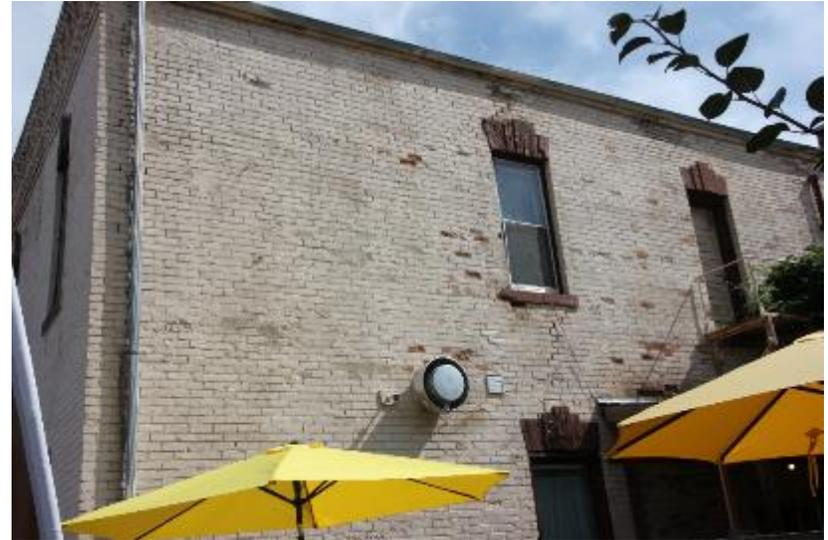
The rear south wall has received the most moisture (presumably from the roof, gutter leaks above), causing paint to peel, brick to spall, stepped cracking to occur, and the brick window arches to expand. This poor condition is the result of moisture frozen behind the single wythe of brick.

Figure 45: Black Bear Inn. The condition of the west portion of the south facade is representative of the façade. Water penetration has caused isolated brick to spall, mortar joints to erode (see cracking at arrow tip).

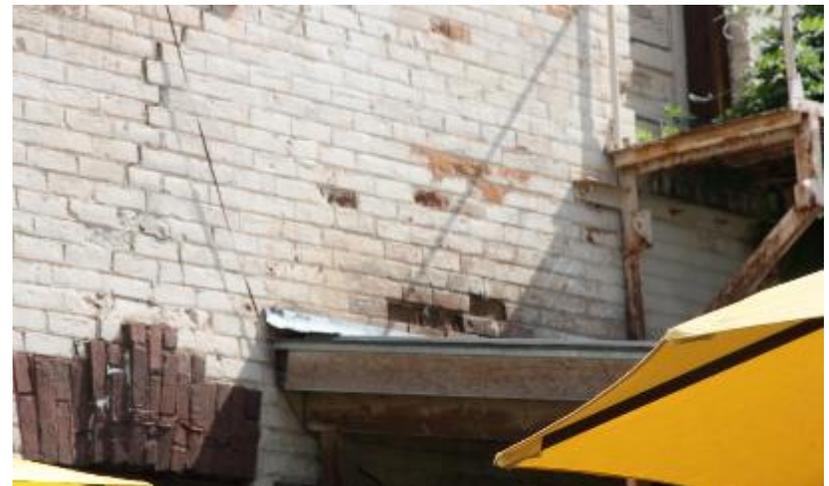
Figure 46: Black Bear Inn. Brick has spalled, mortar joints have cracked, and brick arches have expanded.

4. South façade: Replace or paint spalled brick, depending upon severity of deterioration. Rebuild the window arches/lintels where expanded.
5. Prepare and repaint the projecting sign to protect the sheet metal.

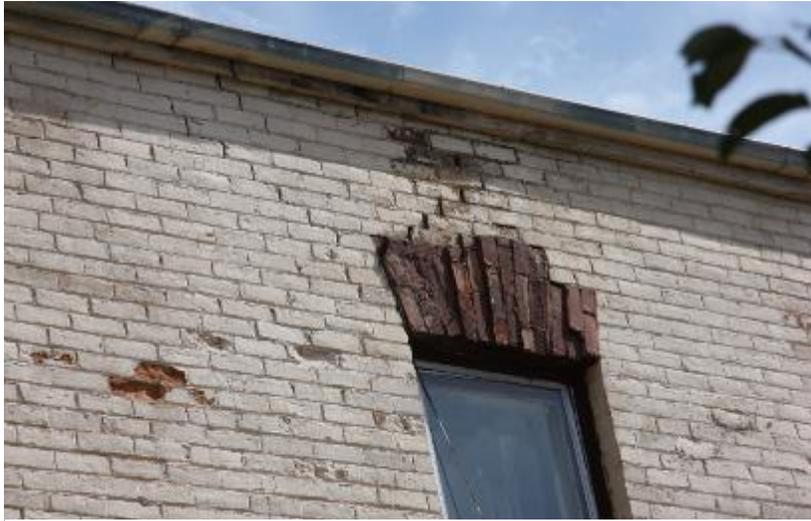
Figure 47: Black Bear Inn. Open mortar joints and spalled brick are the result of moisture penetration into the brick veneer.

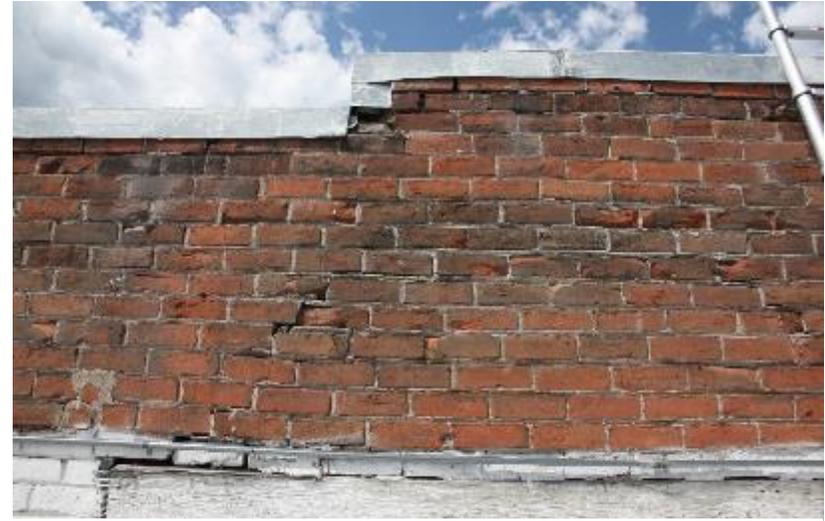
Figure 48: Black Bear Inn, east facade, where mortar is deteriorated at top 2-3 courses of brick.

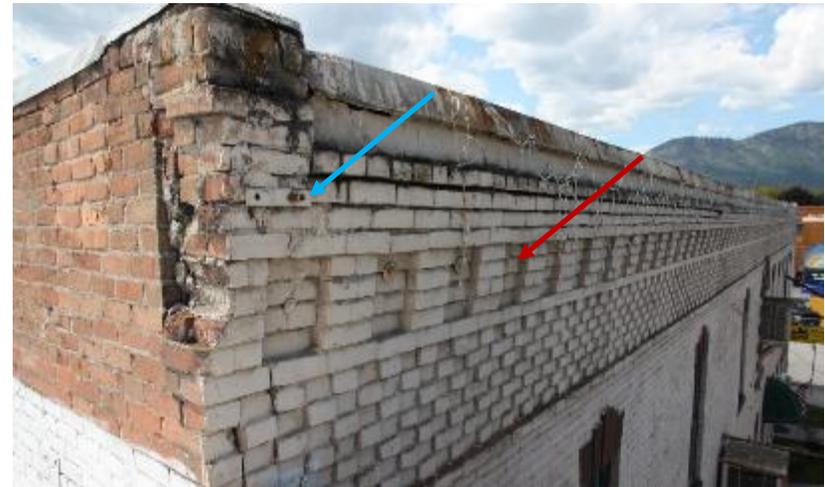
Figure 49: Black Bear Inn. The east end of the corbelled brick cornice has been tied back (at blue arrow tip) to the wall to prevent further pulling away. Anchor bolts have been drilled through the closest four recessed panels of the corbelling (see red arrow tip at furthest one).

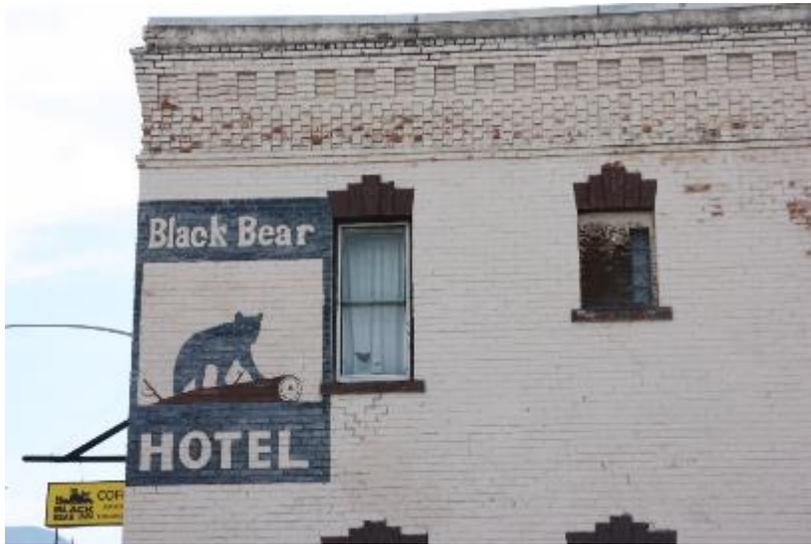
Figure 50: Black Bear Inn. Cornice of west facade. The upper courses of brick and mortar have eroded and loosened from water penetration at the coping.

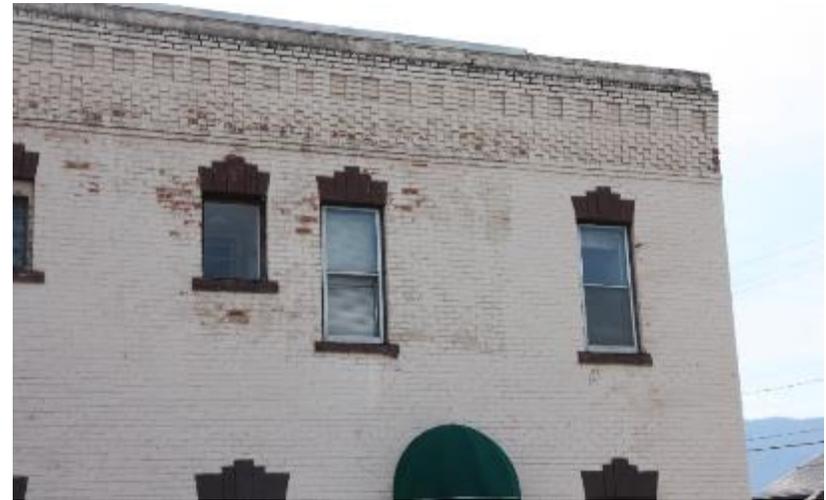
Figure 51: Black Bear Inn. Moisture has caused the top parging to crack and the paint to peel from the brick. Some of the brick have spalled.

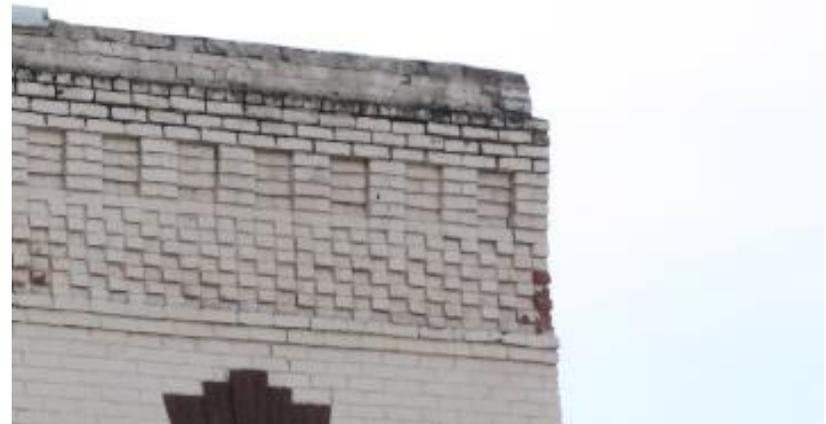
Figure 52: Black Bear Inn. Close-up of cracked and delaminated parging at west parapet.

- b. Remove the parging atop the top cornice brick course. Replace with pre-painted metal flashing to blend with the paint brick color. This should be coordinated with replacement of the sheet metal coping.

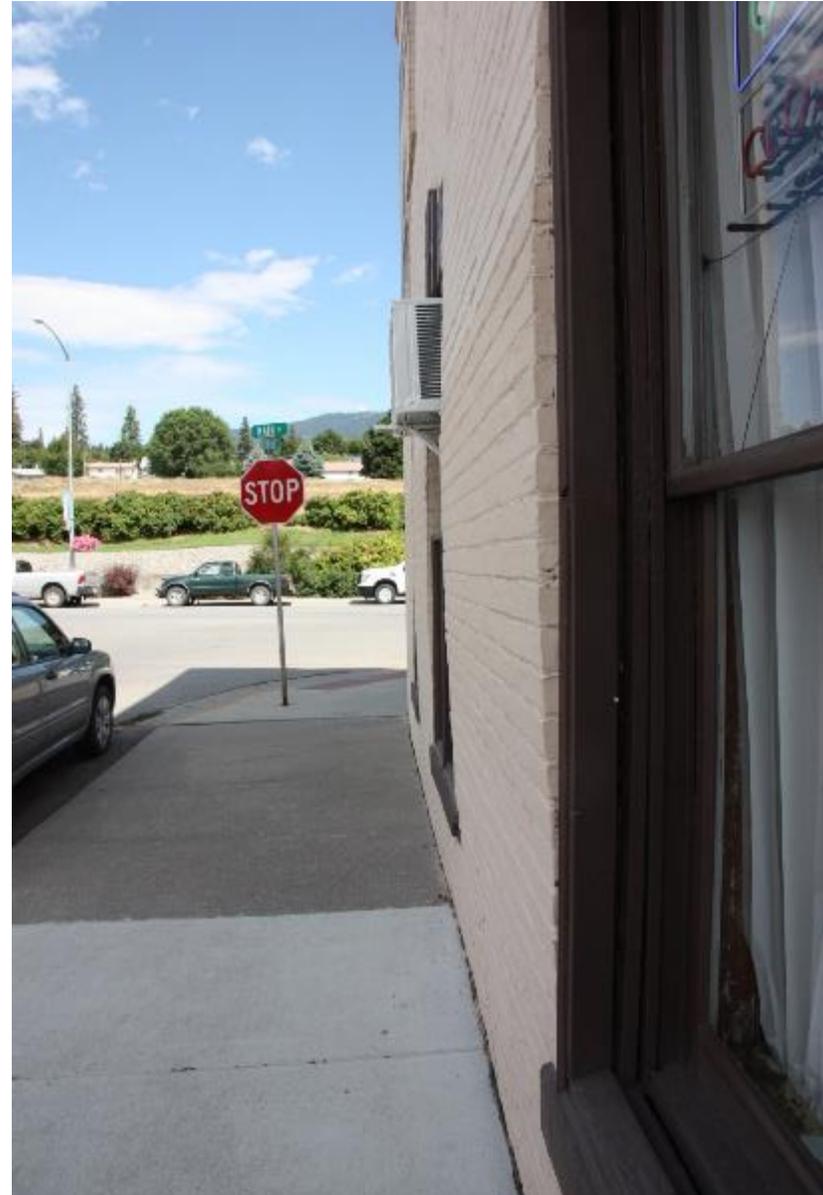
*Figure 53: Black Bear Inn. Typical bowing of brick veneer at first floor of west elevation. Photograph taken looking north.*

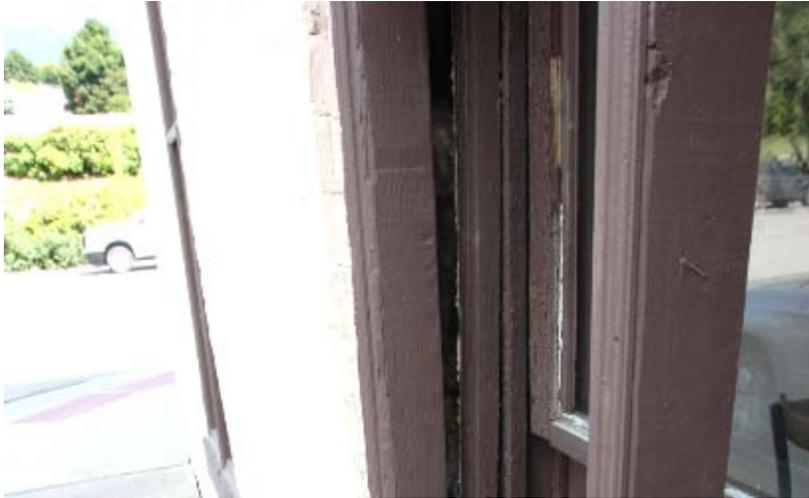
Figure 54: Black Bear Inn. The >2" gap between the brick veneer and the structure is probably indicated of insufficient masonry ties in the original construction.

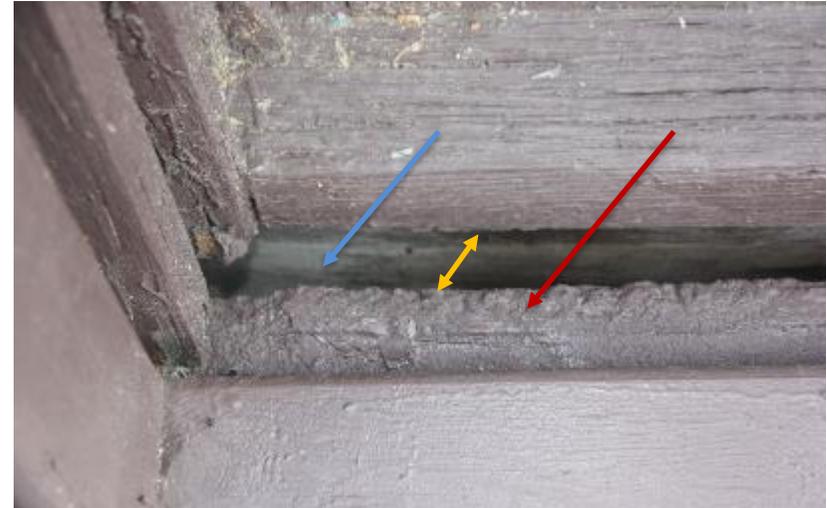
Figure 55: Black Bear Inn. Looking down at gap (orange line) between concrete windowsill (red arrow tip) and wall substrate (blue arrow tip) at first floor window of west facade.

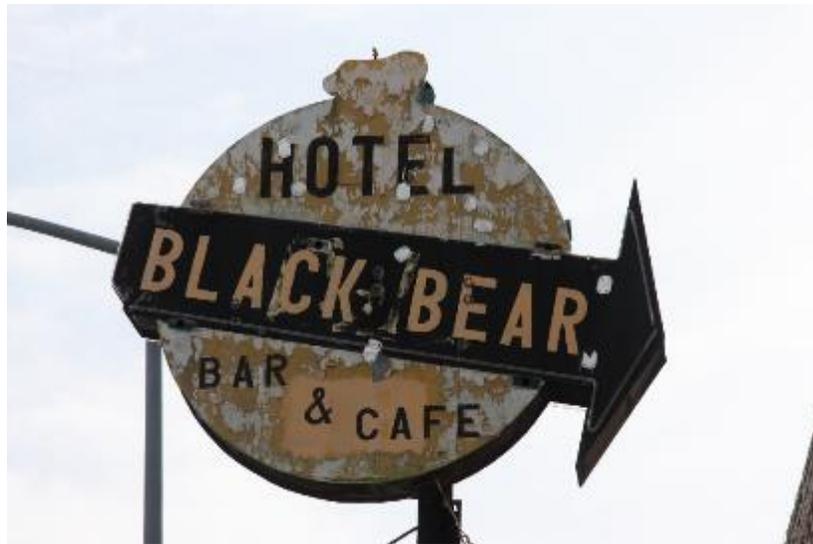
Figure 57: Black Bear Inn. The face of the historic Black Bear Hotel sign has numerous metal patches, presumably covering holes caused by rust.

Moderate: Prepare and repaint the projecting sign to protect the sheet metal.

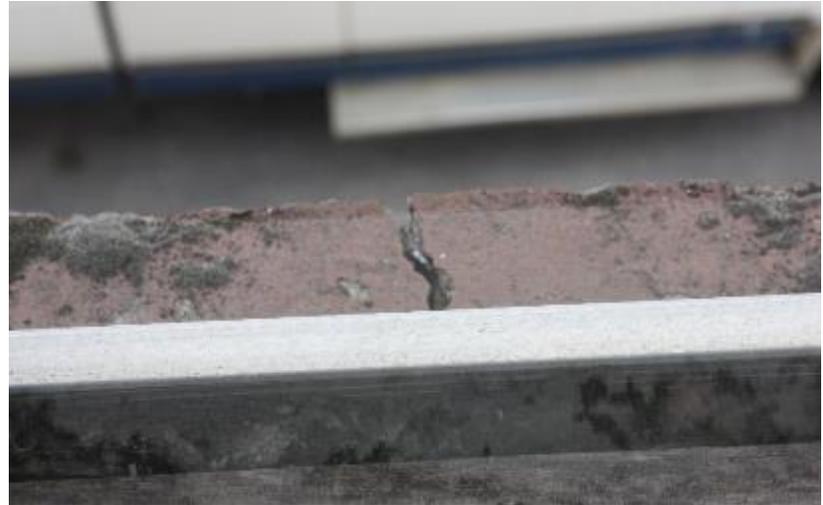
*Figure 60: Black Bear Inn. Crack in exterior concrete windowsill at northwest window in Room 11.*

- c. Replace glazing putty and reset glass with proper glazing points as required.
  - d. Repaint sash and putty.
  - e. Patch cracks in concrete sills.

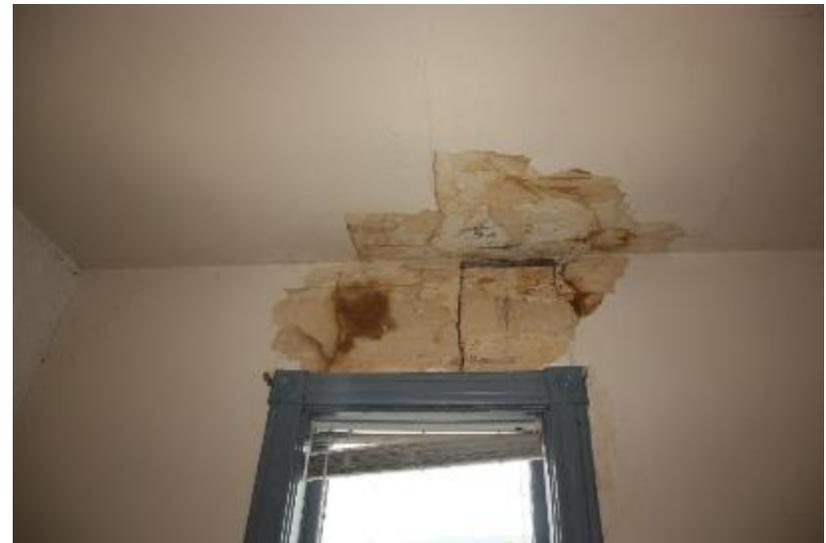
Figure 65: Black Bear Inn. Some of the exterior wall plaster has cracked and delaminated from water penetration.

6. Interior Walls: Remove and discard water-soaked plaster and patch.
7. Wood flooring: Remove all the carpeting. Salvage, repair, and clean the resilient flooring. Repair/patch wood flooring that has been sawcut. Refinish the wood flooring.
