# 3D-Sq. Home Inspection Service

## Property Inspection Report

Property address: **12345 Your Road**  
**Your Town, MO 11111-2222**

Inspection date: **Tuesday, January 30, 2018**

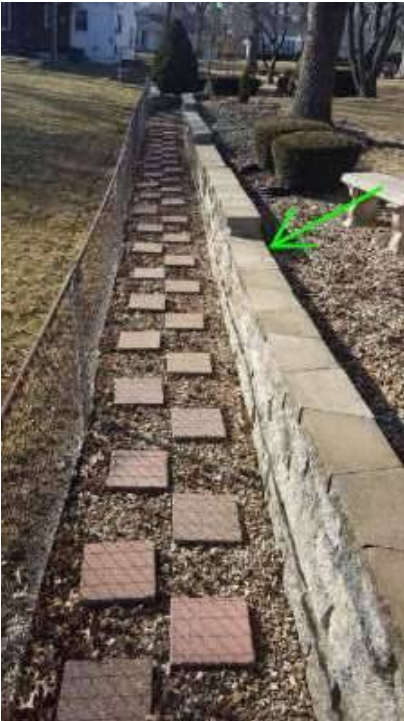
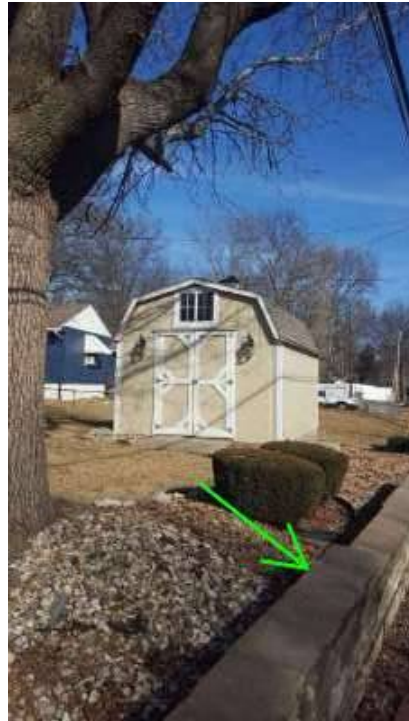
**Condition of retaining walls:** Required repair, replacement and/or evaluation (see comments below), Wall at South of property is leaning out words.

Retaining wall at south of property is leaning. This could be a potential hazard. Have a qualified contractor inspect and repair.

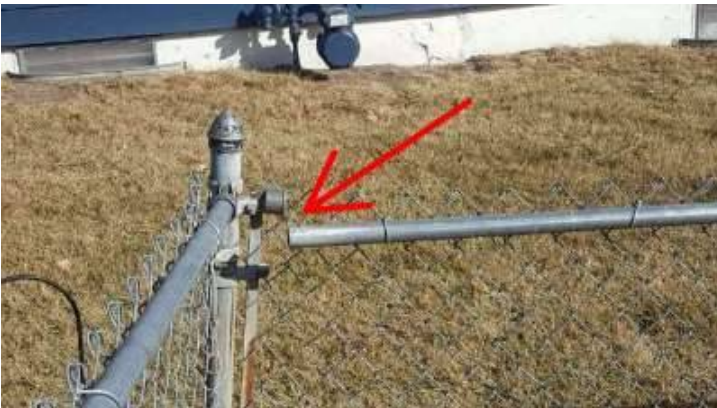
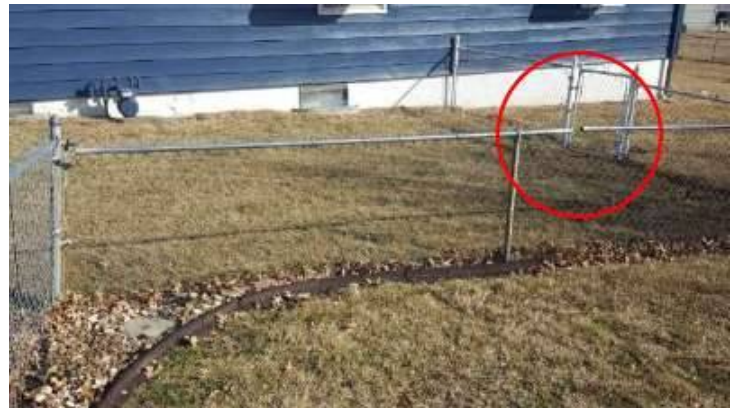
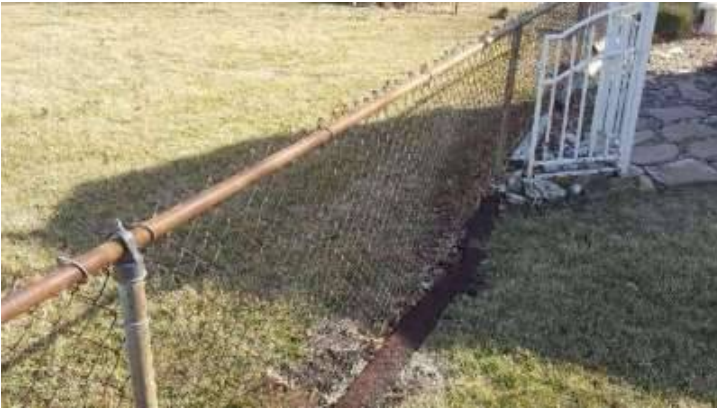
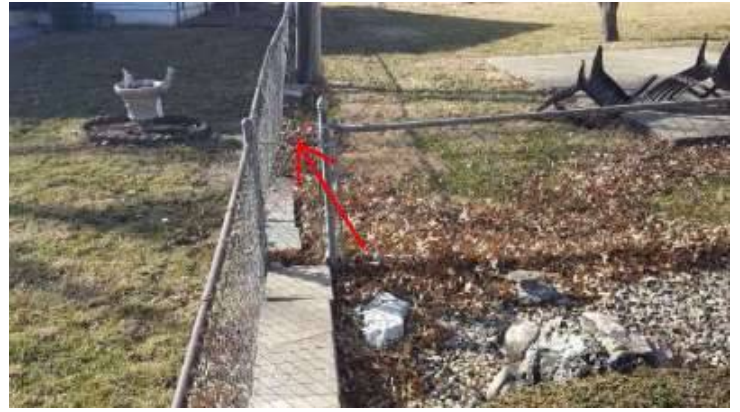
Chain link fence is rusted in has top rails that are missing and/or are loose.

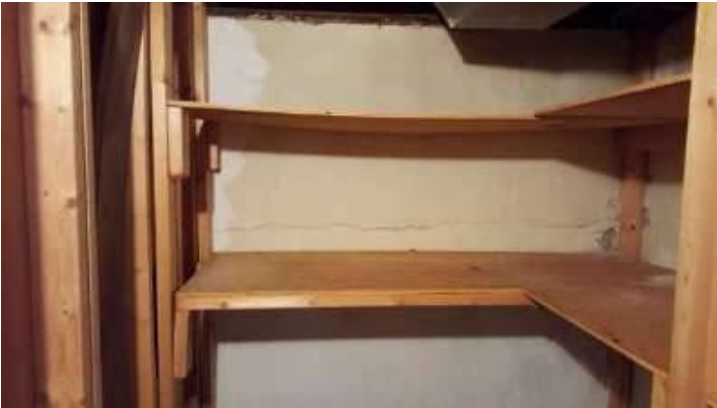
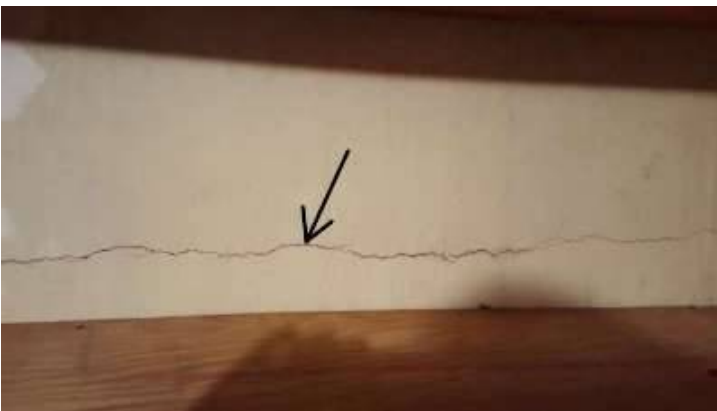
Moderate cracks (1/8 inch - 3/4 inch) and/or leaning were found in the foundation. This may be a structural concern or an indication that settlement is ongoing. The client should consider hiring qualified contractors and/or engineers as necessary for further evaluation. Such contractors may include:

NOTE: This is the only area that a visual inspection was possible as other areas are concealed by framed walls.

At a minimum, recommend sealing cracks to prevent water infiltration. Numerous products exist to seal such cracks including hydraulic cement, resilient caulks and epoxy sealants.

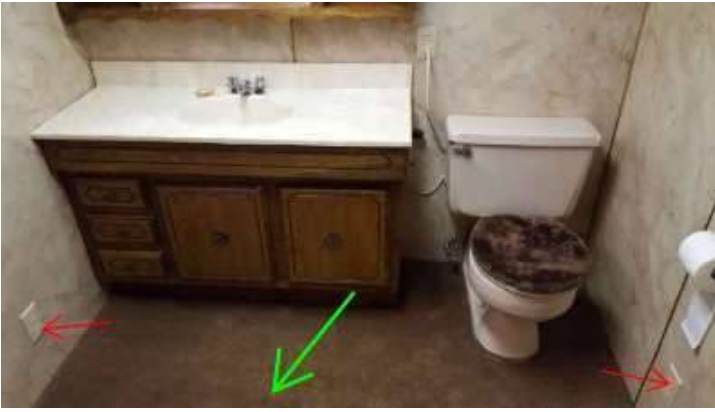
Photo 6-1

Carpet was installed in the basement. Carpet absorbs and retains moisture and odors in humid environments such as basements. Monitor carpeted areas for moisture and odors in the future. Carpeting may need removal and/or replacement with a moisture-resistant flooring material.

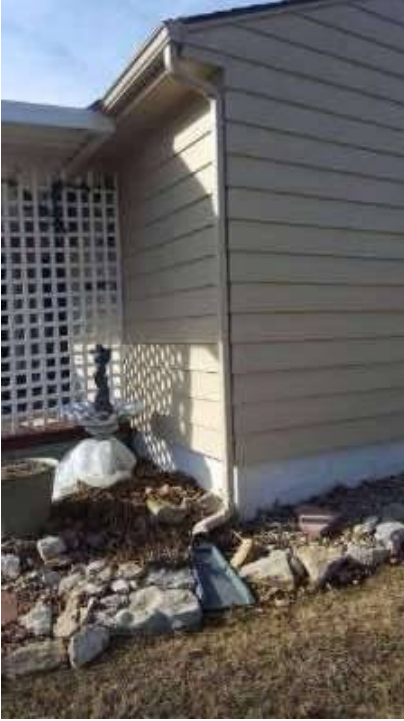
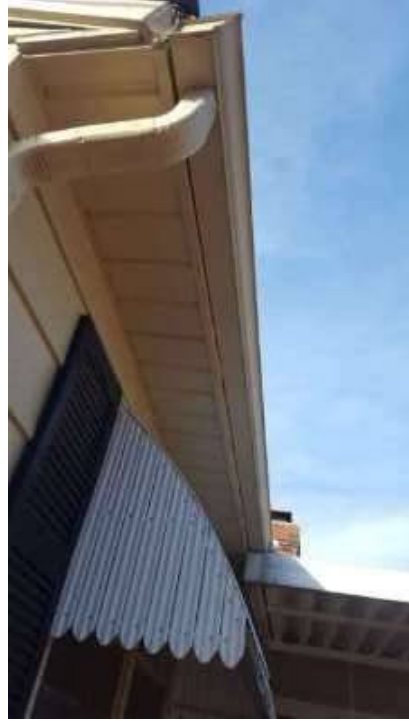
One or more sections of the roof structure appeared to have substandard ventilation, soffit or lower vents were missing. This

can result in high attic and roof surface temperatures, reduce the life of the roof covering materials, and/or increase cooling costs. High levels of moisture are also likely to accumulate in the roof structure or attic, and can be a conducive condition for wood-destroying organisms. Standard building practices require one free square foot of ventilation for every 150 square feet of attic space, and that vents be evenly distributed between the lowest points of the roof structure and the highest points to promote air circulation. Often this means that both soffit vents and ridge or gable end vents are installed. Recommend that a qualified contractor evaluate and repair per standard building practices.

Recommend vents be added in the soffits around the house for positive ventilation.

Add vents to soffits.

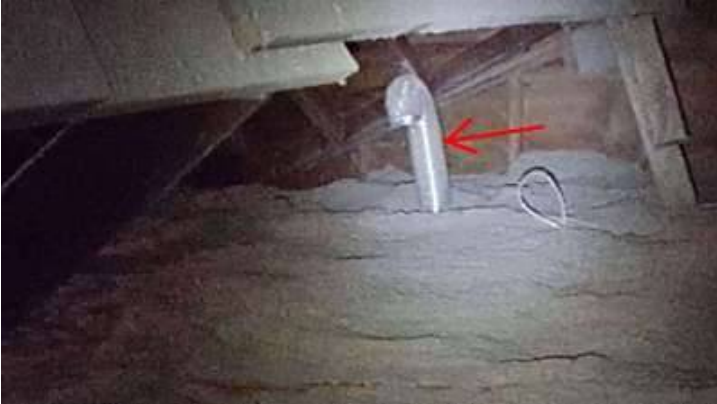
Photo 8-1

One or more exhaust fans in the attic had no duct to route the exhaust air outside. As a result, conditioned air will enter the attic when the fan is operated. This can result in excessive moisture in the attic. Recommend that a qualified contractor install ducting per standard building practices. Typically, this includes a duct with R-4 rated insulation permanently attached to a vent hood or cap installed on the roof or at an exterior wall.

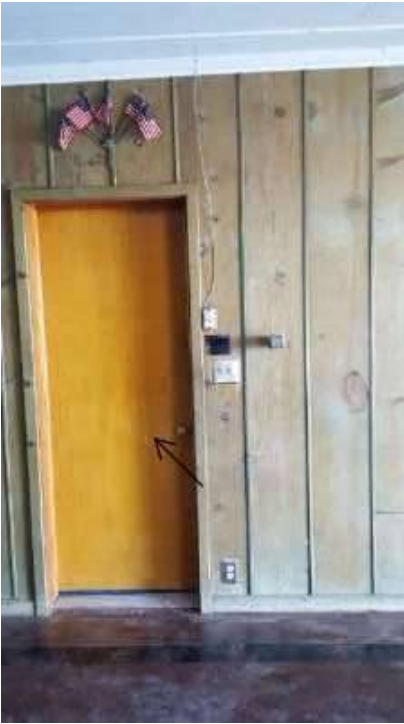
Photo 10-1

The door between the garage and the house did not appear to be fire resistant, or the inspector was unable to verify that it was via a label. This is a potential safety hazard. House to garage doors, to prevent fire and fumes from spreading from the garage into interior living space, should be constructed of fire-resistant materials. Doors, generally considered to be suitable for the purpose, are solid core wood, steel, honeycomb steel or a door that has been factory labeled as fire rated. Recommend that a qualified contractor replace or repair the door and, at that time, make any other corrections that might be required to provide suitable fire resistance between the garage and the dwelling per standard building practices. For more information, visit:

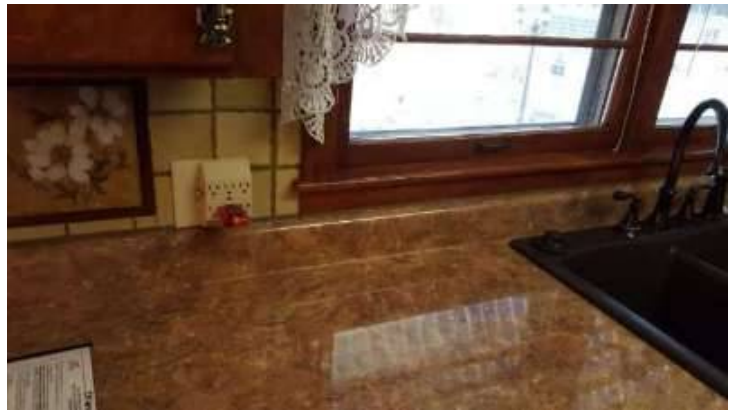
One or more electric receptacles at the kitchen, bathroom(s), 3/4 bath, full bath, laundry area, garage, exterior and/or basement had no visible ground fault circuit interrupter (GFCI) protection, or the inspector was unable to determine if GFCI protection was present. If not GFCI-protected, receptacles in wet areas pose a shock hazard. Recommend that a qualified electrician evaluate and install GFCI protection if necessary and per standard building practices. General guidelines for GFCI-protected receptacles include the following locations:

**Photo 12-1**  
All exterior outlets non GFCI. Some have exposed wiring.

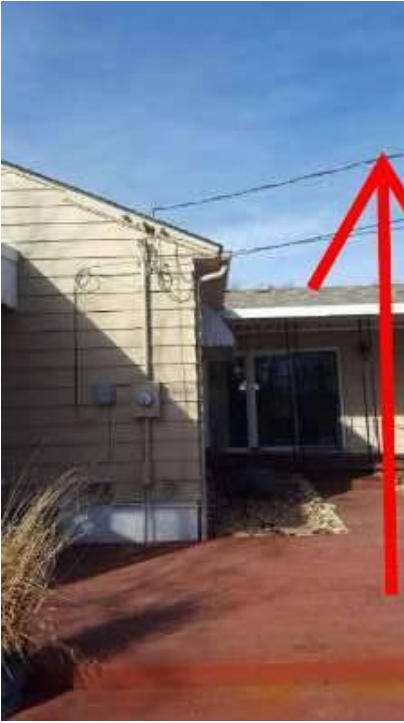
Photo 13-1

The service drop wires were less than 10 feet above the ground, a deck or walkways. This is a shock hazard. A qualified electrician or the utility company should repair per standard building practices.

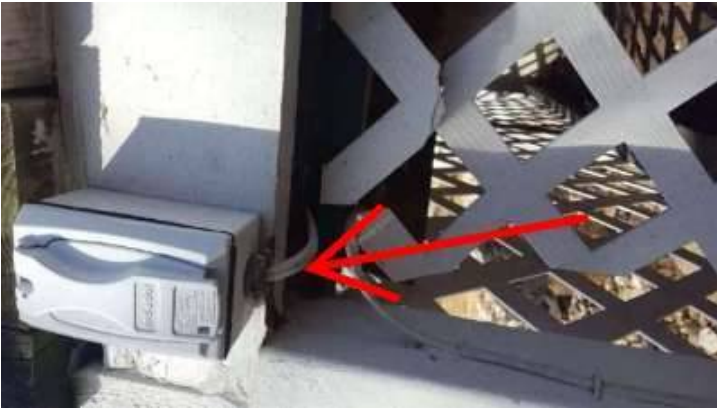
**Photo 15-1**

One or more sections of outdoor wiring were exposed and subject to damage. This is a potential shock hazard. Recommend that a qualified electrician repair per standard building practices. For example, by installing conduit, re-routing wires or replacing wiring.

Expose wiring around the covered porch at the floor.

All exterior outlets non GFCI. Some have exposed wiring.

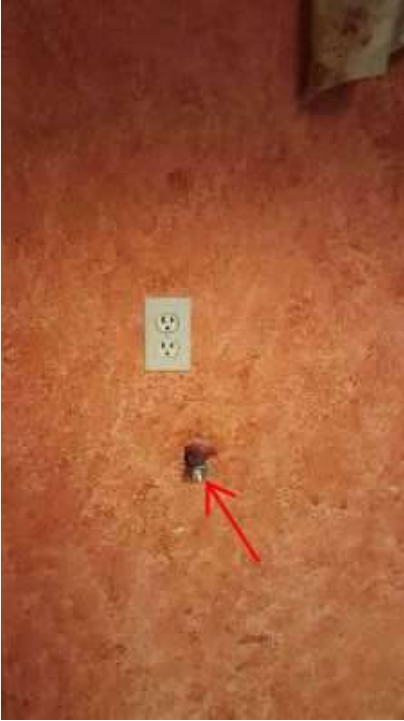
Photo 20-1

20) 🛠️🔴 Gas line with shut off exposed in basement. Needs a plug or to be terminated to an appliance.

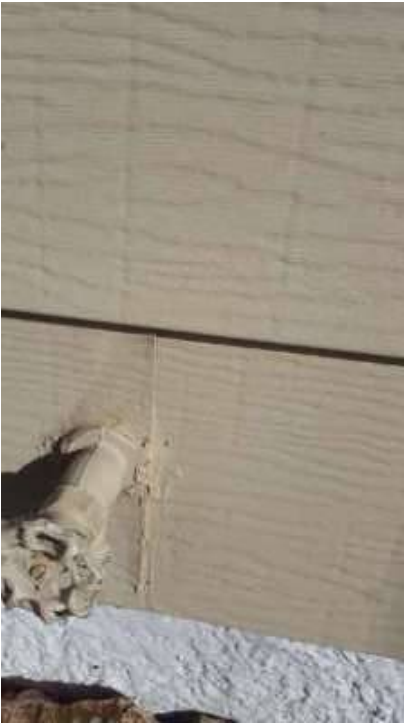
Photo 21-1

21) 🛠️🔴 2 hose bibs were missing backflow prevention devices. These devices reduce the likelihood of gray water entering the potable water supply. Recommend installing backflow prevention devices on all hose bibs where missing. They are available at most home improvement stores and are easily installed. For more information, visit:

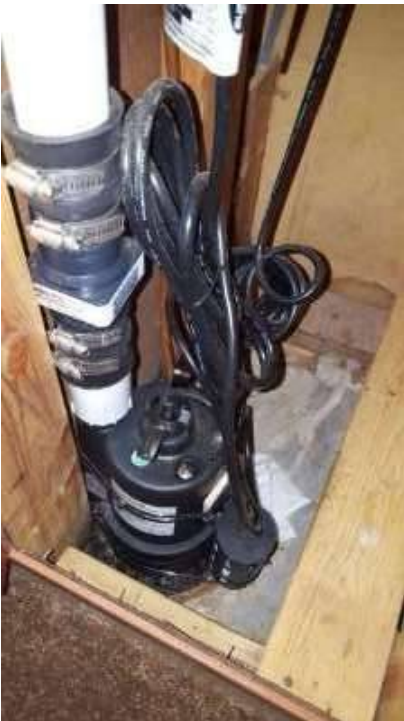
Photo 22-1

Either no pit liner was installed for the sump pump, or the liner was substandard or significantly deteriorated. Sediment can clog and damage the pump. A pit liner such as a plastic bucket or molded concrete should be installed. Typical dimensions are 18 inches in diameter and 2-3 feet deep. Recommend that a qualified person repair per standard building practices. For more information, visit: <http://www.reporhost.com/?IASP>

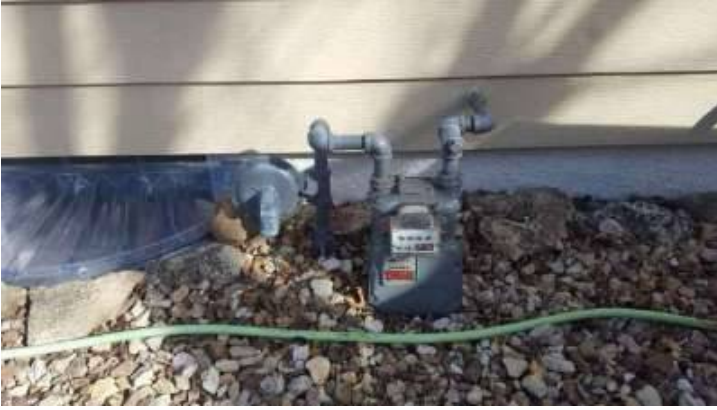
Photo 23-1

The gas meter was in contact with or too close to the soil below and is likely to rust as a result. Gas meters should be located 10 inches or more above the soil below. Soil should be graded or removed as necessary.

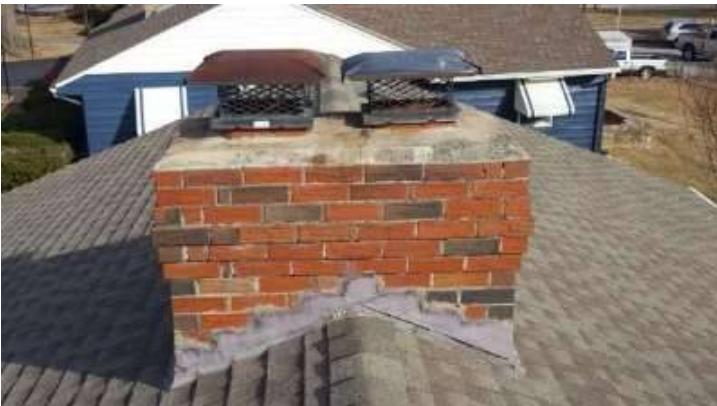
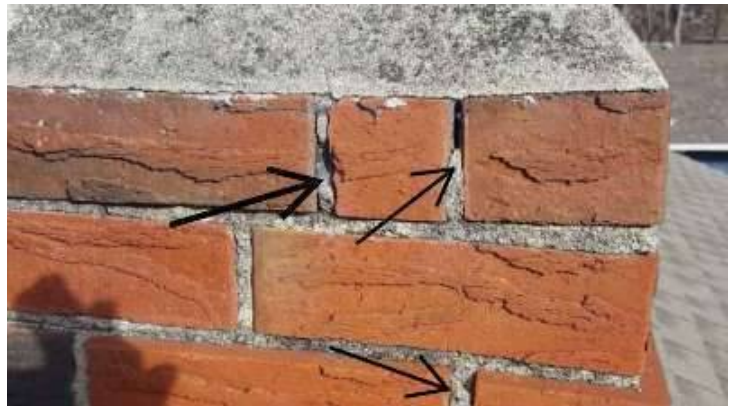
The brick chimney was moderately deteriorated. For example, loose or missing mortar, cracked, broken, loose or spalled bricks. Loose bricks can pose a safety hazard, and deteriorated masonry can allow water to infiltrate the chimney structure and cause further damage. Recommend that a qualified contractor repair as necessary.

Limited tuck pointing needed.

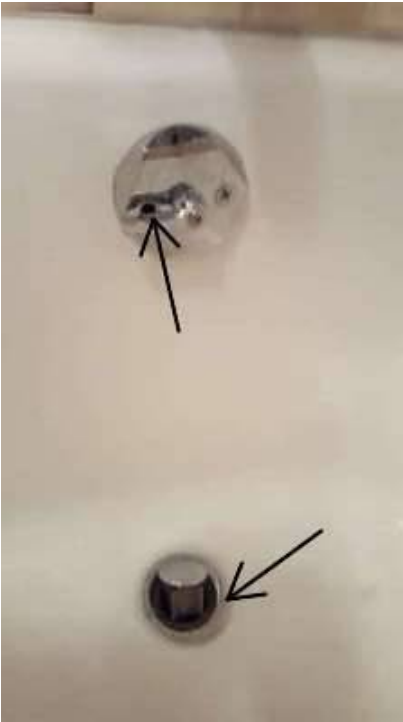
Photo 29-1

The bathtub drain stopper mechanism at location(s) #A was inoperable. Recommend that a qualified person repair or replace as necessary.

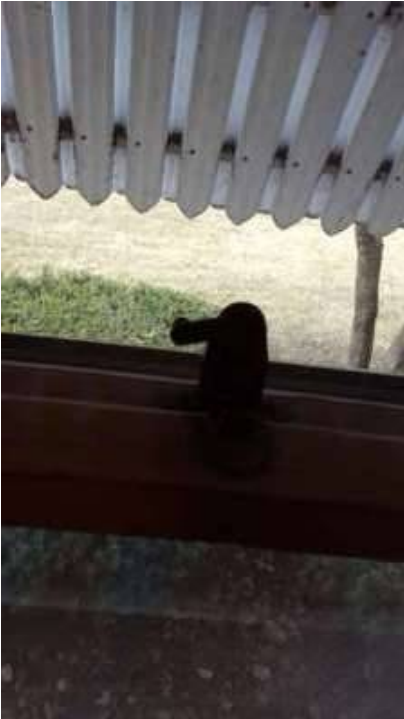
**Photo 31-1**

Lock mechanisms on one or more windows were inoperable. This can pose a security risk. Recommend that a qualified person repair as necessary.

East window on the north wall of the north bedroom latch inoperable. All others serviceable.
