Peace of Mind Automotive Inspection Report.

Site conducted	Unanswered
Customer name	Luis LMJ auto motor sales
Date / Time	Jan 21st
Payment method	Invoice
Inspection cost	199
Vehicle Year / Make / Model / Color	2007 ford f150 KR

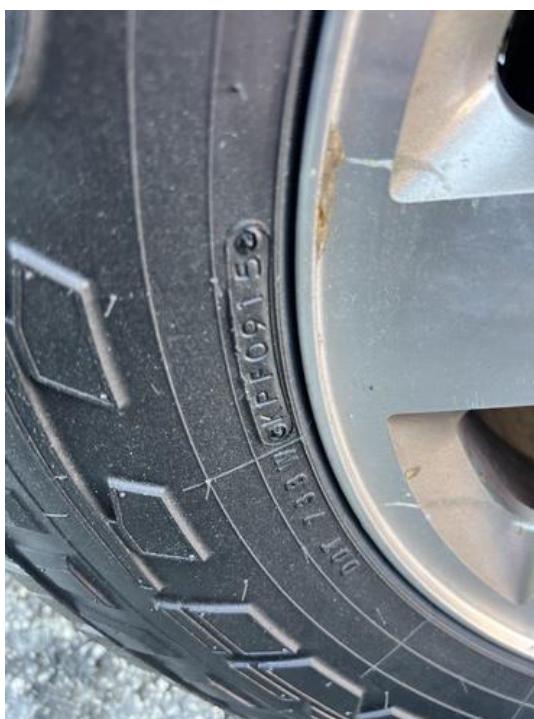
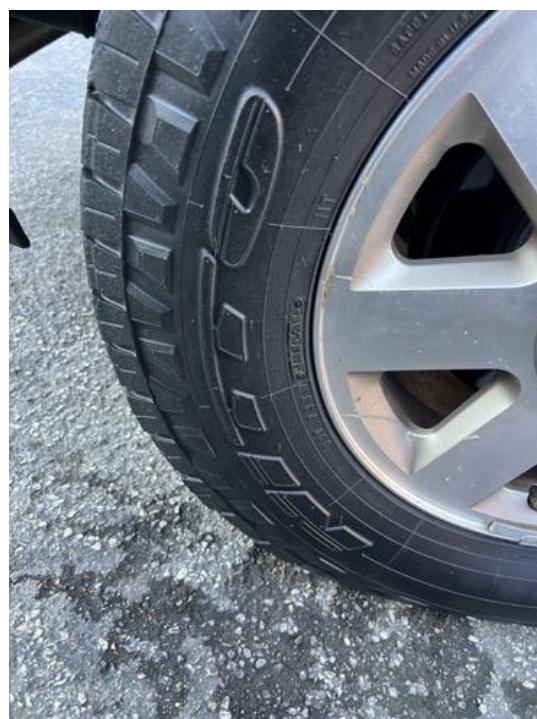
Tires have plenty of tread depth remaining however, the issue with the tires is the age. Tires are dated from 2015, there is visual dry, rot to the tires on the sidewall wall. Due to the age would suggest replacement of the tires.

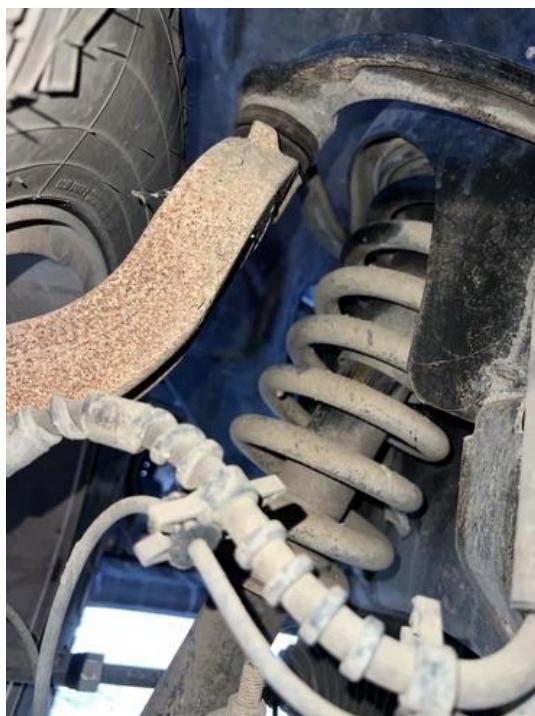
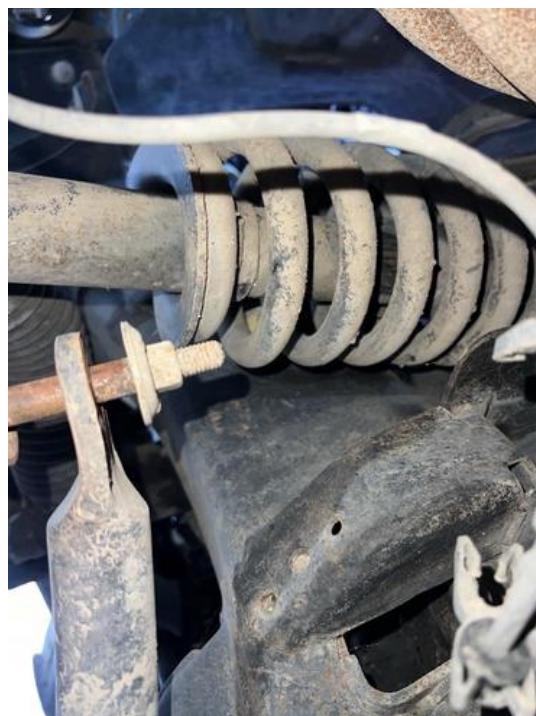
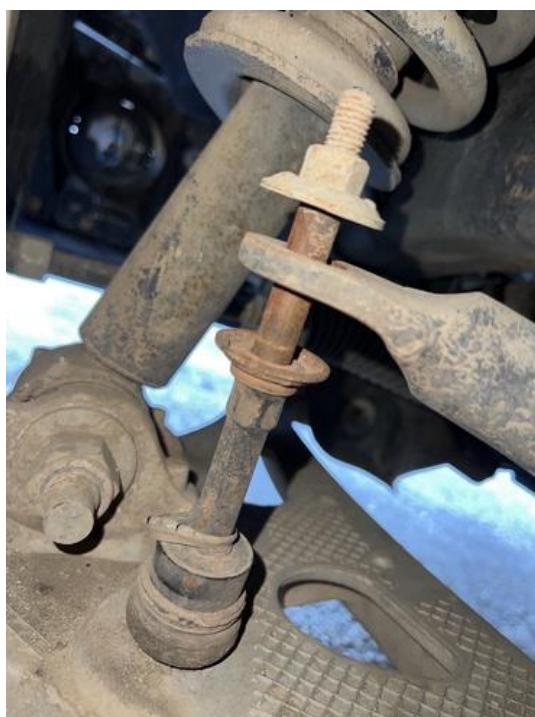
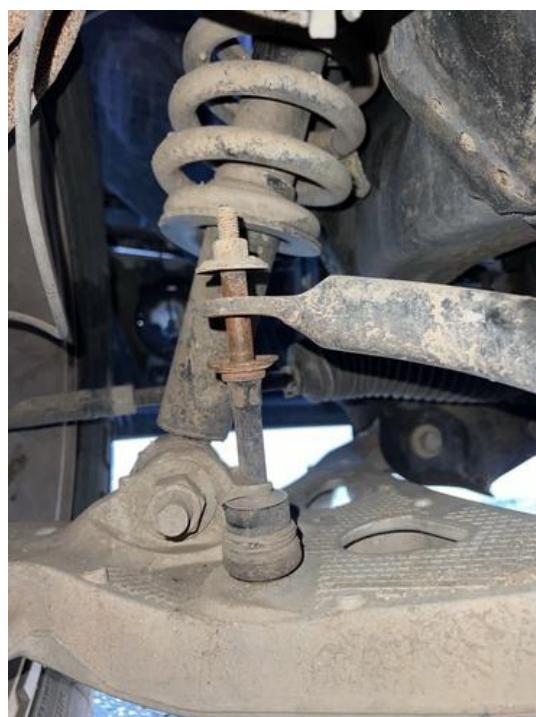
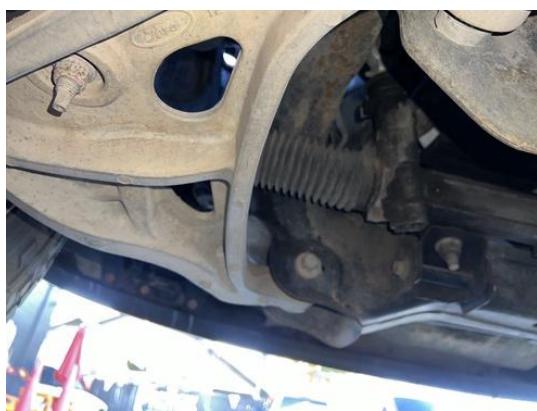
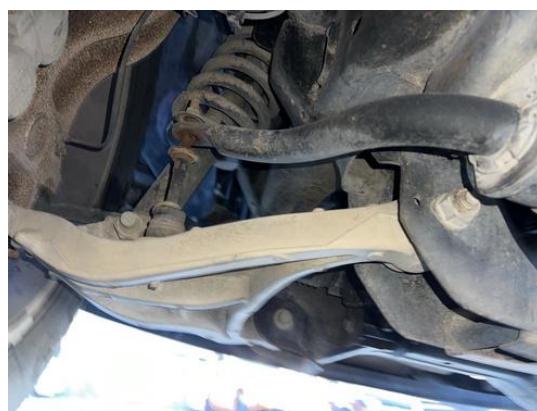
The sway bar in link symbol, the left and right side on the front end of the vehicle need to be replaced, the bushing for the swaybar in link is completely gone. This is causing abnormal feedback/noise from the suspension while driving.

Little bit of noise/feedback notice from the suspension due to the swaybar in links that need to be replaced. Normal drivability characteristics, present as expected for the age and mileage on this specific vehicle.
