## Peace of Mind Automotive Inspection Report.

<b>Site conducted</b>	Unanswered
<b>Customer name</b>	Luis LMJ auto motor sales
<b>Date / Time</b>	Jan 21st
<b>Payment method</b>	Invoice
<b>Inspection cost</b>	199
<b>Vehicle Year / Make / Model / Color</b>	2010 ford f150
<b>VIN</b>	86712 last 5

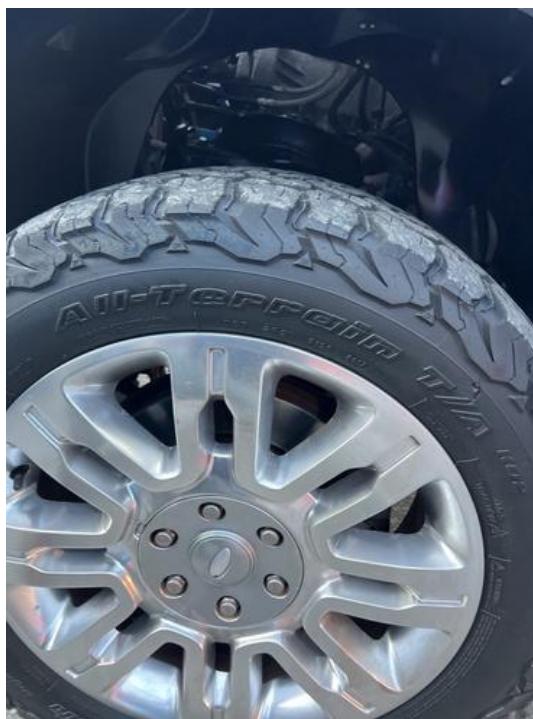
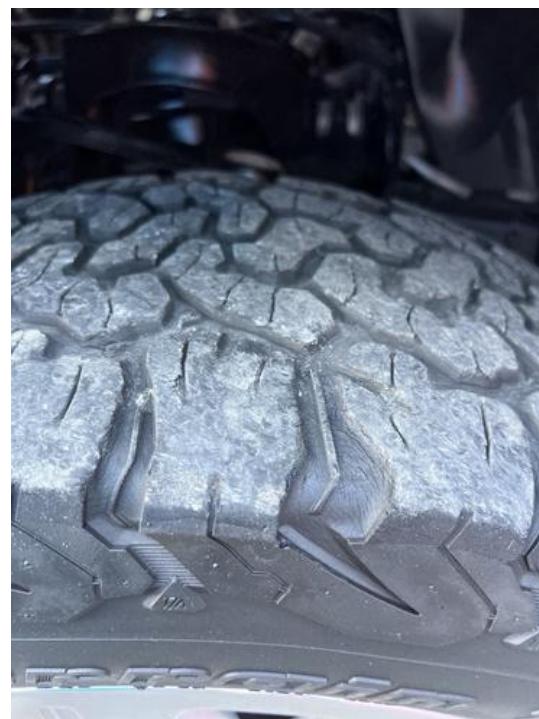
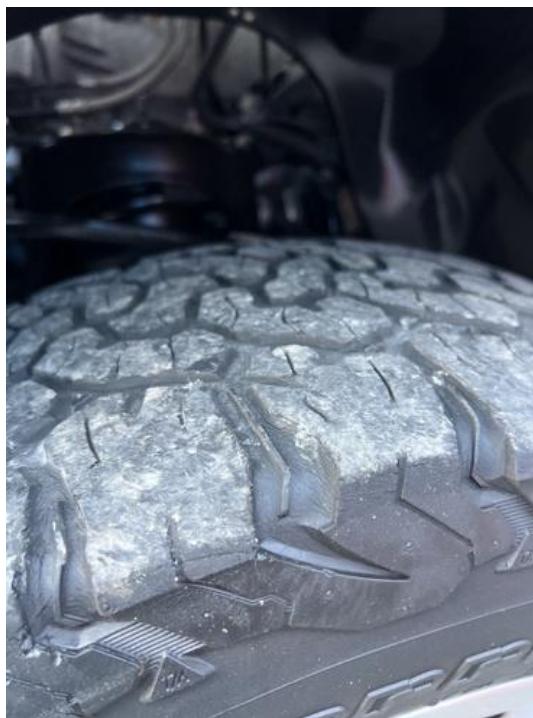
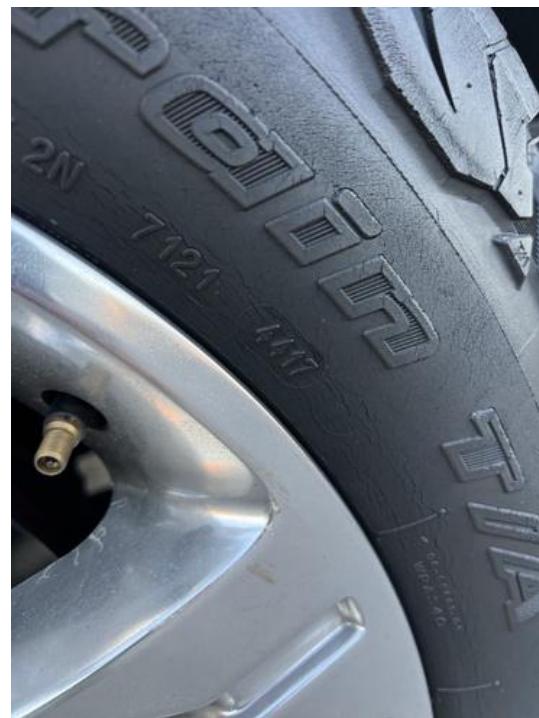
0-25 % remaining

All four tires are soon going to be due for replacement. Tires are dated from 2017 and have less than 20% tread life remaining.

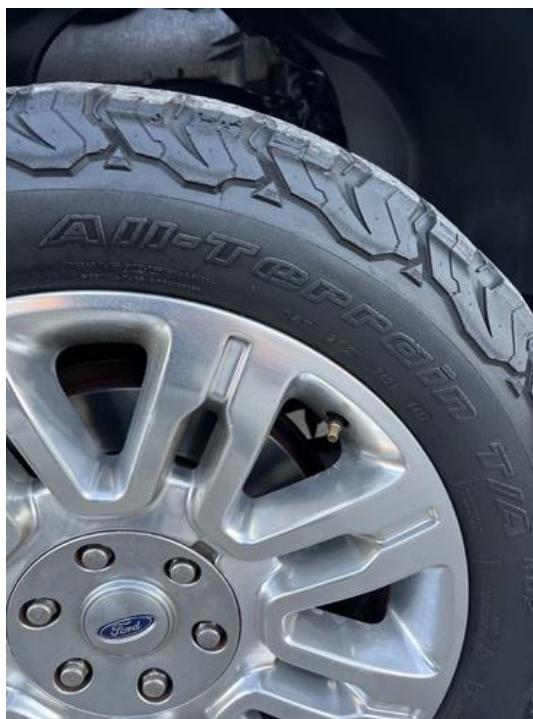
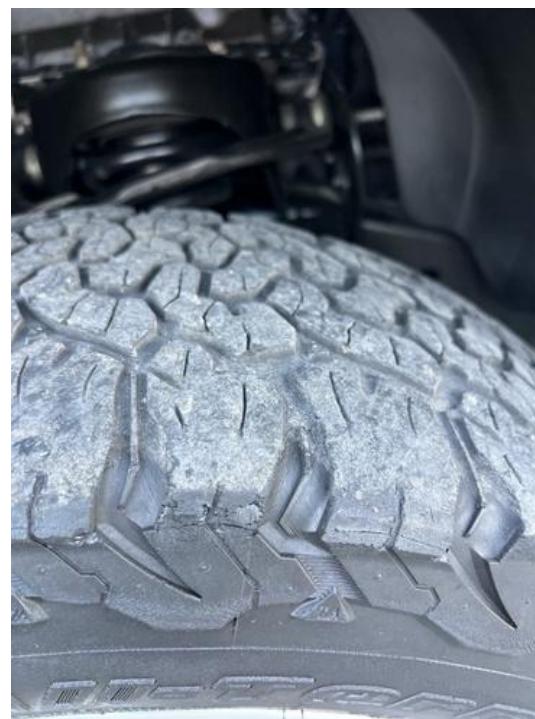
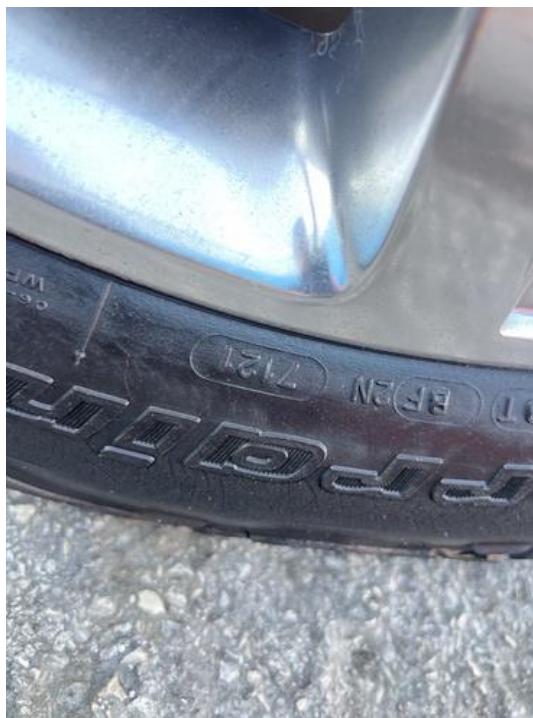
0-25 % remaining

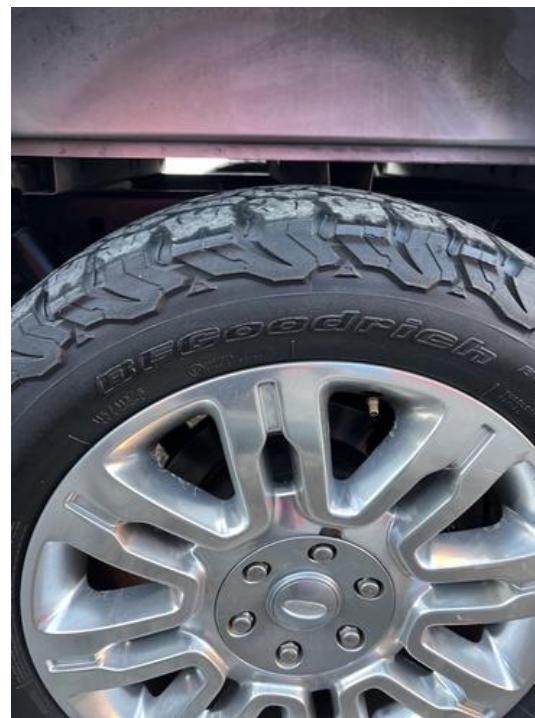
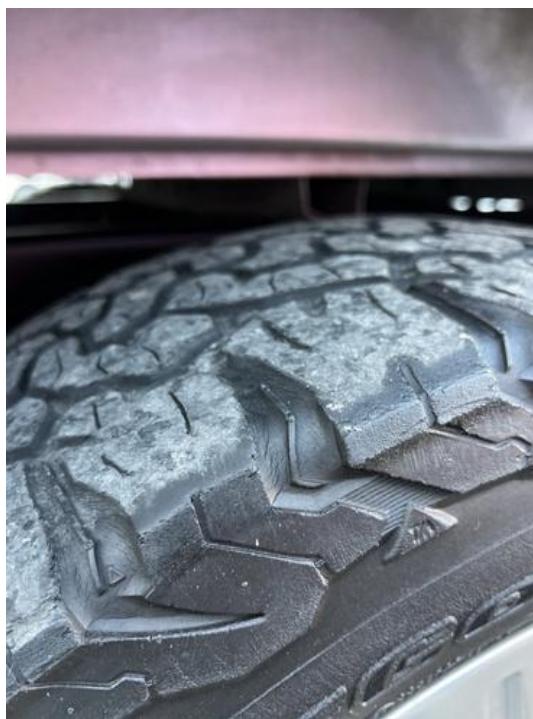
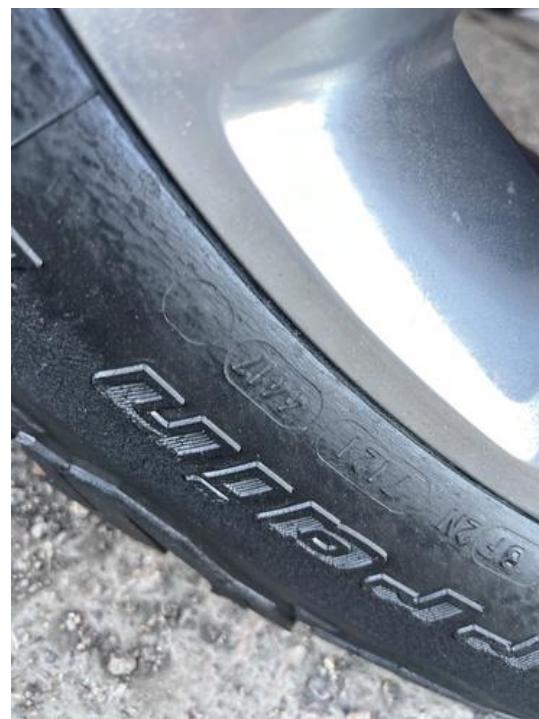
0-25 % remaining

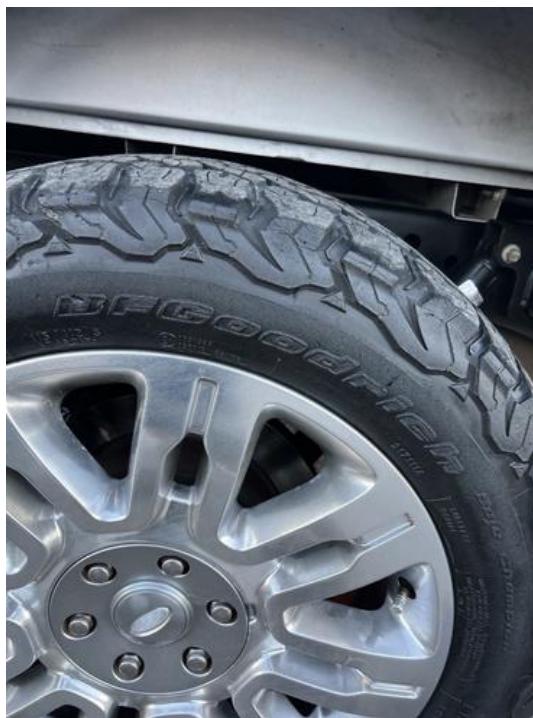
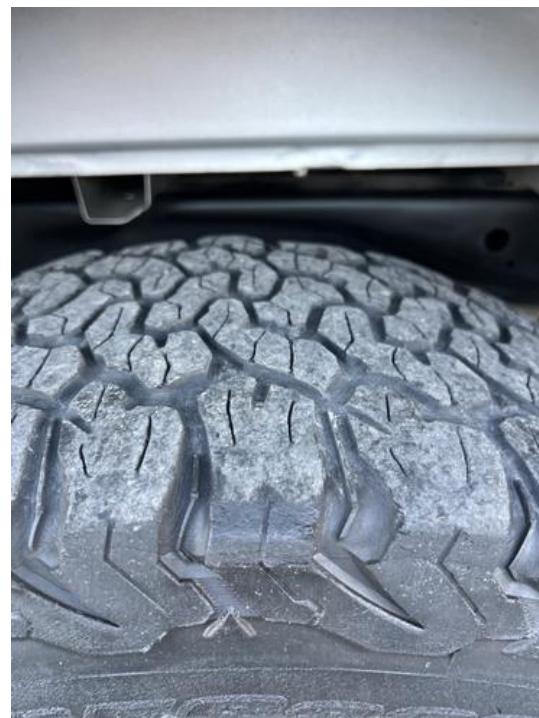
0-25 % remaining

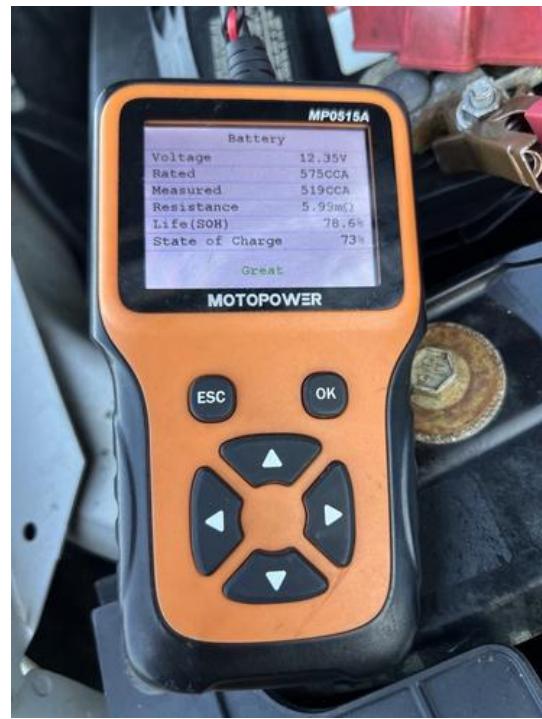
12.9

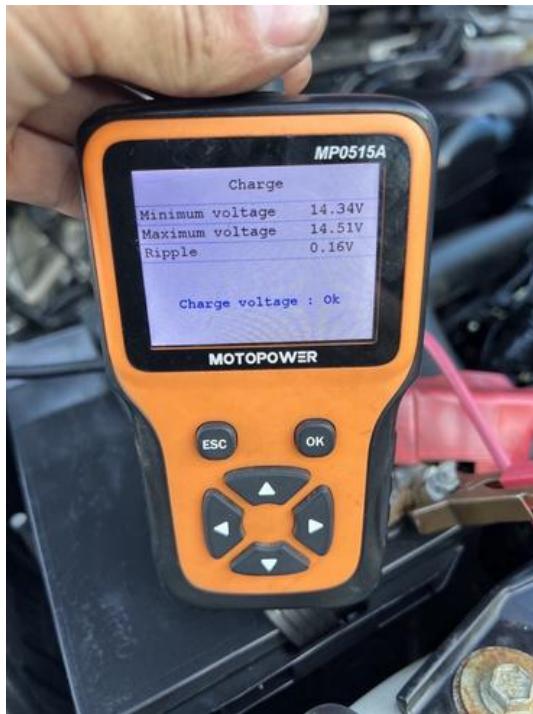
13.8

Battery is accepting the charge from the alternator and the alternator charge output is correct

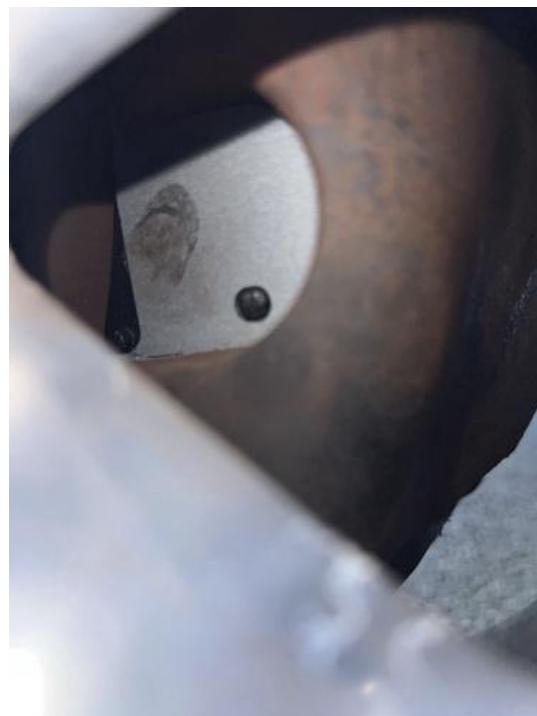
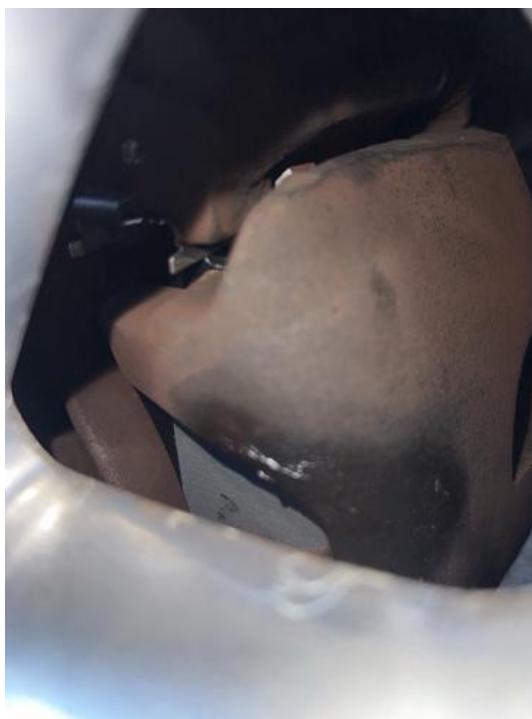
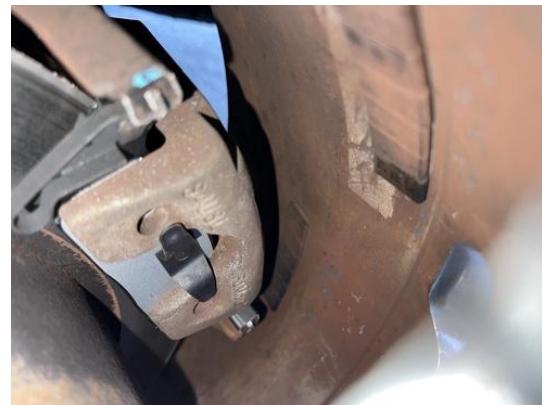
Recent service to both the front and rear brake system. The brake pads have just been replaced on both the front and rear.

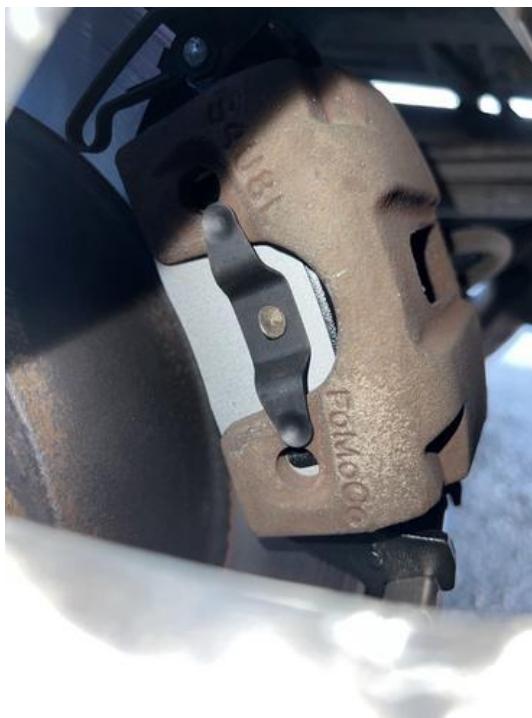
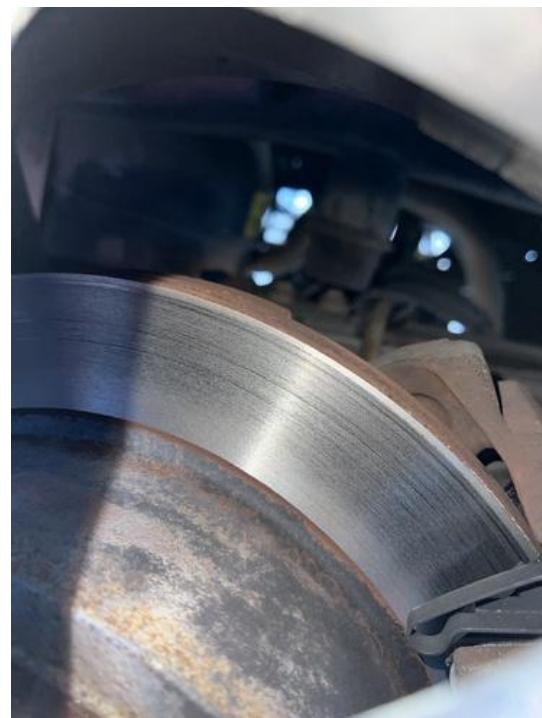
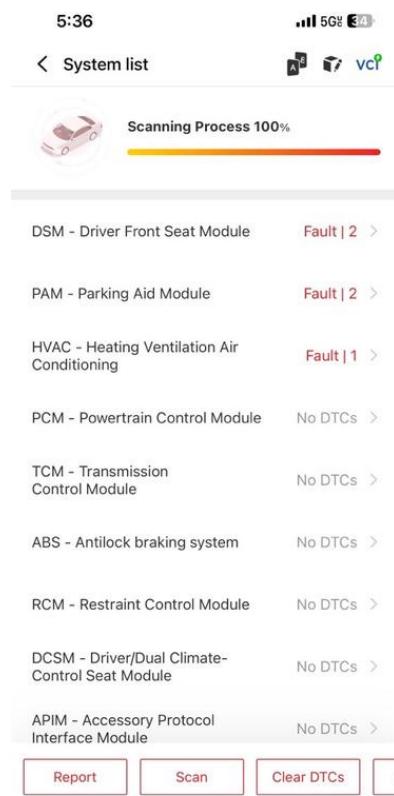
75-100% remaining
