# Peace of Mind Automotive Inspection Report.

Score	4 / 4 (100%)	Flagged items	1	Actions	0
<b>Site conducted</b>					Unanswered
<b>Customer name</b>					Luis LMJ auto motor sales
<b>Date / Time</b>					Jan 21st
<b>Payment method</b>					Invoice
<b>Inspection cost</b>					199
<b>Vehicle Year / Make / Model / Color</b>					2010 ford f150 kR
<b>VIN</b>					11144 last 5

<b>license plate</b>					Dealer
<b>Mileage</b>					117679
<b>Color</b>					Maroon

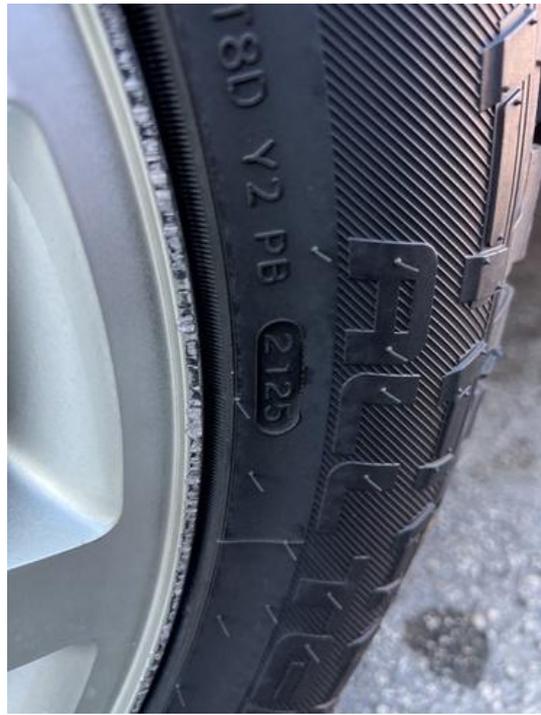
Photo 126

All four tires are matching and in healthy condition. Tires are dated from 2025 and are evenly worn. There is right around 70% tread life remaining on all four tires.

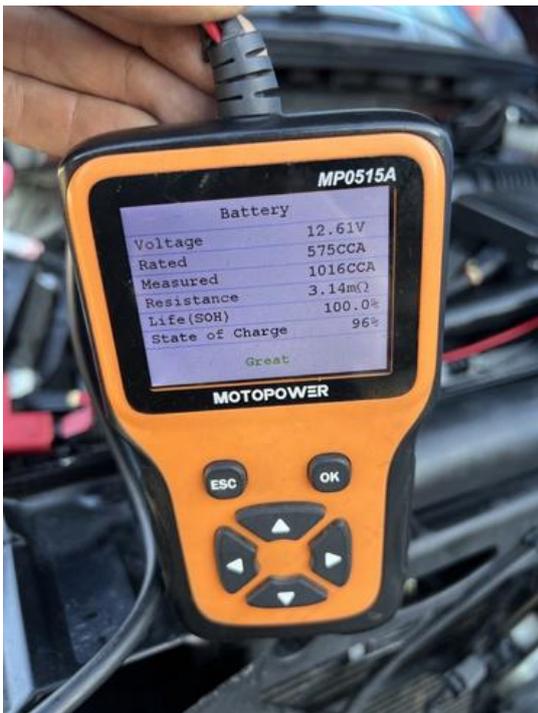
Photo 139

Battery is accepting the charge from the alternator and the alternator charge output is correct

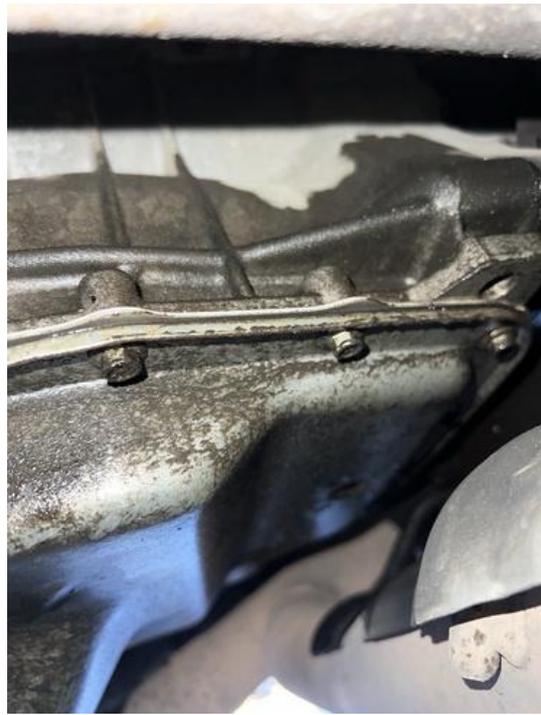
Photo 160

Small amount of transmission fluid leak out notice from the transmission pan gasket area, future replacement of the transmission pan gasket will be expected

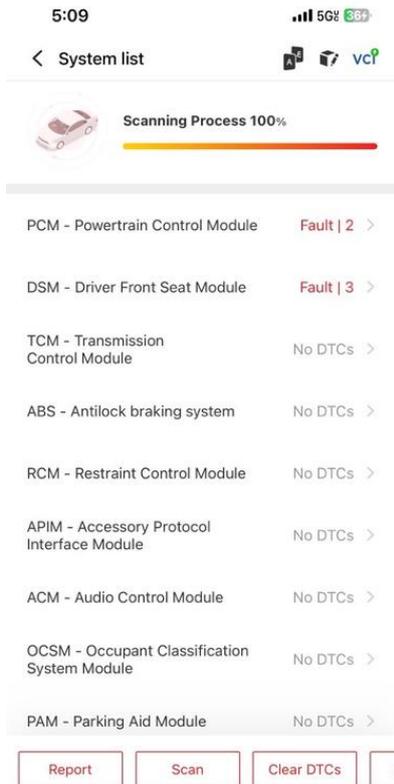
Photo 187

All of the control modules on the vehicle were free of any live/active diagnostic fault codes. All live feed diagnostic testing was successfully passed. There were a couple of different historic/non-active diagnostic fault codes present. No attention is needed for the historic fault codes.
