# Peace of Mind Automotive Inspection Report.

Score	4 / 4 (100%)	Flagged items	0	Actions	0
<b>Site conducted</b>					Unanswered
<b>Customer name</b>					Luis LMJ auto motor sales
<b>Date / Time</b>					May 18th
<b>Payment method</b>					Invoice
<b>Inspection cost</b>					Fleet
<b>Vehicle Year / Make / Model / Color</b>					2011 ford f150 limited
<b>VIN</b>					83091 last 5

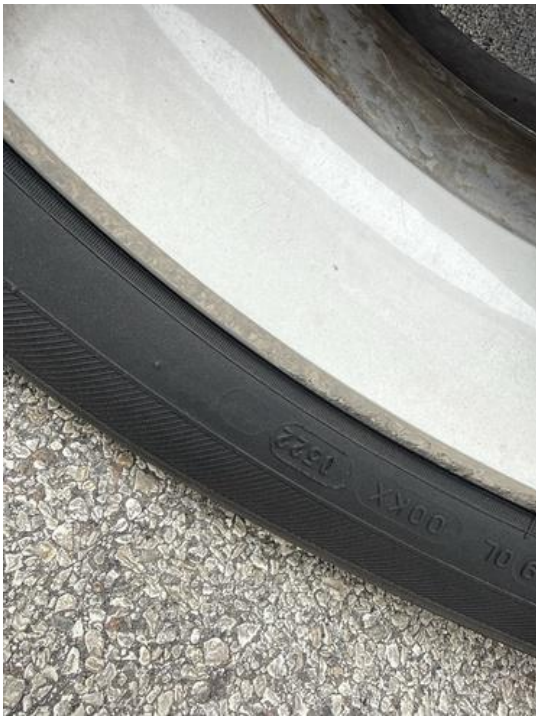
Photo 161

Dealer has replaced all four tires on the vehicle. All four tires are brand, new and matching all around.

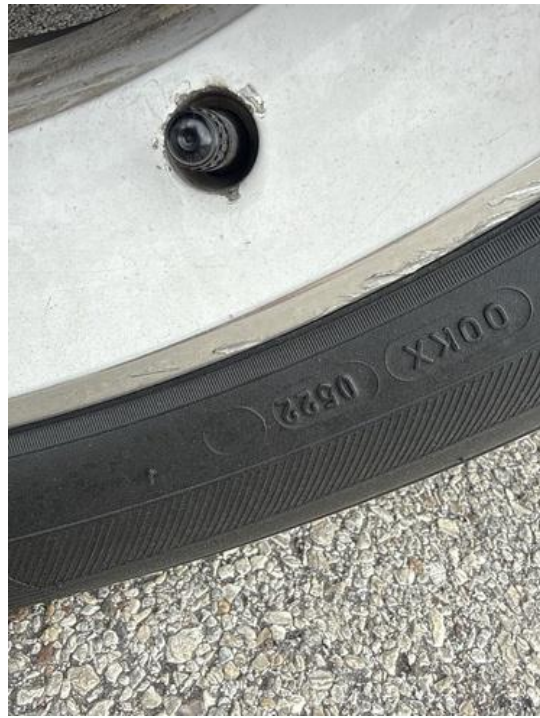
Photo 166

75-100% remaining

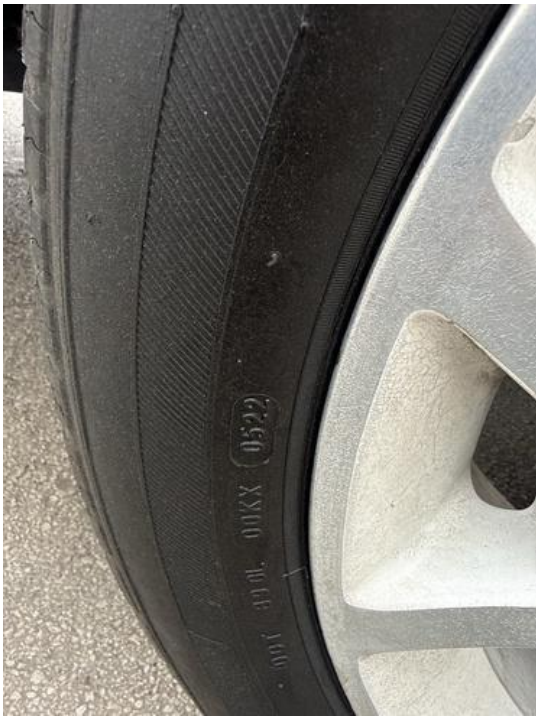
Photo 169

75-100% remaining

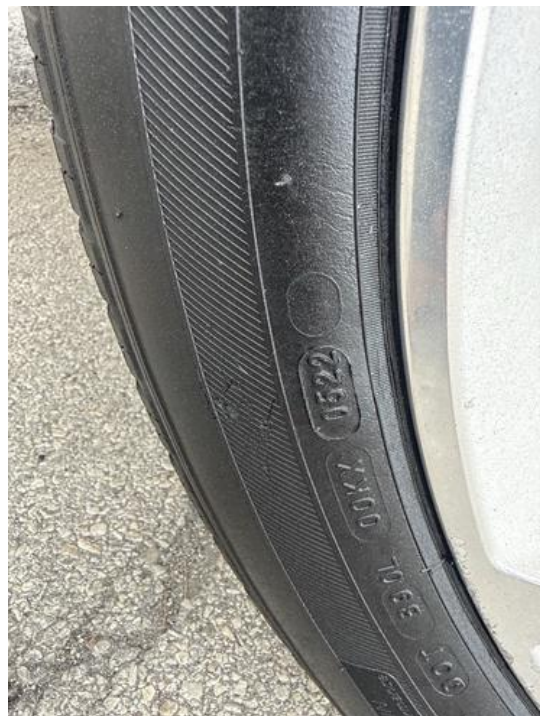
Photo 172

75-100% remaining

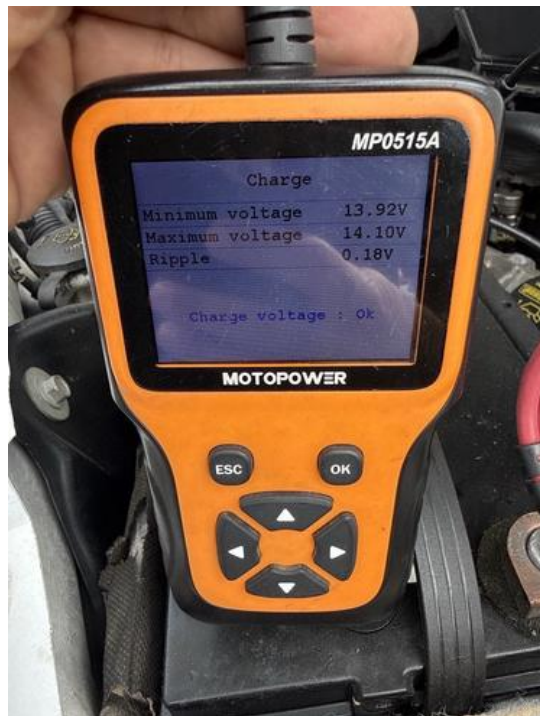
Photo 176

Battery is accepting the charge from the alternator and the alternator charge output is correct

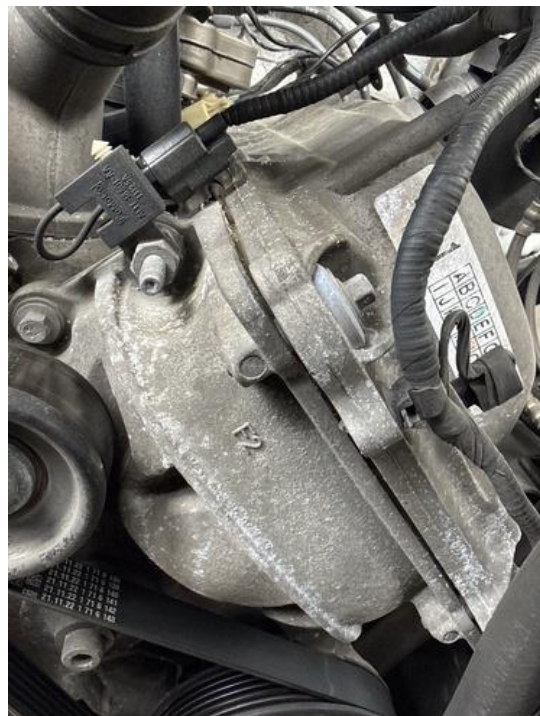
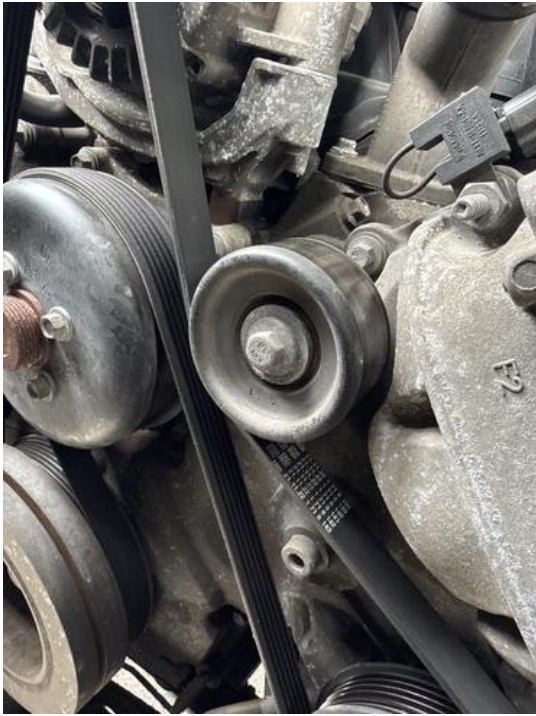
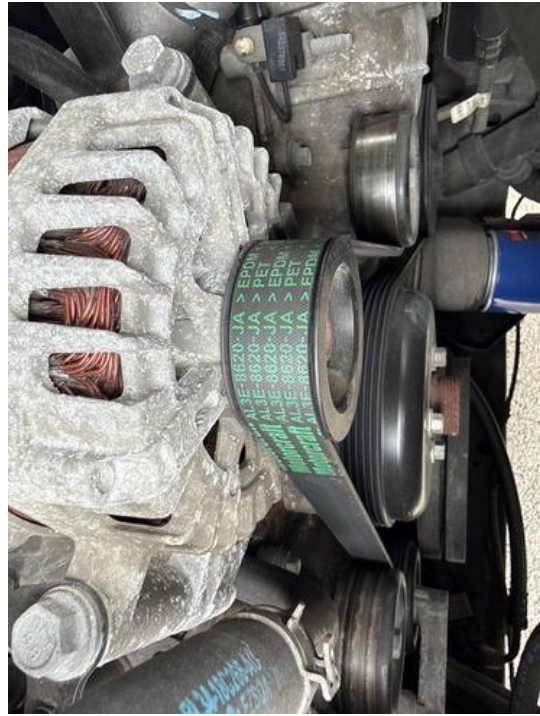
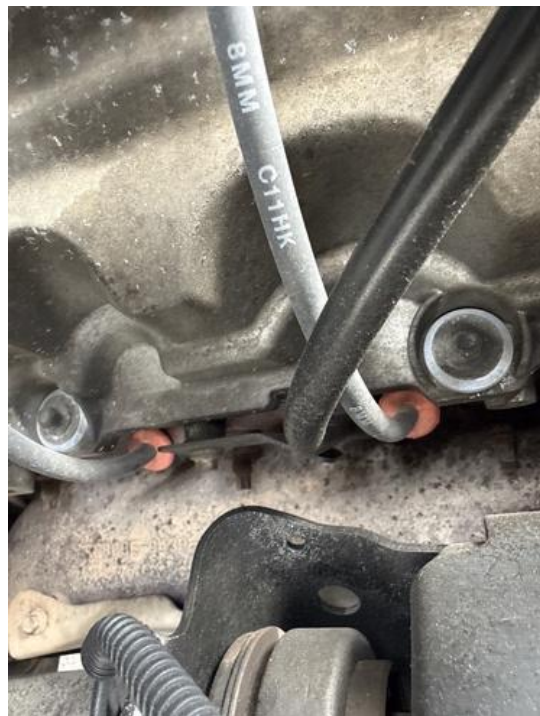
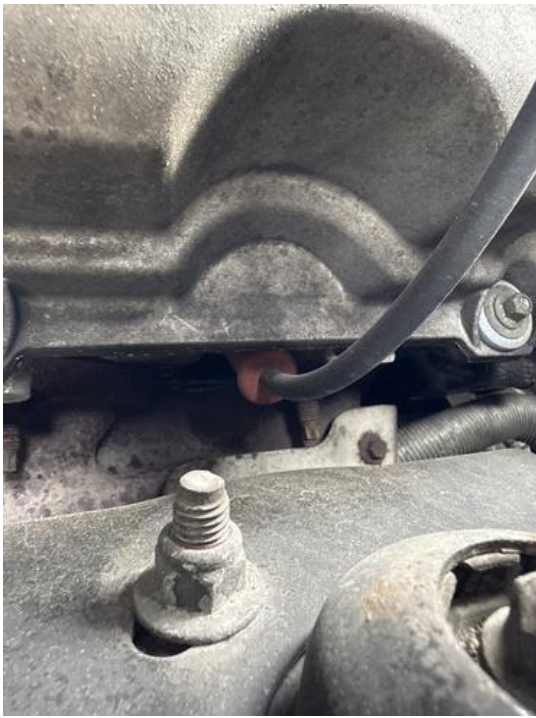
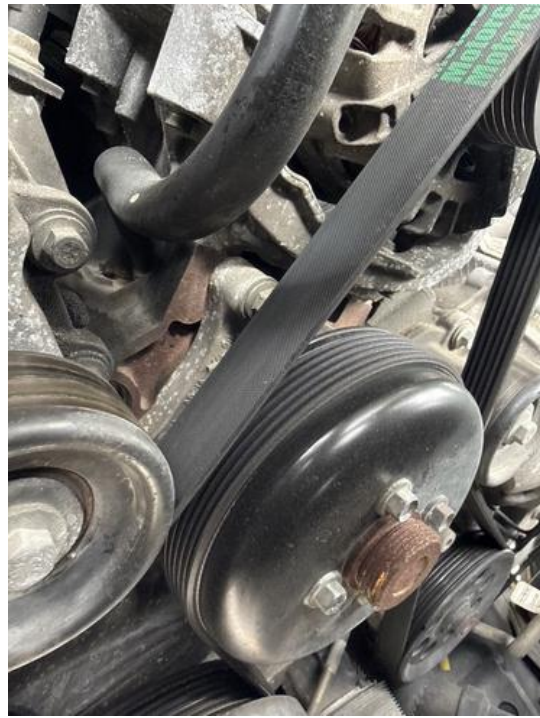
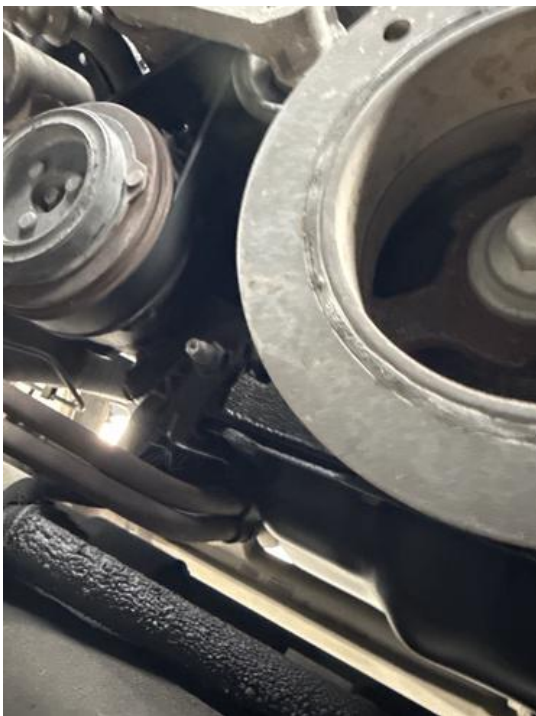
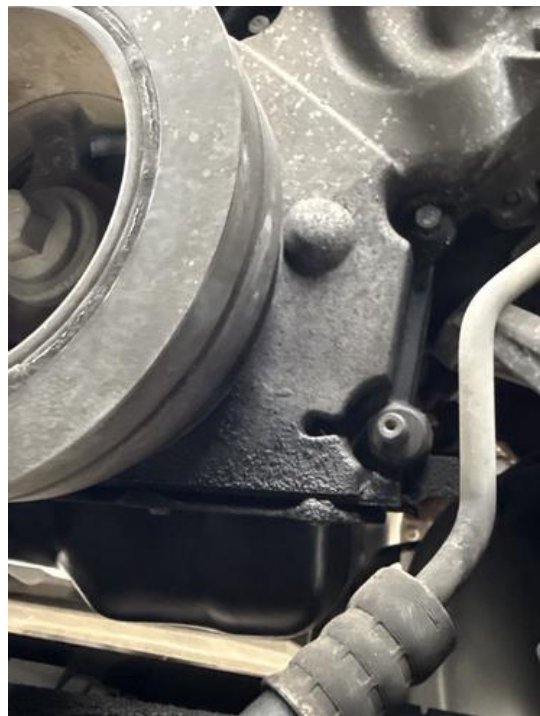
Engine clean internally, no gunk or sludge presents. Proper signs of maintenance present. Block test passed, no internal combustion leak out. Coolant mixture correct and cooling system functionality is healthy. All external engine accessories in good working. No leaks or seepage from anywhere on the engine. External drive belts in decent condition. Currently no concern in mechanical issues present in relation to the engine or related accessories.

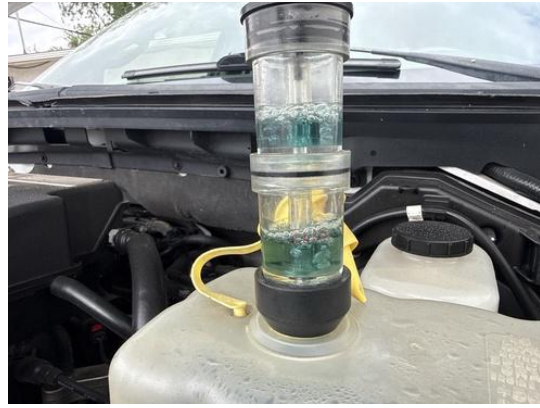
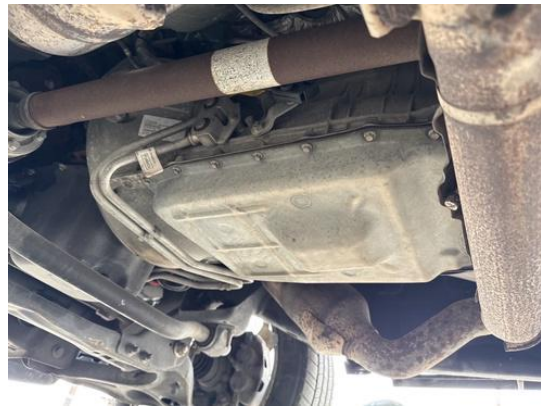
No transmission fluid leaks from the transmission casing or the transmission pan area. The tail shaft seal is free of any fluid leaks. The driveshaft is in healthy condition. Shift transitions out on the road are correct across the board. No fluid leak out from the rear differential. No fluid leak out from the front differential or the center differential. 4 x 4 system functionality is correct.

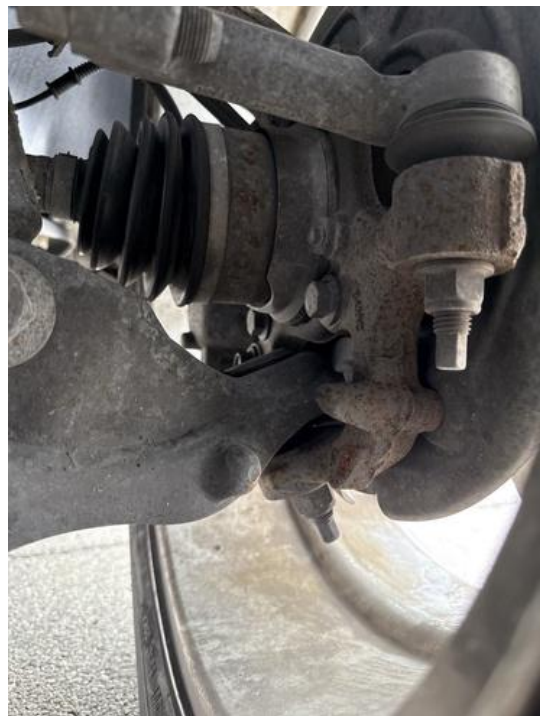
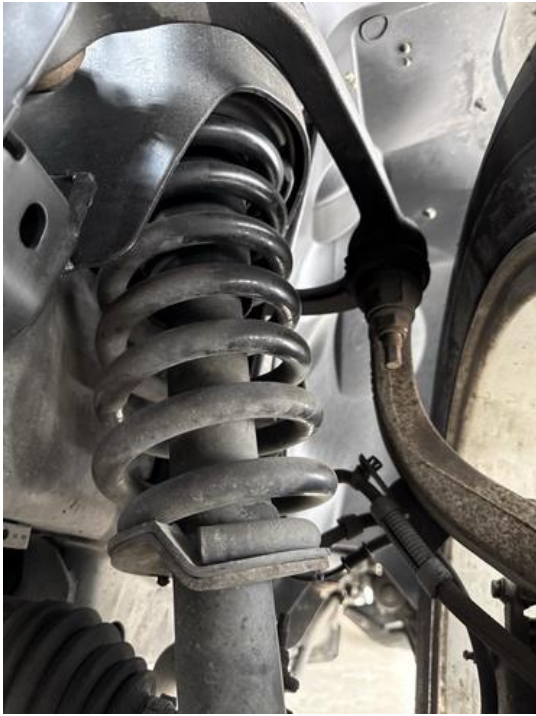
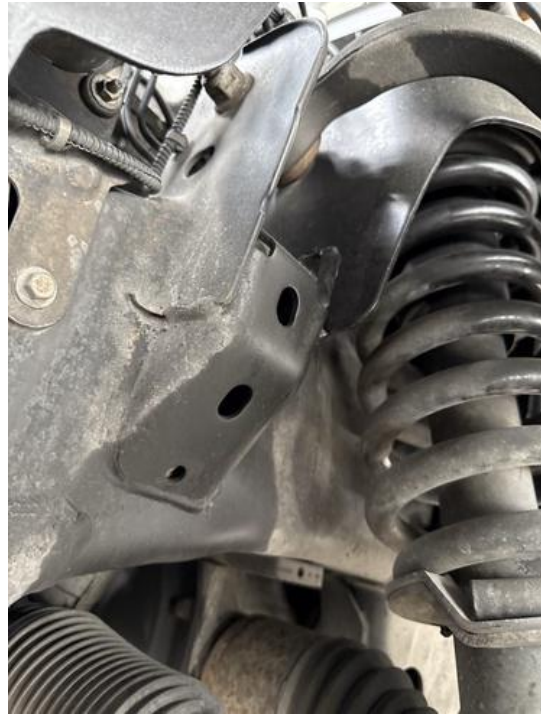
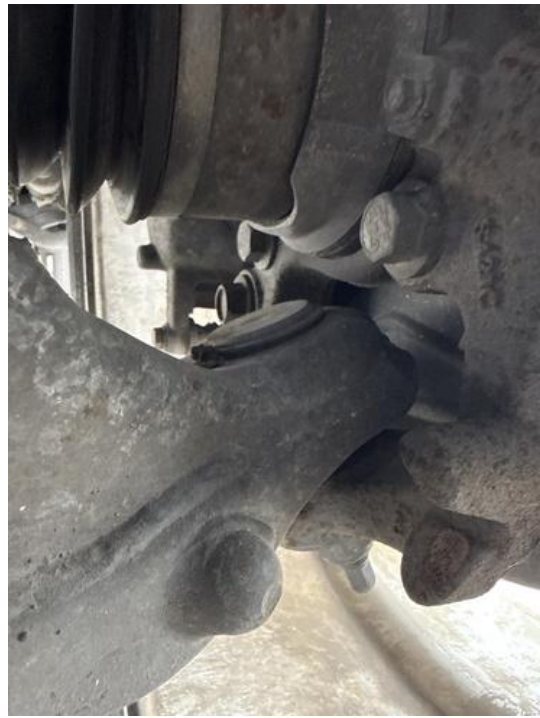
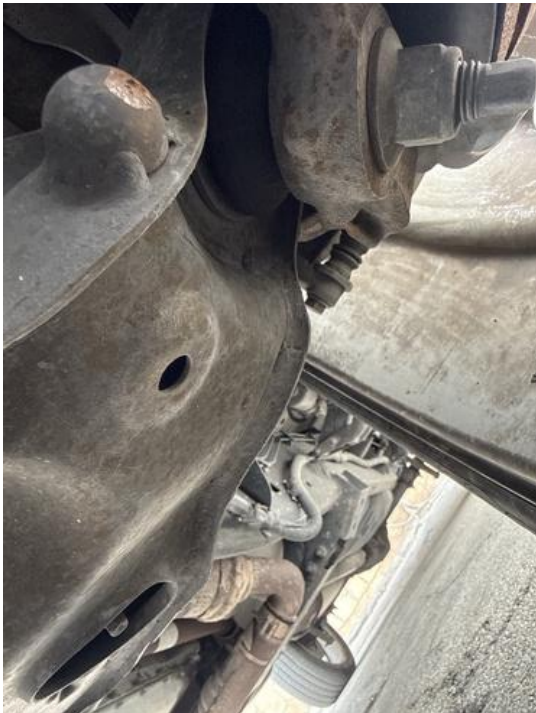
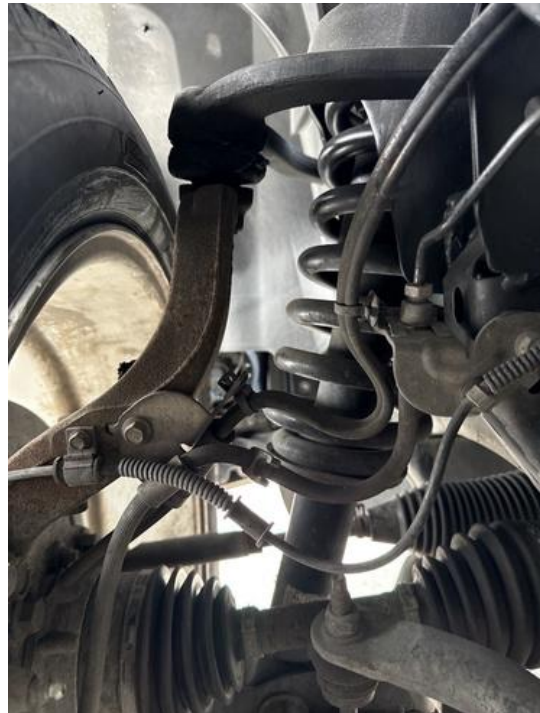
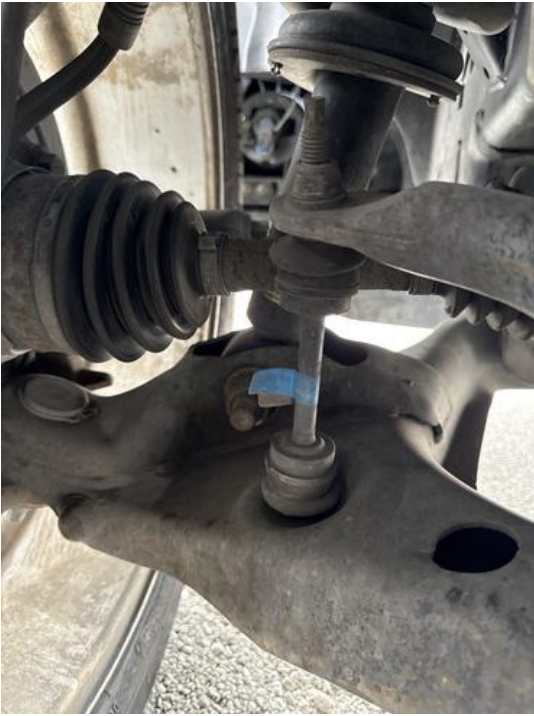
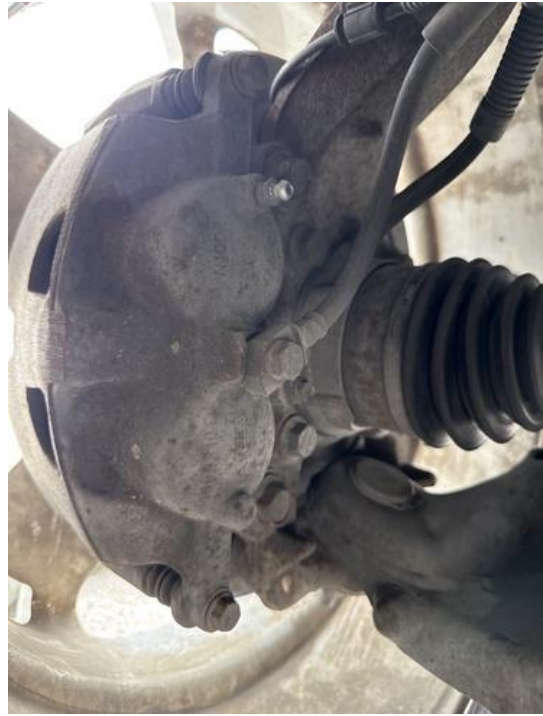
Normal fatigue notice to the suspension components. All of the suspension components seem to be original. None of the suspension components are blown out and due form the replacement. The No excessive surface rust on the exposed metal. No abnormal noise or feedback from the suspension while out on the road. All of the rubber in relation to the mounts, joints and bushings has decent texture.

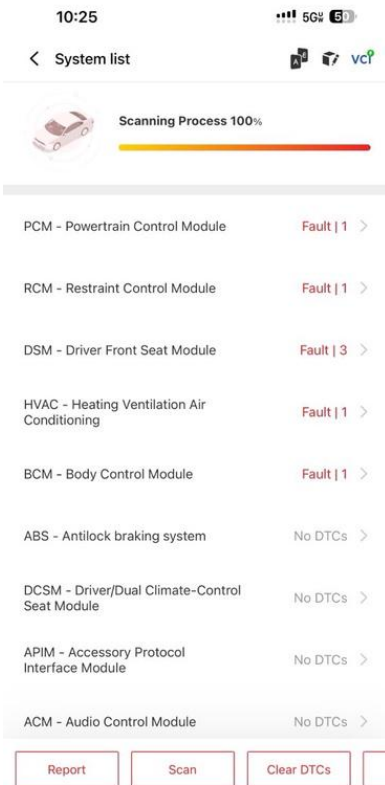
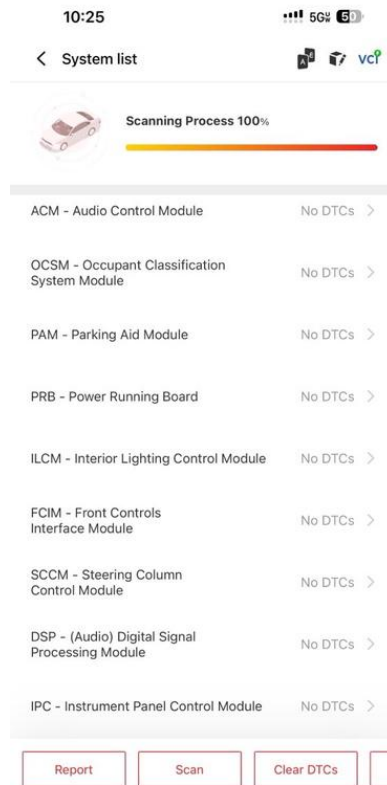
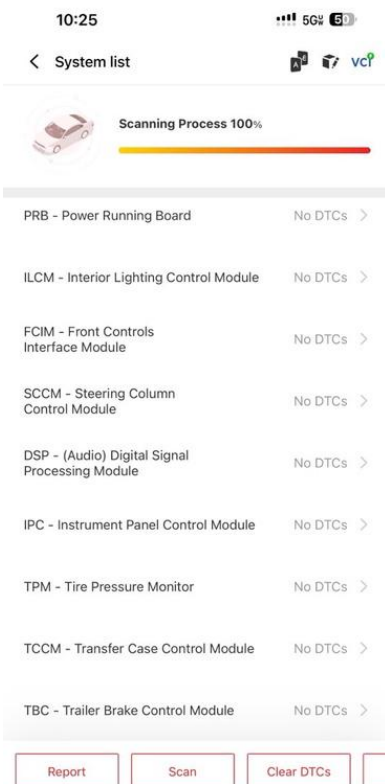
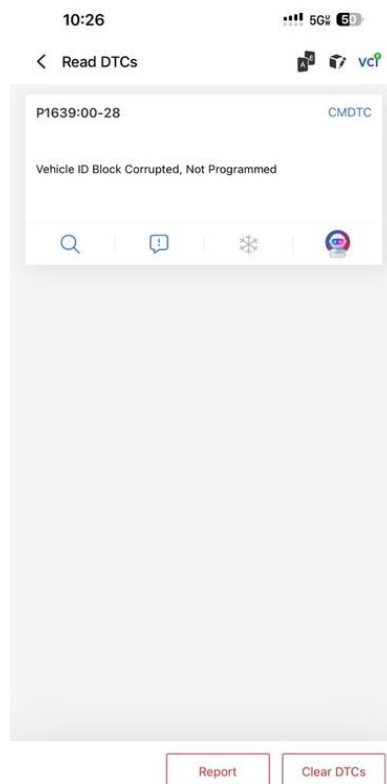
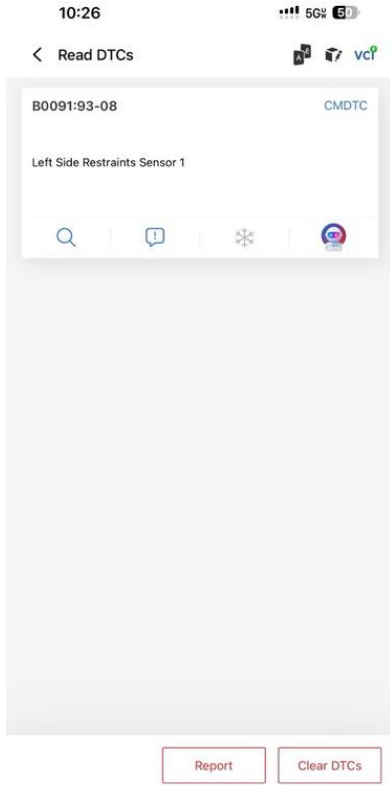
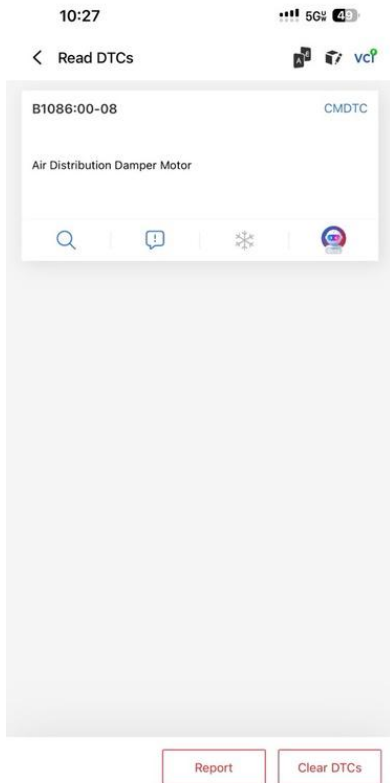
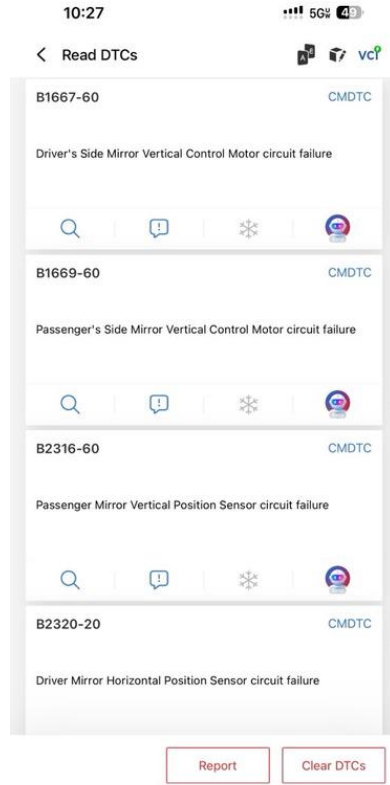
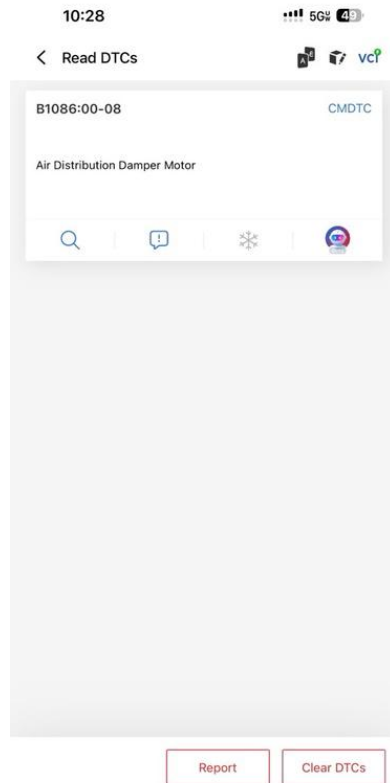
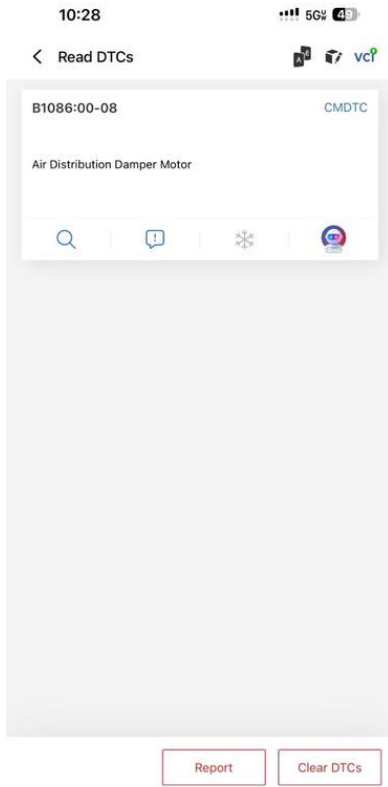
All of the main control modules on the vehicle we're free of any live/active diagnostic fault codes. All live feed diagnostic test testing with successfully passed. All live feed emission test testing was successfully passed. There were a couple of historical/non-active diagnostic fault codes present across a couple of different control modules on the vehicle. No attention is needed for the non-active fault codes. This is just evidence of fault codes that have popped up in the past.
