Peace of Mind Automotive Inspection Report.

Score	4 / 4 (100%)	Flagged items	1	Actions	0
Site conducted					Unanswered
Customer name					Luis LMJ auto motor sales
Date / Time					Jan 21st
Payment method					Invoice
Inspection cost					199
Vehicle Year / Make / Model / Color					2011 Honda CRZ
VIN					15650 last 5

license plate					Dealer
Mileage					122597
Color					White

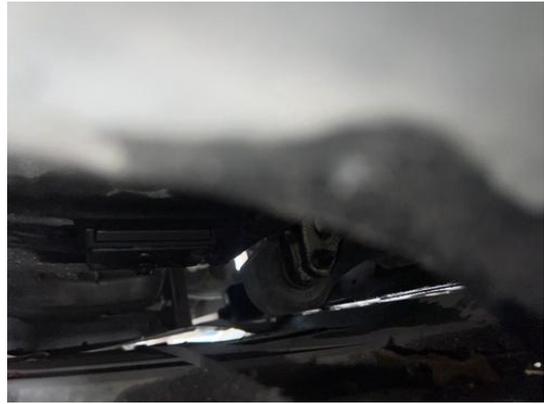
Photo 156

There is a small amount of transmission fluid leak out notice from the driver side of the differential, where the CV axle inserts, fluid leak out could potentially be coming from the axle seal itself, or from the different different differential casing.
