# Peace of Mind Automotive Inspection Report.

Score	4 / 4 (100%)	Flagged items	0	Actions	0
<b>Site conducted</b>					Unanswered
<b>Customer name</b>					Luis LMJ auto motor sales
<b>Date / Time</b>					April 6th
<b>Payment method</b>					Invoice
<b>Inspection cost</b>					Fleet
<b>Vehicle Year / Make / Model / Color</b>					2012 Chevy Camaro
<b>VIN</b>					66757 last 5

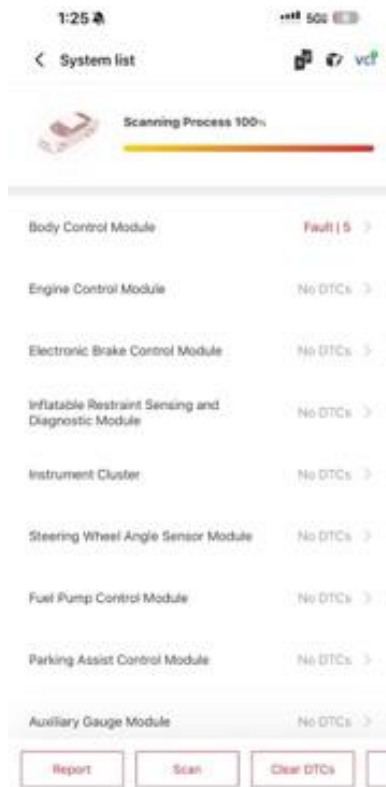
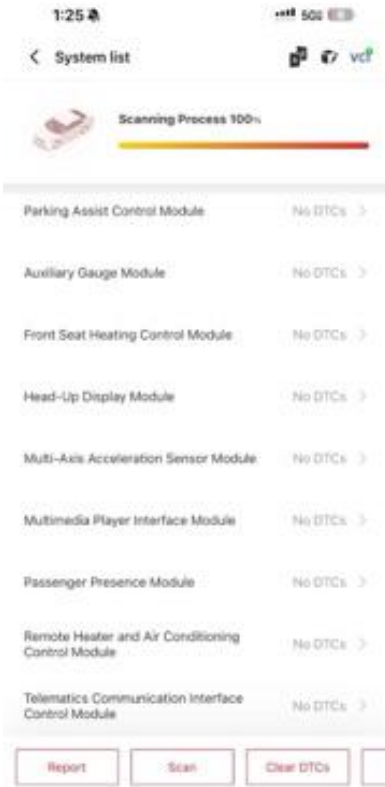
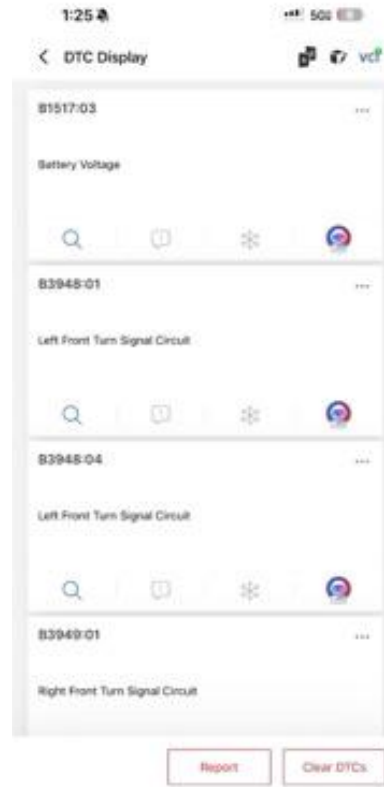
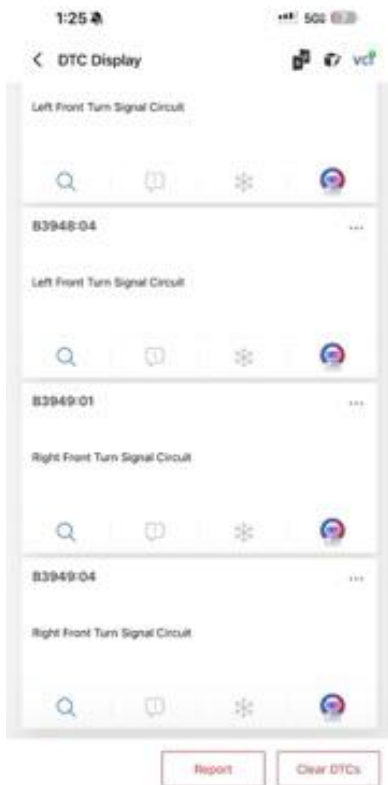
All of the main control modules on the vehicle were free of any live/active diagnostic fault codes. All live feed diagnostic testing was successfully passed. At the time of the inspection, there were no active warning lights present on the vehicle aside from the fault codes in relation to the aftermarket headlights / turn signal.

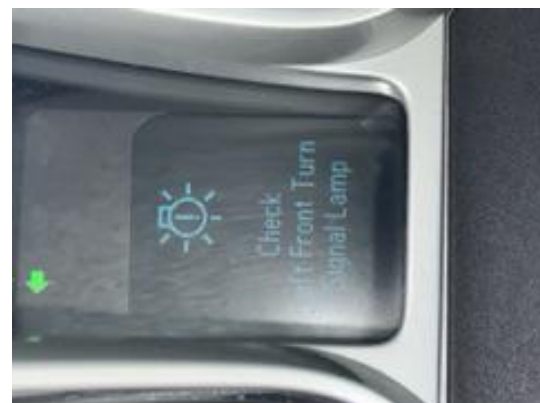
All of the blinkers are functioning correctly, however when engaging the left and right side blinker after a couple of blinks, there is a error message displayed saying that there is a fault with the blinker on both the left and right hand side. This is in relation to the aftermarket headlights and turn signals that are installed on the vehicle. The lighting control module is not communicating correctly with the aftermarket lighting.
