Peace of Mind Automotive Inspection Report.

Site conducted	Unanswered
Customer name	Luis Lmj auto motor sales
Date / Time	Dec 26th
Payment method	Invoice
Inspection cost	Fleet account
Vehicle Year / Make / Model / Color	2012 ford f250 6.7
VIN	61223 last 5

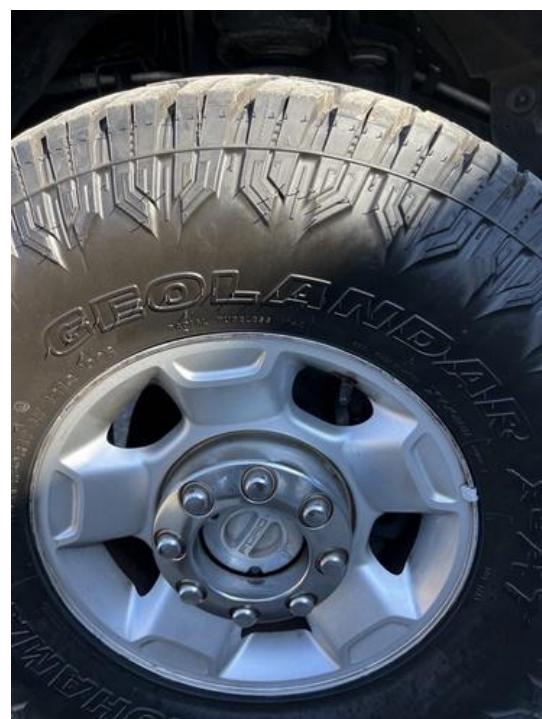
Photo 115

Front driver side tire

75-100% remaining

All four tires are in excellent condition, tires have been recently replaced. Tires are matching all around and have over 90% tread life remaining.

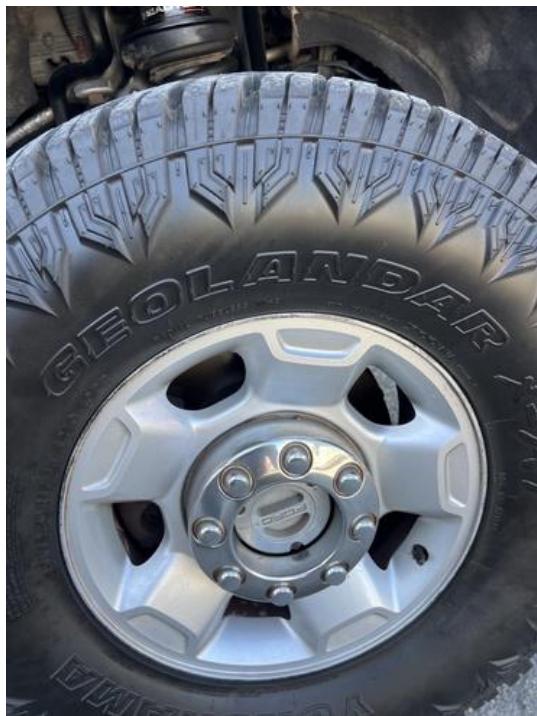
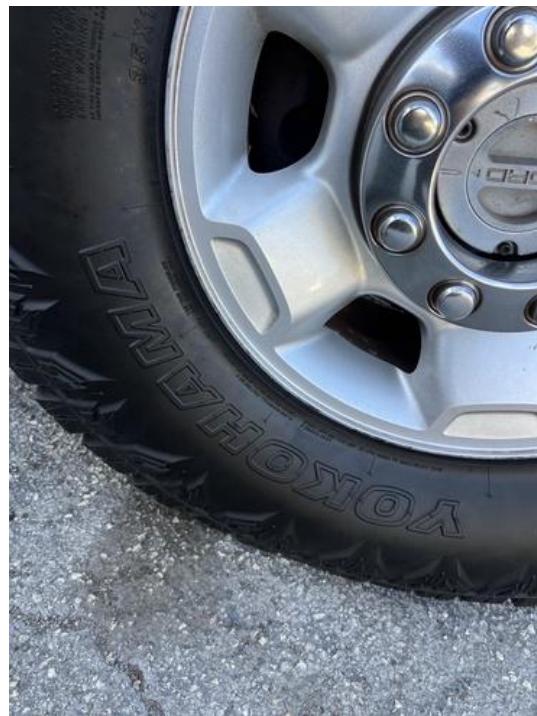
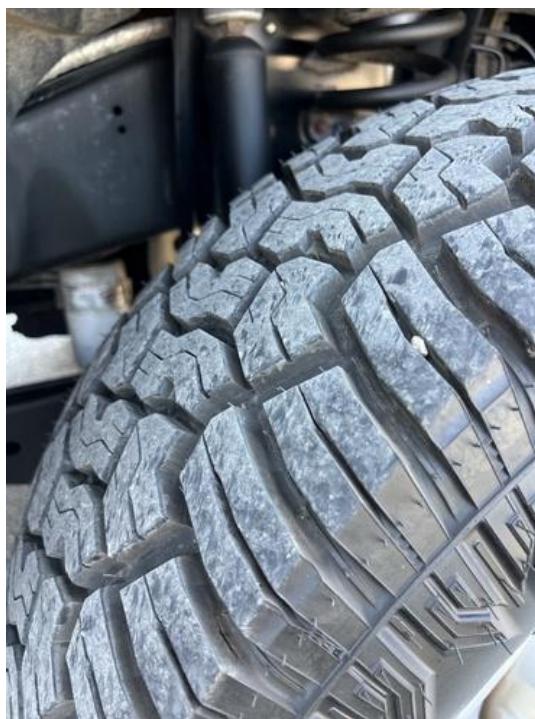
Photo 118

Front passenger side tire

75-100% remaining

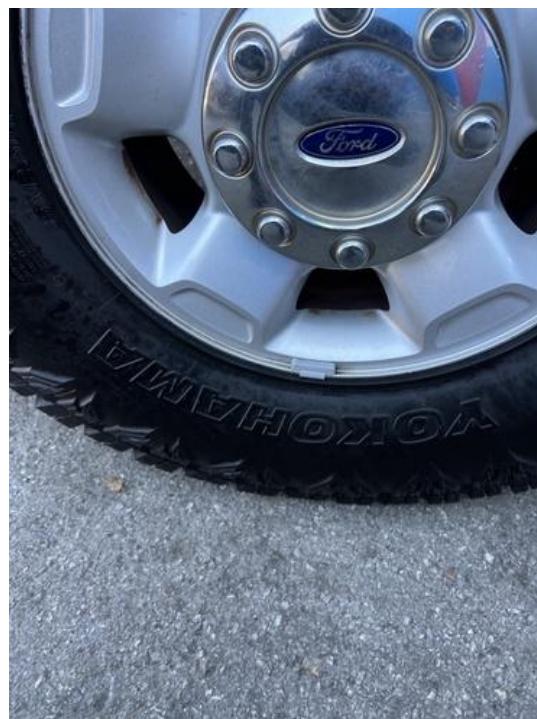
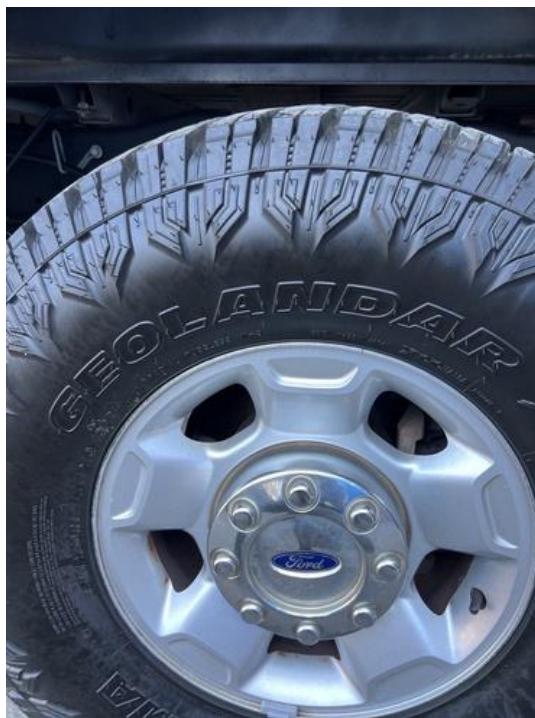
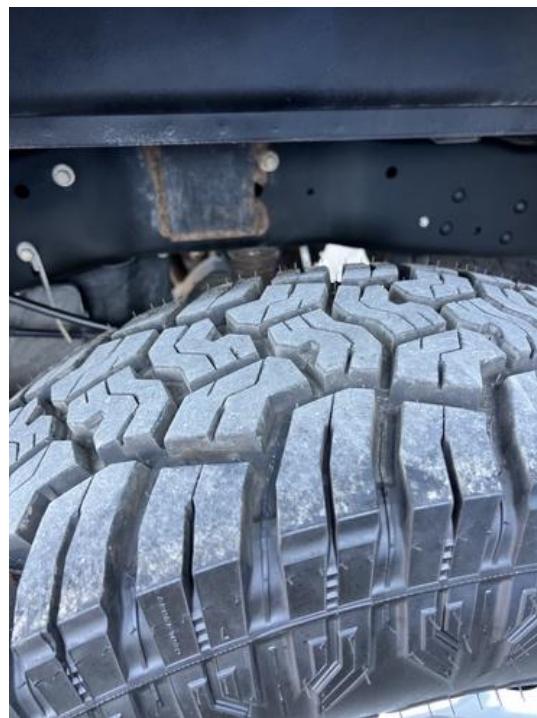
Photo 121

Rear driver side tire

75-100% remaining

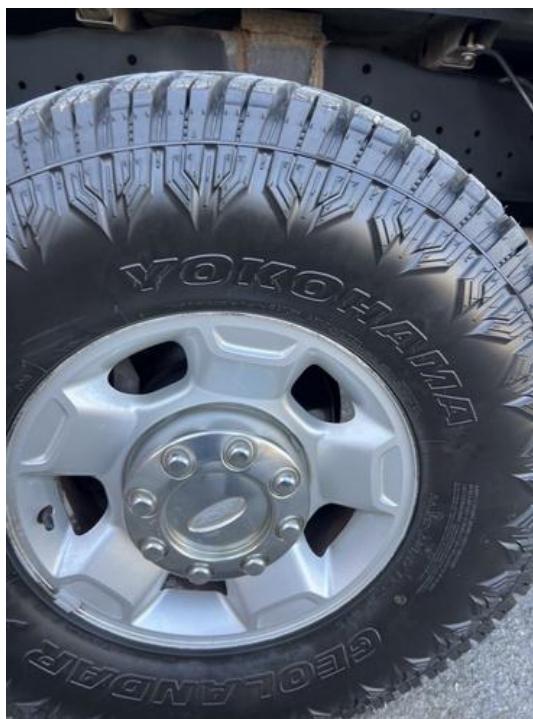
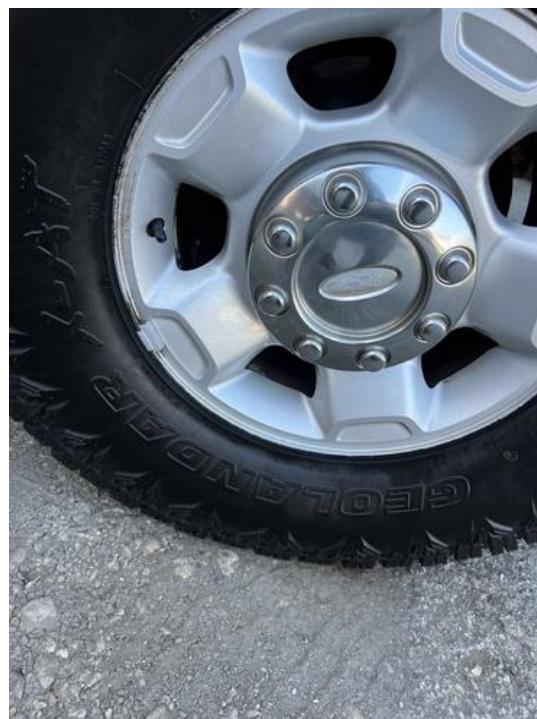
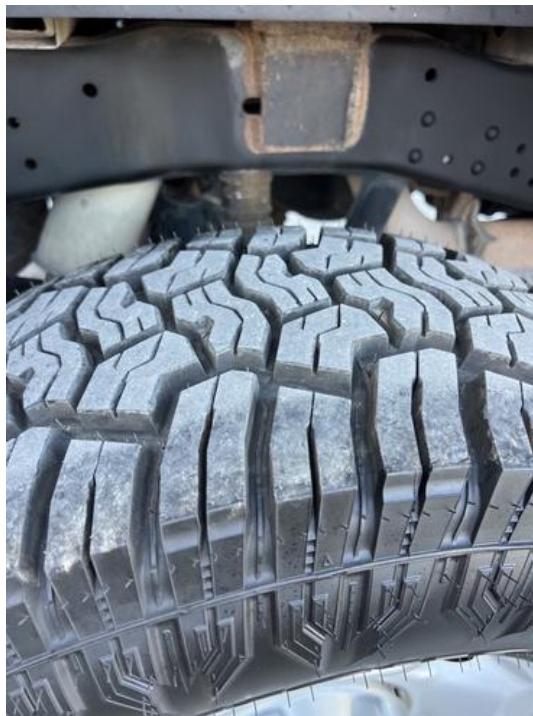
Photo 124

Rear passenger side tire

75-100% remaining

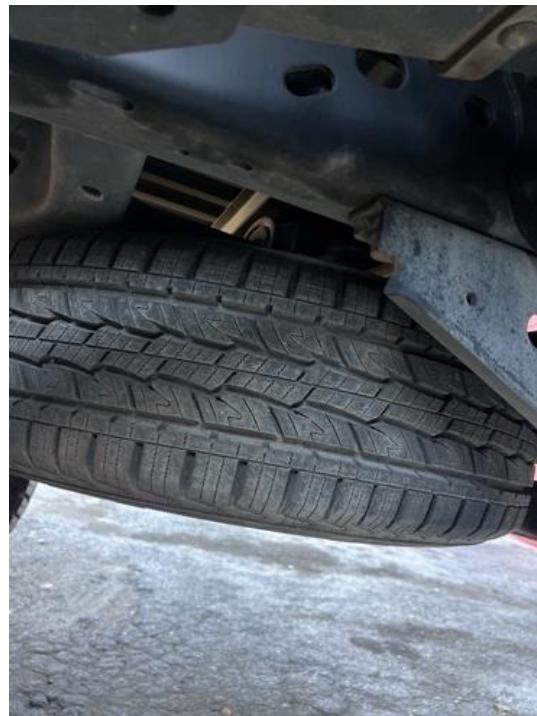
Photo 127

Spare tire and equipment

Spare and tools present

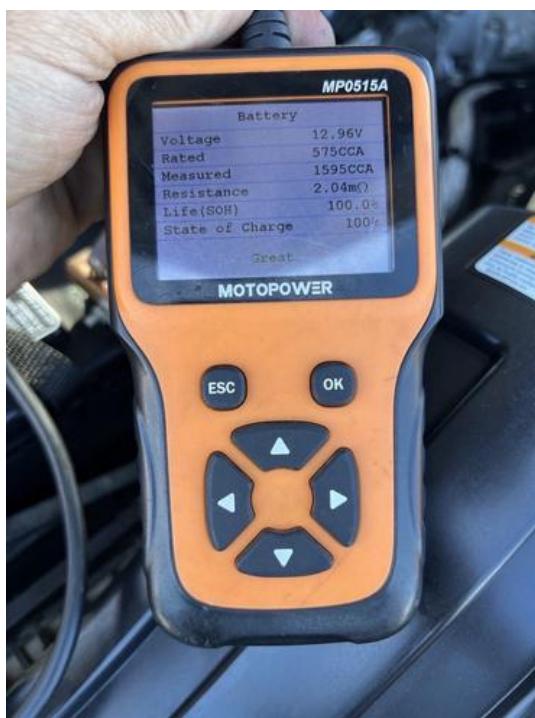
Photo 128

Standing voltage

12.9

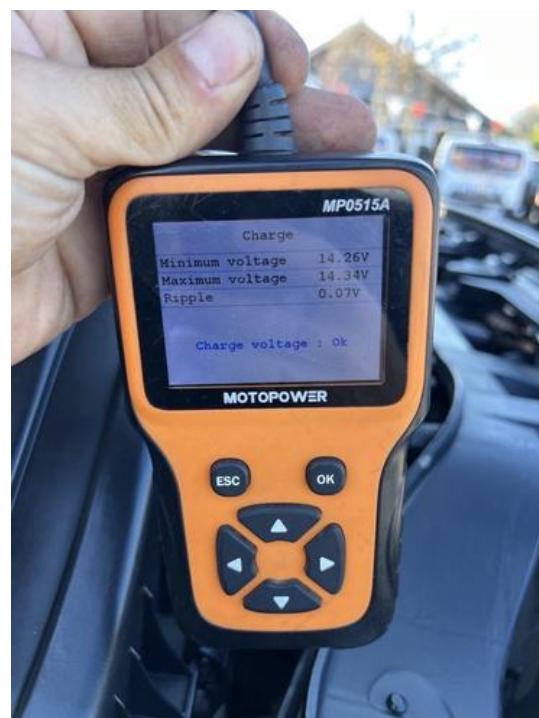
Photo 129

Loaded voltage

14.3

Battery is accepting the charge from the alternator and the alternator charge output is correct

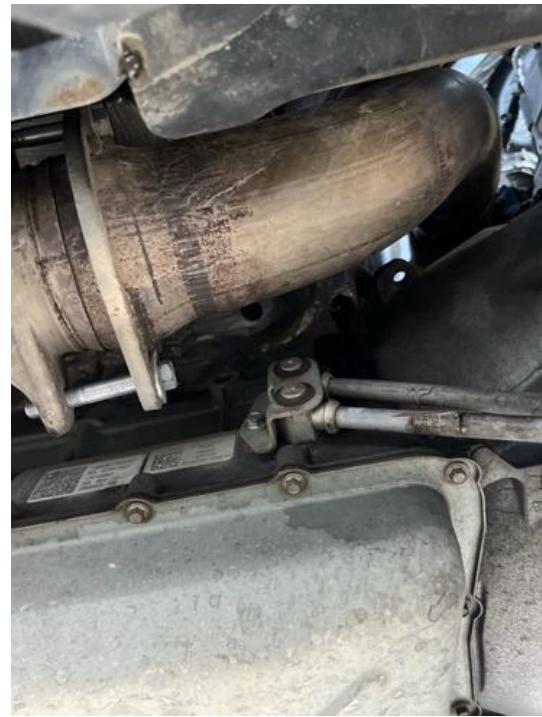
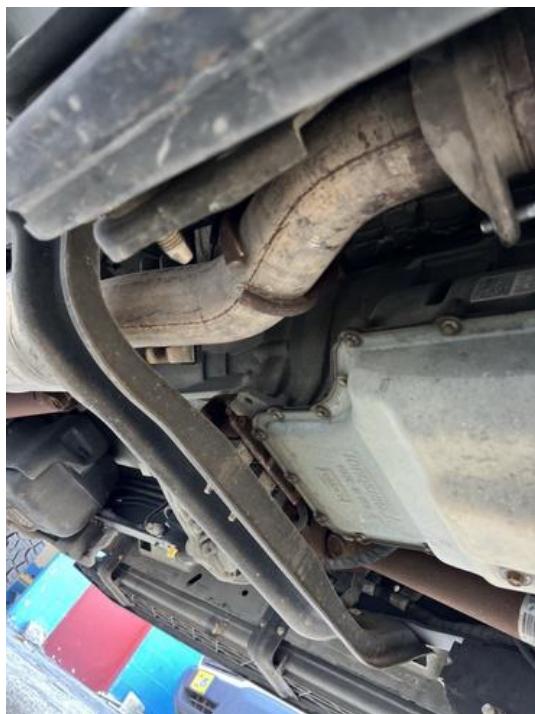
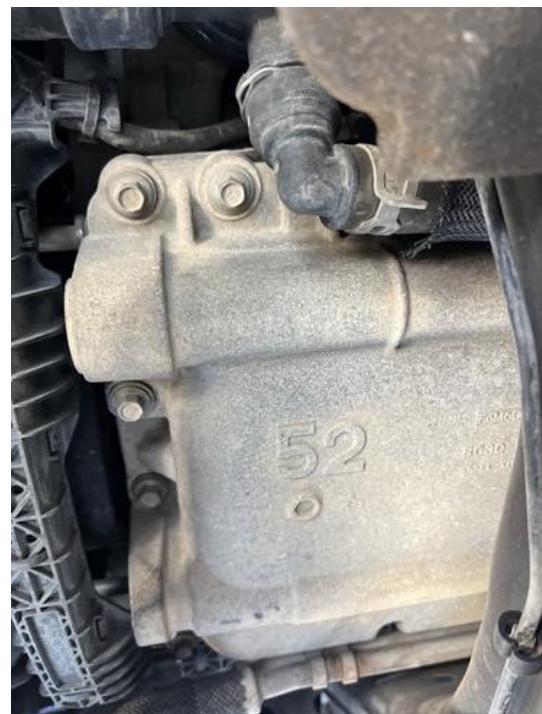
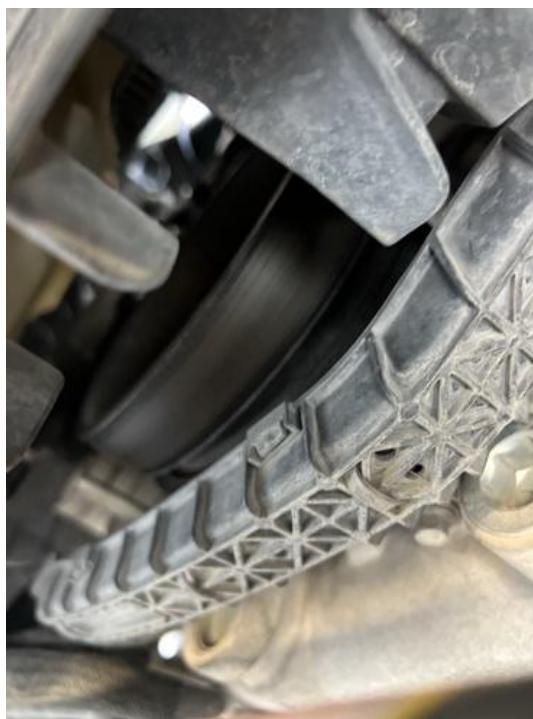
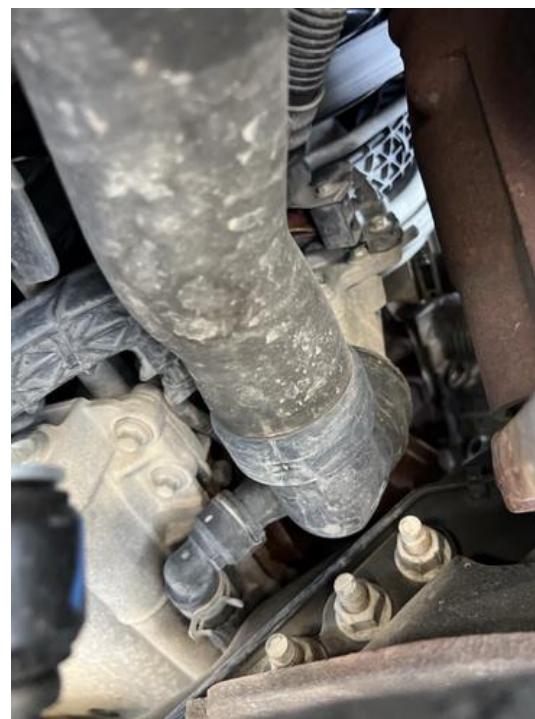
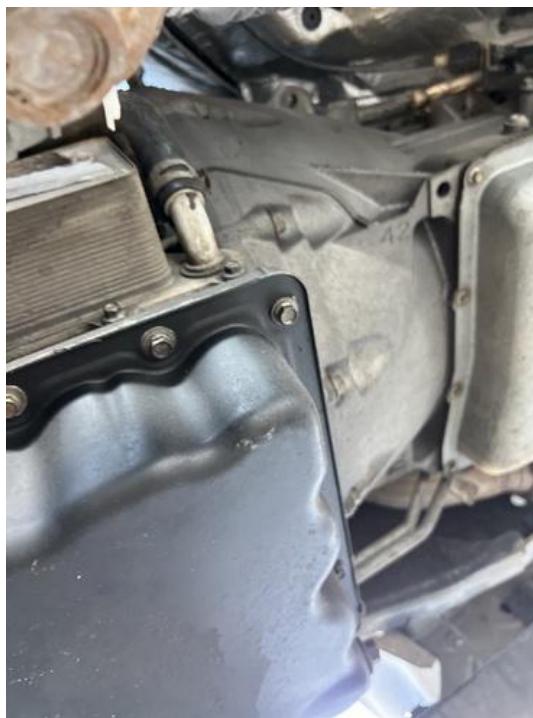
Engine clean internally, no gunk or sludge presents. Proper signs of maintenance present. Block test passed, no internal combustion leak out. Coolant mixture correct and cooling system functionality is healthy. All external engine accessories in good working. No oil leaks or seepage from anywhere on the engine. External drive belts in decent condition. Currently no concern in mechanical issues present in relation to the engine or related accessories.

Engine does have a few aftermarket components, the turbo inlet pipe has been replaced along with the heat exchanger for a nice aftermarket upgrade. The throttle body, the inlet as well as throttlebody adapter has been replaced with a nice metal pipe. The factory silicone pipes tend to tear so this is a nice upgrade. The EGR system has also been deleted, there are block off plates present. The factory converter is still in place/factory exhaust.

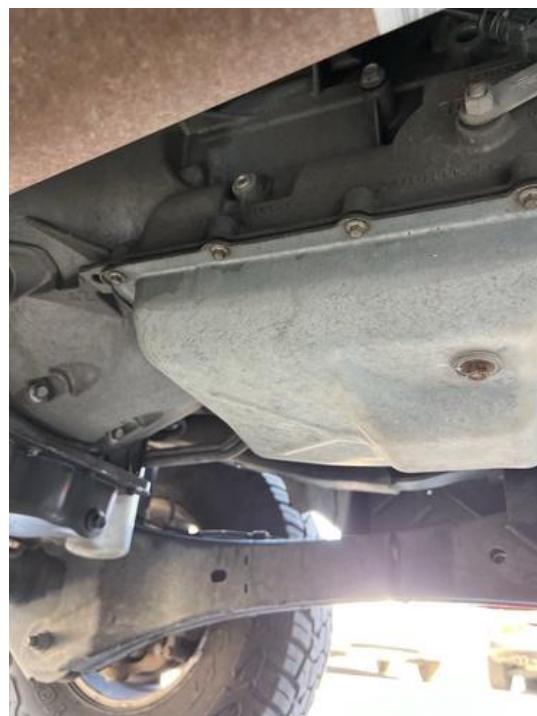
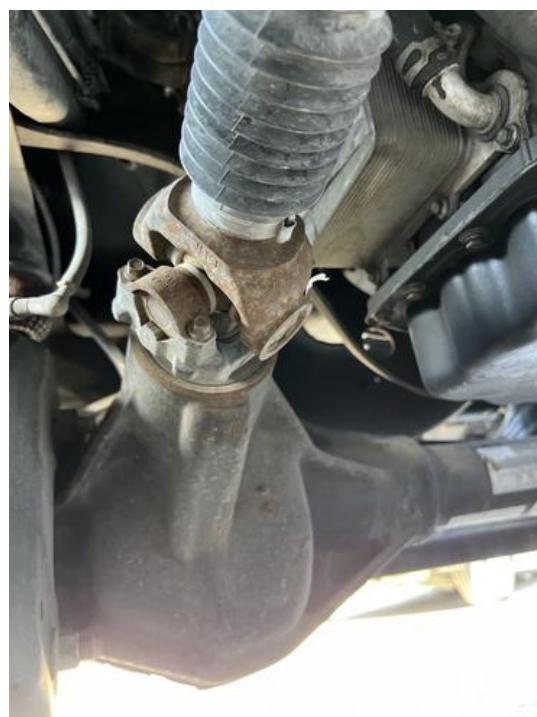
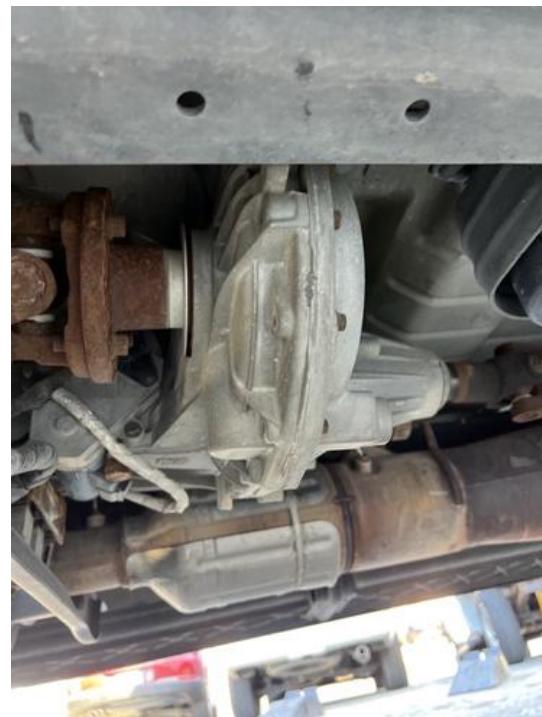
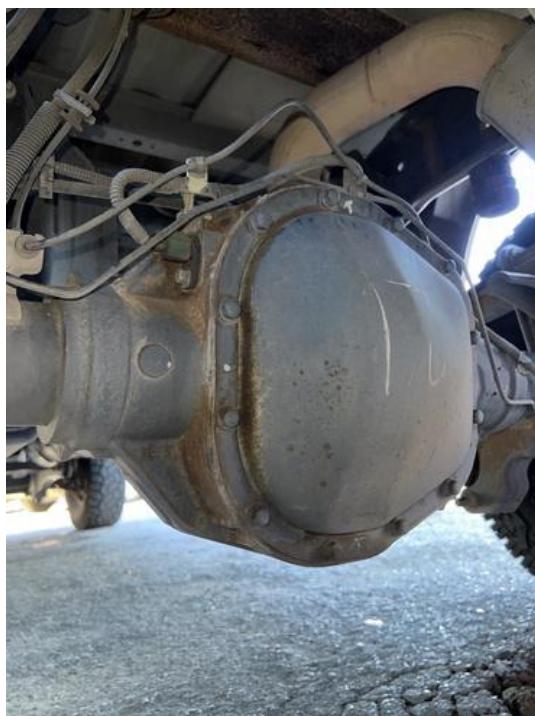
No transmission fluid leak out from the transmission casing or the transmission pan area. Drive shaft and seal is free of any fluid leaks. The rear differential is free of any fluid leak out. Shift transitions out on the road are correct across the board.

No fluid leak out from the front differential or center differential. 4 x 4 system functionality is correct.

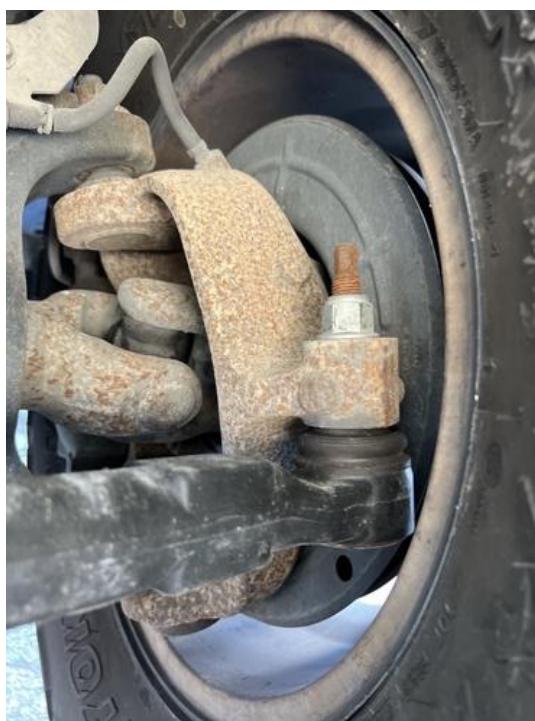
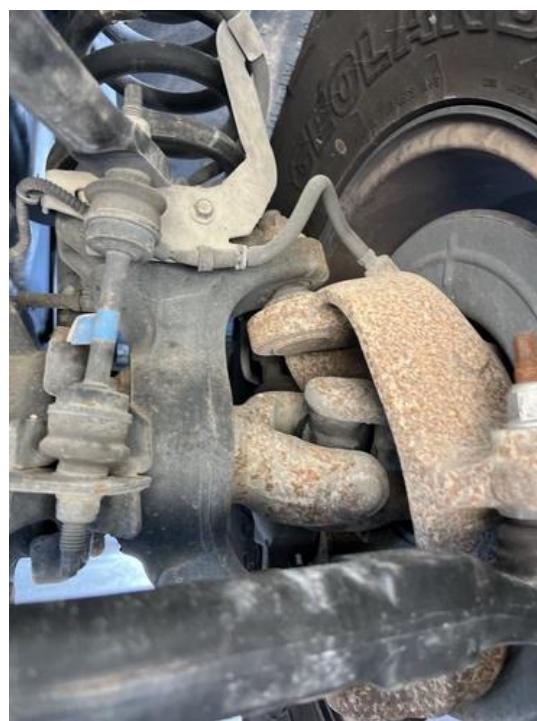
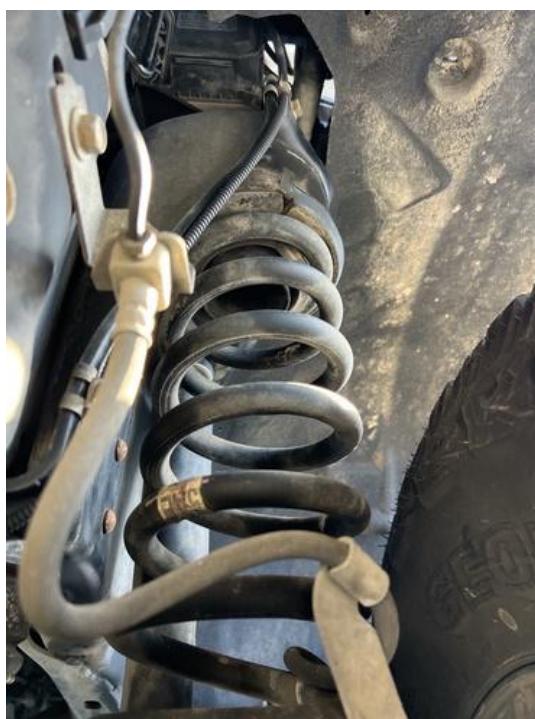
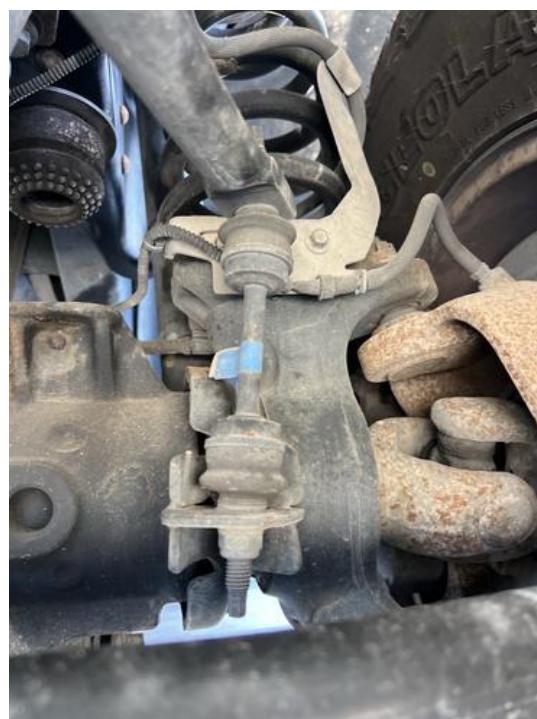
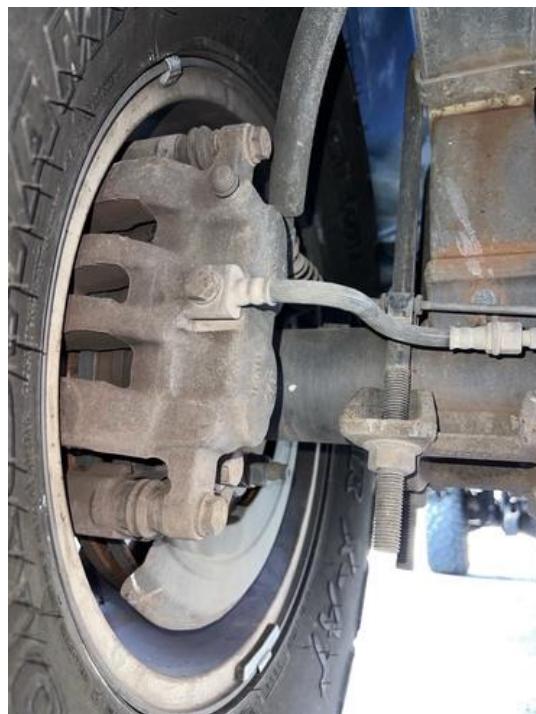
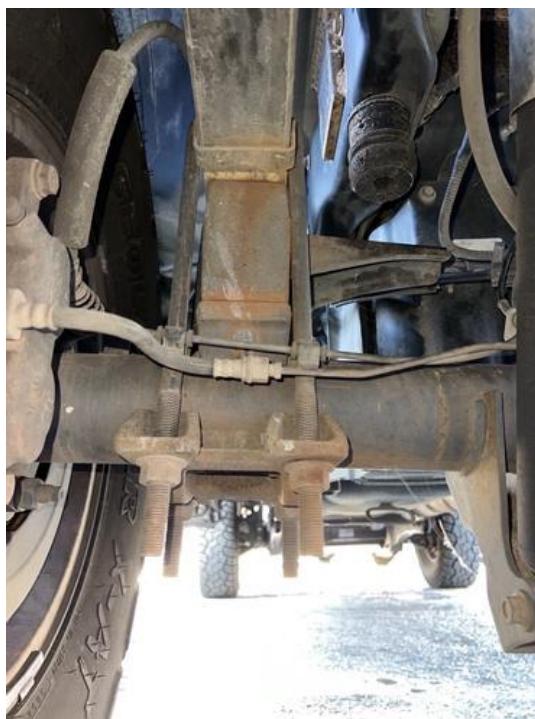
Normal fatigue notice to the suspension components. All of the suspension components seem to be original. None of the suspension components are blown out and due form the replacement. The No excessive surface rust on the exposed metal. No abnormal noise or feedback from the suspension while out on the road. All of the rubber in relation to the mounts, joints and bushings has decent texture.

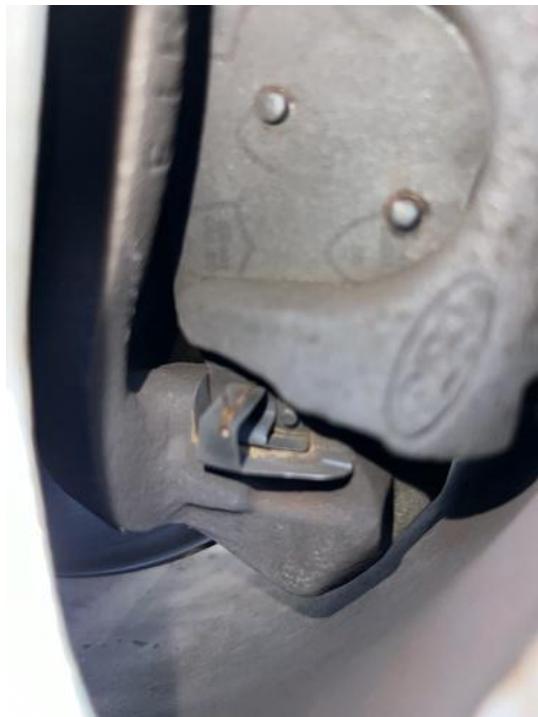
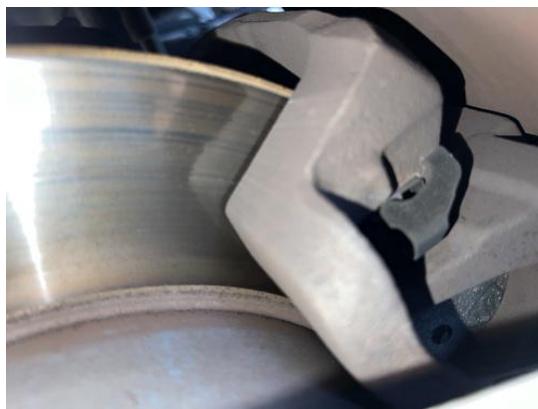
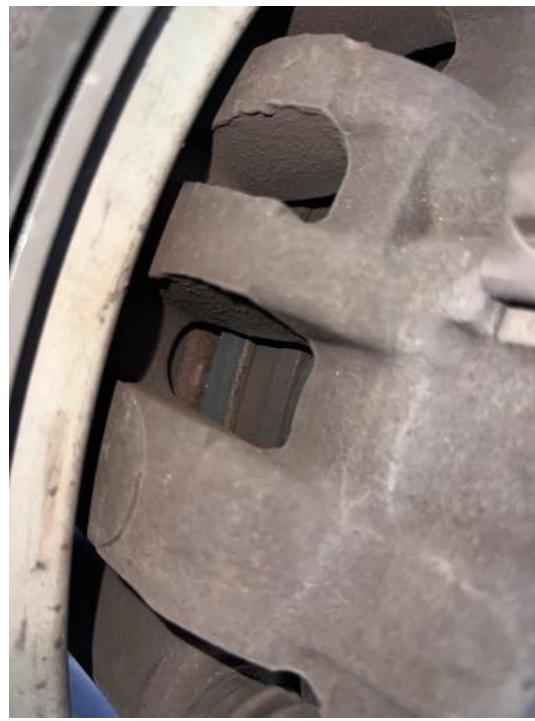
Right about 80% brake pad life remaining on the front brake system and right about 75% brake pad life remaining on the rear brake system.
