Peace of Mind Automotive Inspection Report.

Score	4 / 4 (100%)	Flagged items	0	Actions	0
Site conducted					Unanswered
Customer name					Luis LMJ auto motor sales
Date / Time					April 6th
Payment method					Invoice
Inspection cost					Fleet
Vehicle Year / Make / Model / Color					2012 ford f150 king ranch
VIN					10106 last 5

license plate					Dealer
Mileage					154009
Color					White

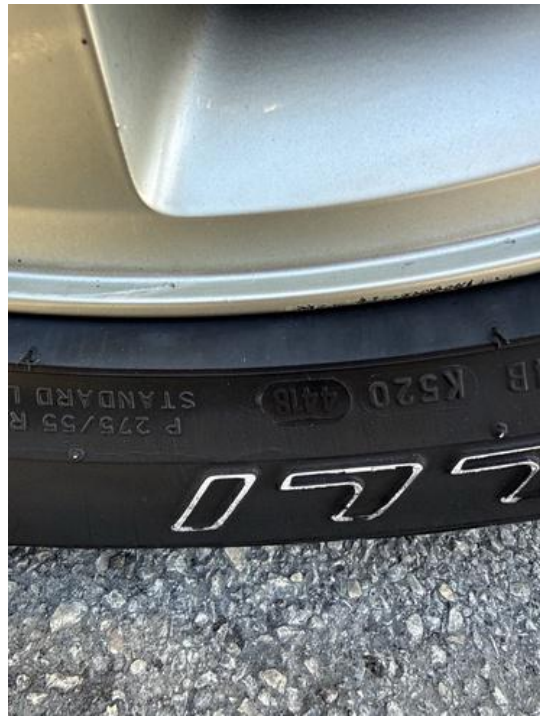
Photo 138

Tire condition

Front driver side tire

25-50% remaining

All four tires are aged and dated from 2018. All four tires will soon be due for a replacement although one of the tires is completely bald on the edge and should be replaced immediately.

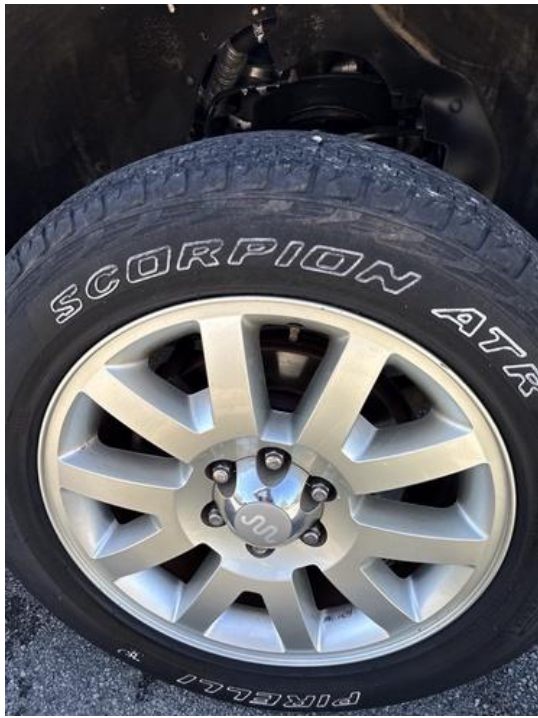
Photo 141

Front passenger side tire

25-50% remaining

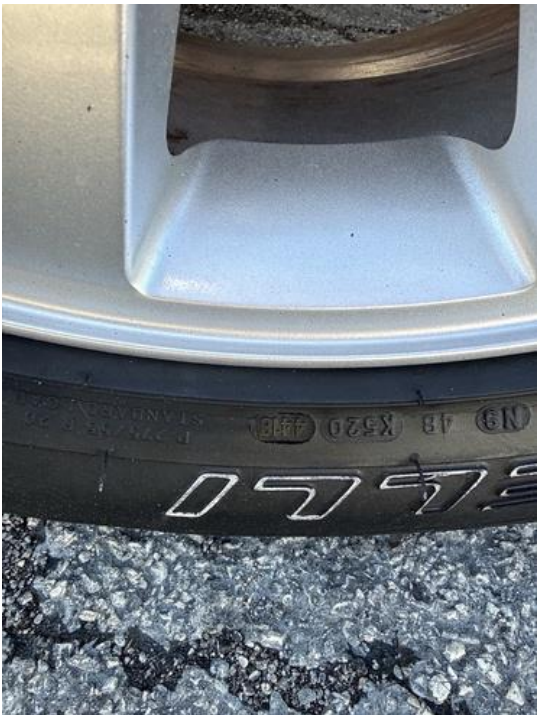
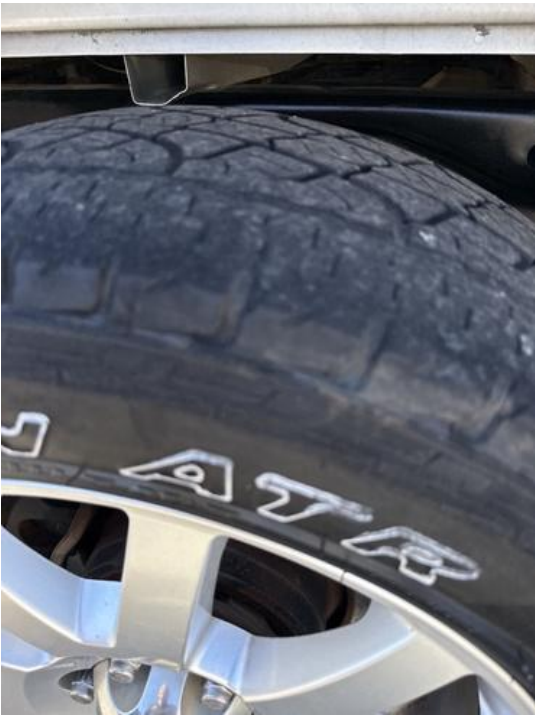
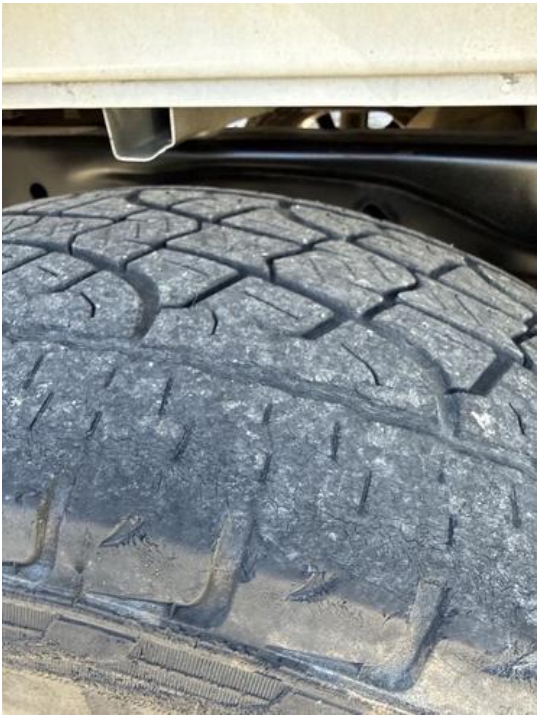
Rear passenger side tire

0-25 % remaining

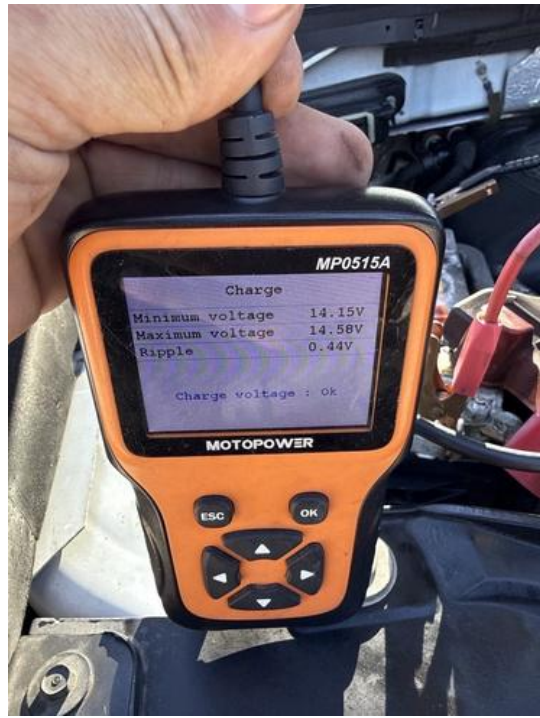
Photo 150

Battery / charging system

Standing voltage 12.8

Loaded voltage 14.58

Battery is accepting the charge from the alternator and the alternator charge output is correct

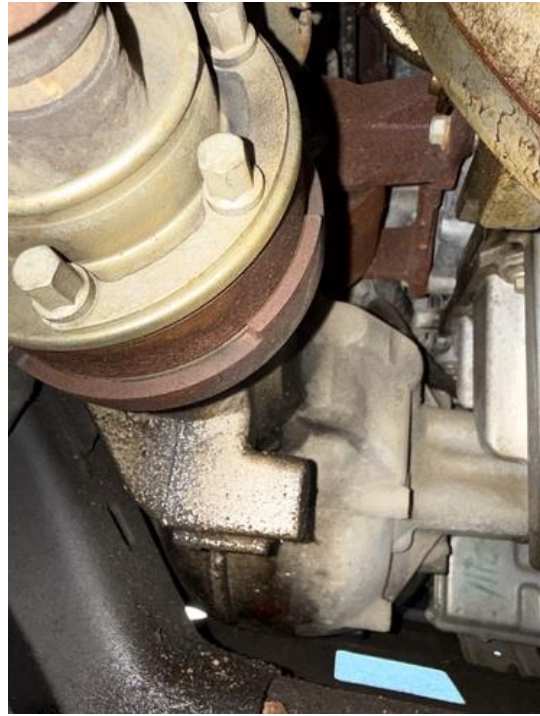
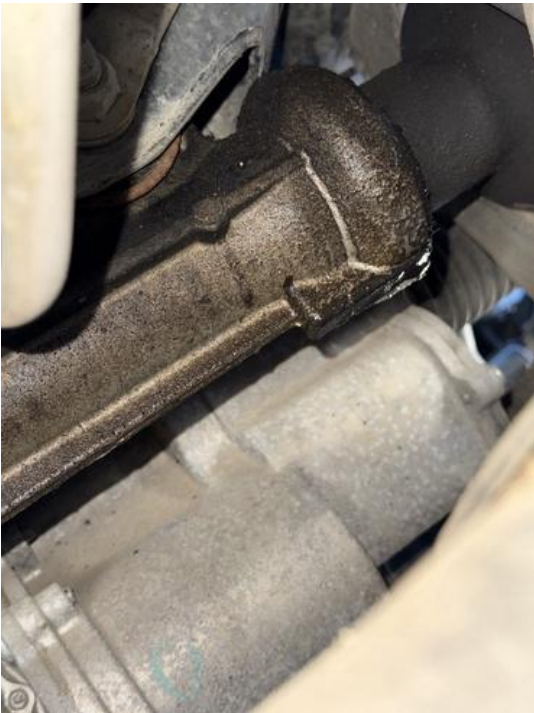
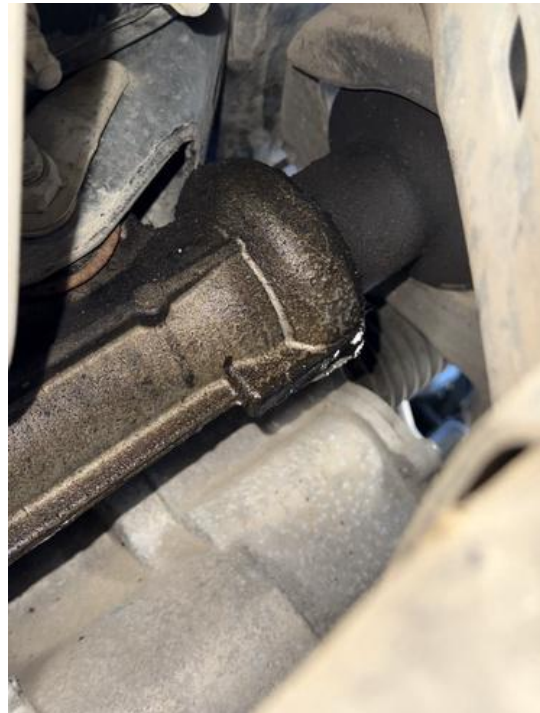
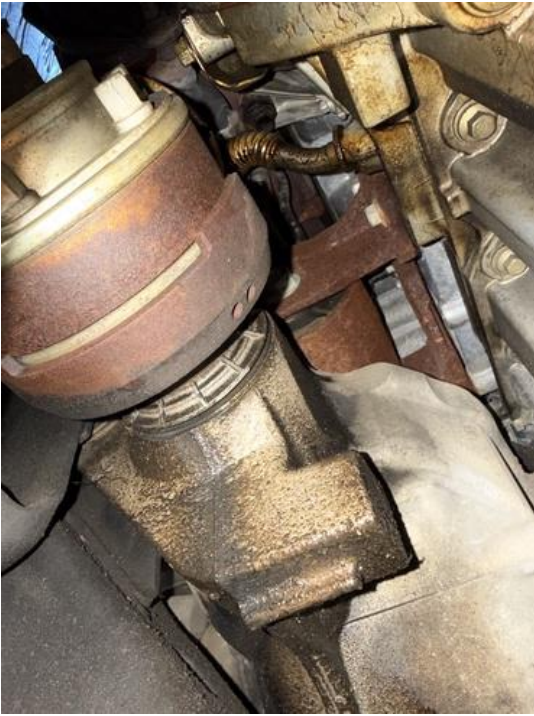
Front differential condition	Issue present
-------------------------------------	---------------

There was some fluid seepage notice from the front differential and front axle area. Seemed as if the input shaft seal on the front differential has started to leak as well as the passenger side axle seal.

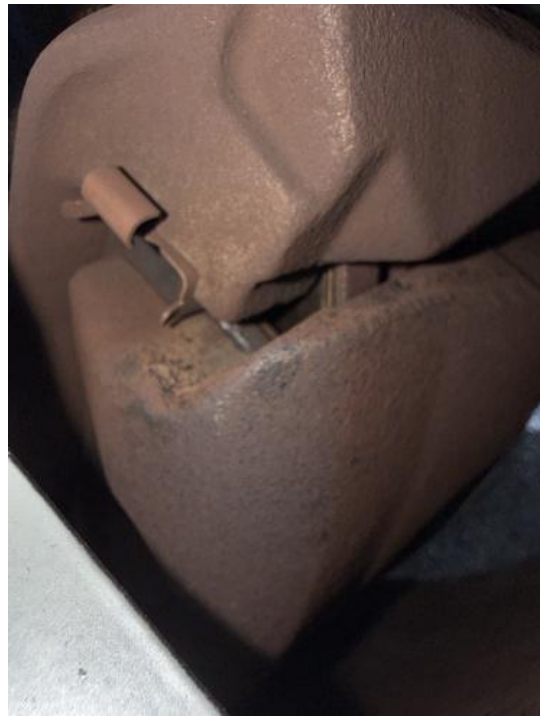
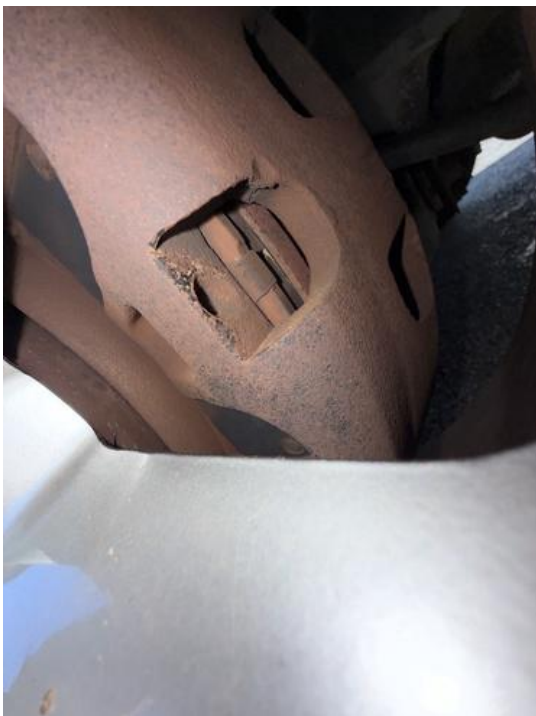
Braking system condition	
Brake fluid condition	Healthy
Brake fluid level	Healthy
Brake fluid leaks	None
Moisture content in brake fluid	None
Brake lines	Healthy
Brake calipers front	Healthy
Brake calipers rear	Healthy
Brake drums rear	N/A
Brake rotors front	Healthy
Brake rotors rear	Healthy
Front brake pad life remaining Right around 35% brake pad life remaining

Photo 198 Photo 199	25-50% remaining
Rear brake pad life remaining Right about 70% brake pad life remaining
