## Peace of Mind Automotive Inspection Report.

<b>Site conducted</b>	Unanswered
<b>Customer name</b>	Luis Imj auto motor sales
<b>Date / Time</b>	Dec 26th
<b>Payment method</b>	Invoice
<b>Inspection cost</b>	199
<b>Vehicle Year / Make / Model / Color</b>	2012 Lincoln navigator

<b>VIN</b>	02279 last 5

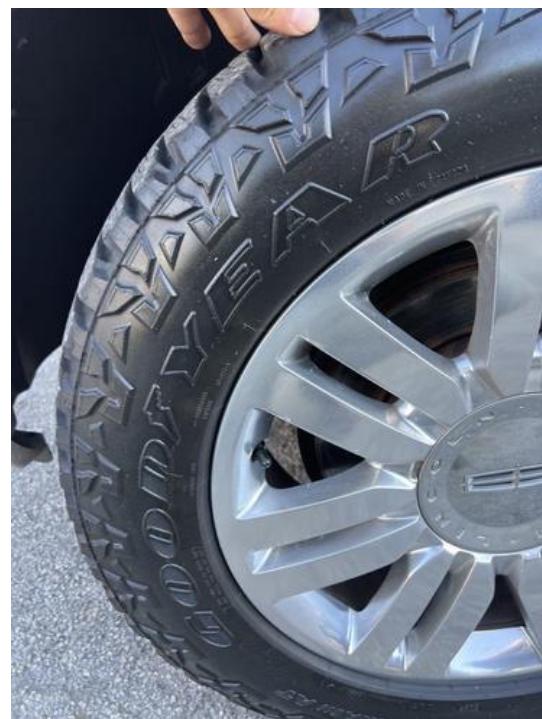
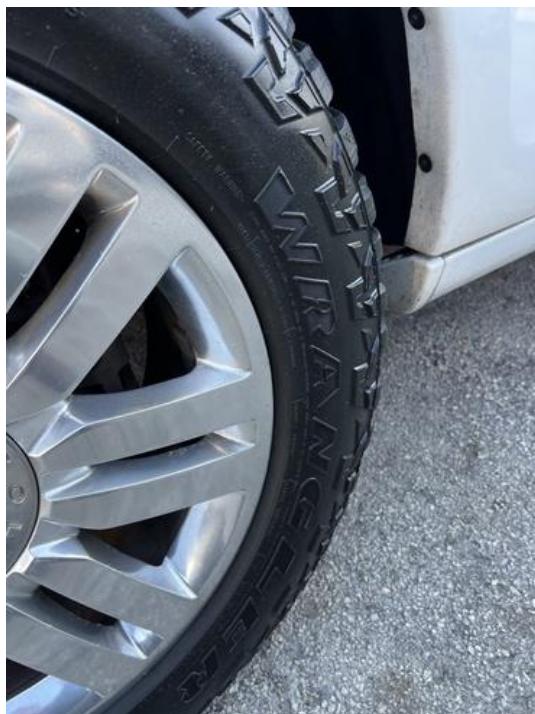
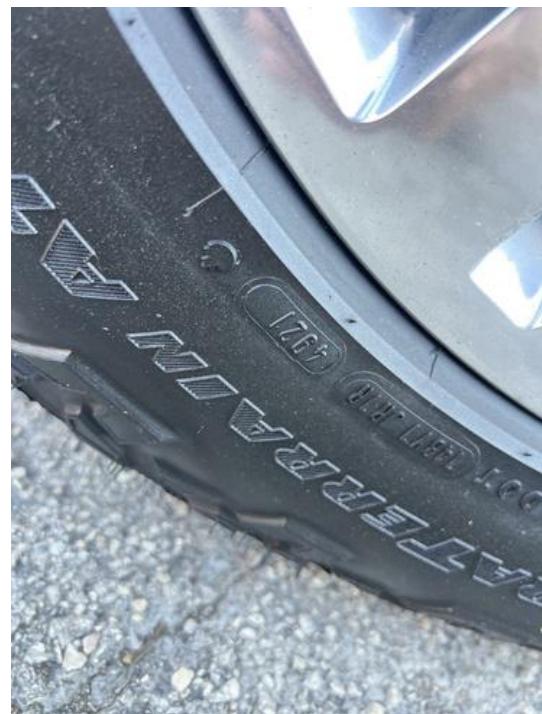
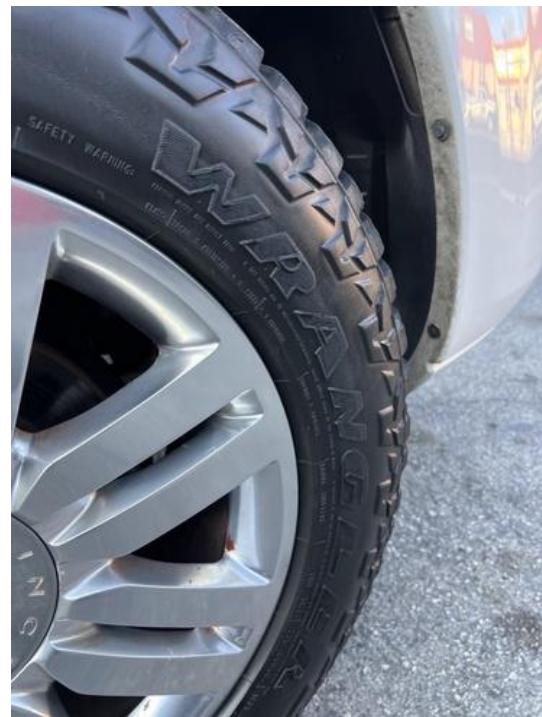
All four tires are matching and in healthy condition. Tires are dated from late 2021. All four tires have right around 70% tread life remaining and are evenly worn.

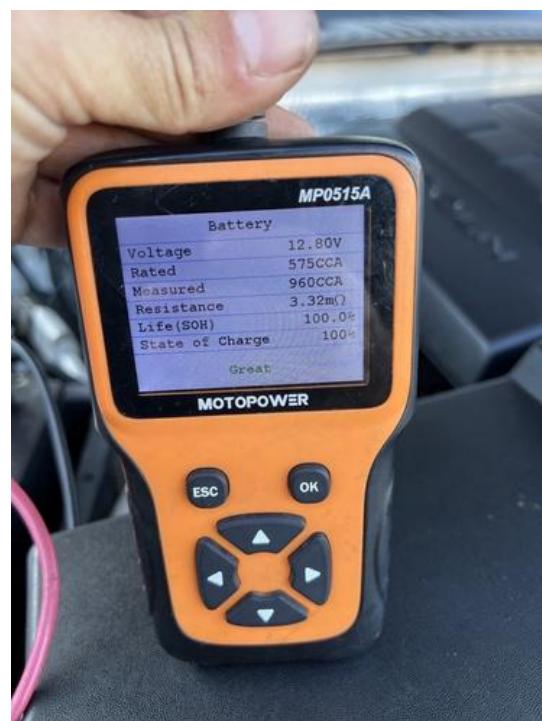
Photo 136

12.8

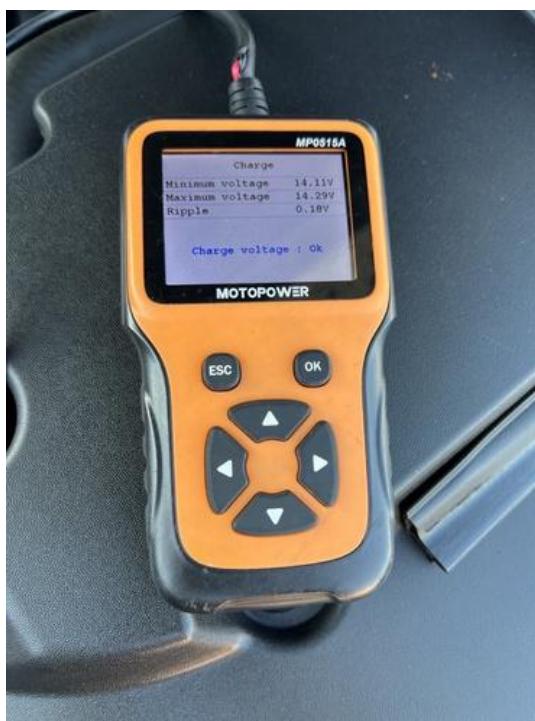
Photo 137

14.29

Battery is accepting the charge from the alternator and the alternator charge output is correct

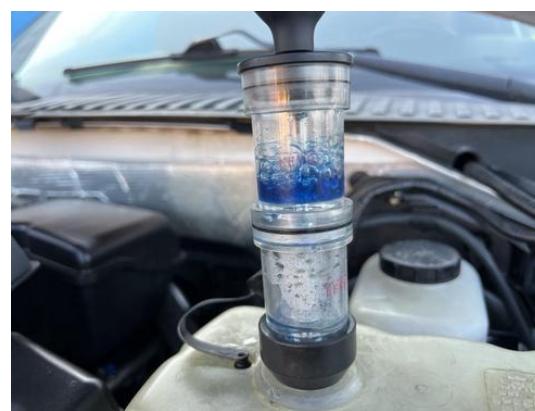
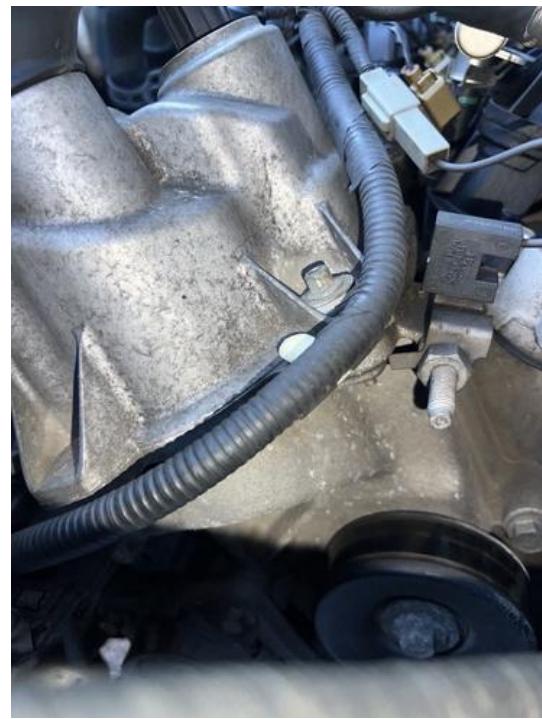
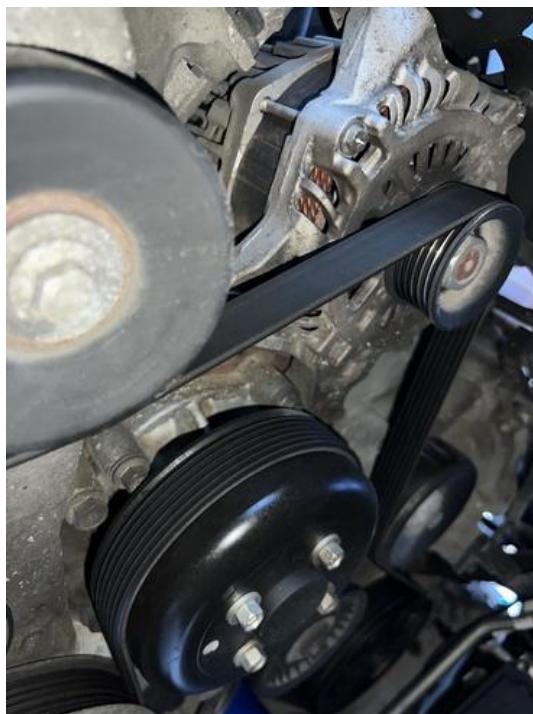
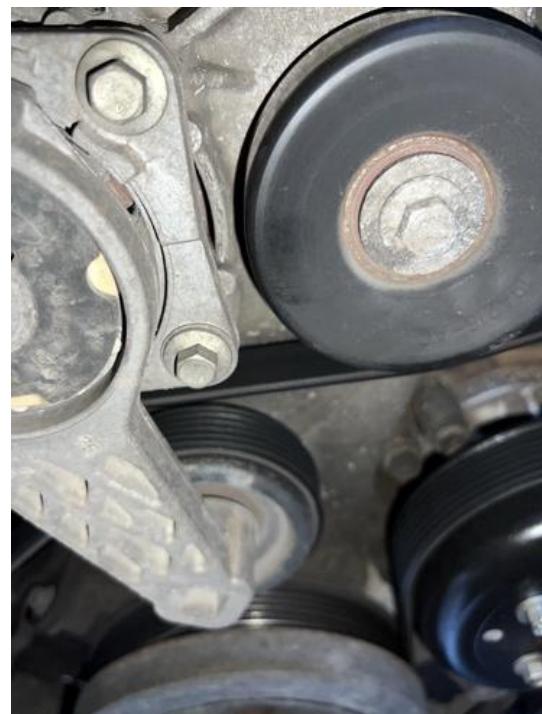
Engine clean internally, no excessive gunk or sludge present, there was a little bit of discoloration, noticed up on internally, inspecting the engine. Would suggest reducing oil change intervals from here on out to around 4000 miles. Would not hurt to run a engine flush as well toward the end of the next oil change to help break down a little bit of the buildup. Coolant level is slightly low in the reservoir, would suggest filling up the coolant reservoir. As of the time of the inspection, there is no evidence of any sort of coolant consumption nor any sort of coolant leak out externally from anywhere on the engine/cooling system.. Proper signs of maintenance present. Block test passed, no internal combustion leak out. All external engine accessories in good working. No oil leaks or seepage from anywhere on the engine. External drive belts in decent condition. Currently no concern in mechanical issues present in relation to the engine or related accessories.

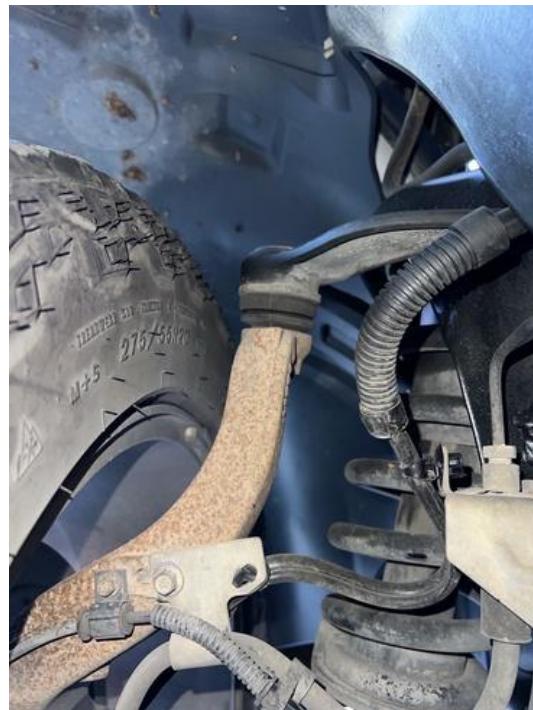
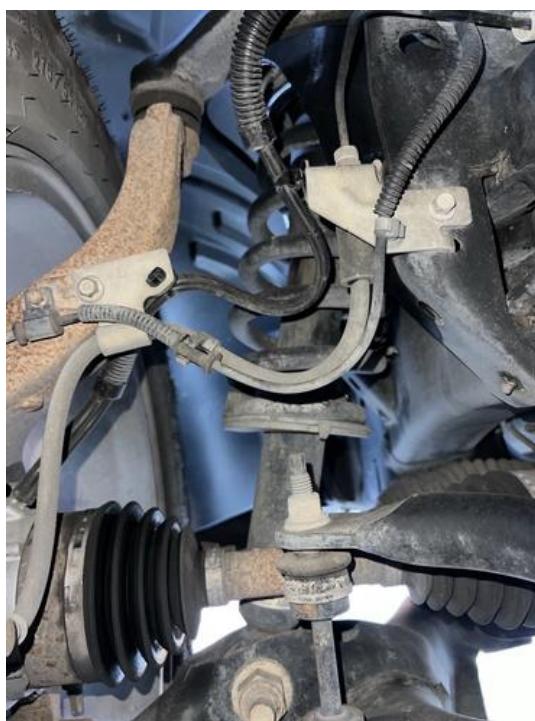
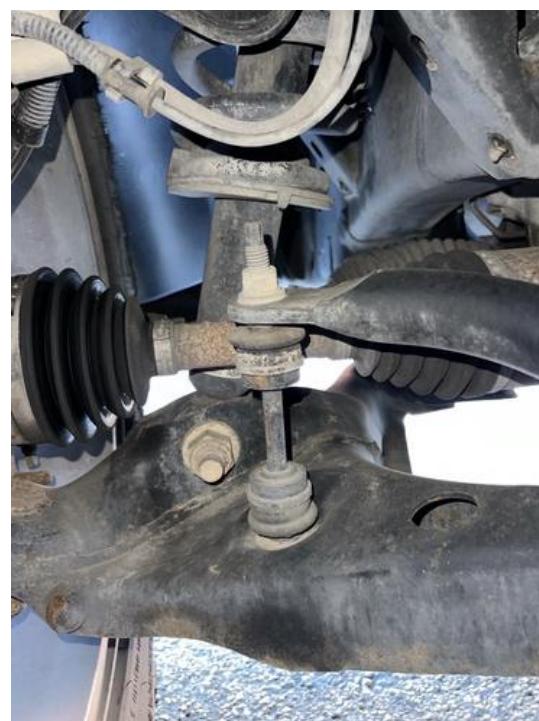
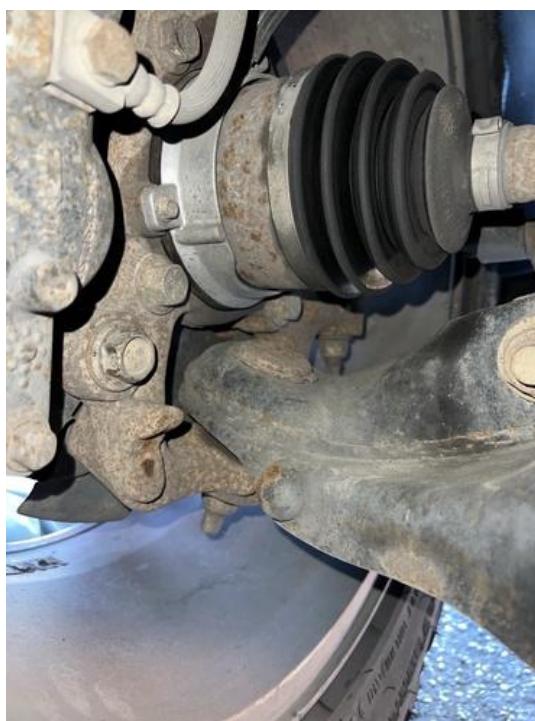
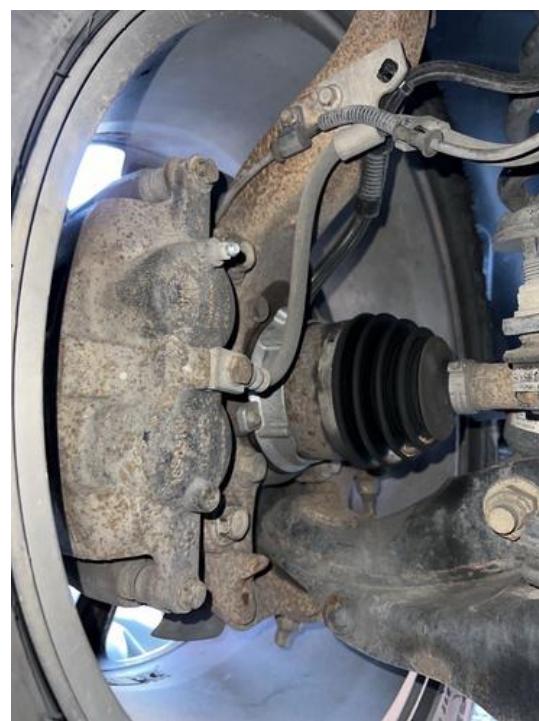
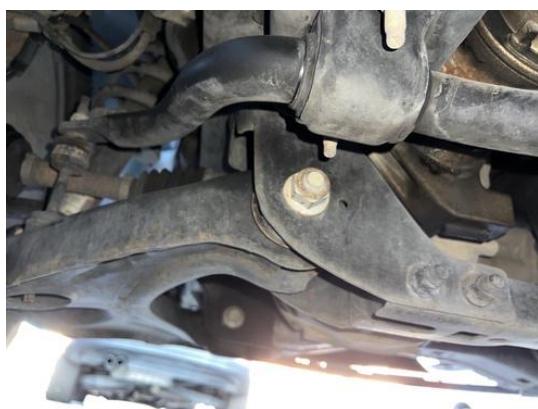
Normal fatigue notice to the suspension components. All of the suspension components seem to be original. None of the suspension components are blown out and due form the replacement. The No excessive surface rust on the exposed metal. No abnormal noise or feedback from the suspension while out on the road. All of the rubber in relation to the mounts, joints and bushings has decent texture.

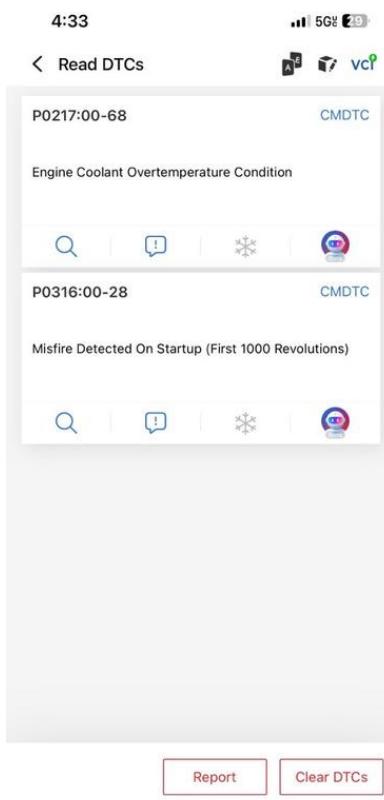
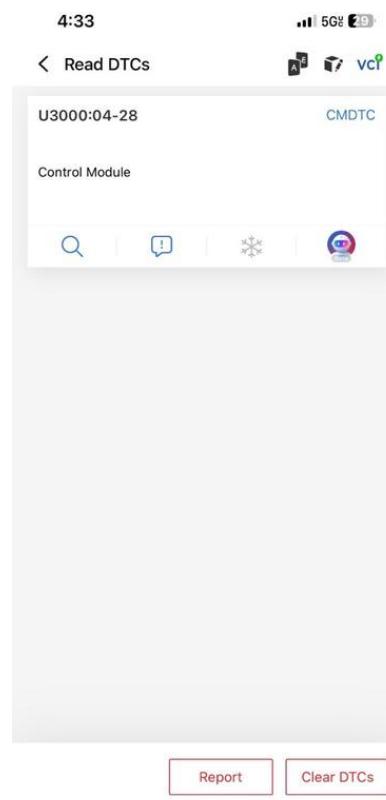
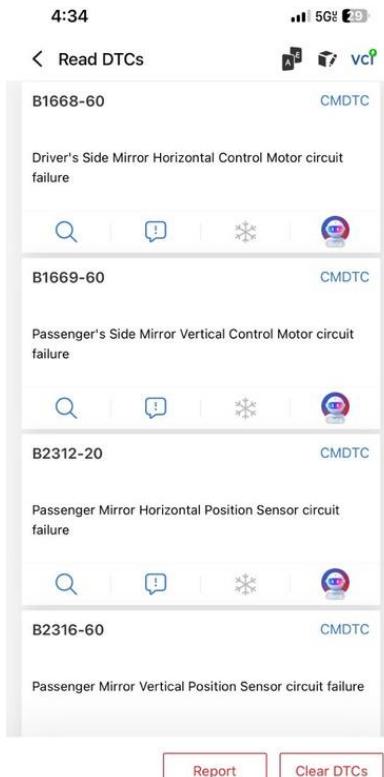
There are no active diagnostic fault codes present across any of the control modules on the vehicle. There were a few different different historical diagnostic codes although none of these codes are live/active and not of any current concern.
