## Peace of Mind Automotive Inspection Report.

| Vehicle Year / Make / Model / Color | | | | 2013 ford f150 | |
| Mileage | | | | 174411 | |

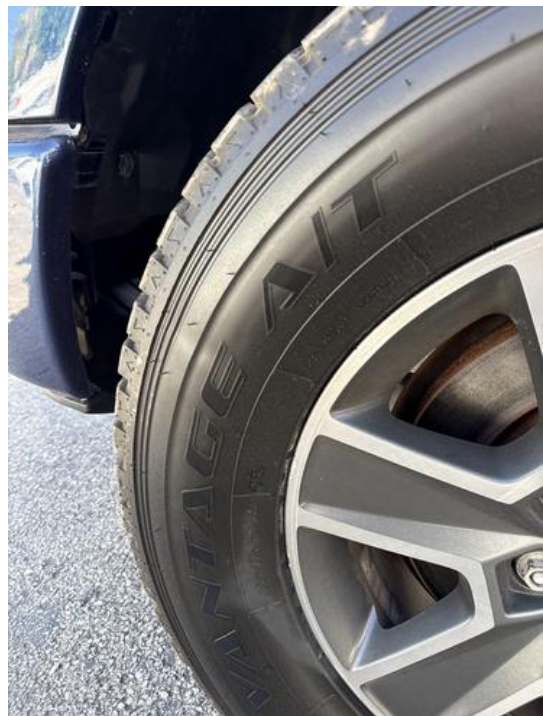
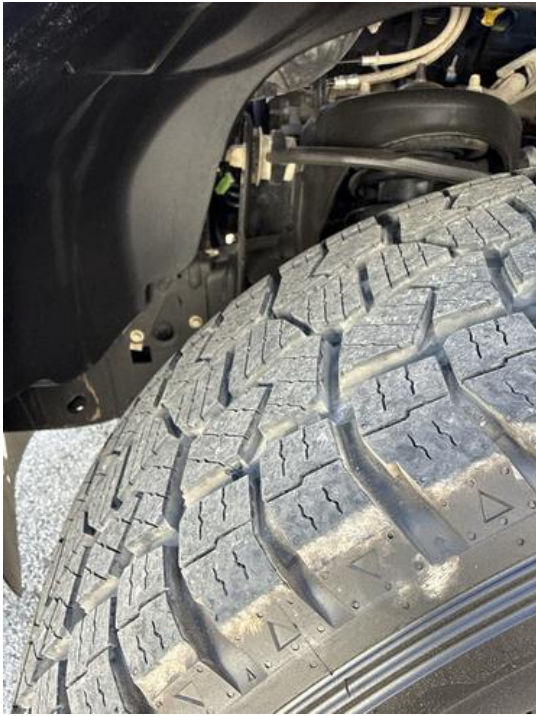
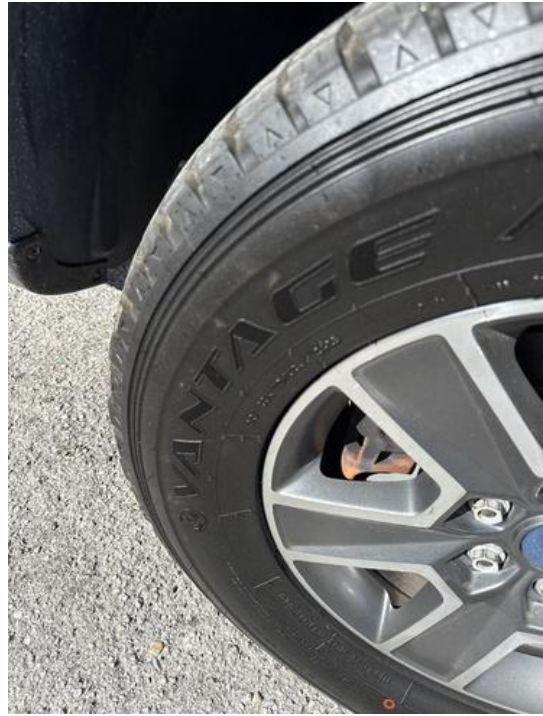
All four tires are dated from 2025 and have been recently replaced. Tires are matching and in healthy condition with over 85% tread life remaining.

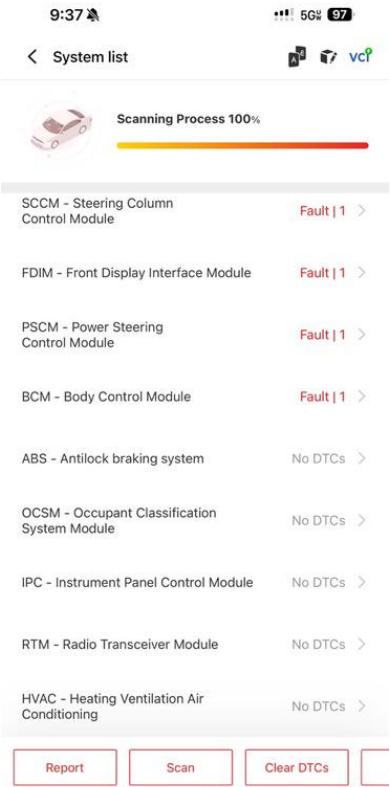
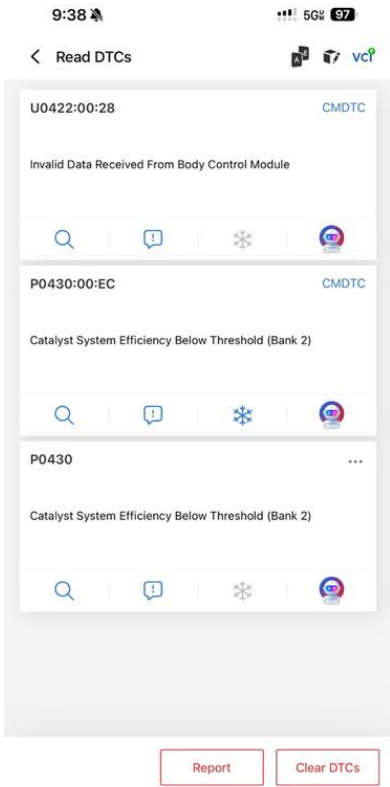
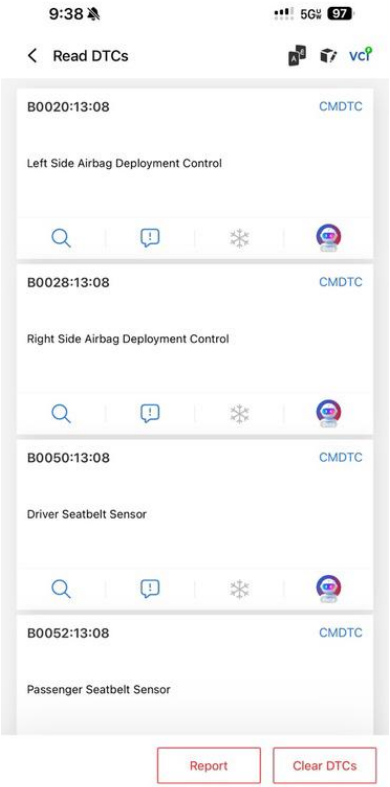
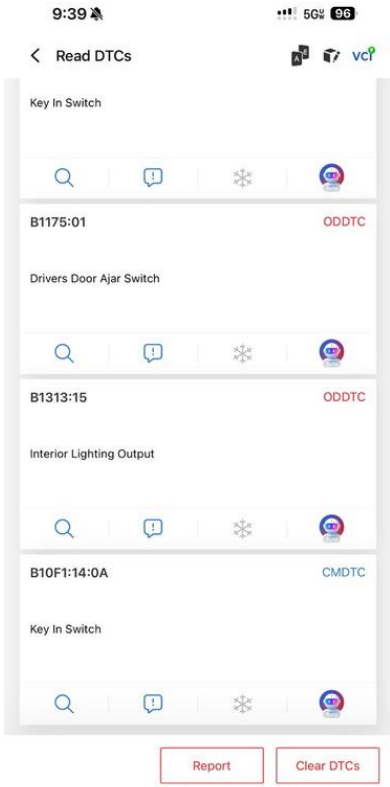
The only active warning light present at the time of the inspection was the check engine light, there were a couple of different fault codes present within the engine control module in relation to the catalyst efficiency. This could be an indication that the original catalytic converters are starting to flow not as well as they are supposed to. All of the other fault codes within the other control modules were non-active/historic.
