## Peace of Mind Automotive Inspection Report.

| Vehicle Year / Make / Model / Color | | | | 2013 ford f250 | |

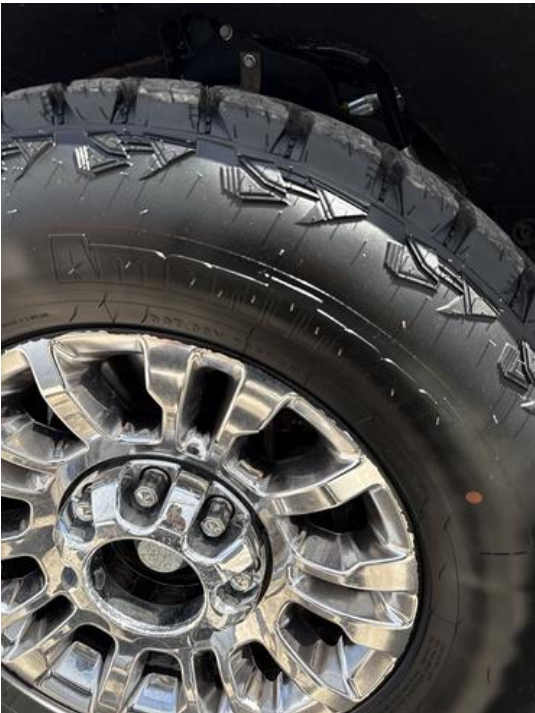
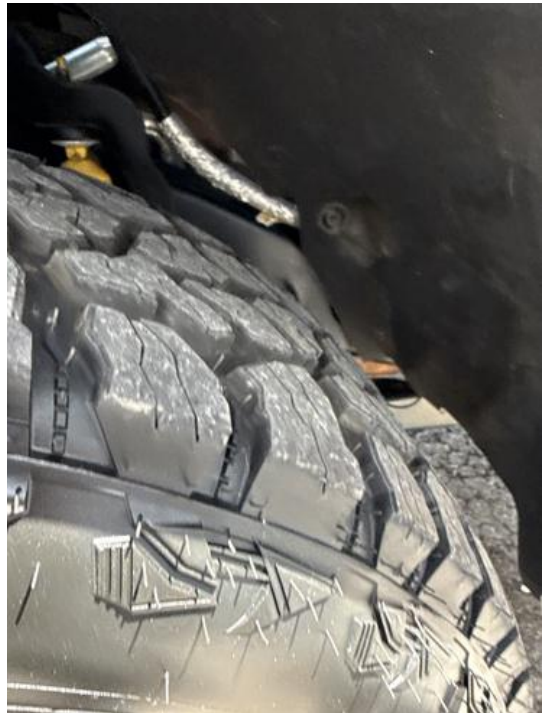
Photo 85

All four tires are matching and have been recently replaced, tires have over 95% tread life remaining

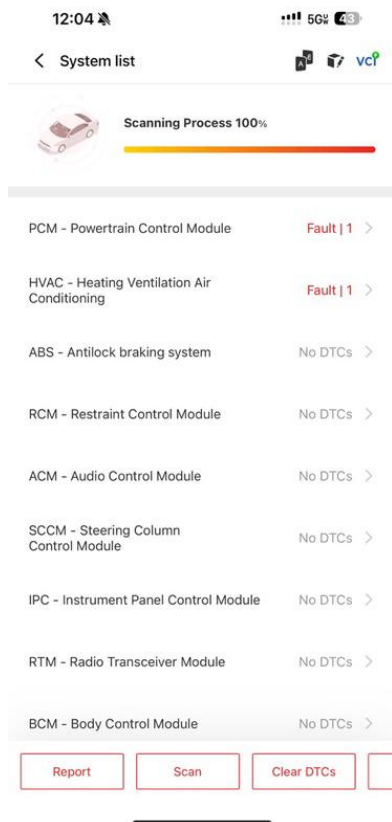
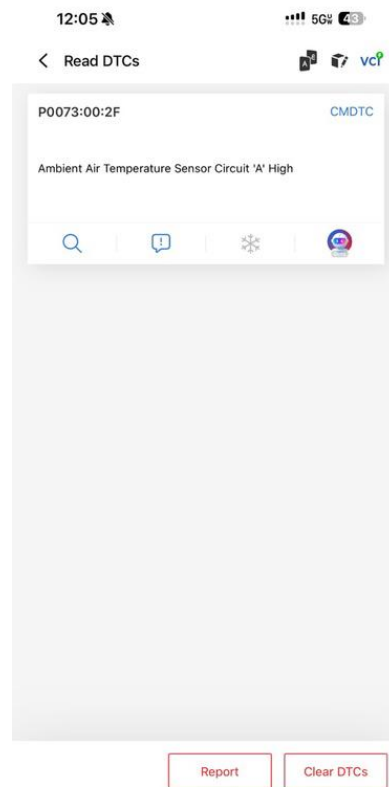
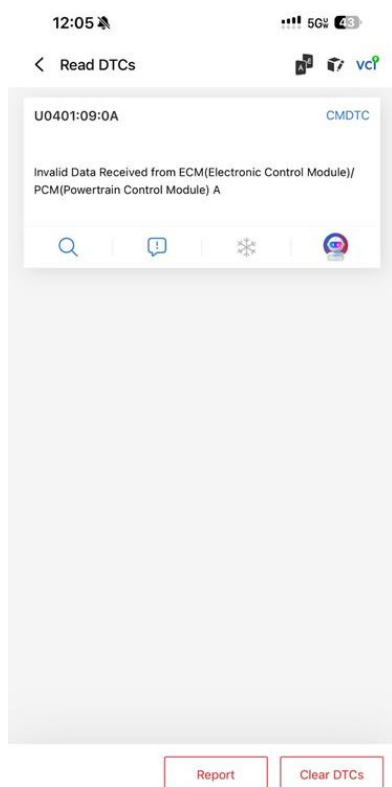
At the time of the inspection, there were no active warning lights present. All of the live feed diagnostic testing was successfully passed. All of the live feed emission testing was successfully passed.
